Real-Time Water Quality Report

Outer Cove Brook Network

Deployment Period
June 2, 2015 to July 22, 2015

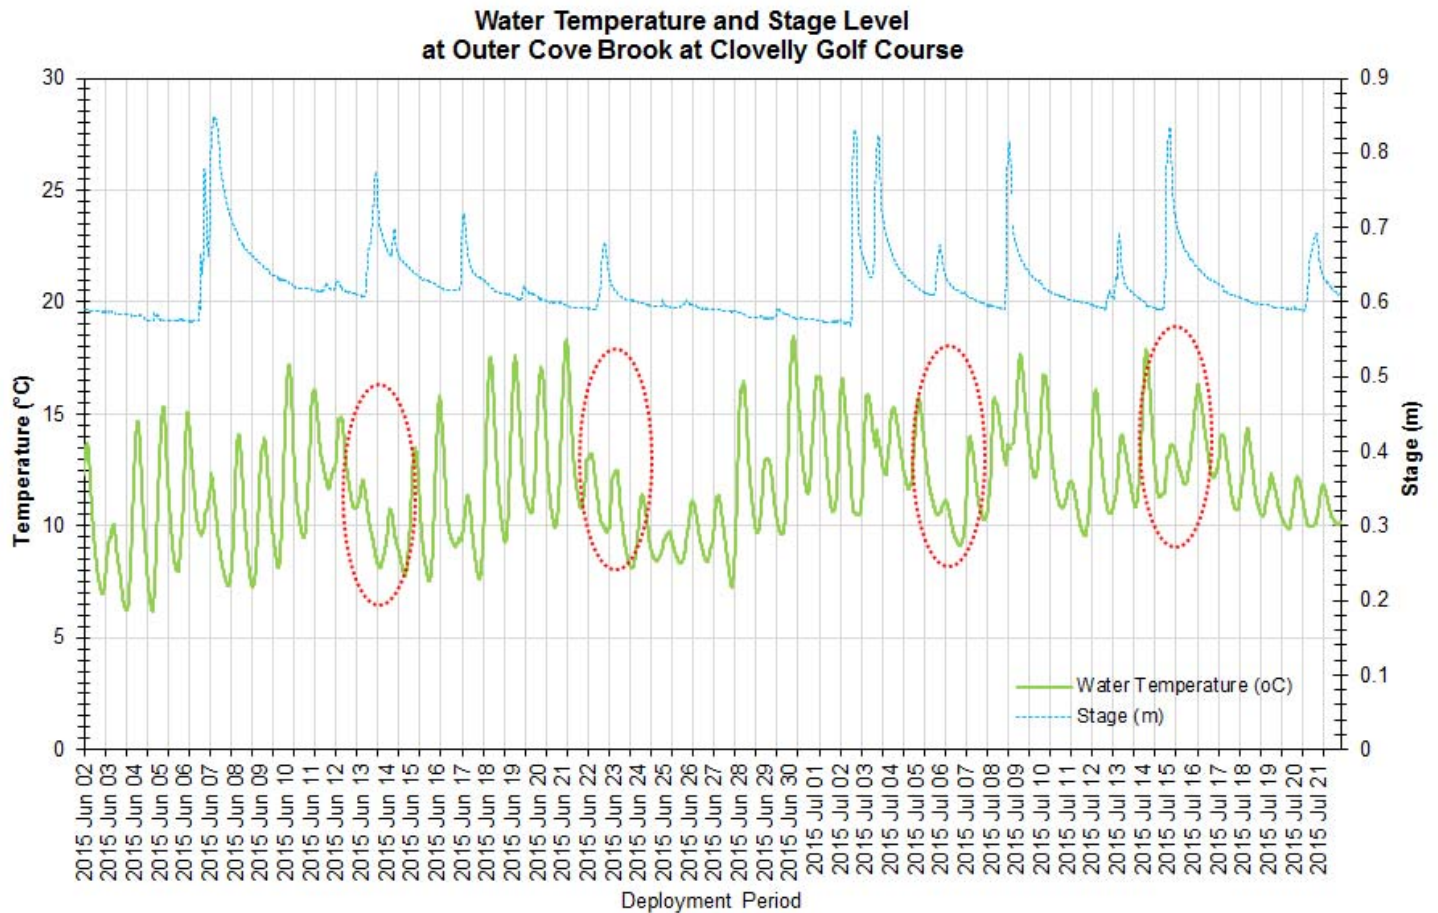
Water temperature ranged from 6.20°C to 18.51°C during this deployment period (Figure 8).

During this deployment period the water temperature remains reasonably consistent. Water temperatures dip slightly during higher stage levels circled in red on Figure 8.

Figure 8: Water temperature (°C) and Stage (m) levels at Outer Cove Brook at Clovelly Golf Course.

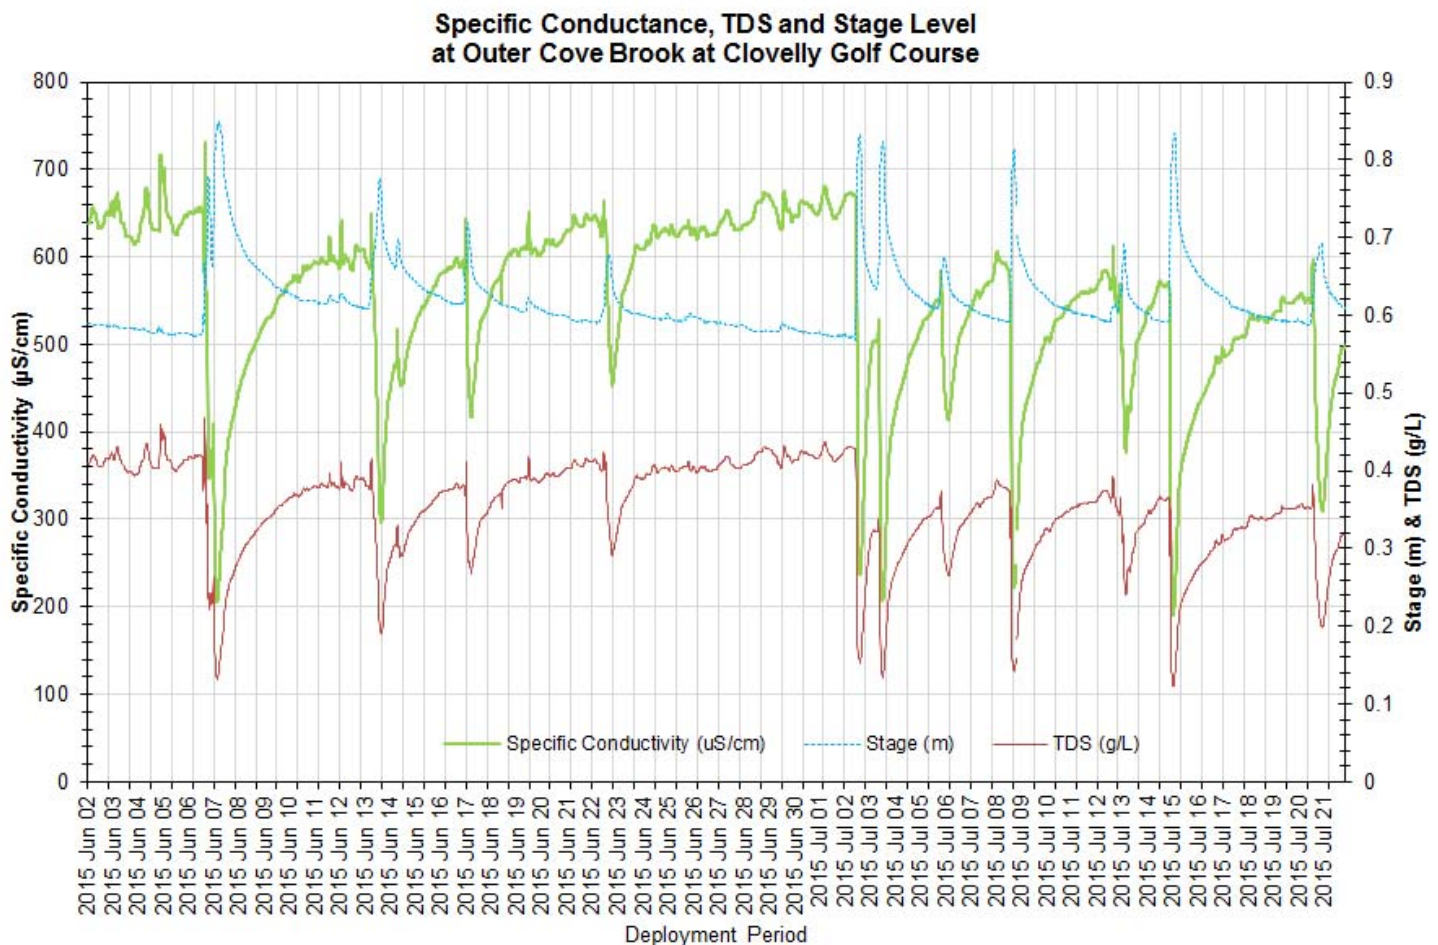
The conductivity levels were within 190.7 μ S/cm and 731.0 μ S/cm during this deployment period. TDS ranged from 0.1220g/L to 0.4680g/L (Figure 10)

Generally, rainfall saturates the brook and flushes the dissolved particles from the water column diluting the conductivity levels for a short period of time. This is evident on Figure 10, as the stage increases in the brook the conductivity levels dip for short periods of time.

Total Dissolved Solids (TDS), is a parameter that the instrument calculates by an algorithm that utilizes the data from specific conductivity and water temperature to produce a TDS value and generally always mirrors specific conductivity.

Figure 10: Specific conductivity (μ S/cm) and stage (m) values at Outer Cove Brook at Clovelly Golf Course.

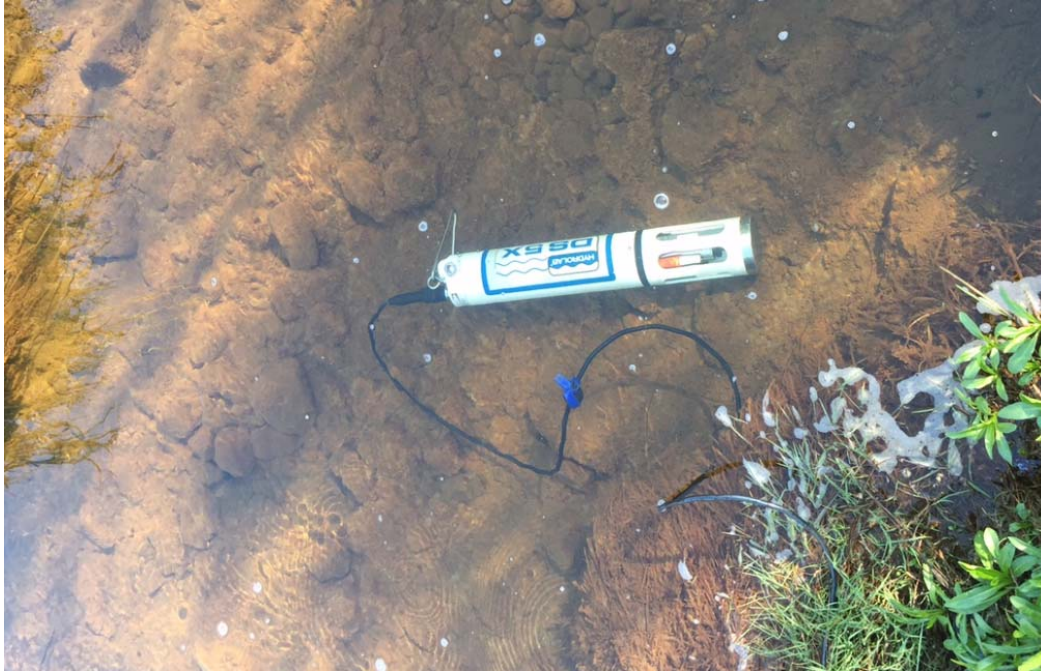
The Outer Cove Brook stations during the winter months are coated in a brown-grey slime like algae that will coat whatever is present in the brook during this time. As the water temperatures increase the slime like algae starts to sloth off and can cause disturbance in the turbidity levels of the brook as well as the dissolved oxygen levels (Appendix I).

Figure 14: QAQC sonde in Outer Cove Brook below Airport. Evidence of the algae present on the brook floor.

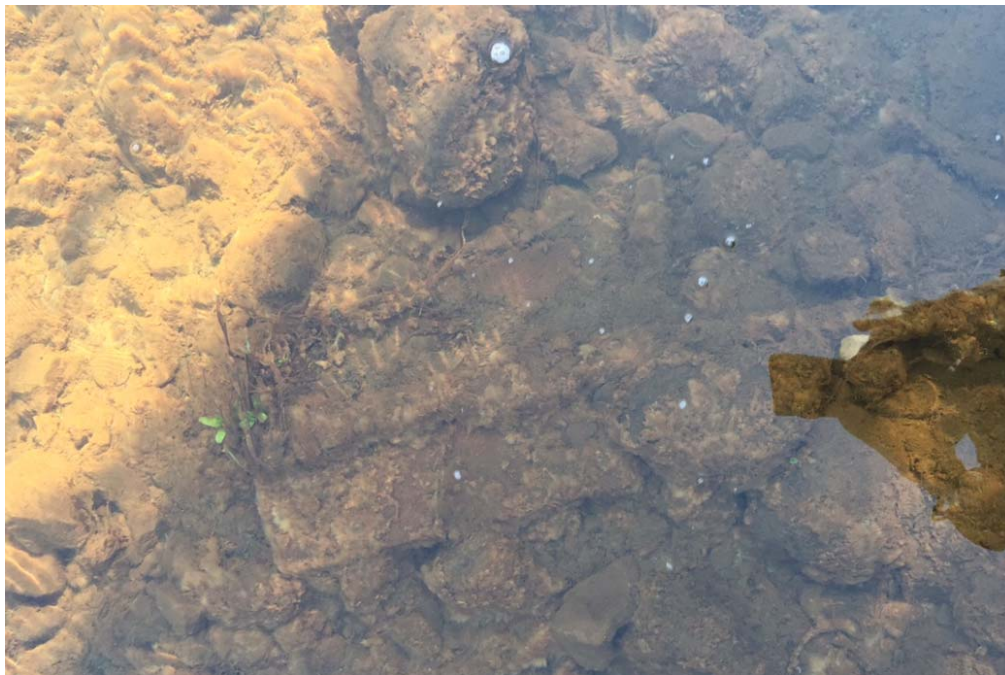
Figure 15: Outer Cove Brook below Airport. A closer look at the algae present in the brook.

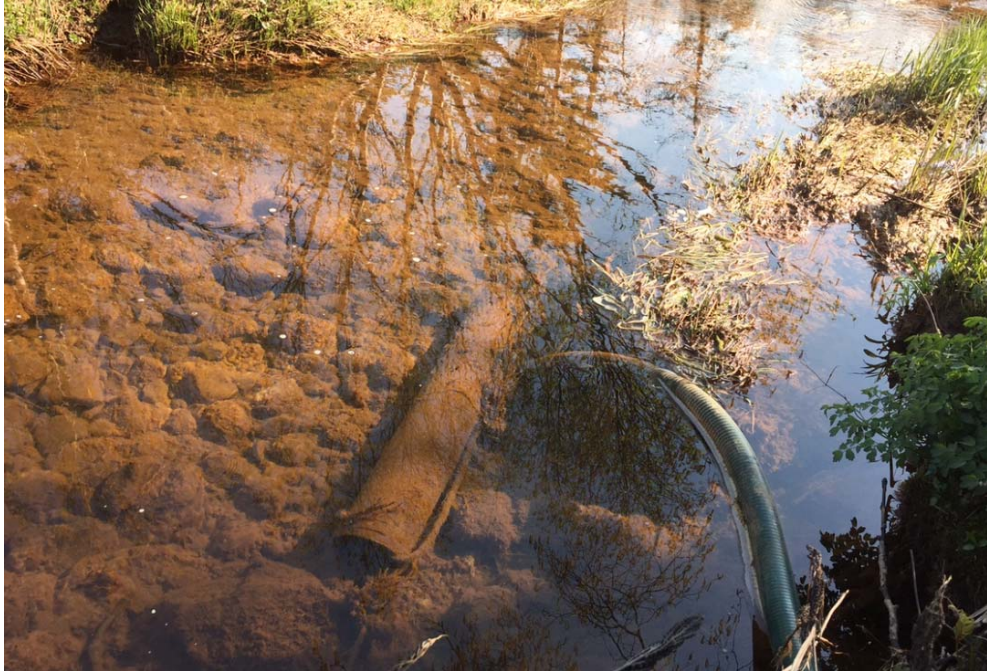
Figure 16: Field Instrument in Outer Cove Brook below Airport. Algae is present on everything in the water

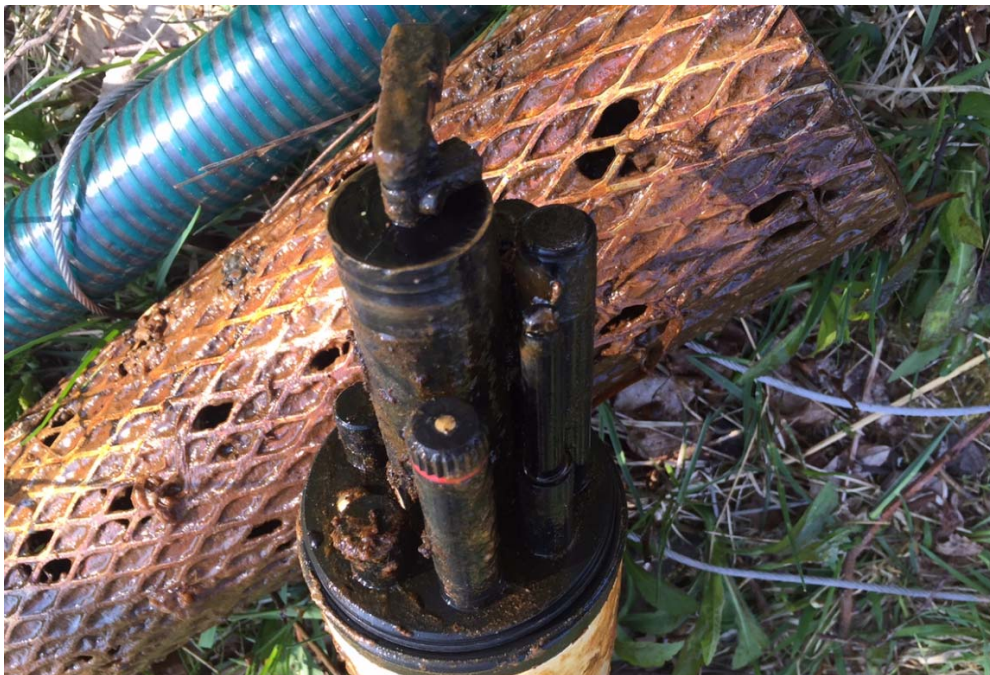
Figure 17: Field Instrument from Outer Cove Brook below Airport removed after a deployment period. Algae are present on the instrument however the wiper has managed to keep majority of the fouling away from the tops of the sensors.
