Town of Brighton Dam Restoration Project

Brighton Original Reservoir Dam

Dam Restoration Design

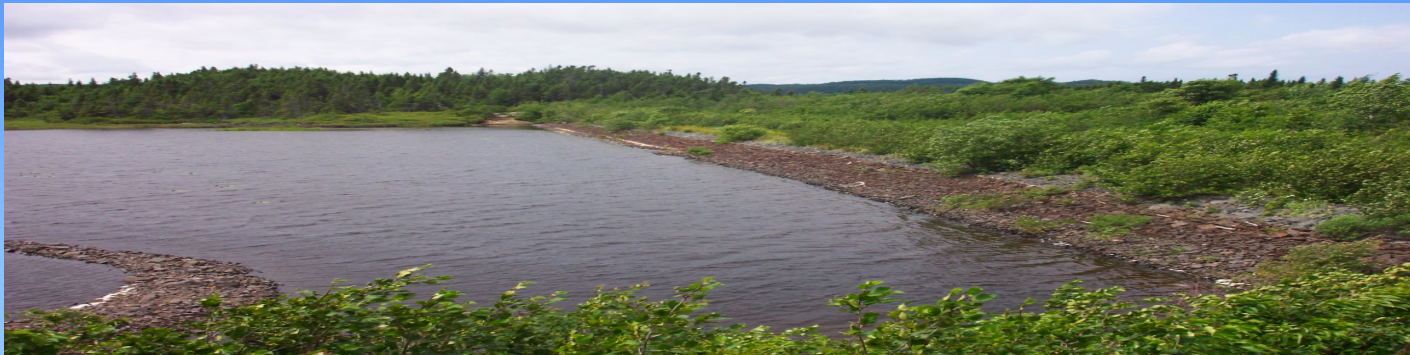
- The original Brighton dam was constructed in the 1980's
- Towards the end of the decade the town started noticing leaks on the downstream base
- The town first considered the leaks minor but over time the problem escalated
- By 2007 the leakage had become so bad the town enlisted the help of Angus Bradley from Municipal Affairs to do a leak survey subsequently identifying 19 leaks.

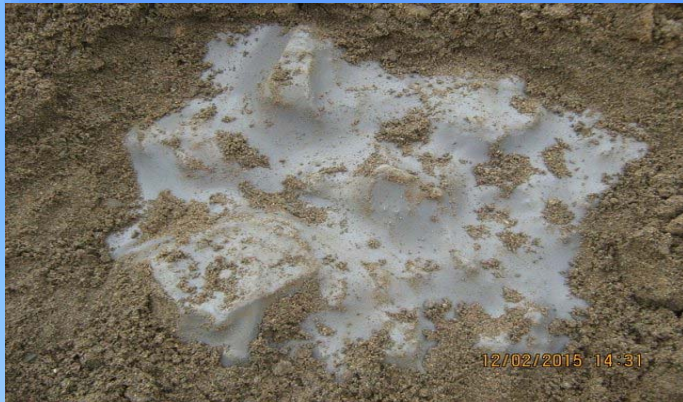
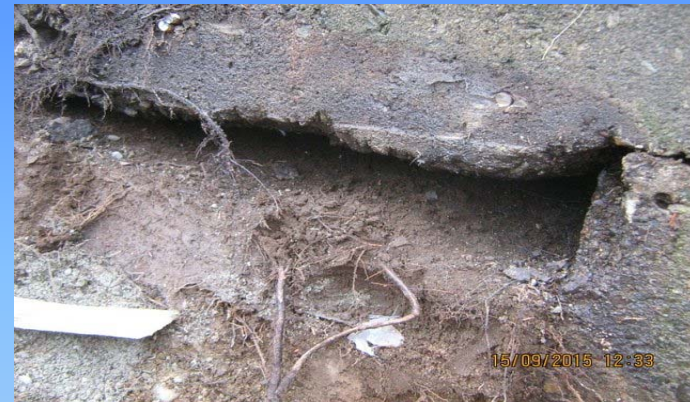
Further investigation revealed two main causes for the excessive leakage problem in the old dam:

- The HDPE liner had been placed directly on rock fill with no protective sand & gravel bedding layer. This would eventually lead to failure of the liner.
- Improper sealing of the liner to the concrete spillway created a large leak under the spillway.

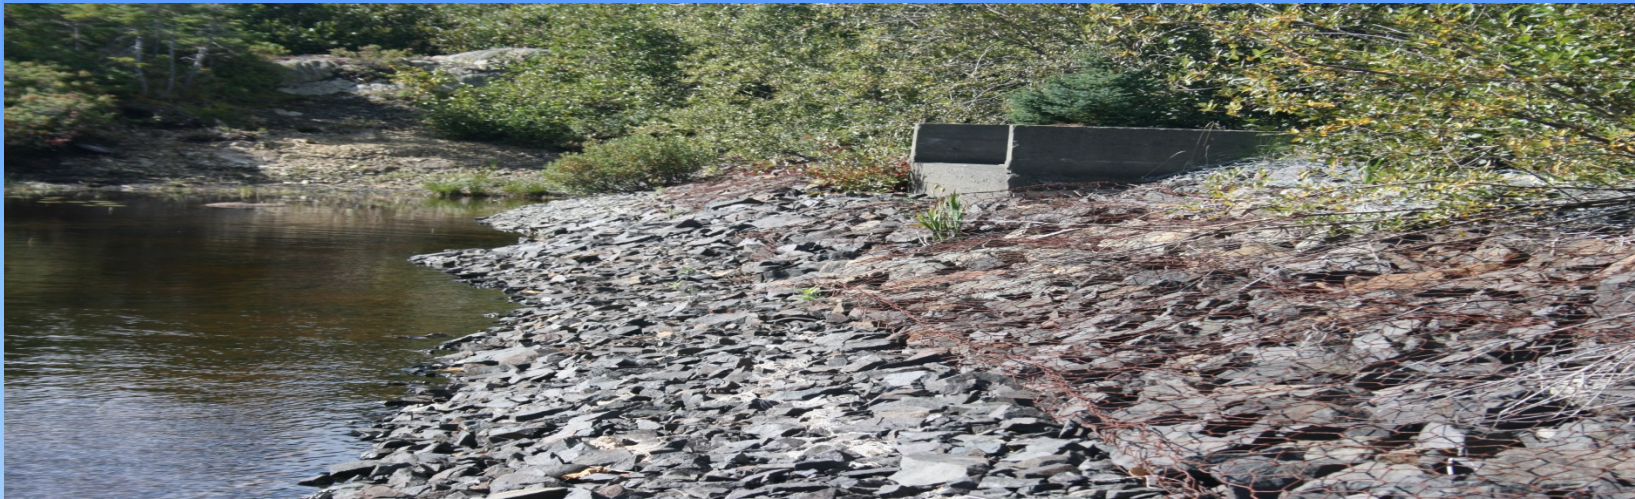
The loss of water caused major consequences for the town

- The town came seriously close to running out of water during summer months
- The operator had to keep close watch on the pumps to ensure they did not run dry due to low water

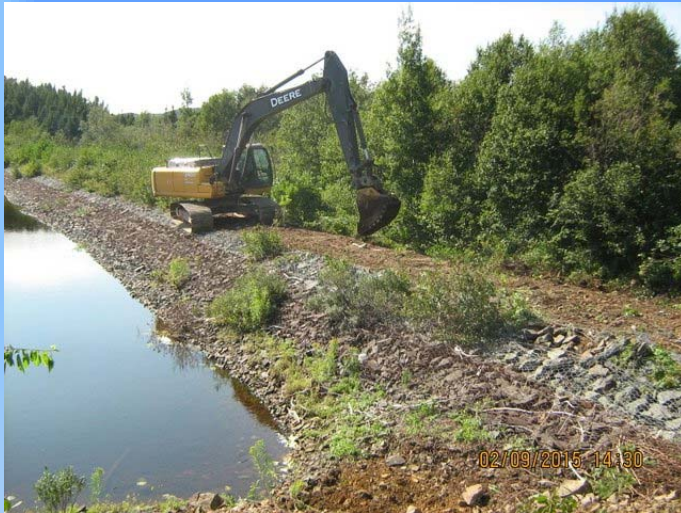
Grubbing work was carried out on both sides of the dam

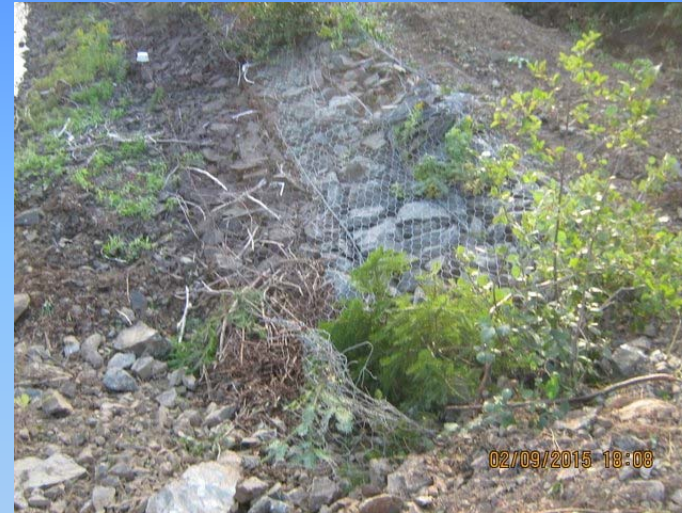
Excavation of the dam itself involved the removal of these rock gabions and the old liner

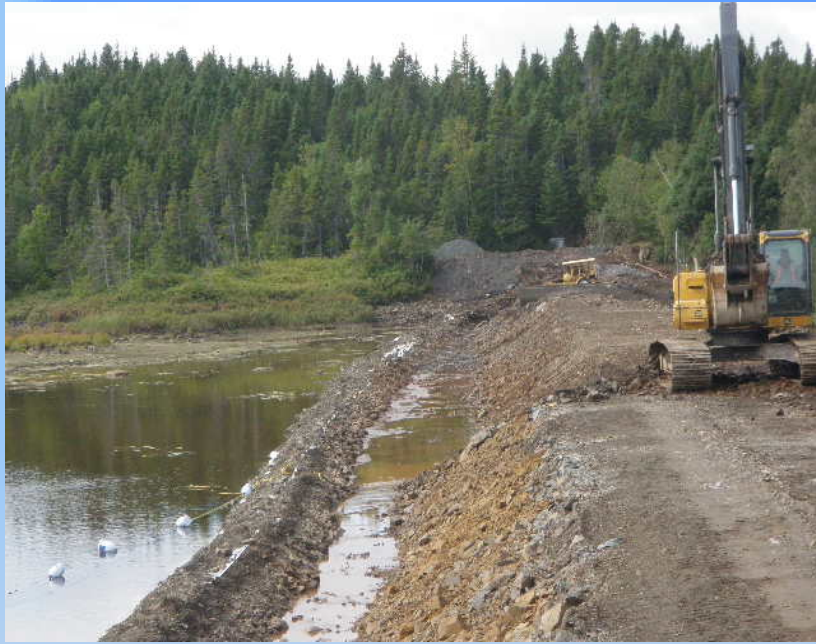
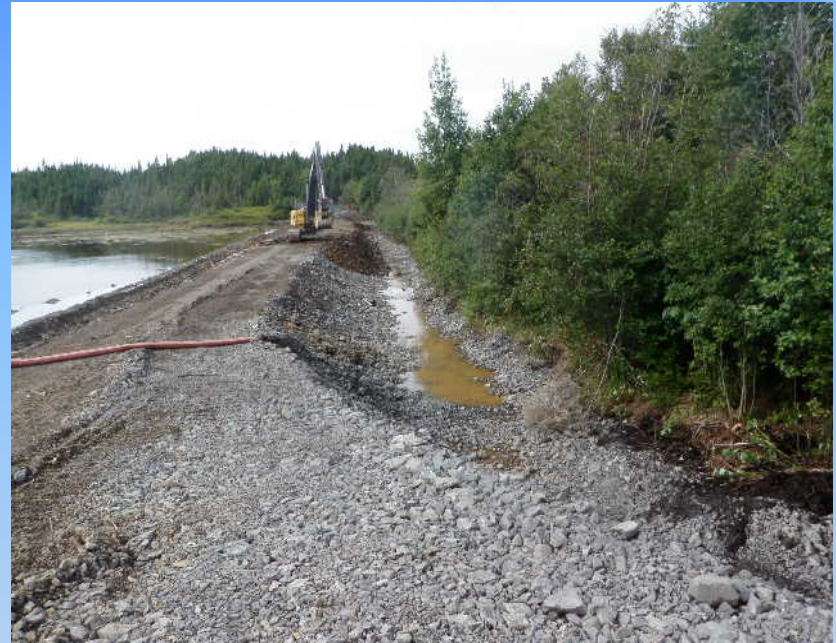
This is how the dam looked after completion of the grubbing on both slopes.

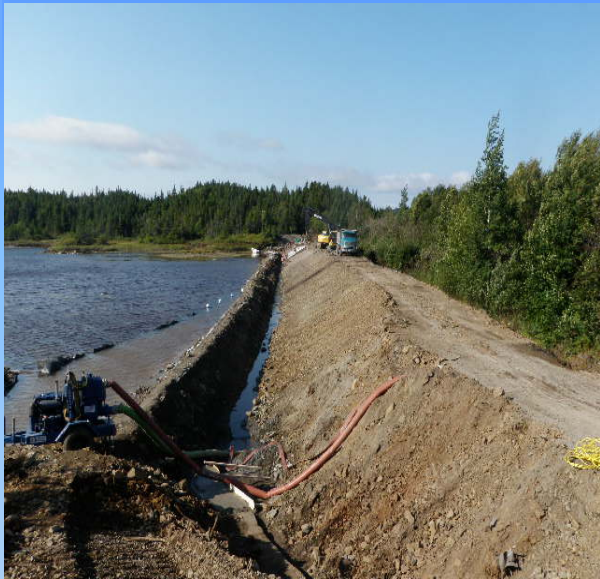
- Cofferdam installation and pumping;
- a cofferdam had to be constructed
 - pumps were used to keep the work area dry

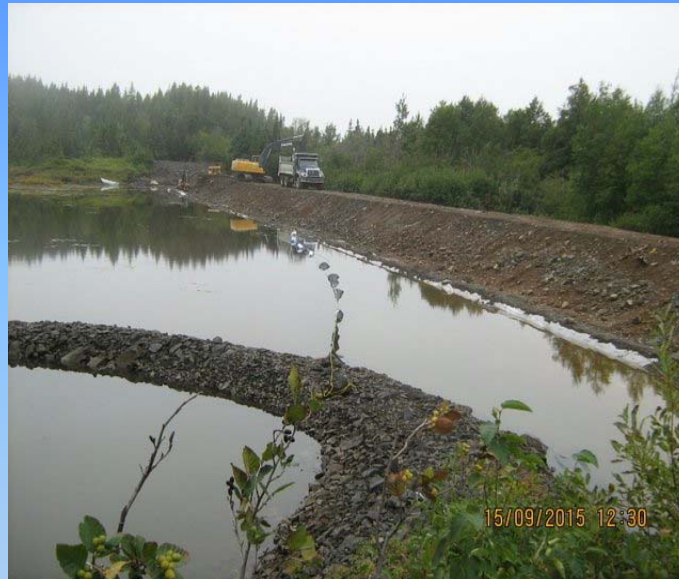
- Excavating and hauling away overburden while shaping dam slopes:
- all overburden had to be removed from upstream and downstream slopes

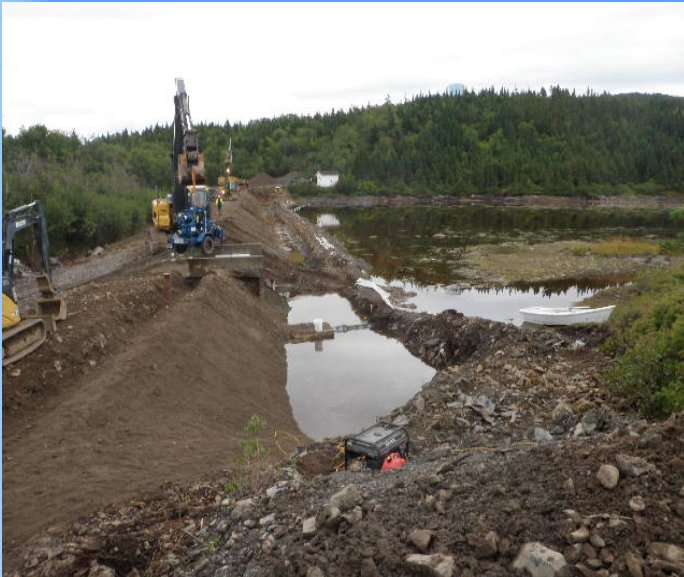
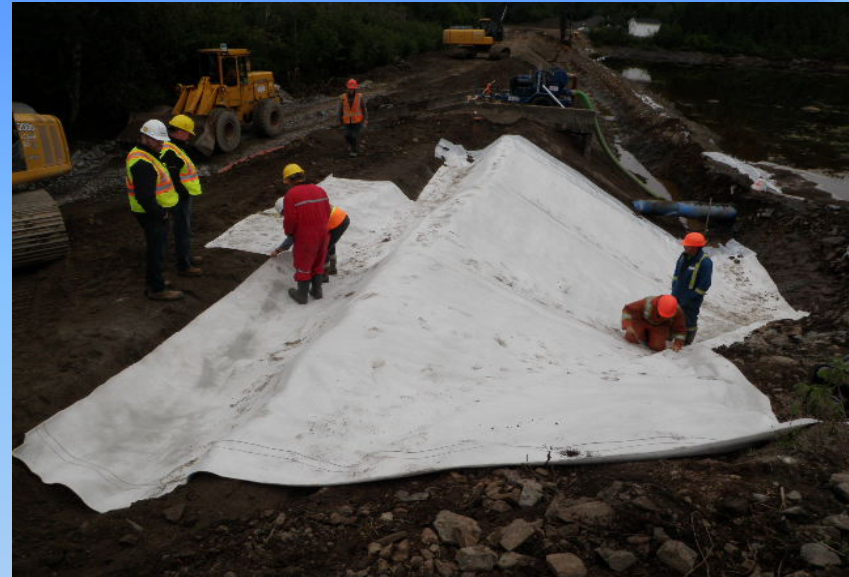
Working on section between far shore and spillway. The first picture shows the slopes prepared for Geosynthetic Clay Liner (GCL). The second picture shows the liner being installed up to the top anchor trench.

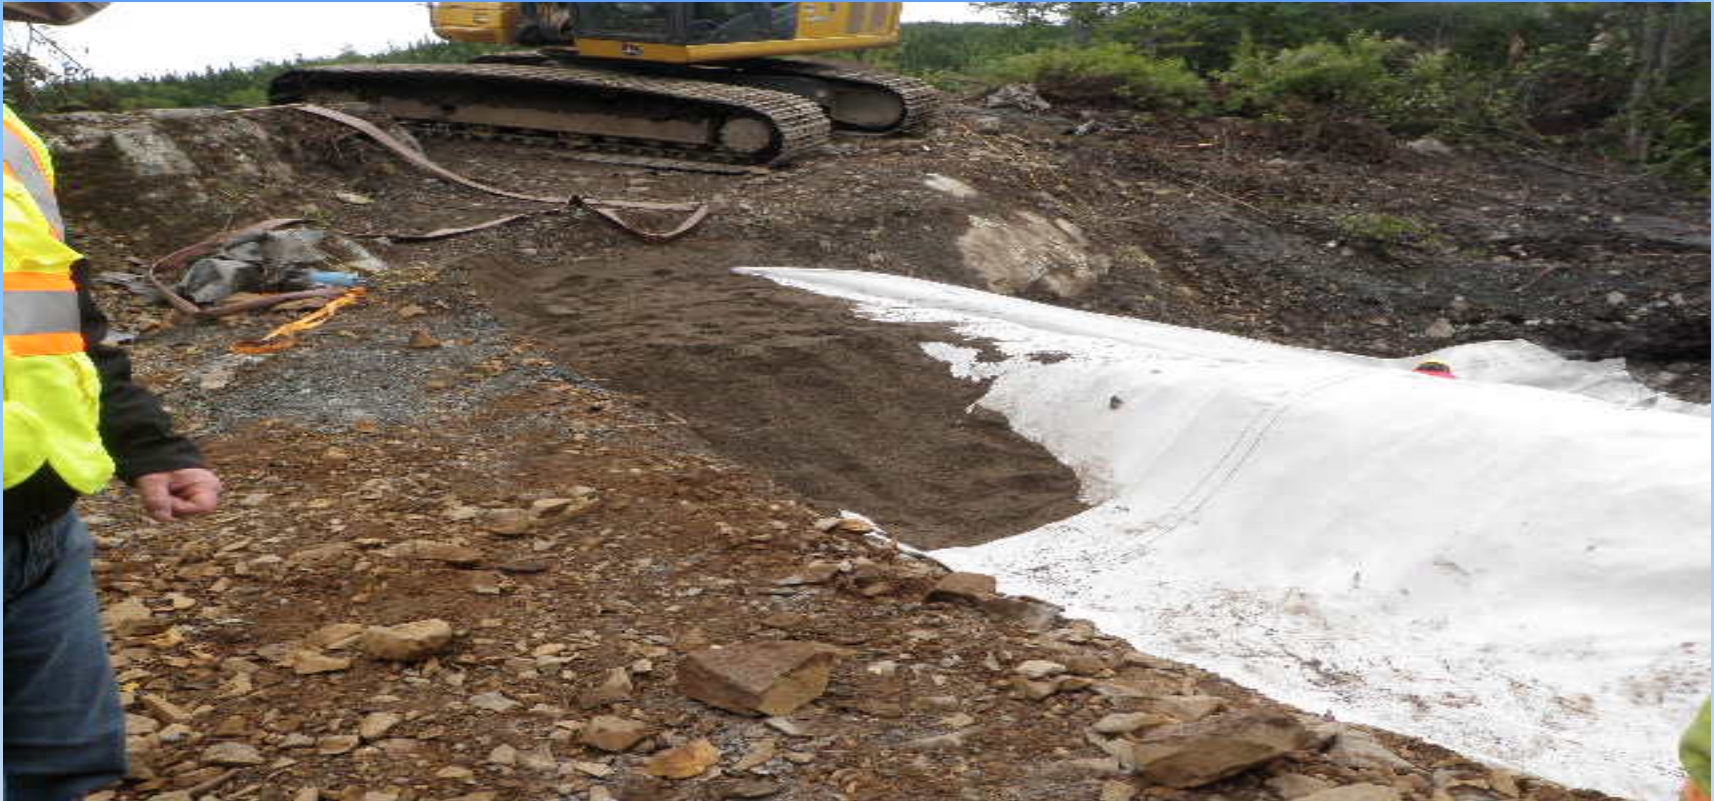
Tying in the dam liner to rock outcrop on far shore.

- Liner is sealed to bedrock using bentonite
- Sand and gravel being placed in the anchor trench

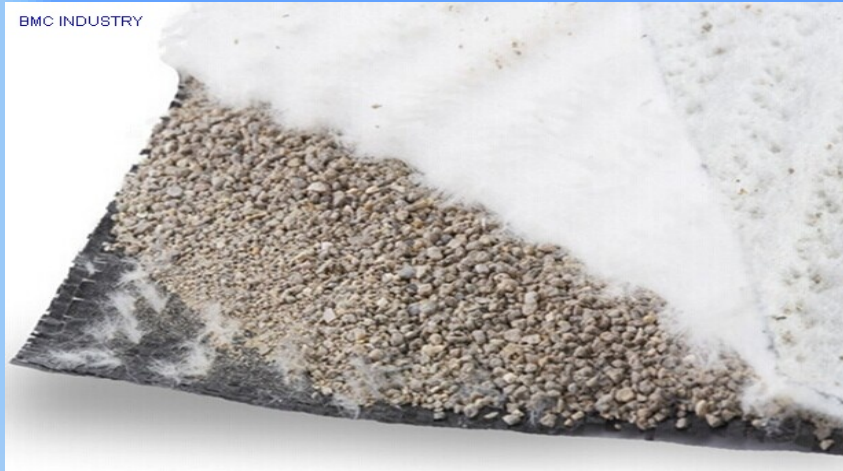
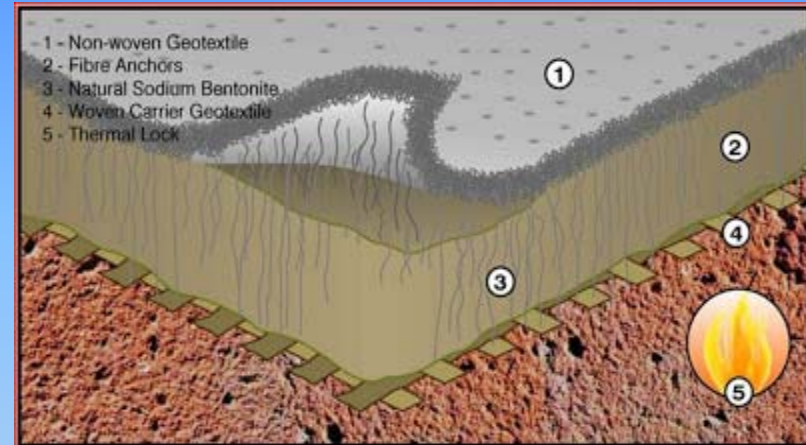
Geosynthetic Clay Liner creates the waterproofing for the dam:

- It is made by filling high swelling sodium bentonite between special composite geotextile fabric
- Water contact initiates the swelling of the bentonite up to 6 times its original volume to create a waterproof seal
- A layer of bentonite is also placed between the fabric at overlaps to seal the joints

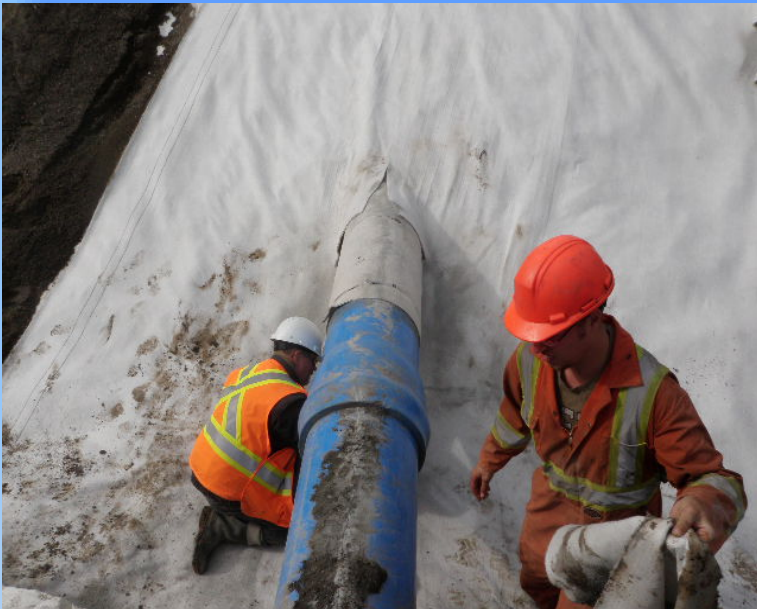
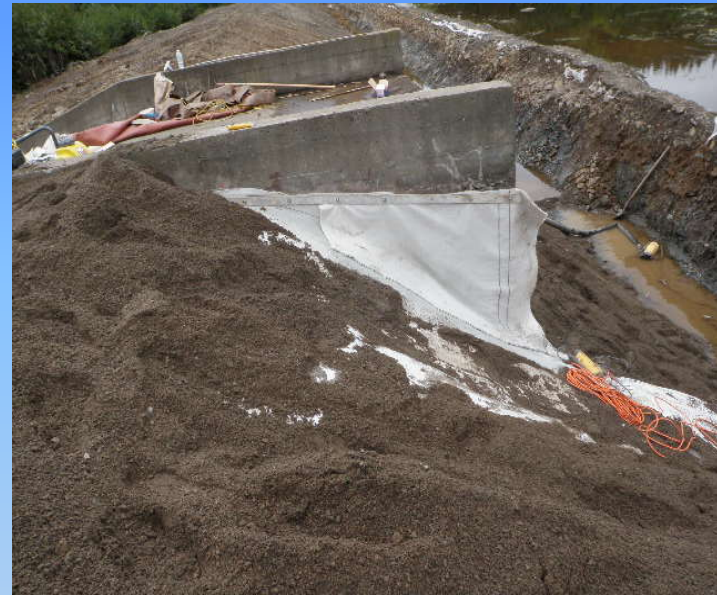
Tying in the GCL liner to seal around the 400 mm drain pipe and the concrete face of the spillway structure. Proper installation is crucial to getting a water tight seal.

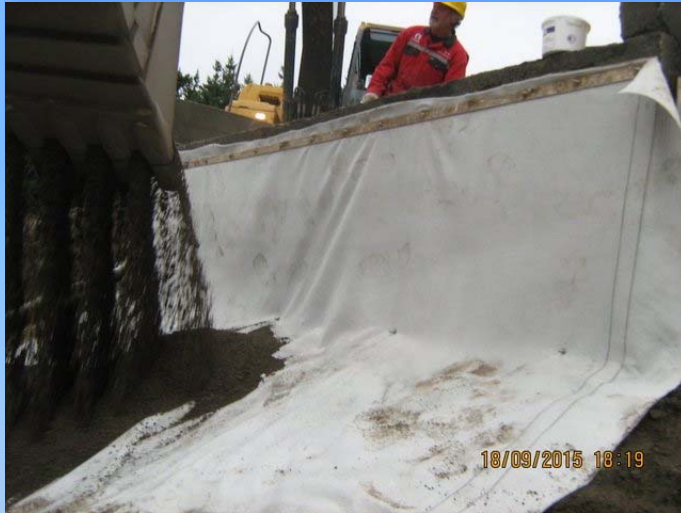
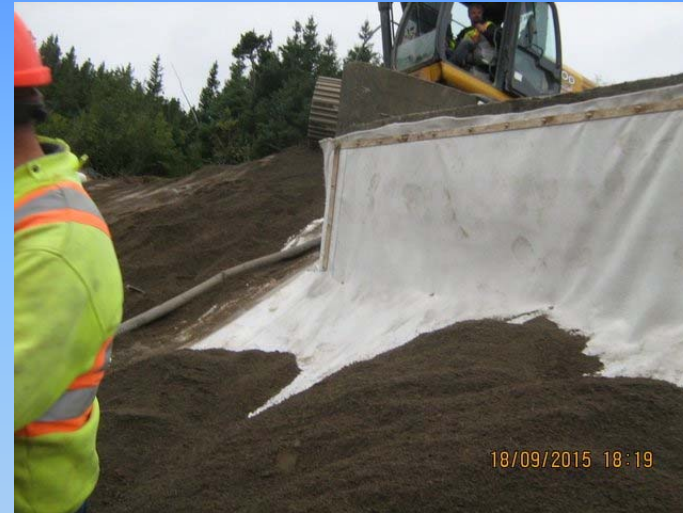
Maintaining waterproof seal around the spillway structure

- GCL liner is affixed to the spillway structure using lumber and anchor bolts at the top
- Anchor bolts have been spotted along the base to keep fabric tight
- Backfill is then carefully applied to the area.

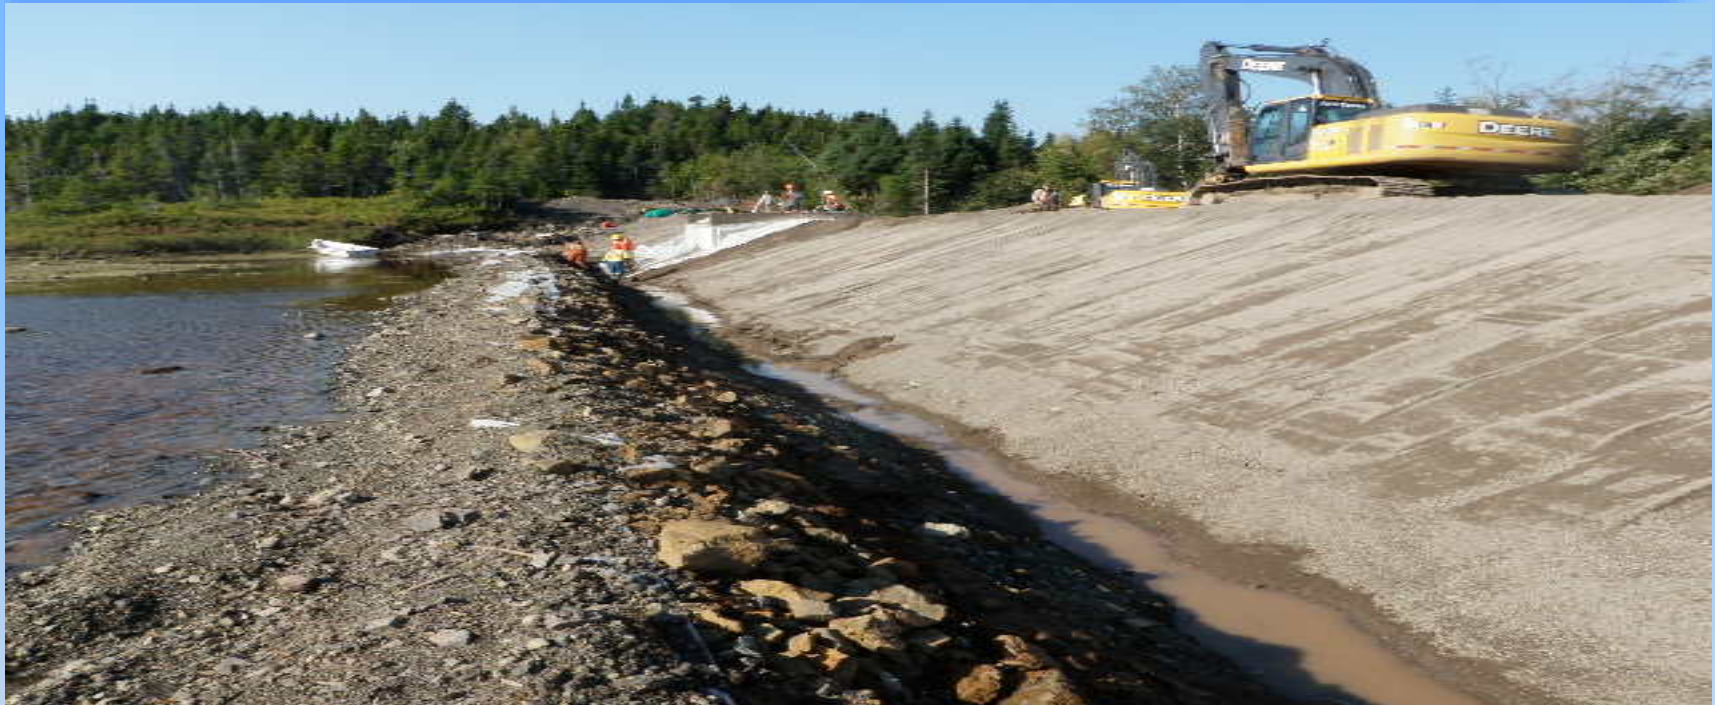
Subgrade prepared for liner placement

Here you can see a large section of the upstream dam face prepared for the installation of the liner. The slopes have been dressed to 3:1. A uniform sand and gravel bed has been compacted in place.

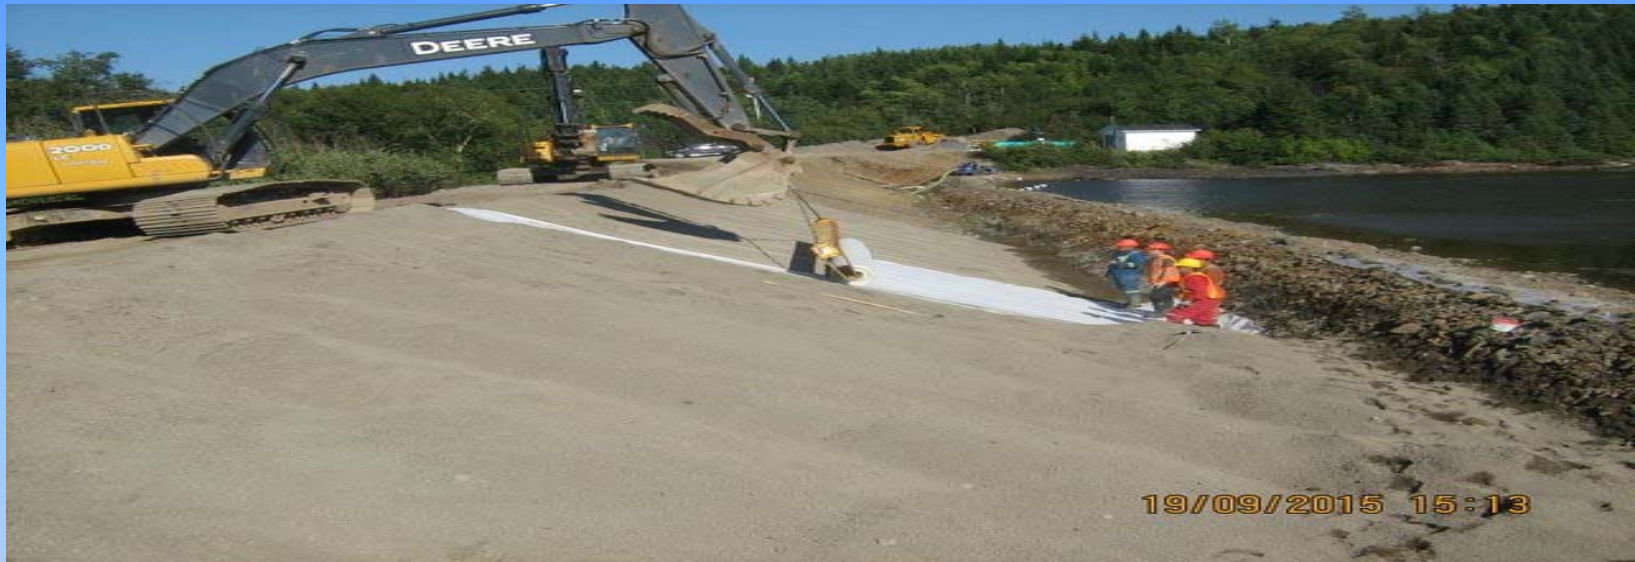
Installation and covering of the GCL liner is shown here.

The excavator is using a special dispensing reel to unroll the fabric in place.

The 300mm sand & gravel cover is being placed over the liner following installation.

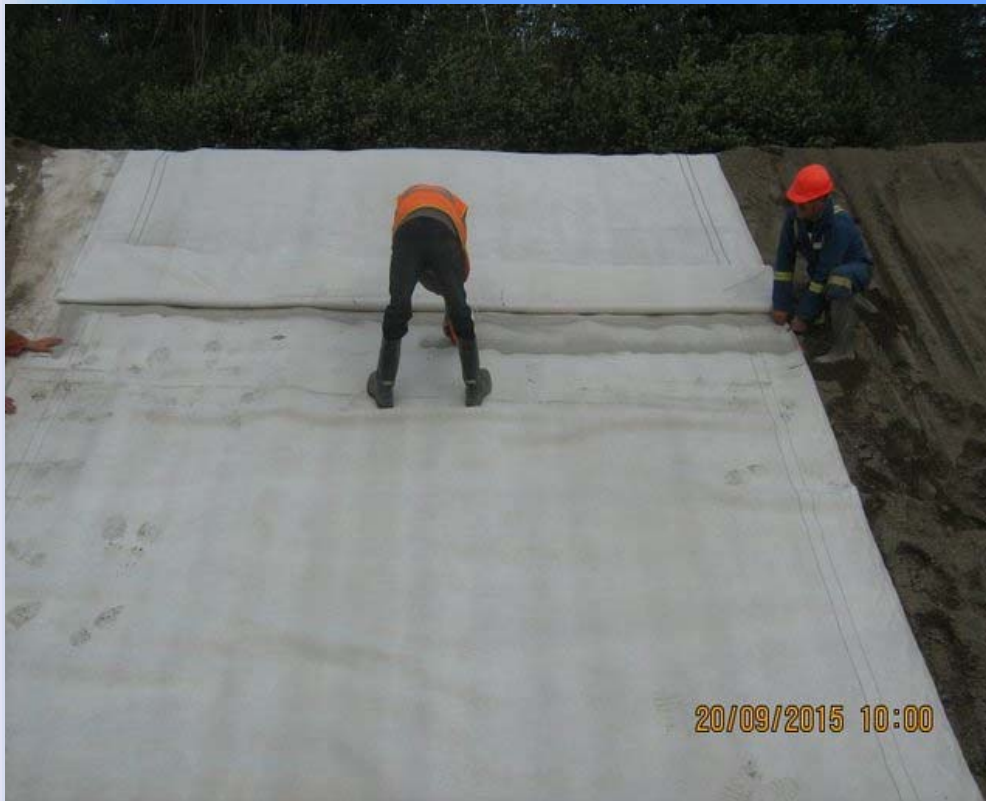
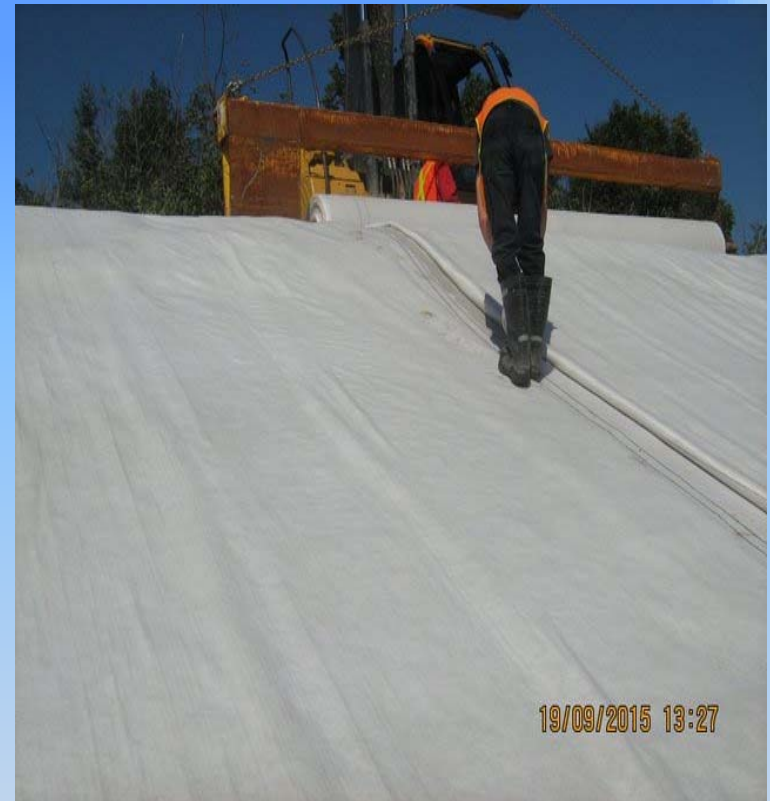
Placing bentonite sealant between horizontal and vertical joints in GCL liner. Once contacted with water the bentonite will expand creating a waterproof seal between the layers.

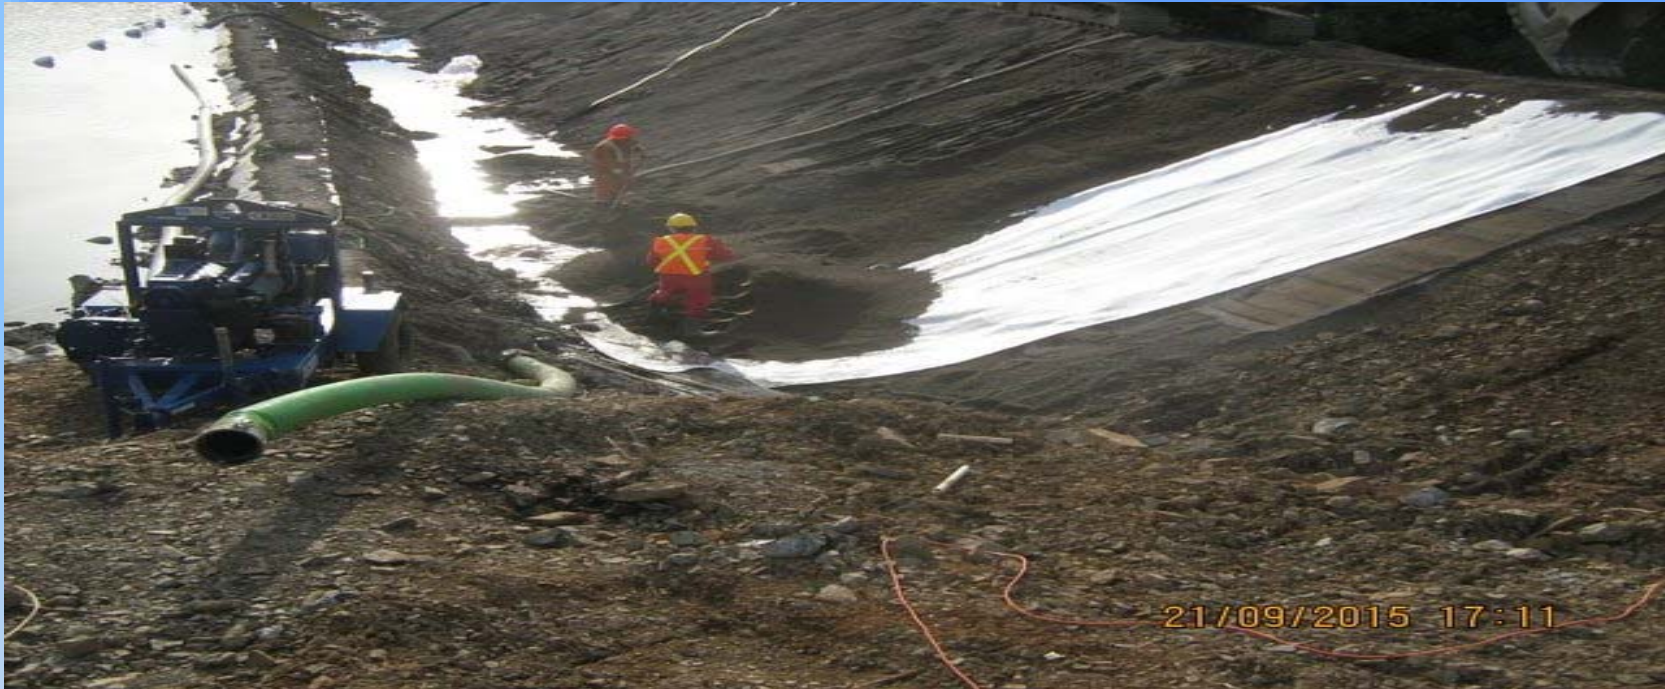
Brighton Dam Covering GCL liner with sand and gravel

- A 300mm sand and gravel layer is placed over the GCL liner for protection.
- Slope of the dam is increased to 3:1
- Liner is anchored in the bottom by 1 m wide anchor trench

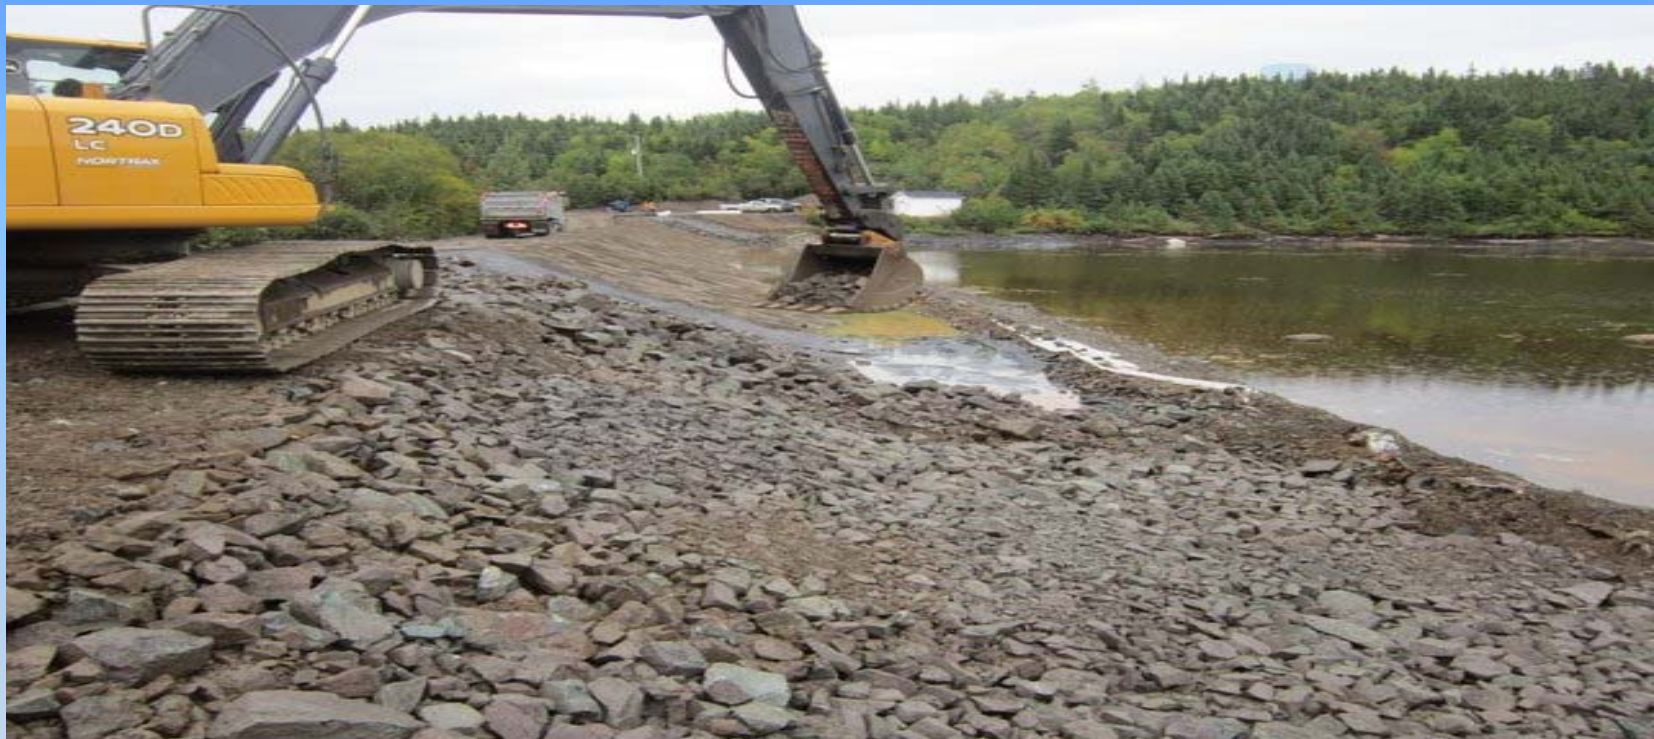
Brighton Dam Finishing Slopes With Rip Rap

- An 800mm blanket of rip rap protects the face of the dam from erosion
- 150 mm sized rip rap is used for this phase

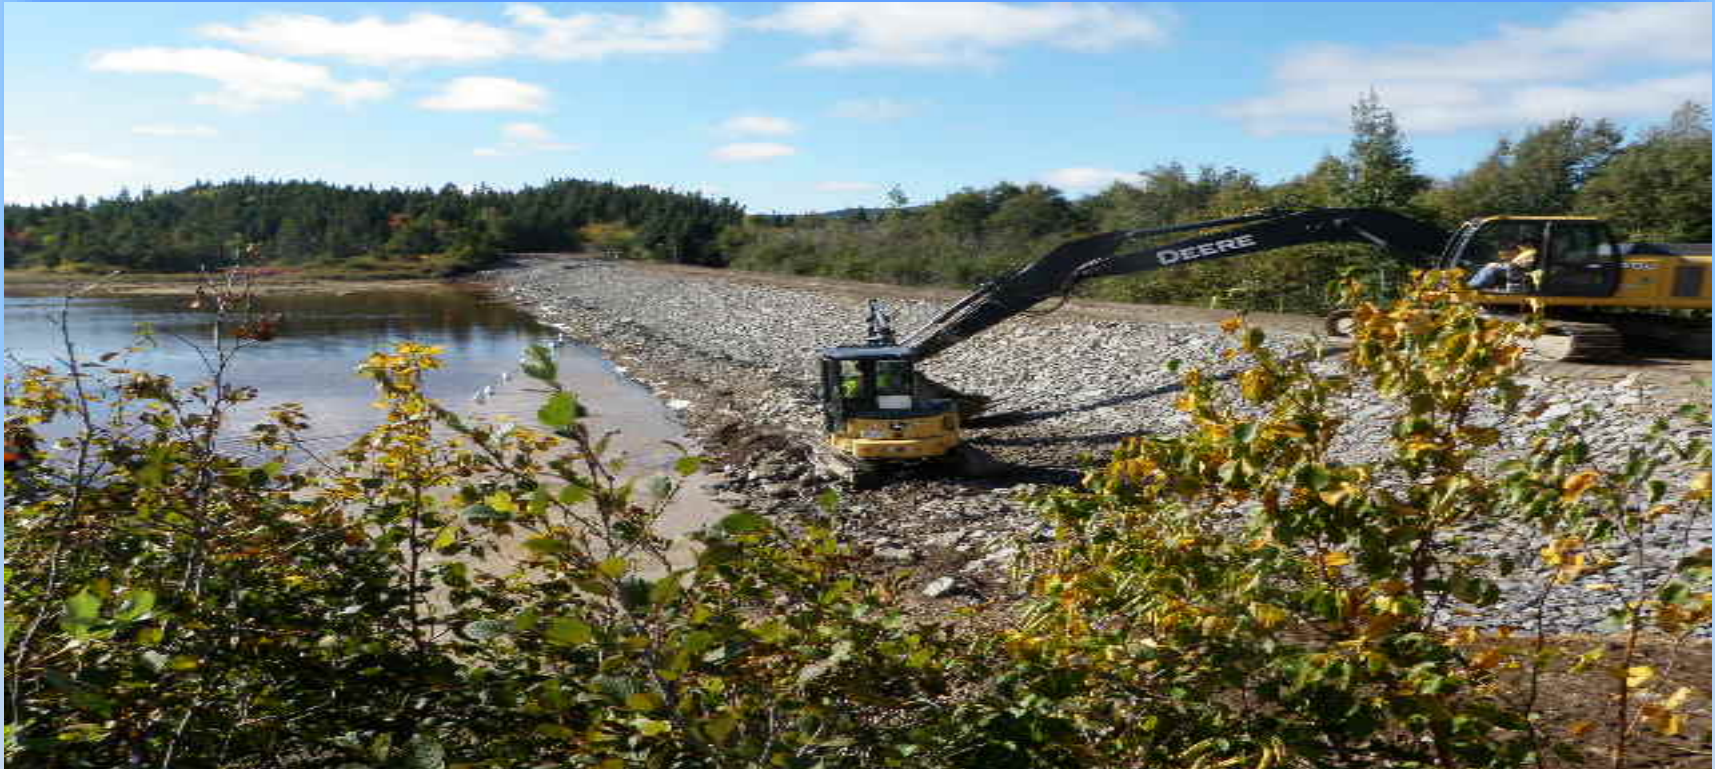
Two excavators working in tandem to complete rip rap placement at the toe of the upstream slope.

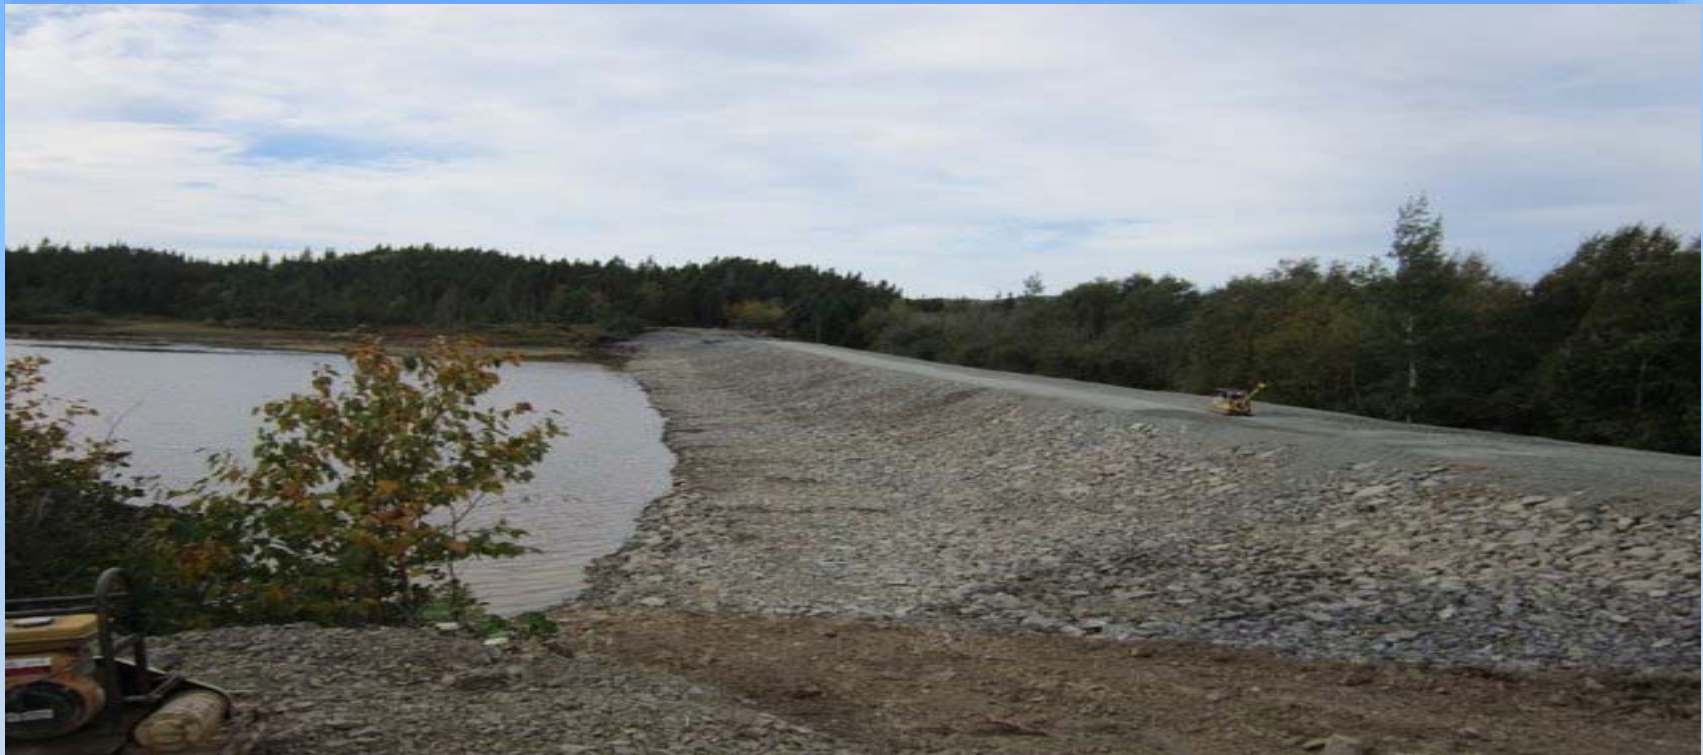
Brighton Dam Finishing Crest of Dam With Class A Fill

- A 100mm layer of Class “A” fill is used to cap the crest of the dam.
- This was the final stage of construction

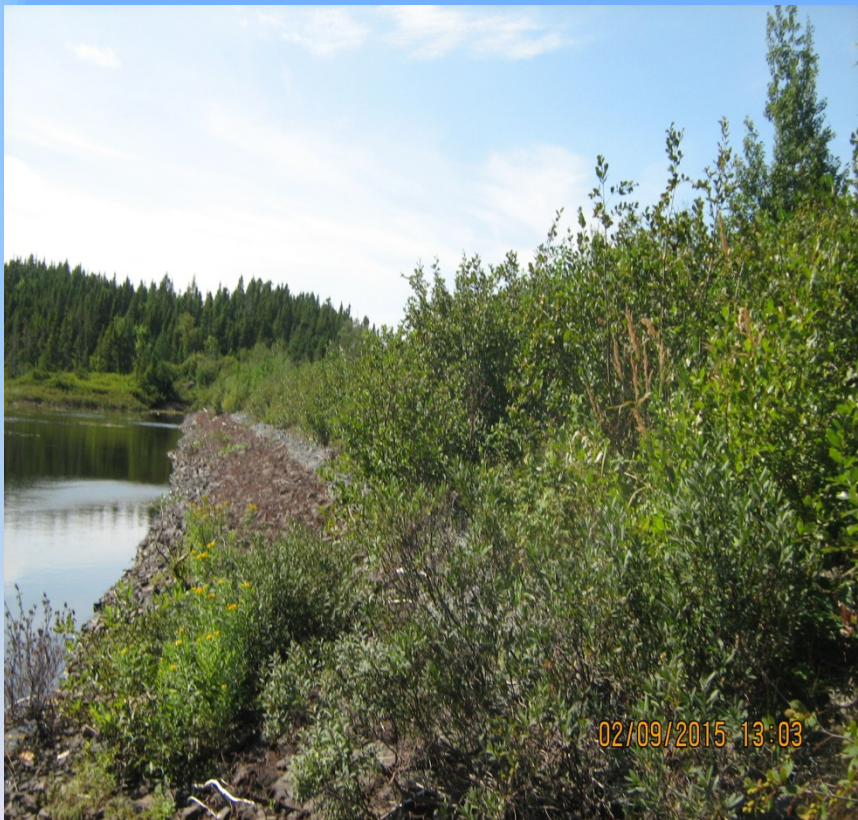
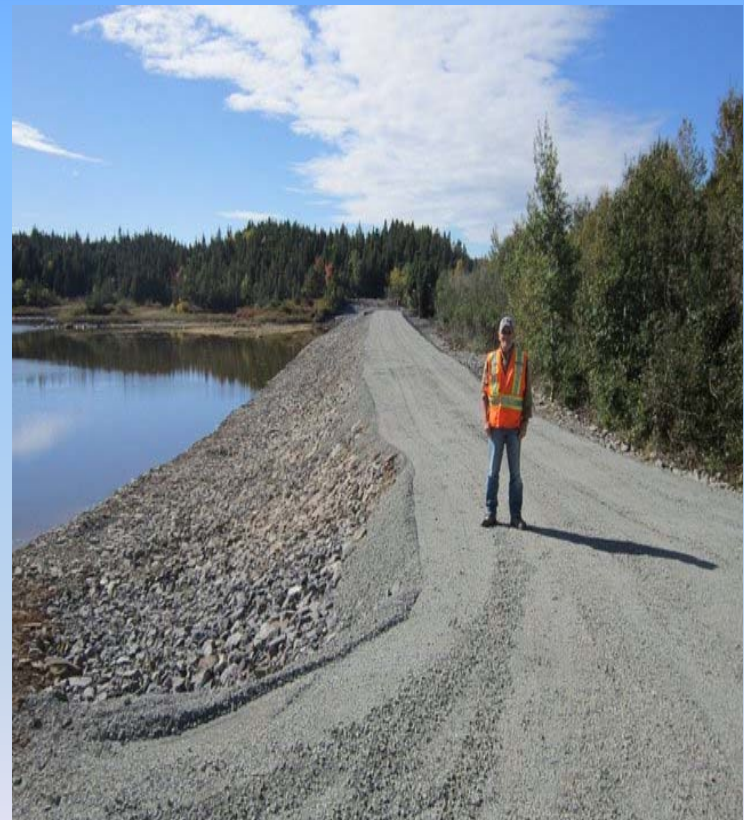
Before and After

Brighton dam was completed Nov 16, 2015.

There is a continuous flow of water through the spillway and Brighton no longer has to worry about low water levels or water shortages.
