Chemically Assisted Flushing in the Town of Gander

Presented by:
Dave Moulton
Town of Gander

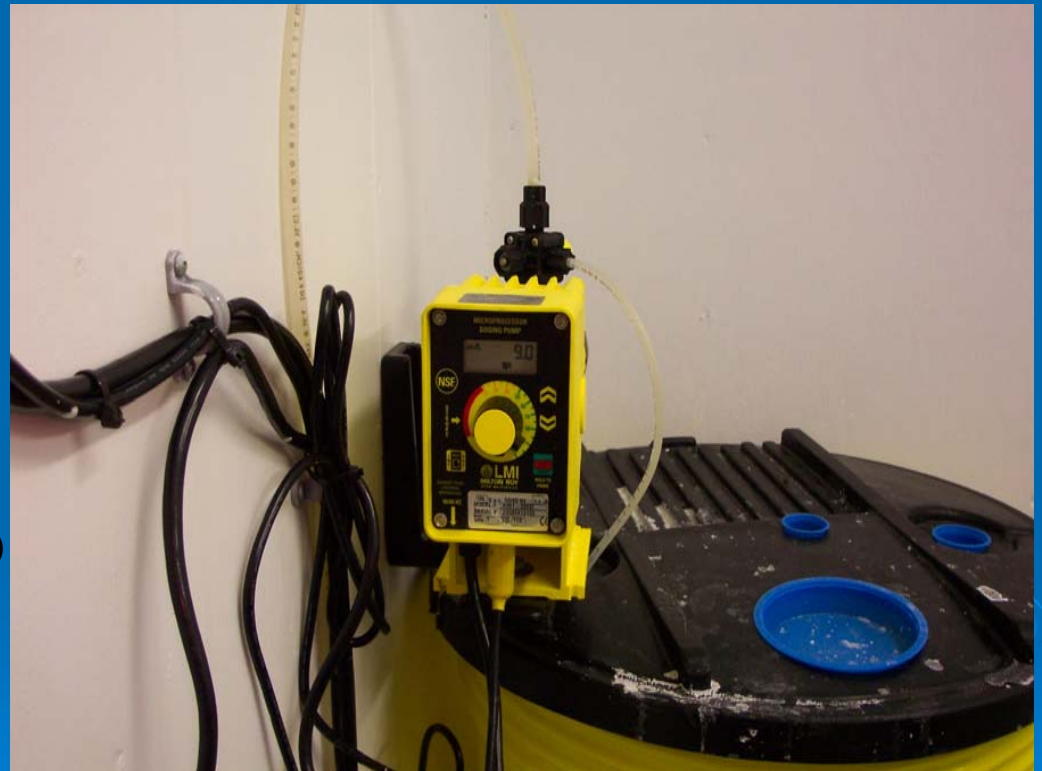
- Began treatment of the water with WD-3100 in November 2006
- It is dosed with a chemical feed pump just like any liquid chlorine system

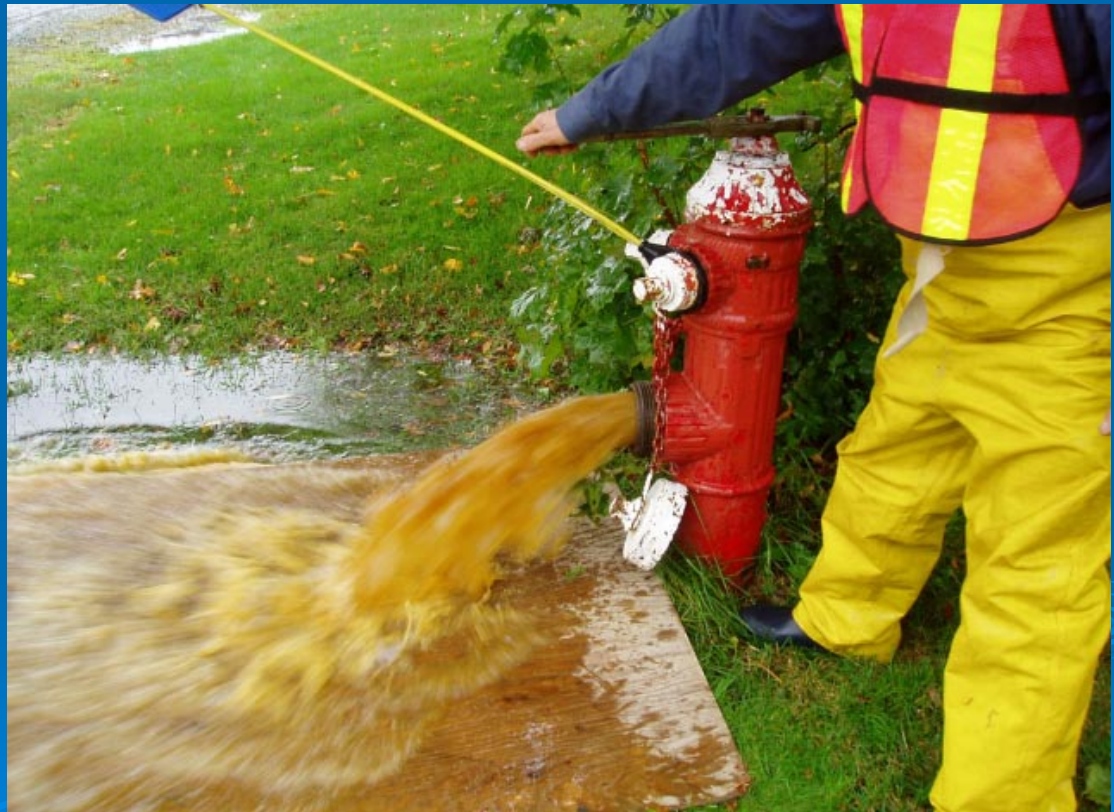
- Flushing began after six days of treatment

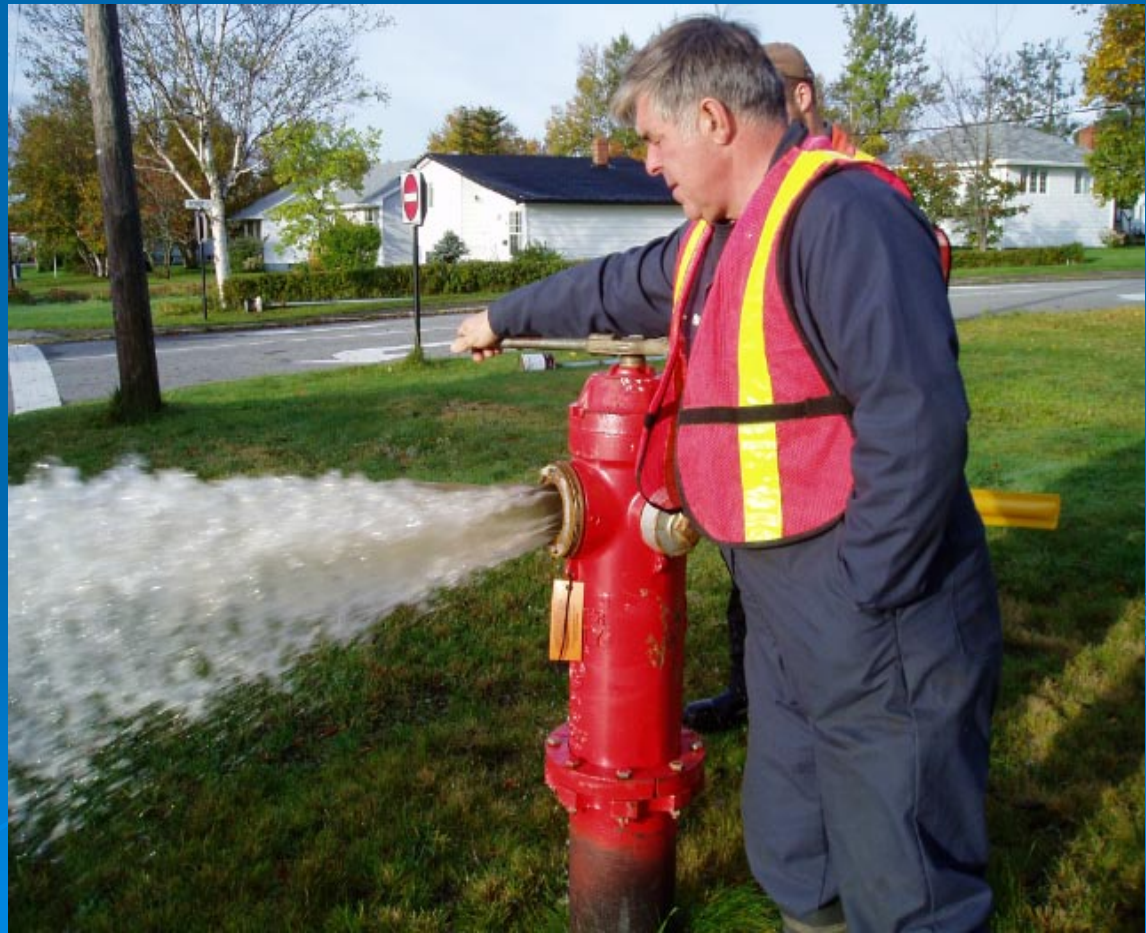
- Uni-directional Flushing continued for the next 12 days

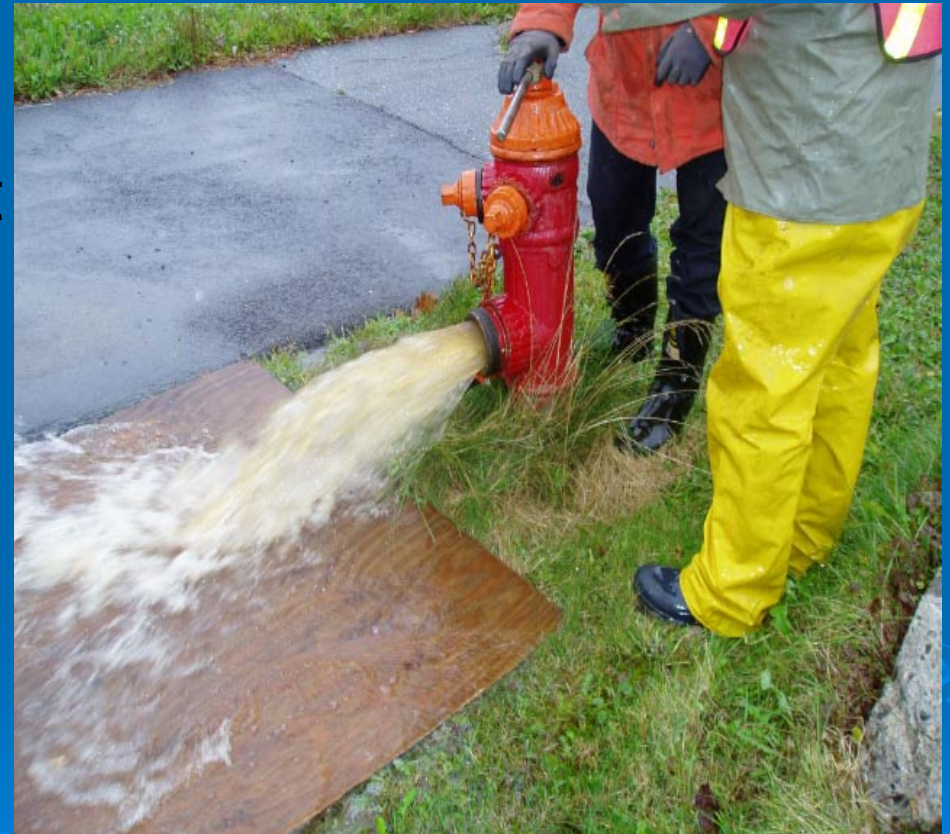
- Town uses plywood sheets to diffuse water flows to prevent erosion of ground around the hydrants

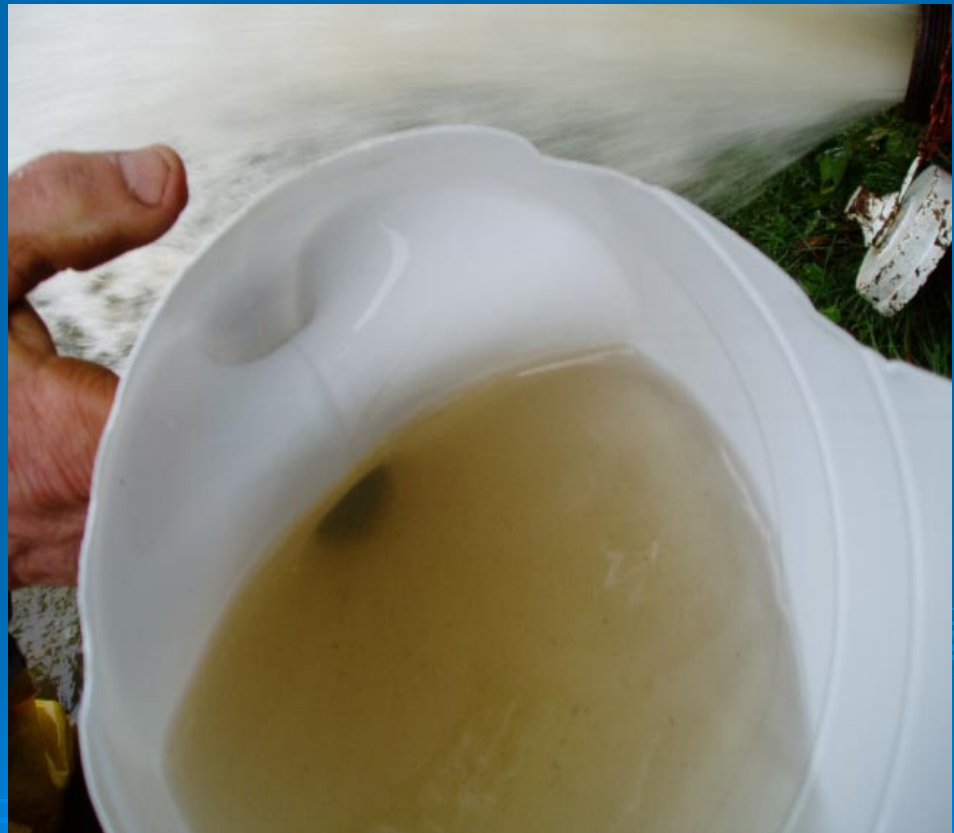
- Water taken from hydrant during the flushing

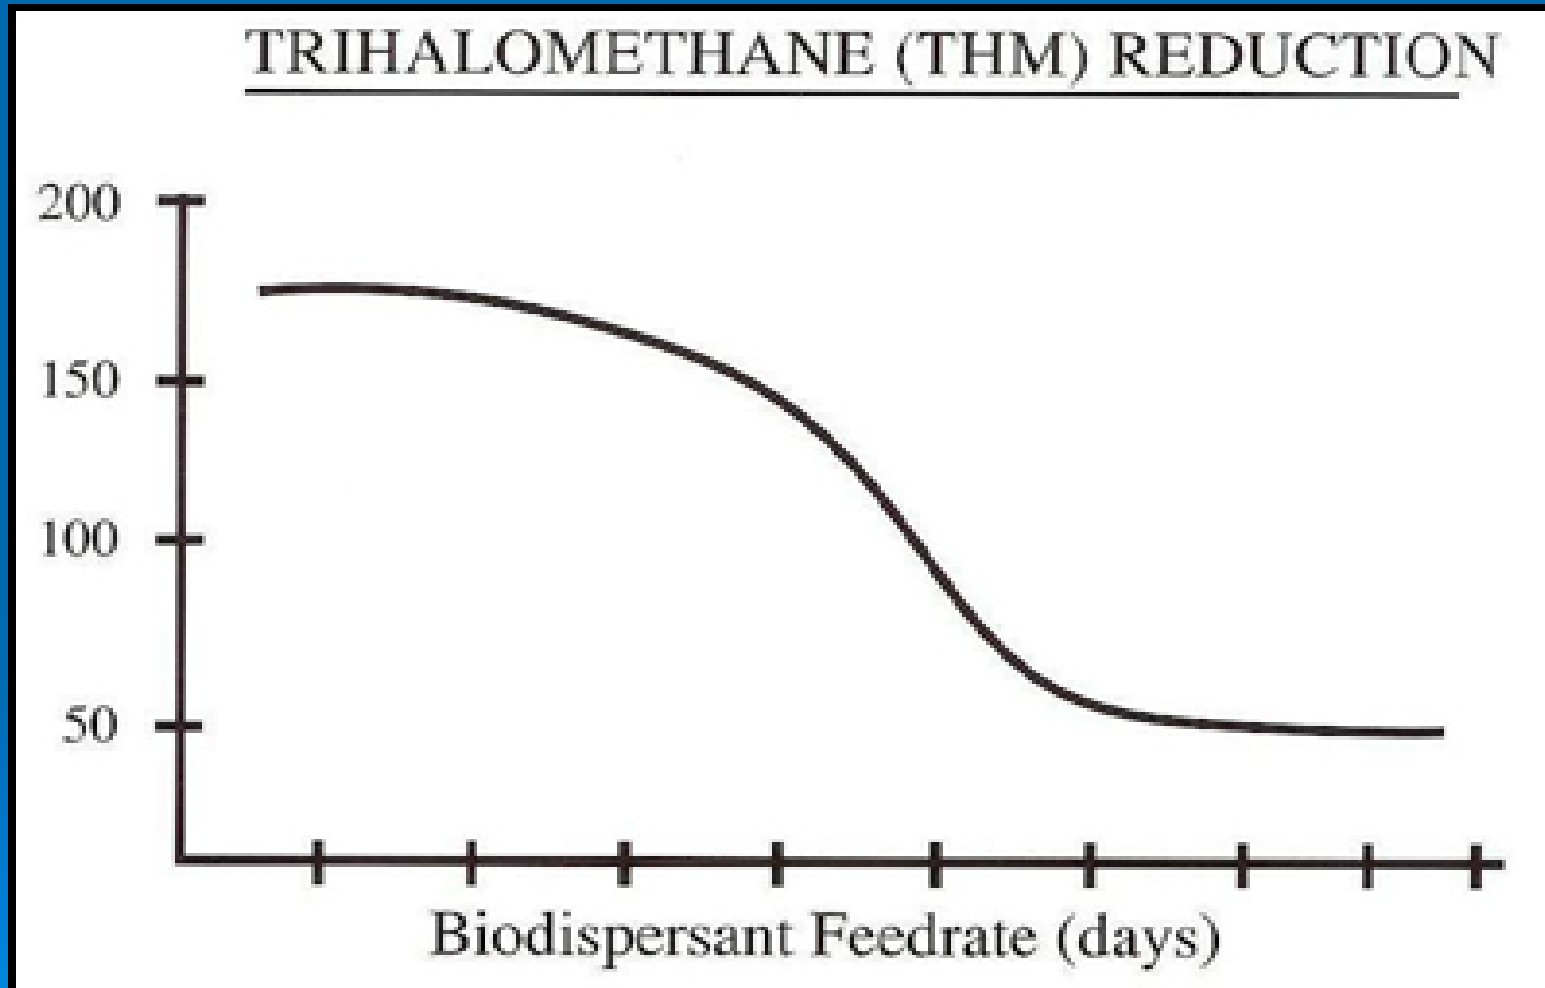
THM Reduction

- The following is not a graph of Gander's information, it is from the Bio-Purge website
- The THM Graph in the following slide depicts THM levels decreasing as the number of days using the Bio-Purge increases
