Department of Environment,
Climate Change, and Municipalities

Climate Change Flood Risk Map Study Humber River Communities

1:20 AEP Flood Extent Comparison Map
Current Climate and Current Development
to Historical Condition

Deer Lake
Blue Gulch Brook, Pasadena Watercourses

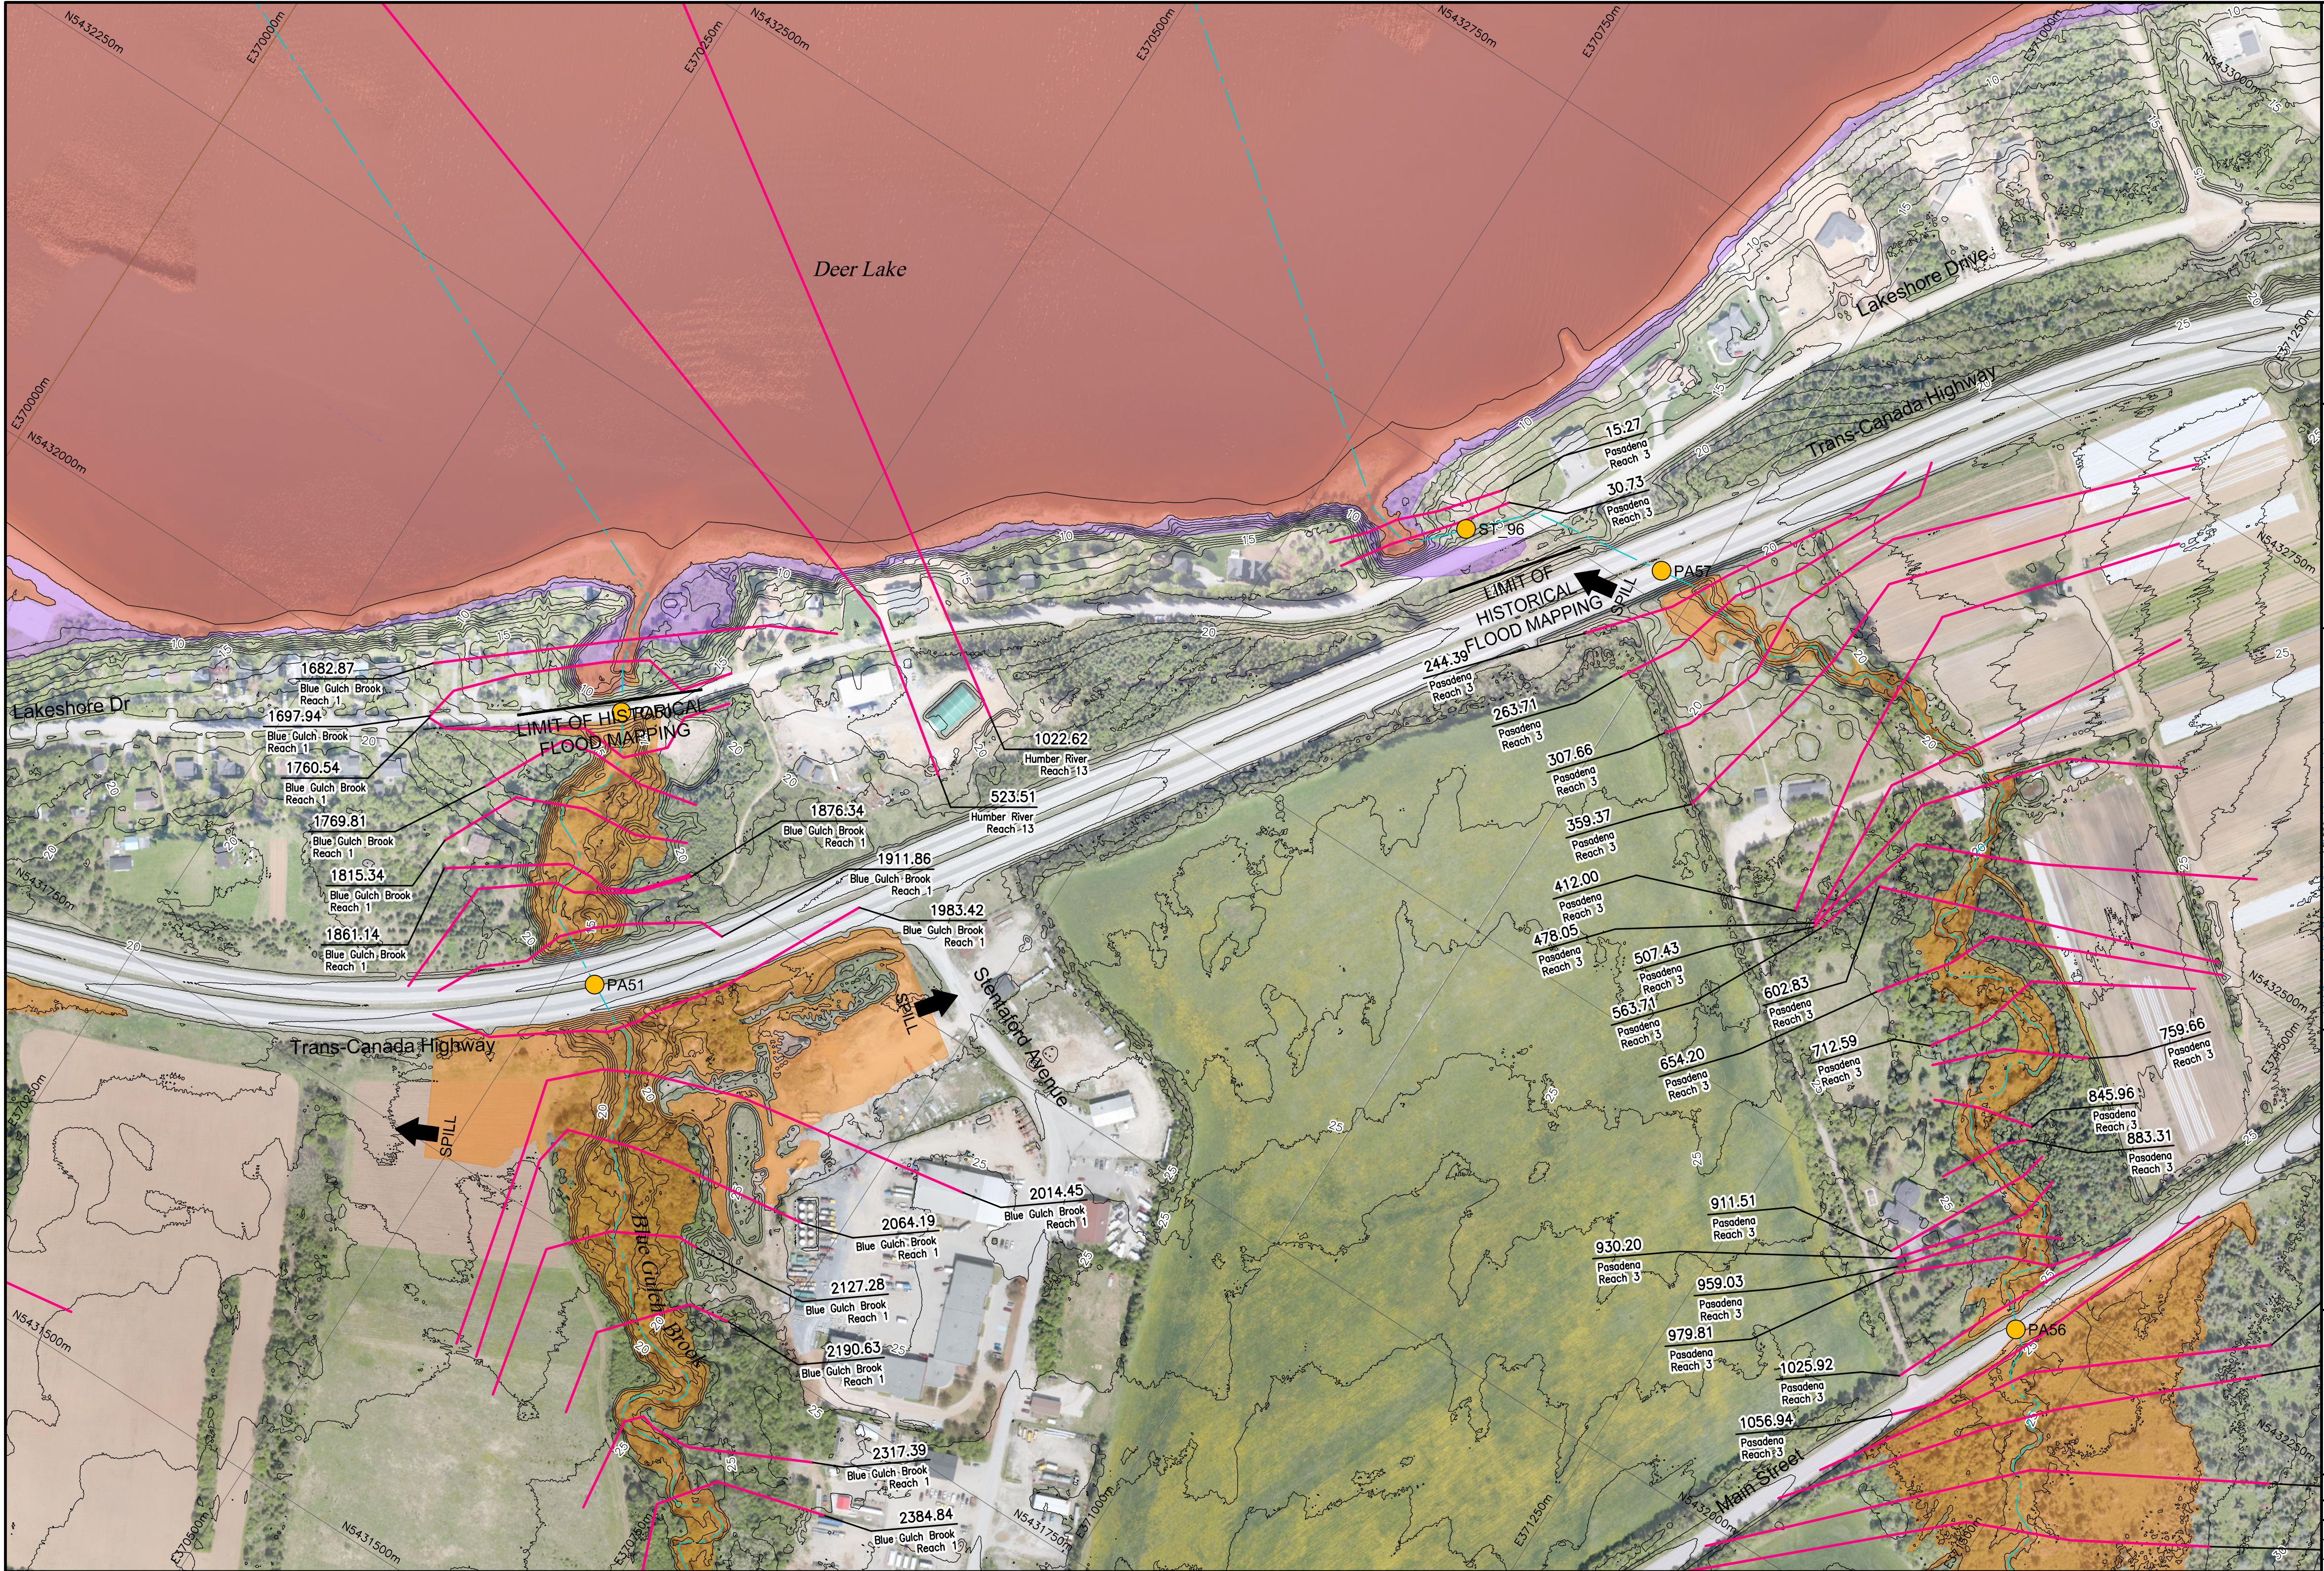
NOTE:
HISTORICAL 1:20 AEP AND 1:100 AEP FLOODLINES
HAVE BEEN DIGITIZED FROM RASTER 1:10000
FLOOD INFORMATION MAPS OF DEER LAKE AND
STEADY BROOK THAT HAVE BEEN GEO-REFERENCED
USING BEST FIT/RUBBERSHEETING PRACTICES.

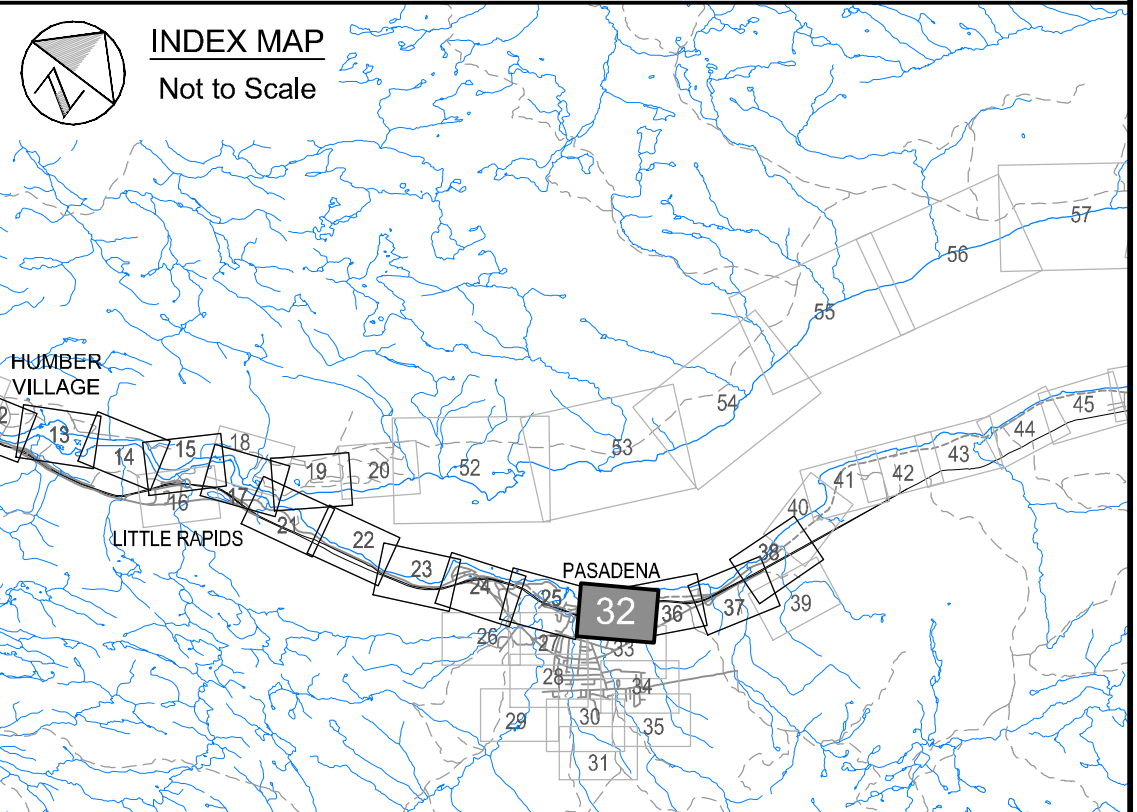
**Current Climate and
Current Development**

1:20 AEP Flood Zone

**Historical
Condition**
