**Step 3 Initial Testing Program and  
Step 4 Site Classification  
Former Pinetree Line Radar Station  
Spotted Island  
NL17AS01  
Contract Number: 65745**

GEMTEC Project: 10550.04.02 (Final)

**Re: Final Report: Step 3 Initial Testing Program and Step 4 Site Classification and Step 4 Site Classification, Former Pine Tree Line Radar Station, Spotted Island, Labrador, DCC Project Number: NL17AS01, Contract Number 65745**

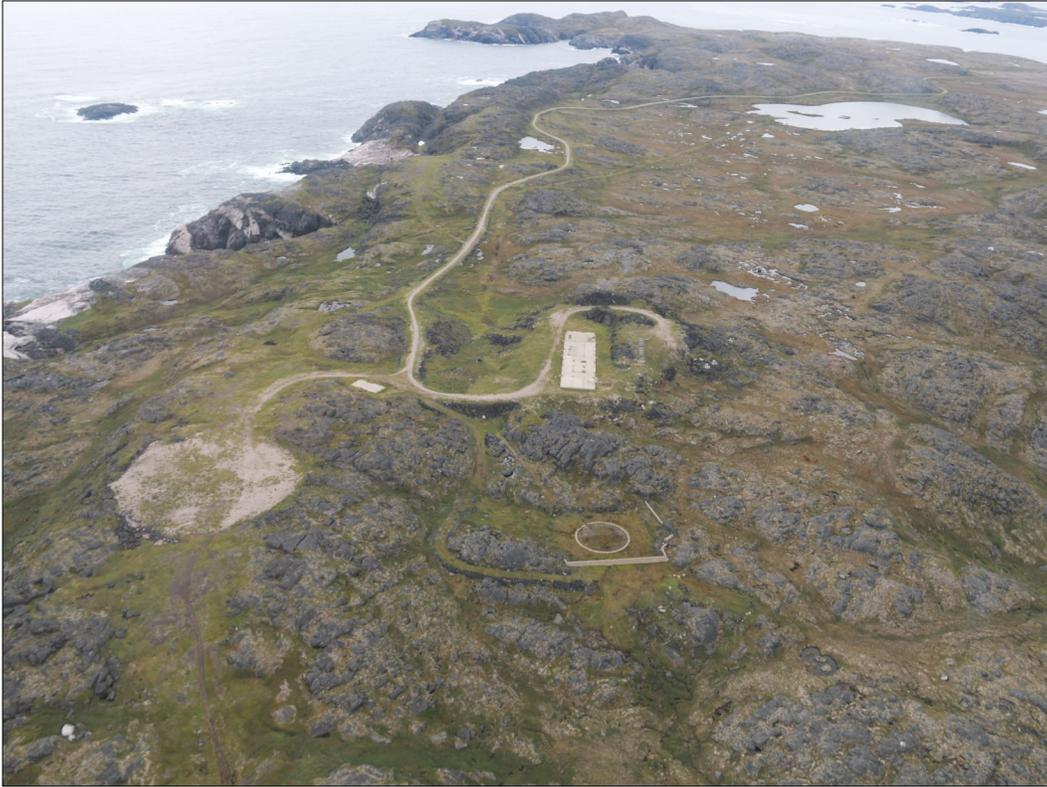
PHOTO 5 - Aerial view of the Upper site, approaching from the north. Helicopter pad, former AST pad, and remains of Main building foundation visible (September, 2017).

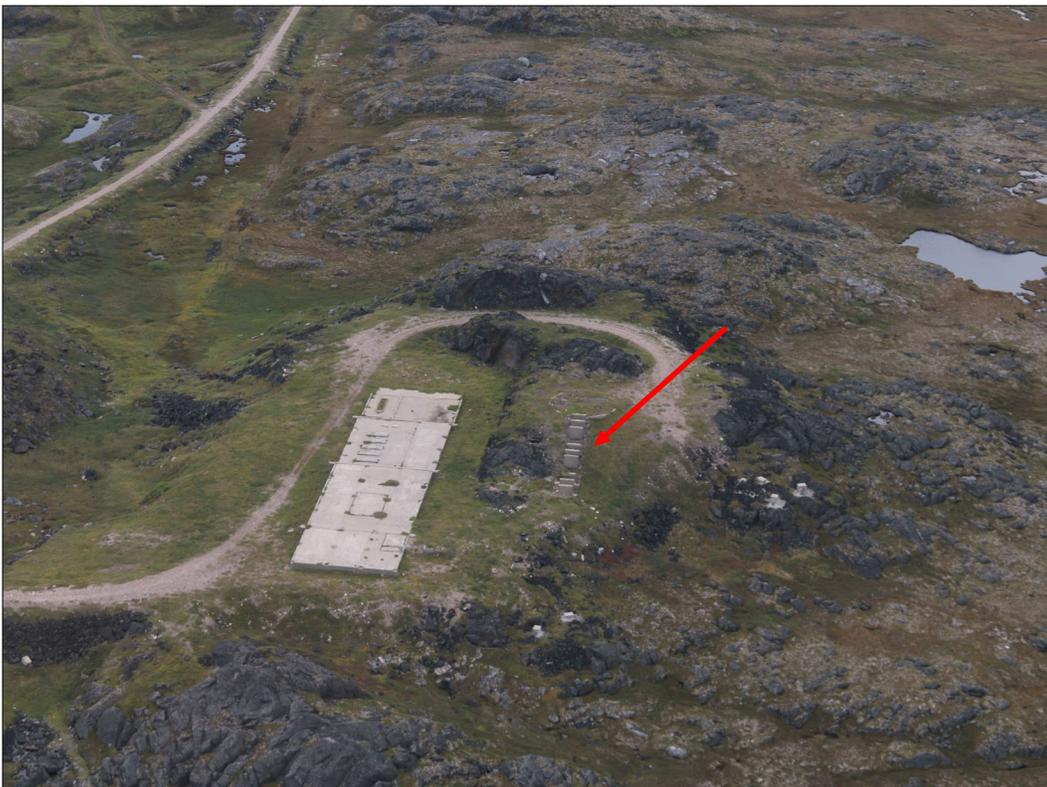
PHOTO 6 - Aerial view of Main building foundation, and, to the right, what appeared to be a drum cached based on satellite imagery (arrow) (September, 2017).

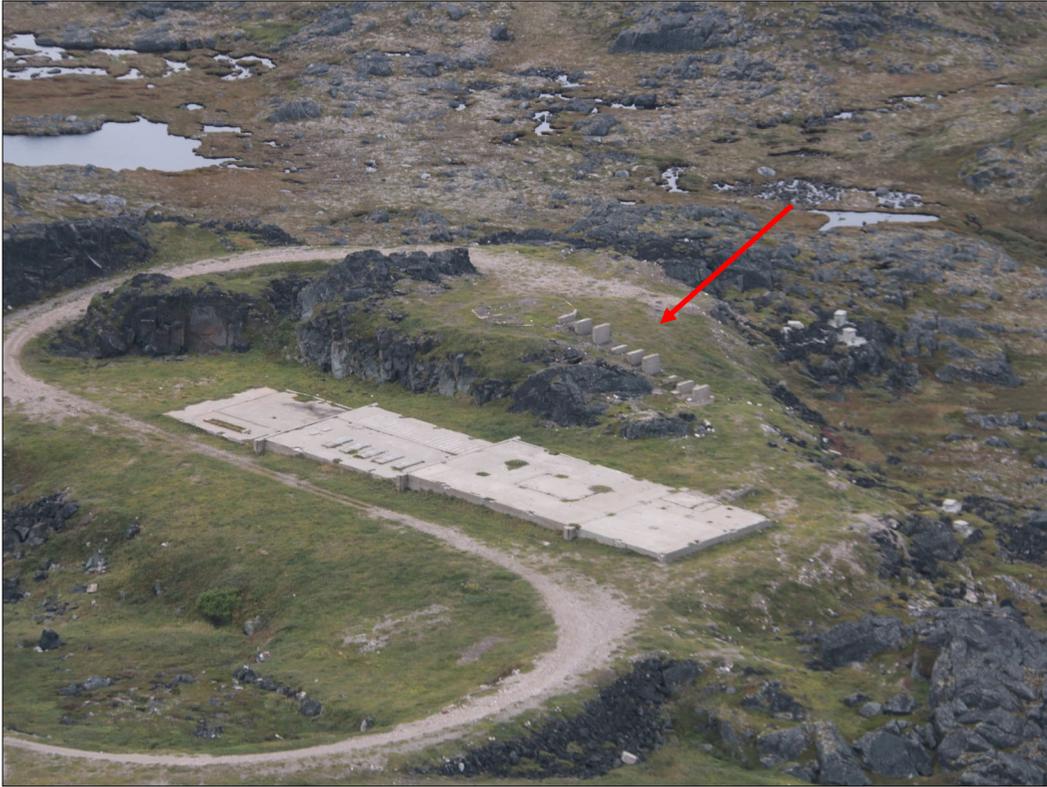
PHOTO 7 - View of what appeared to be a drum cache (arrow). Structures are remains of supports for former tunnel between Main building and the Radom (September, 2017).

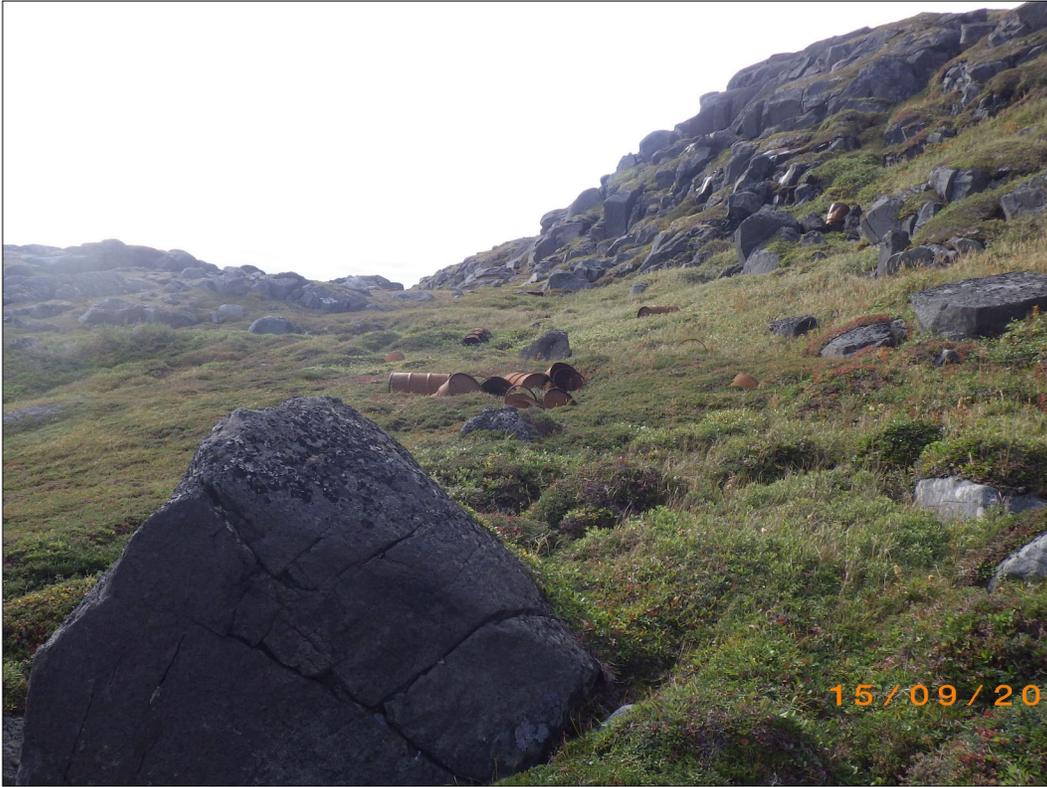
PHOTO 19 - APEC #4 (adjusted): Approximately 20—30 discarded barrels were found. (September, 2017)

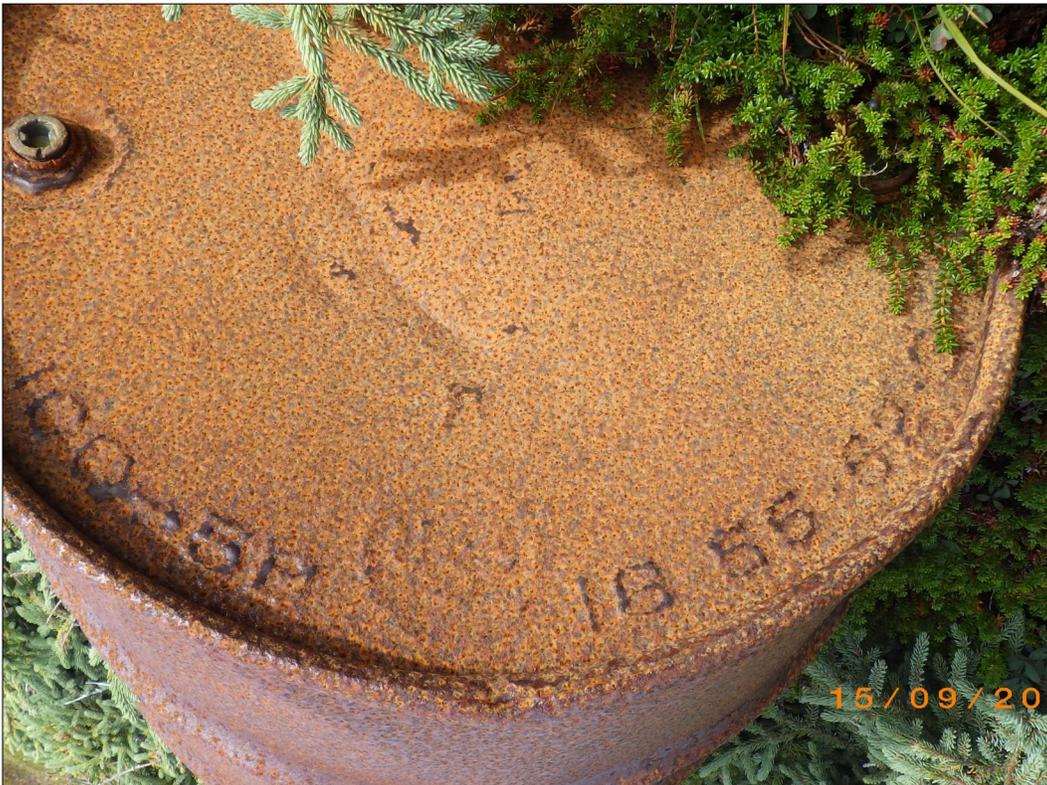
PHOTO 20 - APEC #4 (adjusted): Close up view of a discarded drum. Contents of barrel not confirmed, but presumed to be PHC, used for fueling helicopters. (September, 2017)

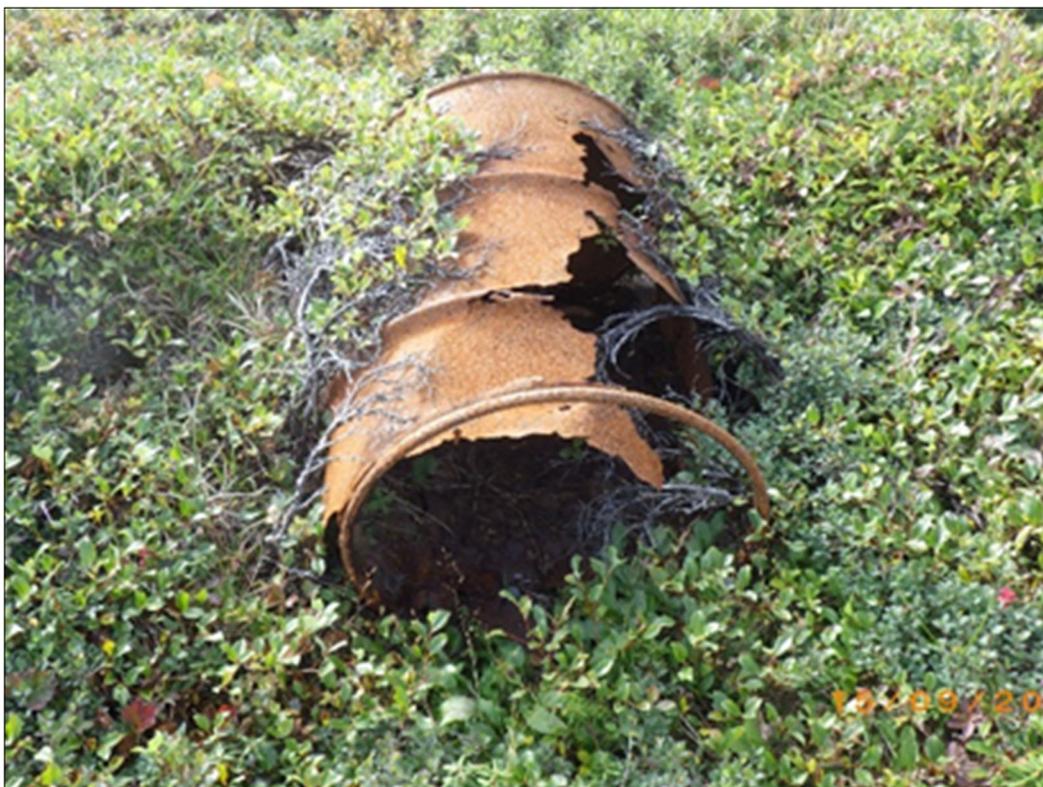
PHOTO 24 - APEC #4: Another view of a degraded drum. (September, 2017)

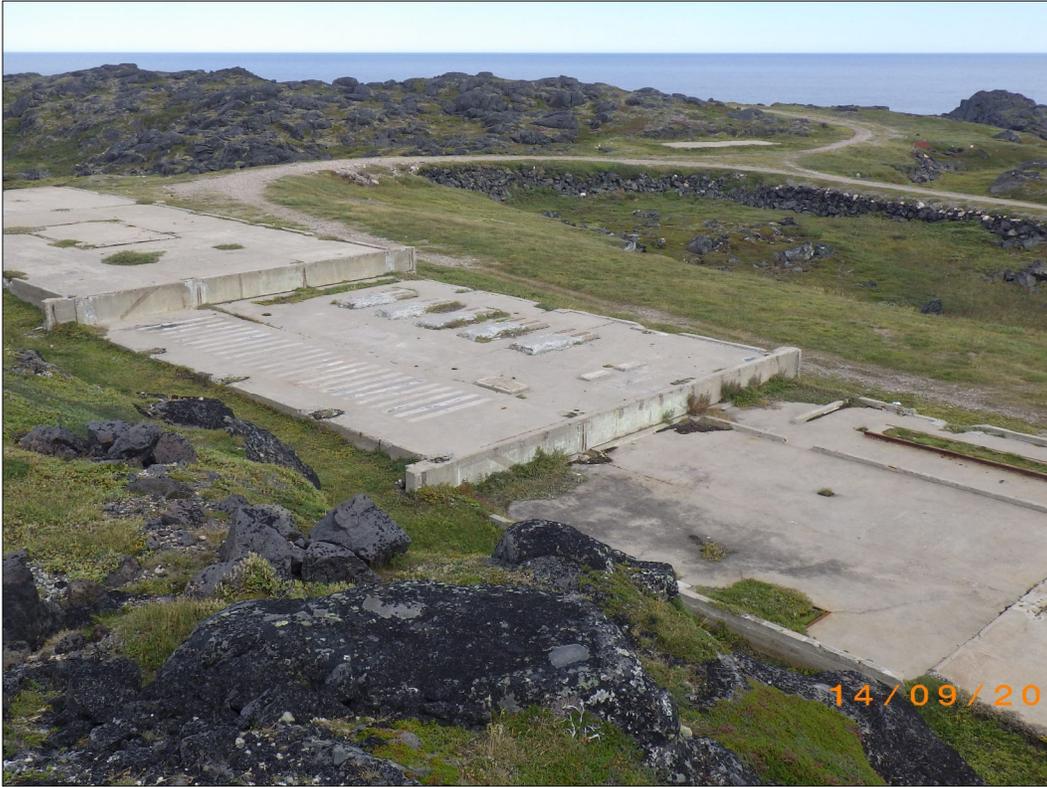
PHOTO 25 - APEC #5: Main building showing step foundation. (September, 2017)

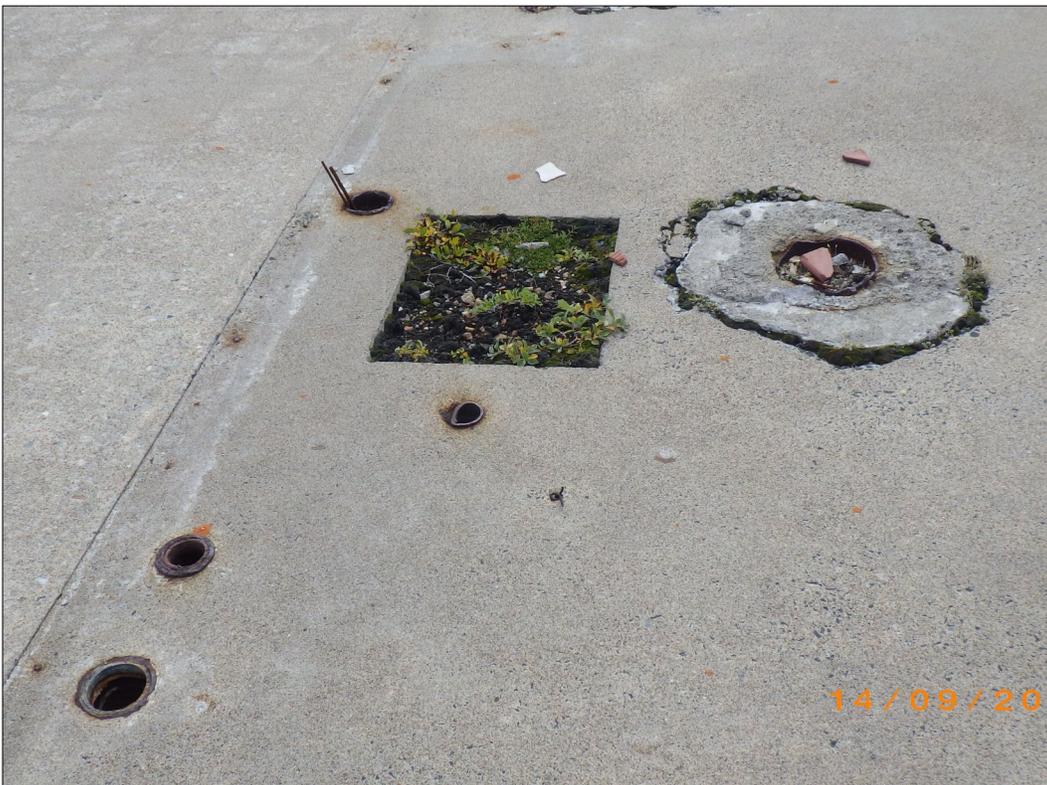
PHOTO 26 - APEC #5: View of penetrations through the slab of the Main building. Metal fittings presumed to be lead-containing. (September, 2017)

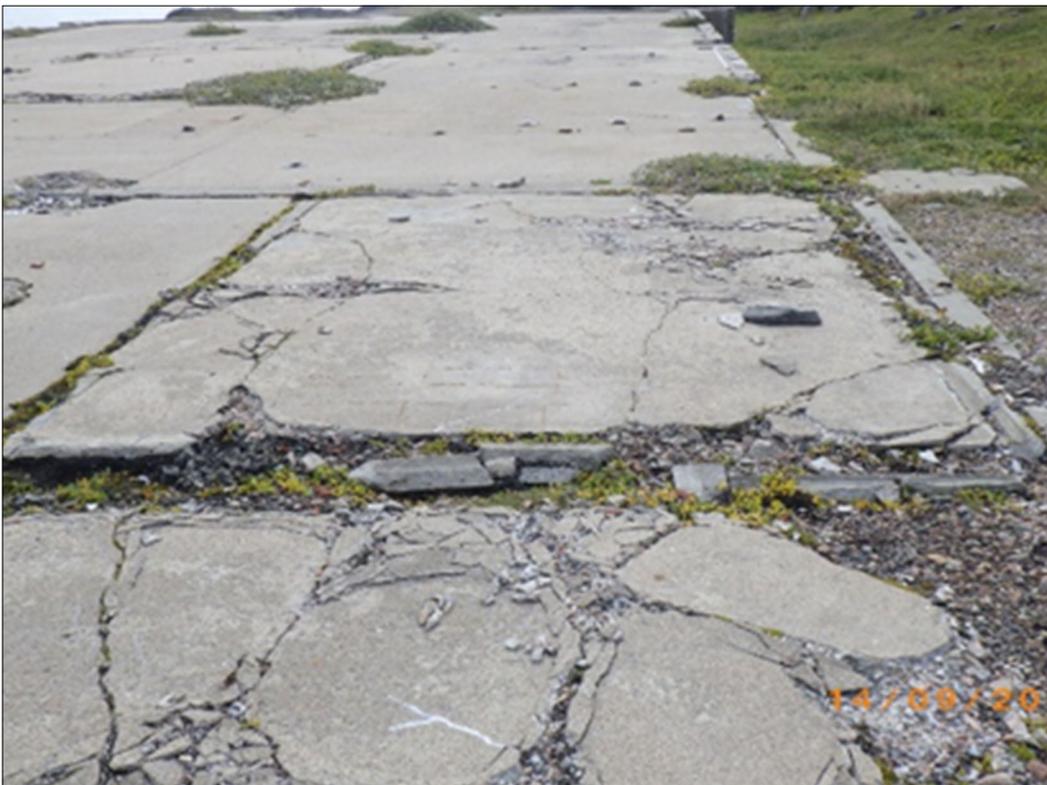
PHOTO 34 - APEC #5: View of former main building concrete slab. Slab is in good condition in most areas, but is degraded in other areas. (September, 2017)

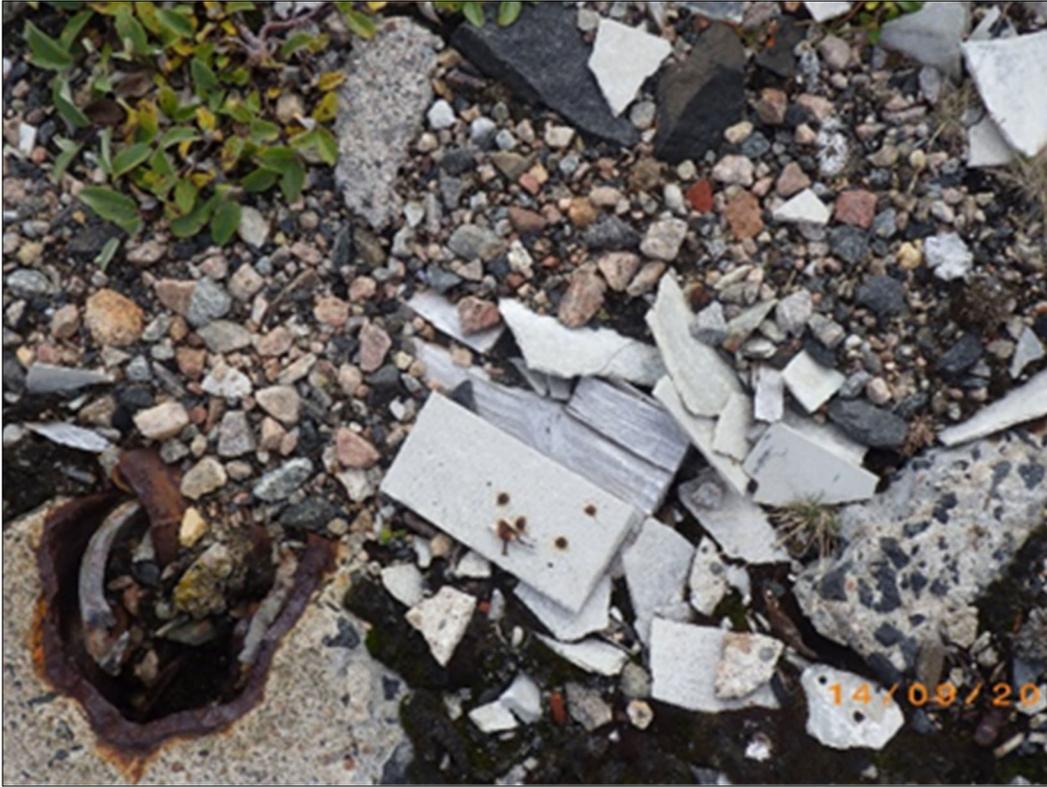
PHOTO 35 - APEC #5: View of potential ACM debris. (September, 2017)

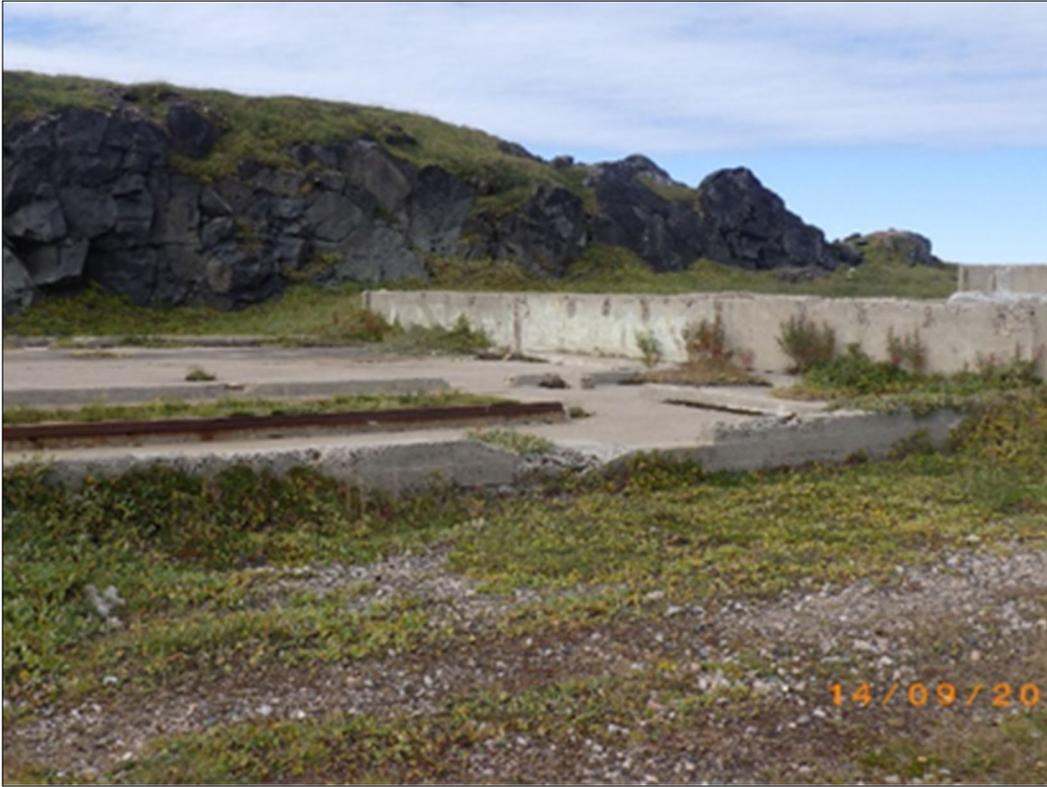
PHOTO 39 - APEC #5: View of stepping in former main building concrete foundation. (September, 2017)

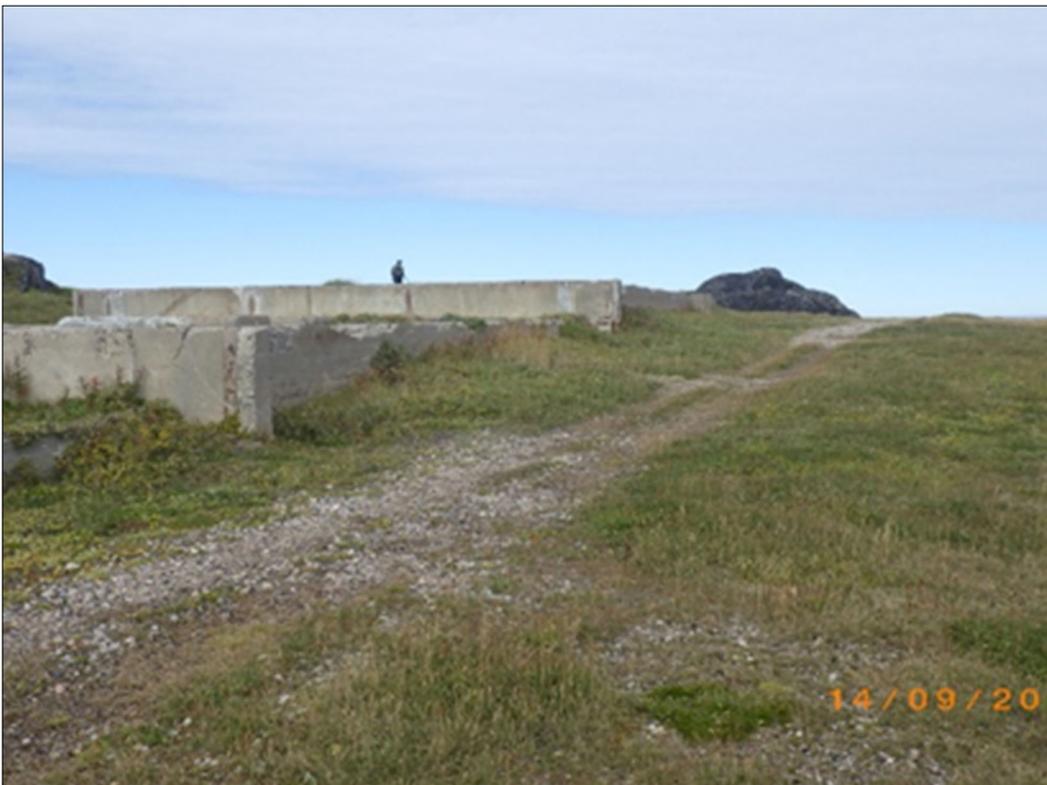
PHOTO 40 - APEC #5: View of stepping in former main building concrete foundation. Access road to the right. (September, 2017)

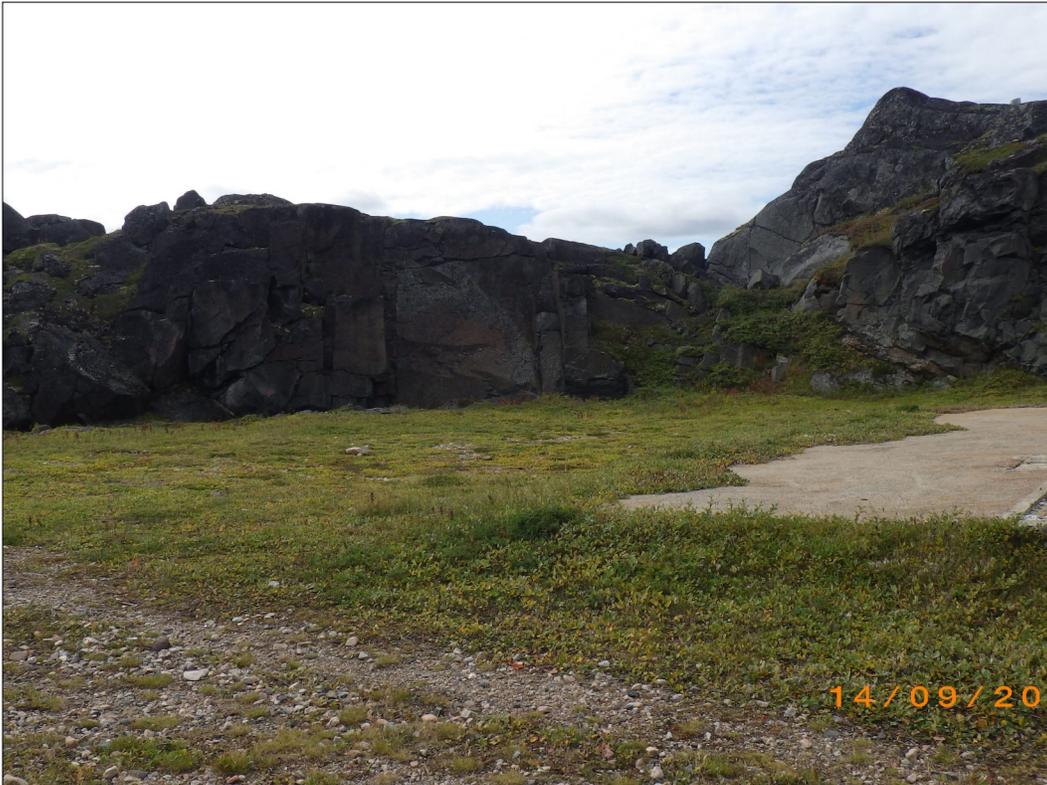
PHOTO 41 – APEC #6 (Preliminary): Rock face appeared in satellite imagery to be a crevasse where landfilling may have occurred. No environmental concerns identified. (September, 2017)

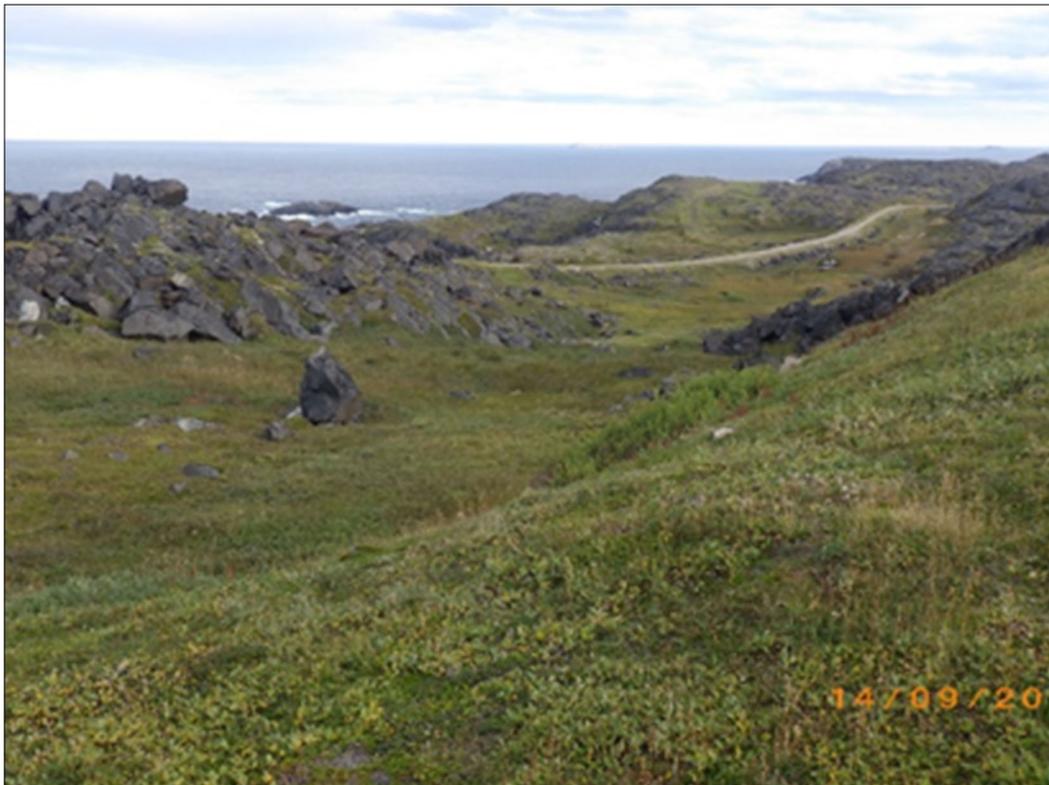
PHOTO 42 - APEC #6: Depression located adjacent to the former main building concrete foundation. (September, 2017)

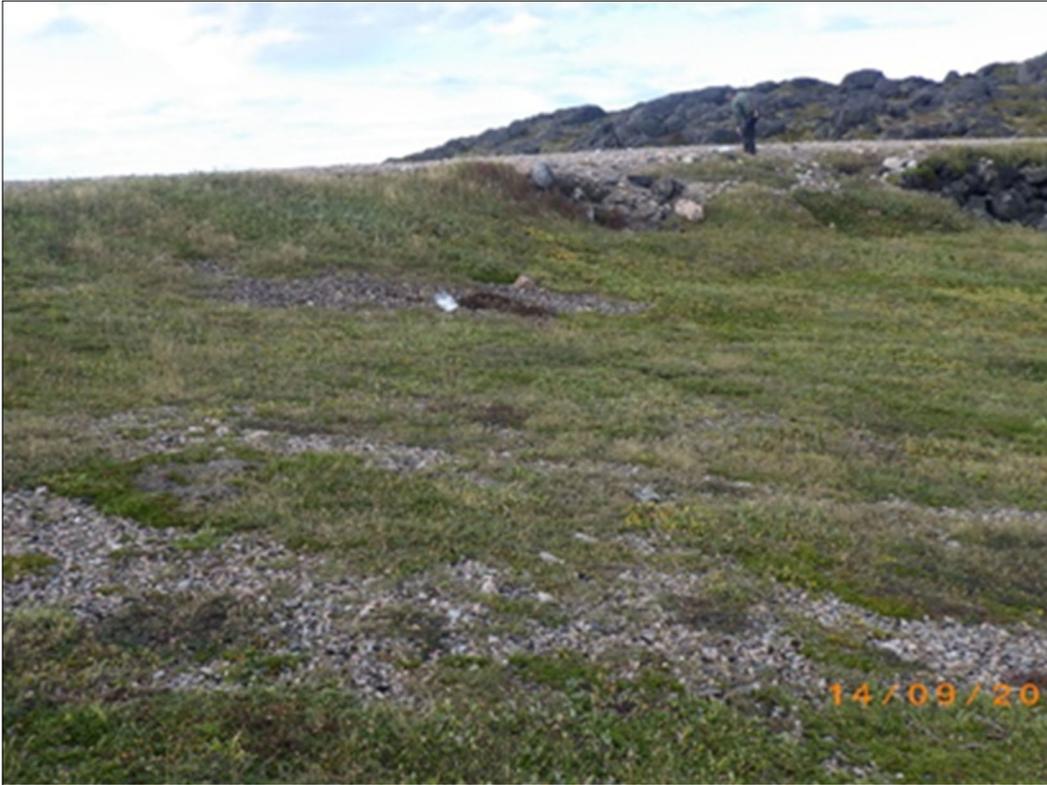
PHOTO 43 – APEC #6: View of some debris (plastic, small metal objects, a buried, was observed in this area). (September, 2017)

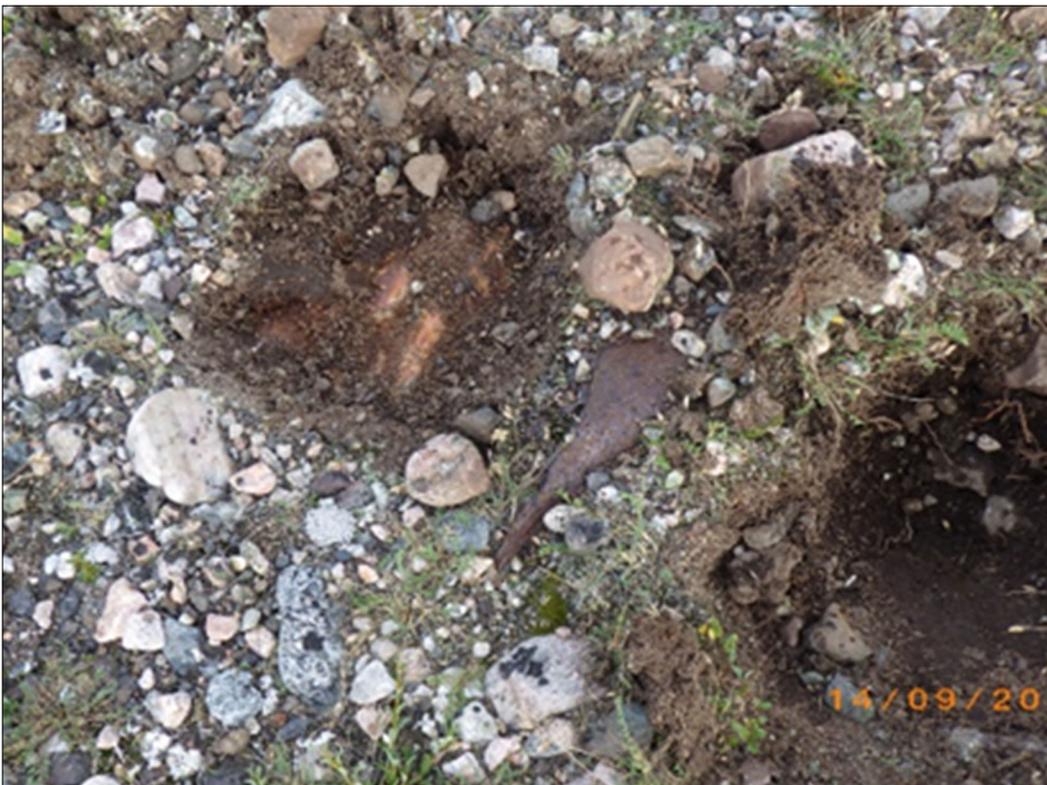
PHOTO 44 - APEC #6: Test Pit completed in the depression area. (September, 2017)

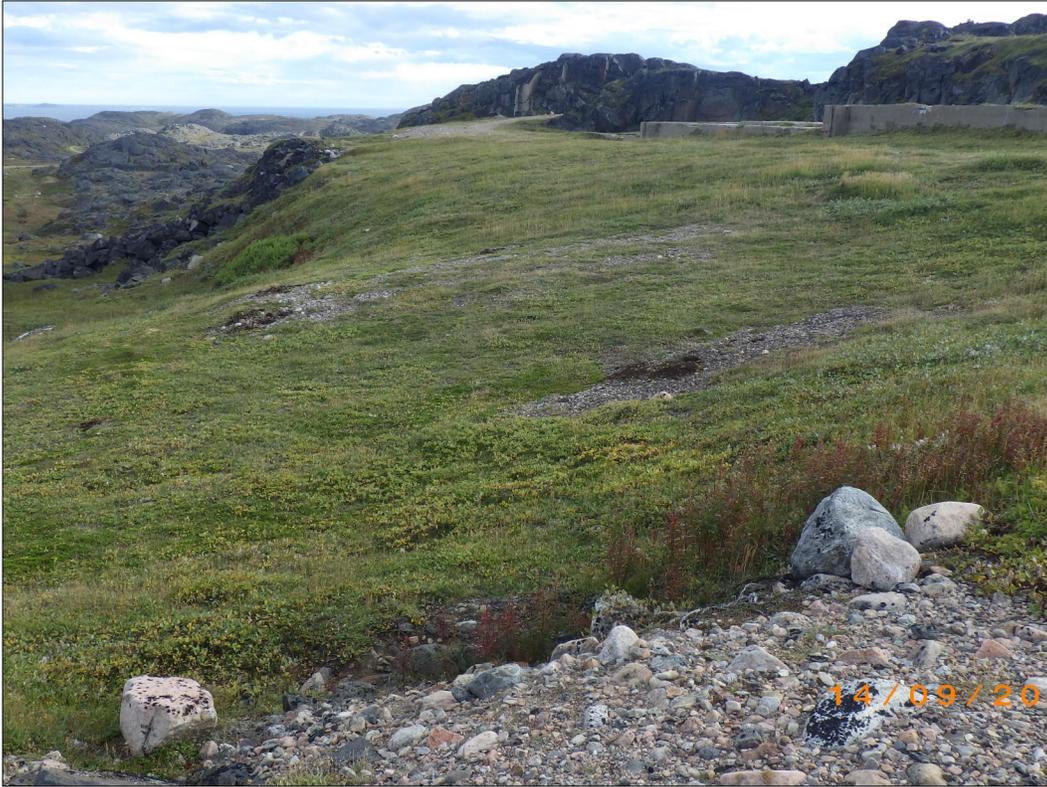
PHOTO 45 – APEC #6: Area immediately east of APEC #5, where evidence of buried debris was noted. (September, 2017)

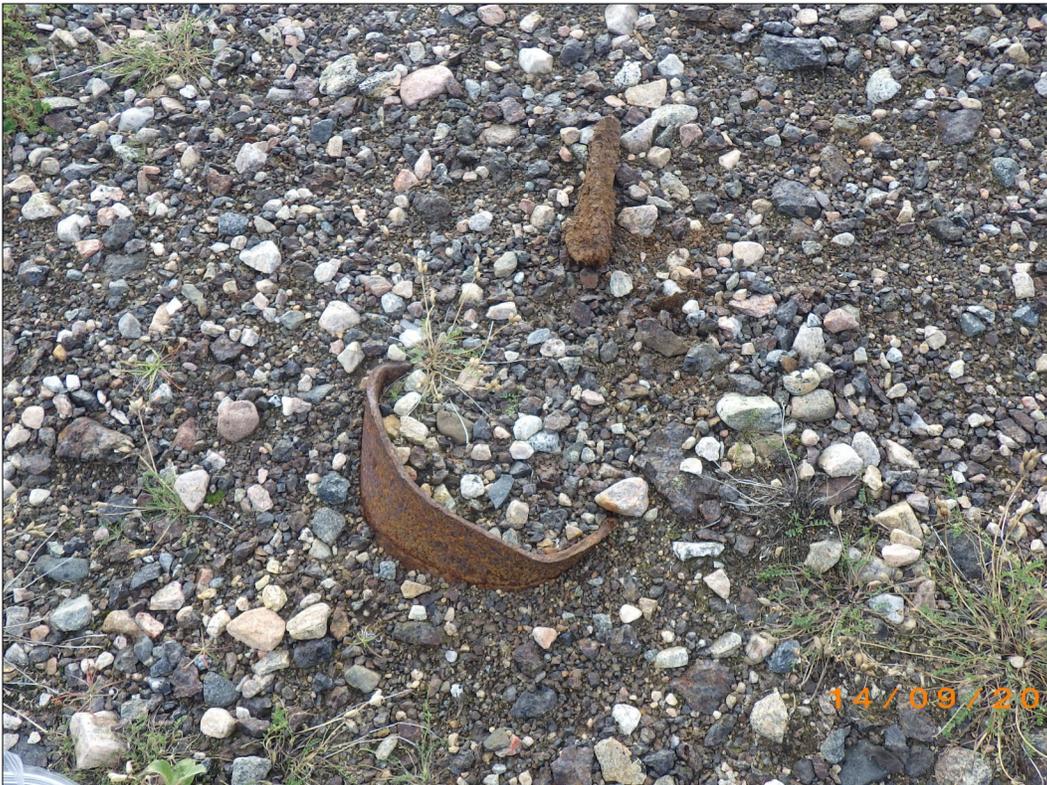
PHOTO 46 - APEC #6: Close up view of debris. (September, 2017)

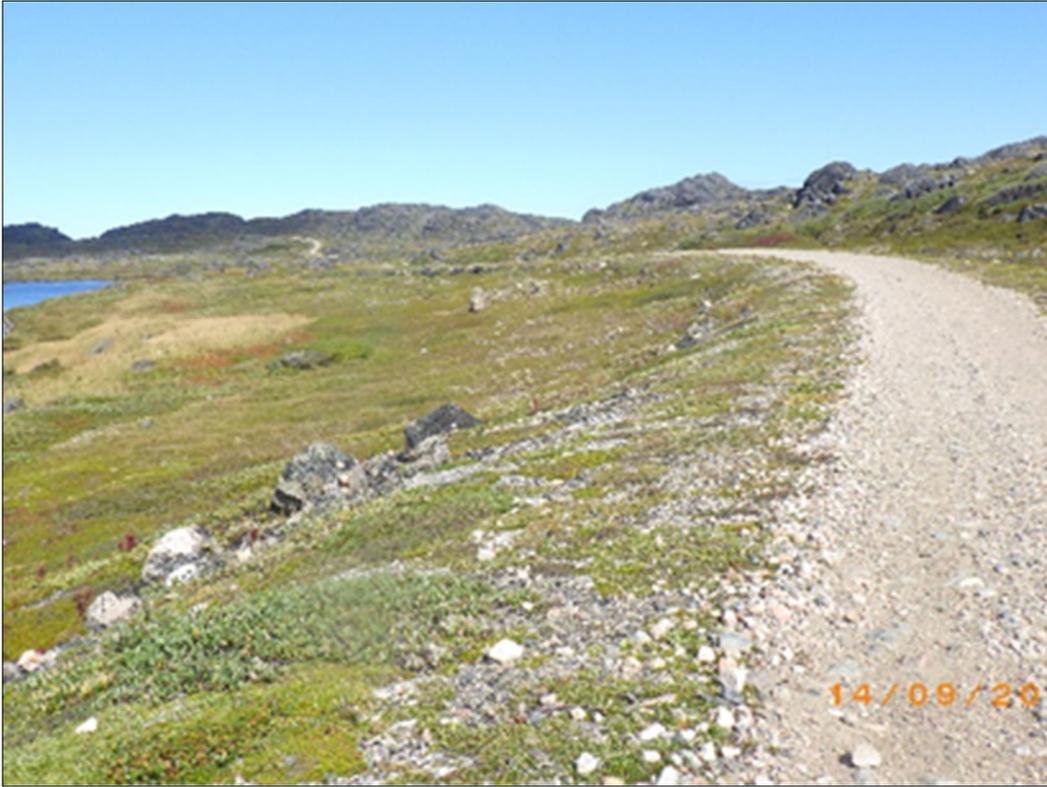
PHOTO 47 – APEC #7: Gravel access road that connects the Upper Site to the lower Site, still in good condition. (September, 2017)

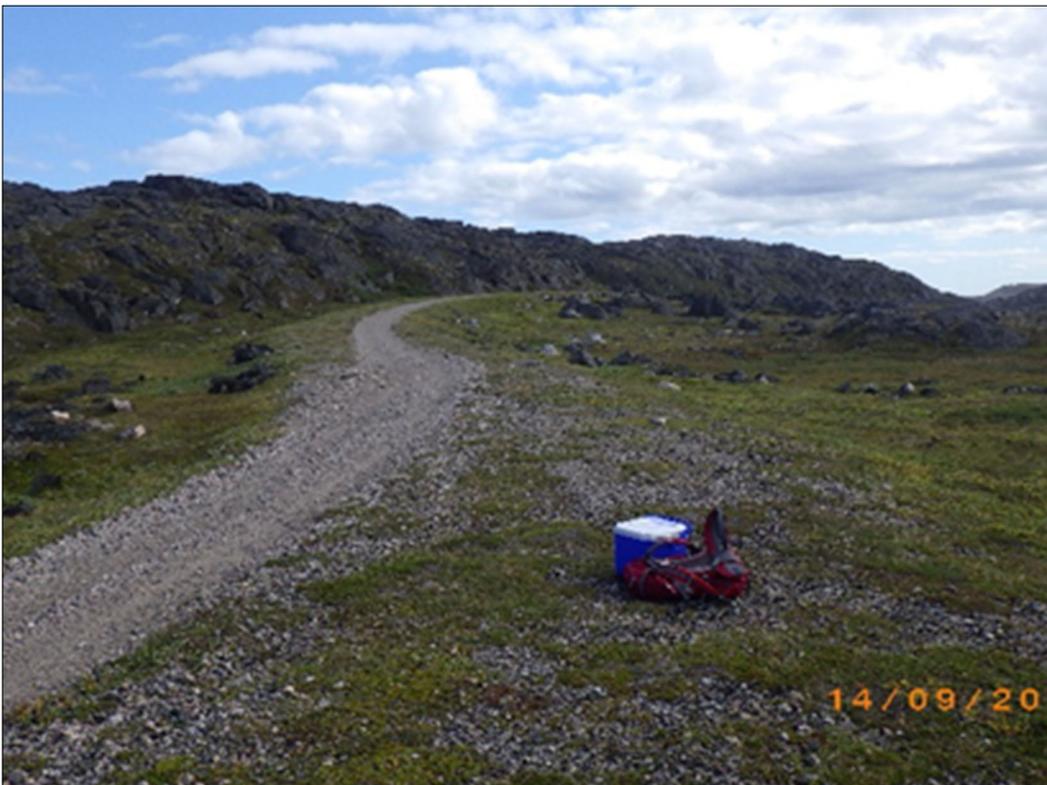
PHOTO 48 - APEC 7: Gravel access road that connects the Upper Site to the Lower Site, still in good condition. (September, 2017)

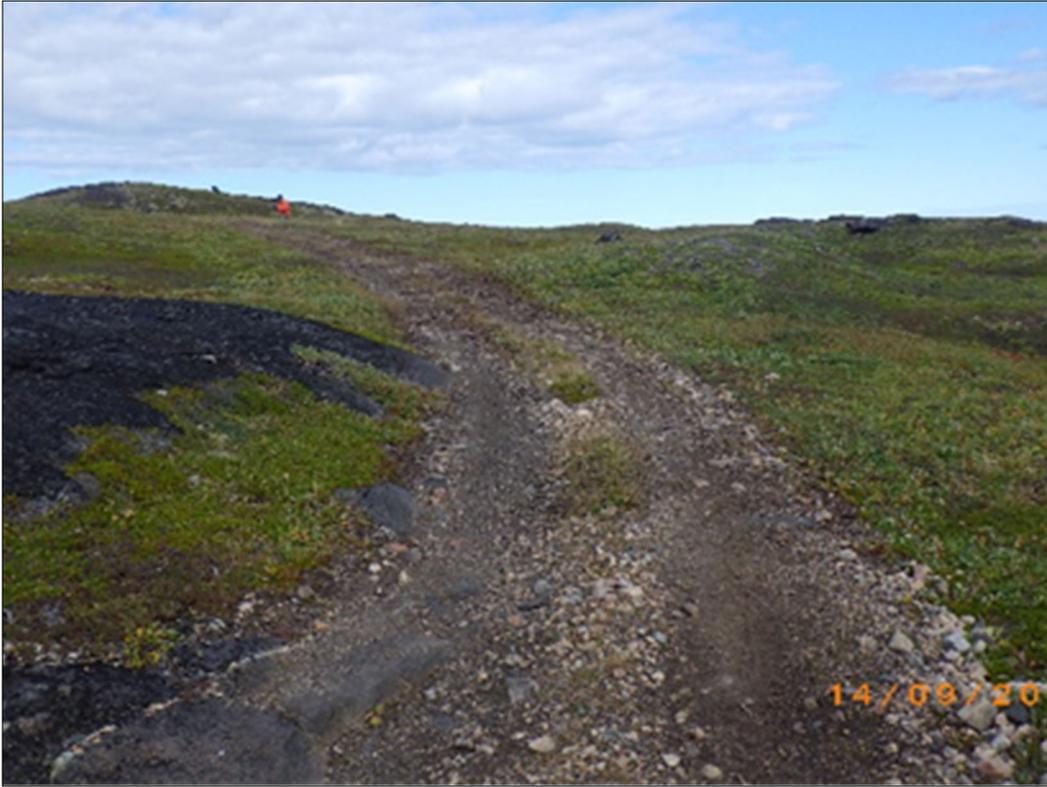
PHOTO 49 – APEC #7: Gravel access road that connects the Upper Site to the lower Site, still in good condition. (September, 2017)

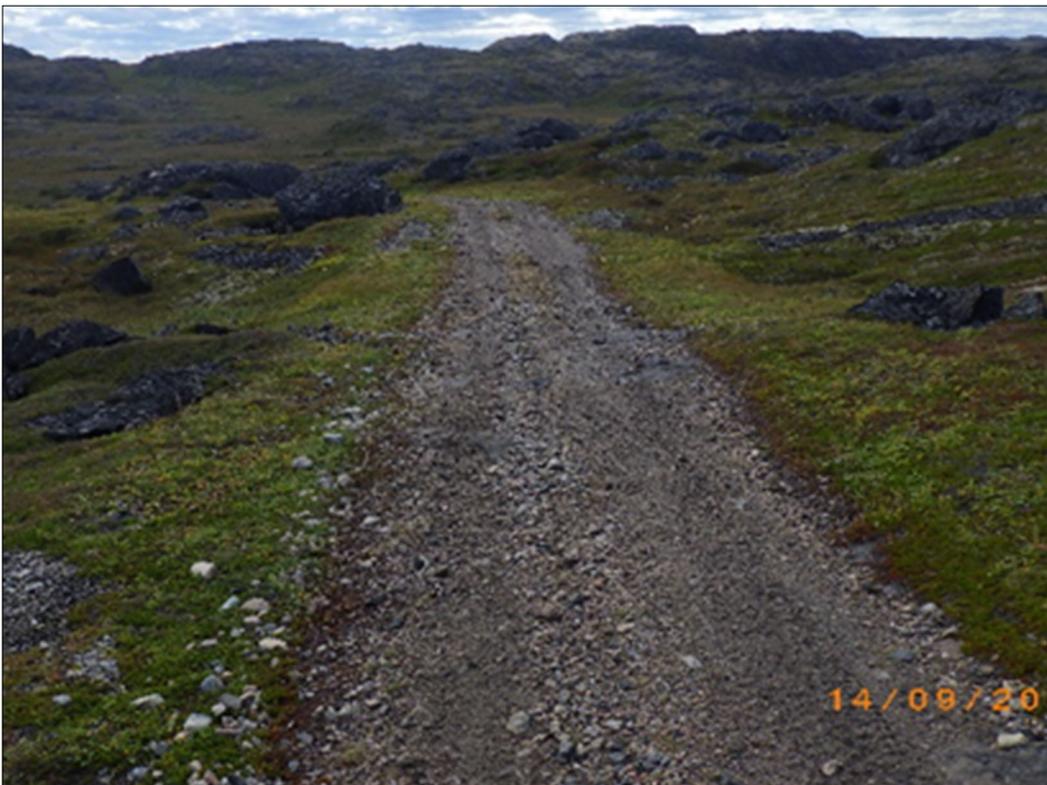
PHOTO 50 - APEC #7: Gravel access road that connects the Upper Site to the Lower Site, still in good condition. (September, 2017)

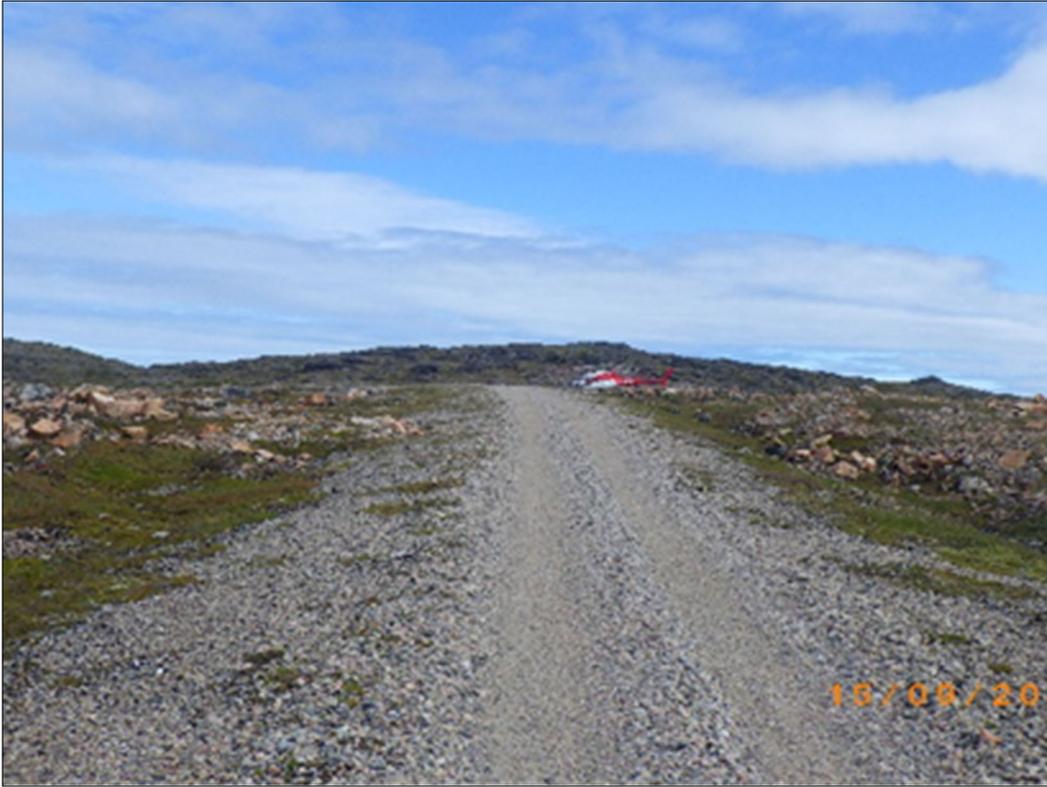
PHOTO 51 – APEC #7: Gravel access road that connects the Upper Site to the lower Site, still in good condition. (September, 2017)

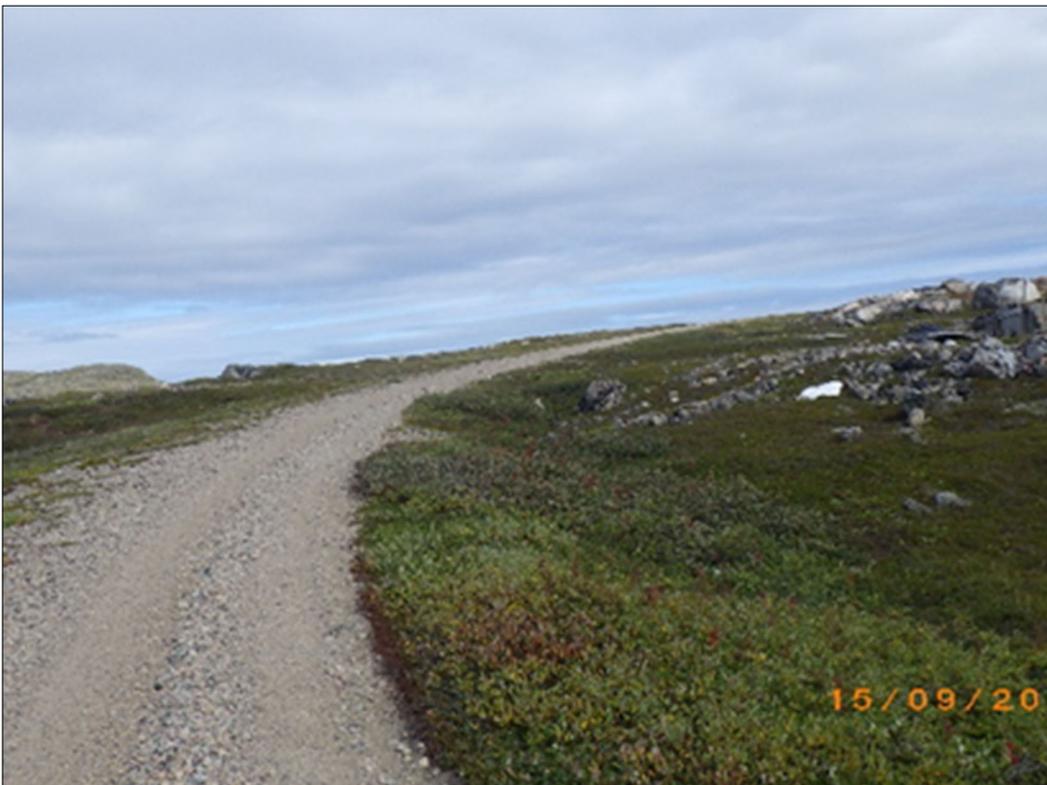
PHOTO 52 - APEC #7: Gravel access road that connects the Upper Site to the Lower Site, still in good condition. (September, 2017)

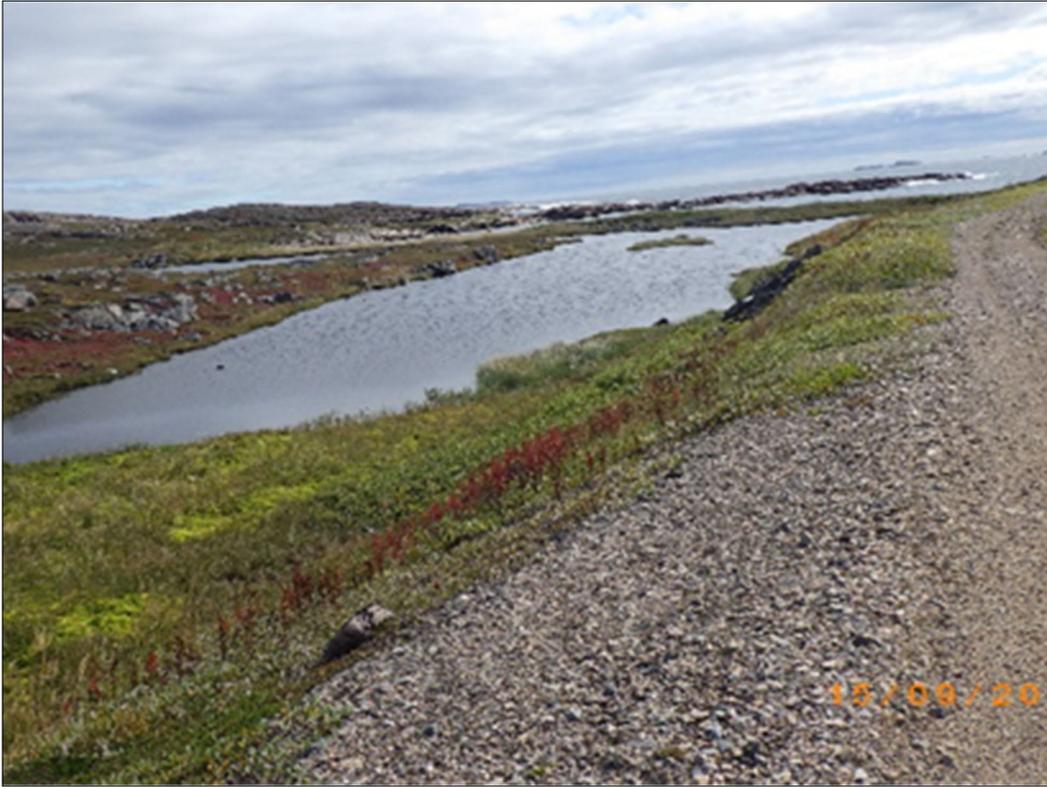
PHOTO 53 – APEC #7: Gravel access road that connects the Upper Site to the lower Site, still in good condition. (September, 2017)

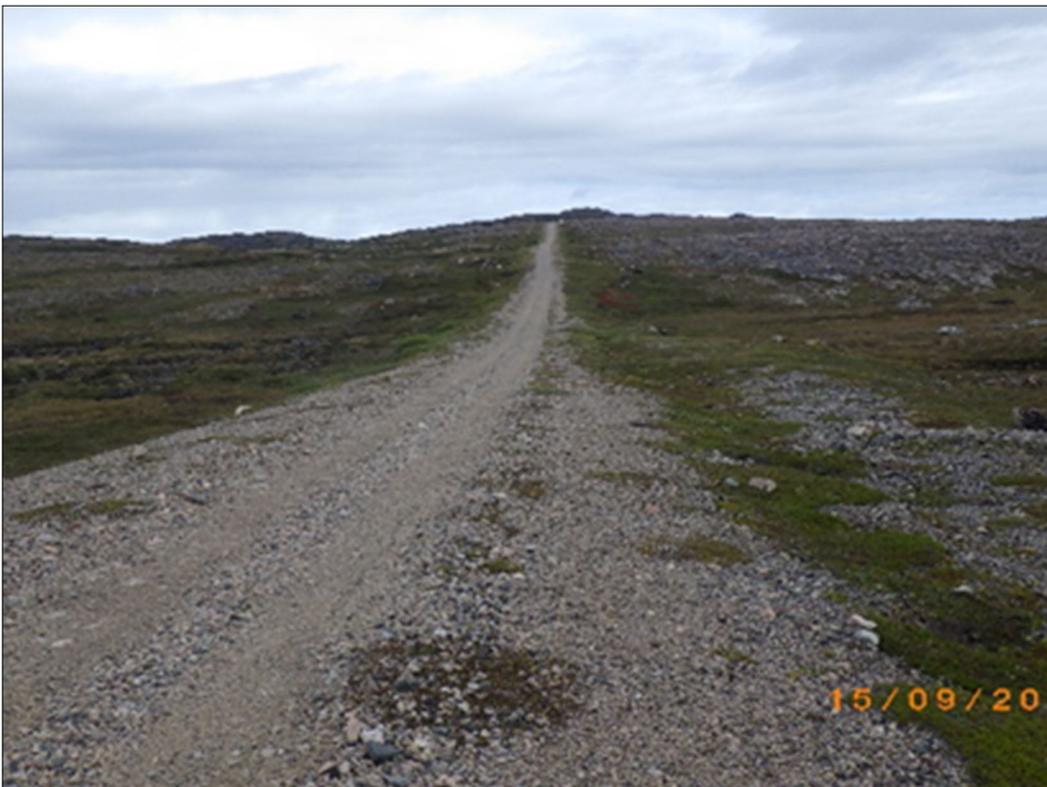
PHOTO 54 - APEC #7: Gravel access road that connects the Upper Site to the Lower Site, still in good condition. (September, 2017)

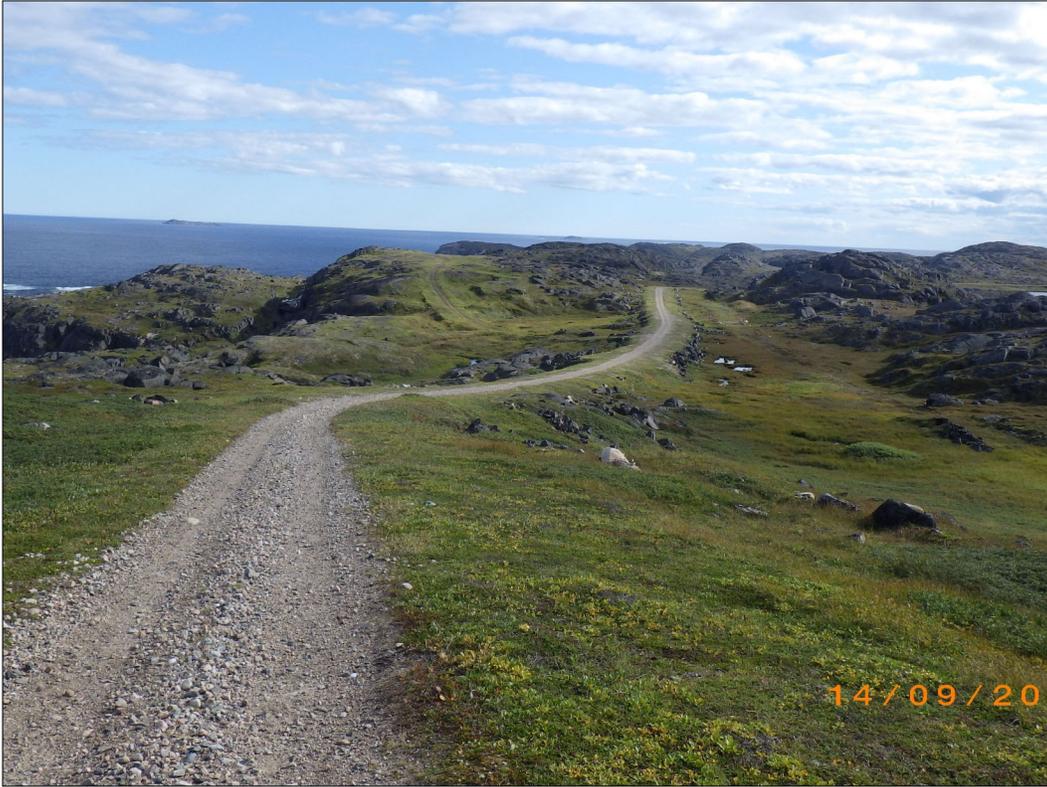
PHOTO 55 – APEC #7: Gravel roadway between the Upper and Lower sites, Above ground fuel line was historically present adjacent to the roadway. (September, 2017)
