**Step 3 Initial Testing Program and  
Step 4 Site Classification  
Former Pinetree Line Radar Station  
Spotted Island  
NL17AS01  
Contract Number: 65745**

GEMTEC Project: 10550.04.02 (Final)

**Re: Final Report: Step 3 Initial Testing Program and Step 4 Site Classification and Step 4 Site Classification, Former Pine Tree Line Radar Station, Spotted Island, Labrador, DCC Project Number: NL17AS01, Contract Number 65745**

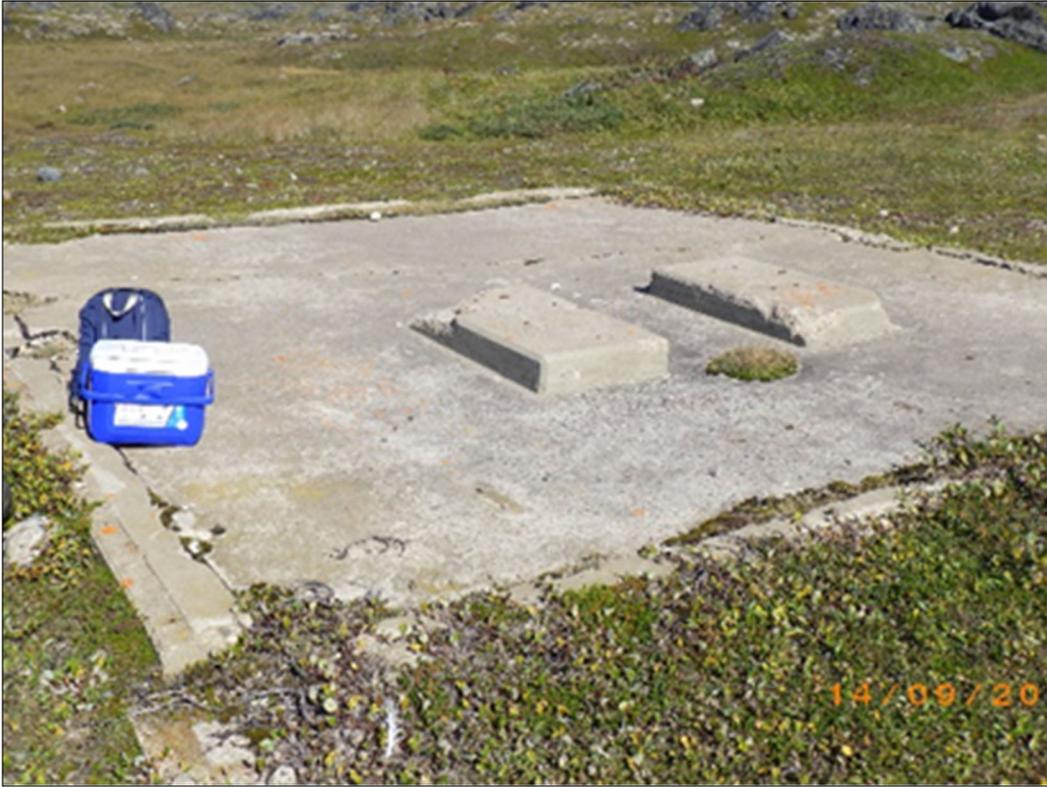
PHOTO 63– APEC #9: Former pump house concrete foundation. (September, 2017)

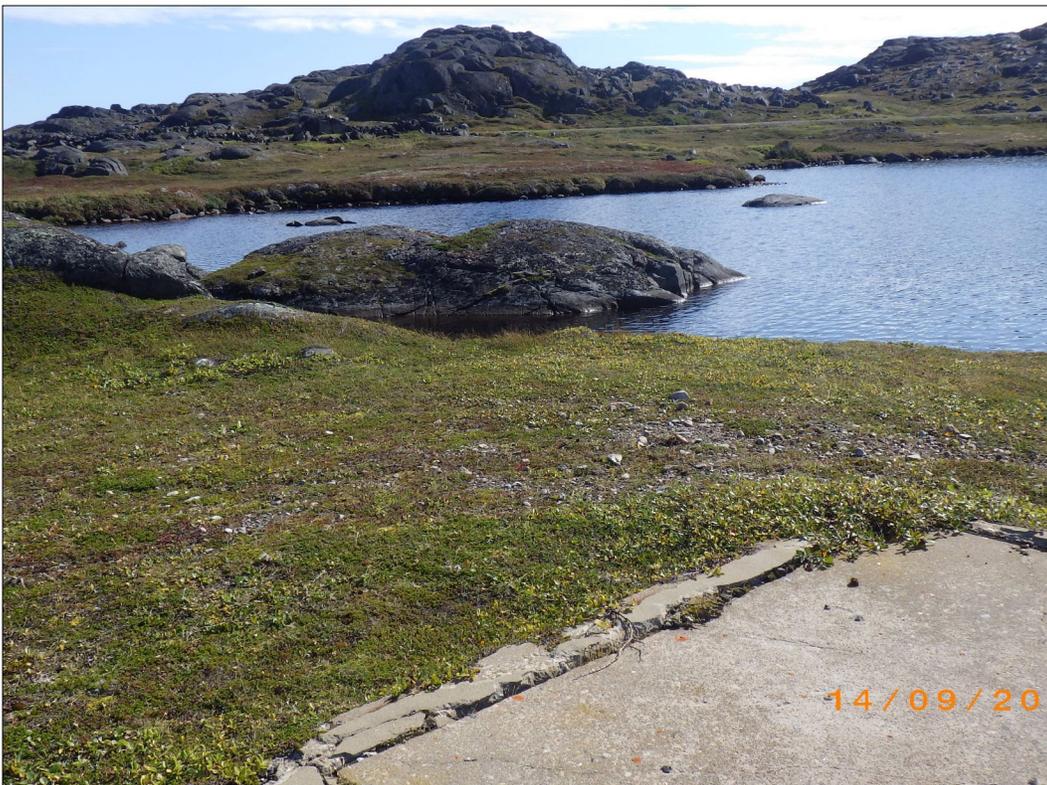
PHOTO 64 - APEC #9: Pump house and water source, showing remains of pump house foundation. (September 2017)

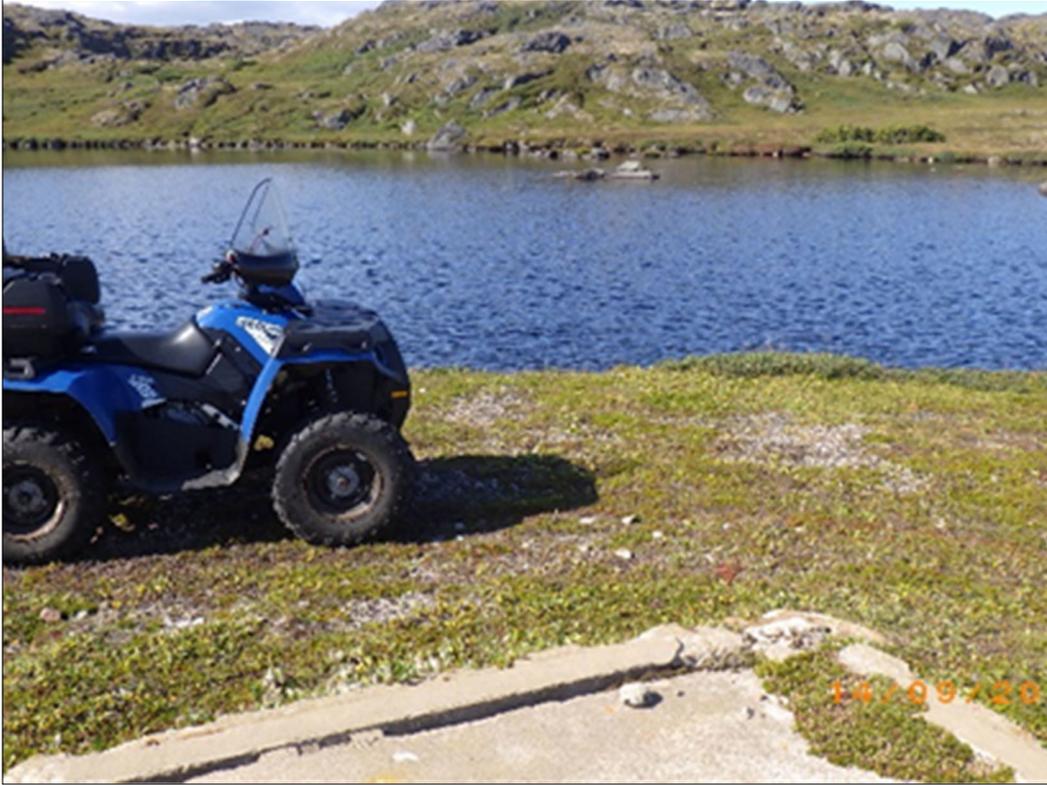
PHOTO 65– APEC #9: View of surface water body from the former pump house concrete foundation. ATV belongs to seasonal resident (September, 2017)

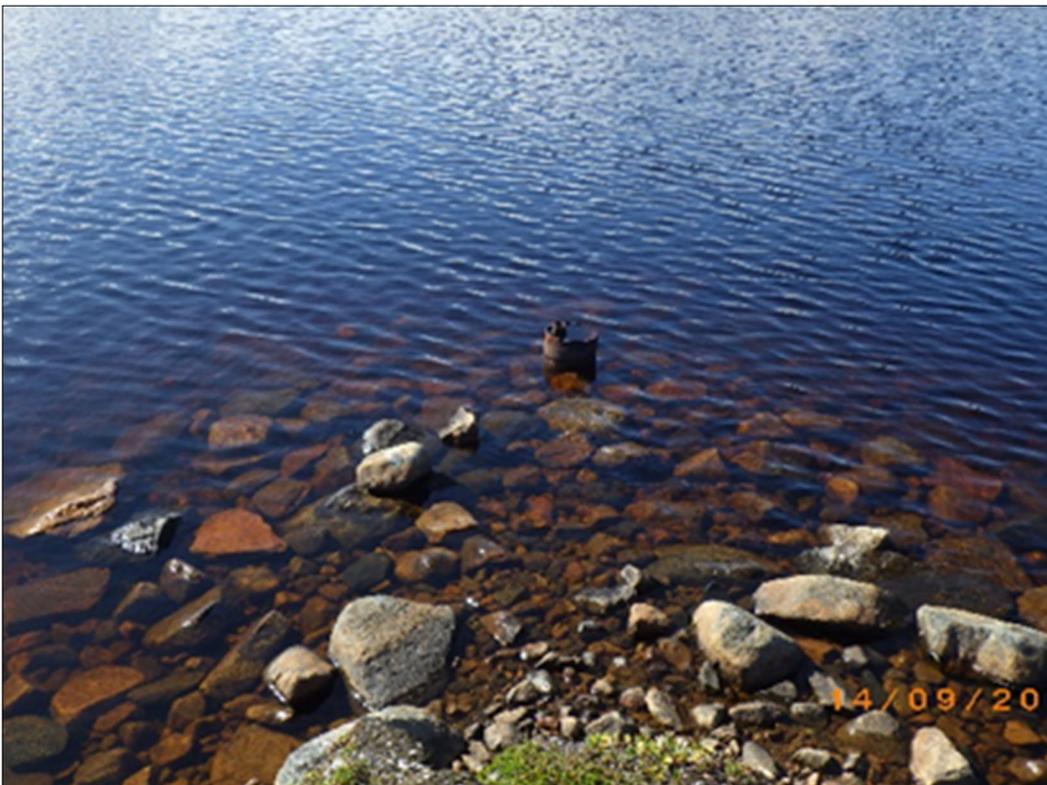
PHOTO 66 - APEC #9: View of substrate in the surface water body. (September 2017)

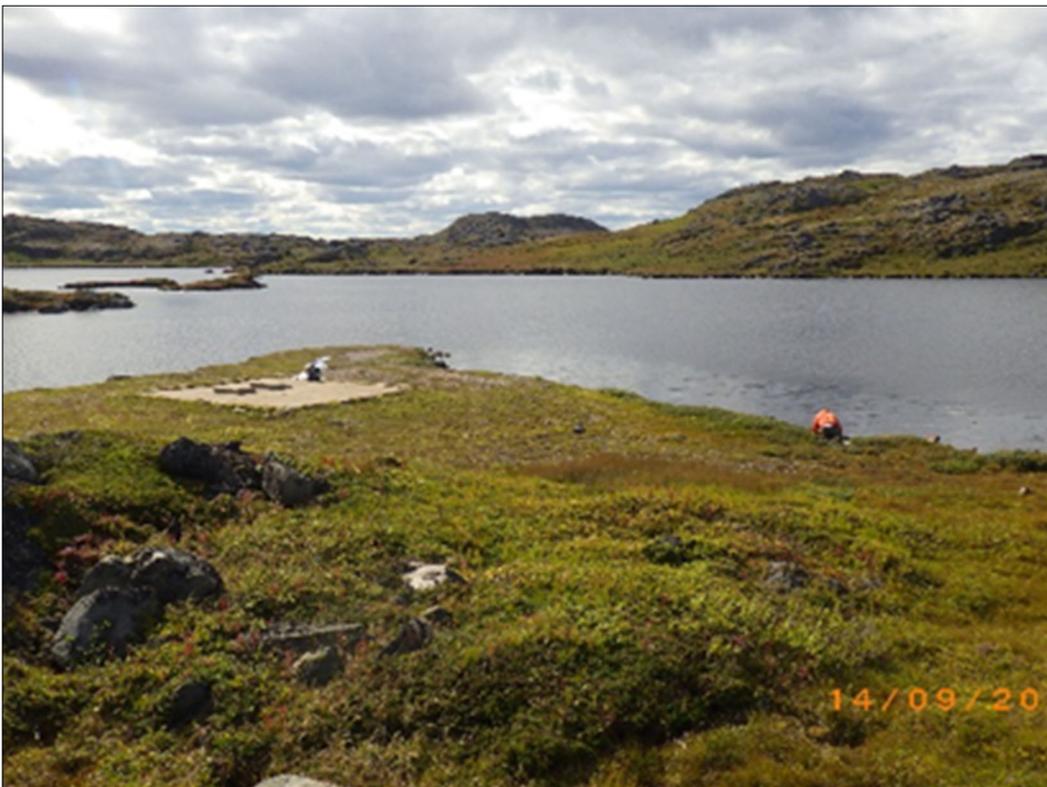
PHOTO 70 - APEC #9: View of former pump house concrete foundation and surface water body. (September 2017)

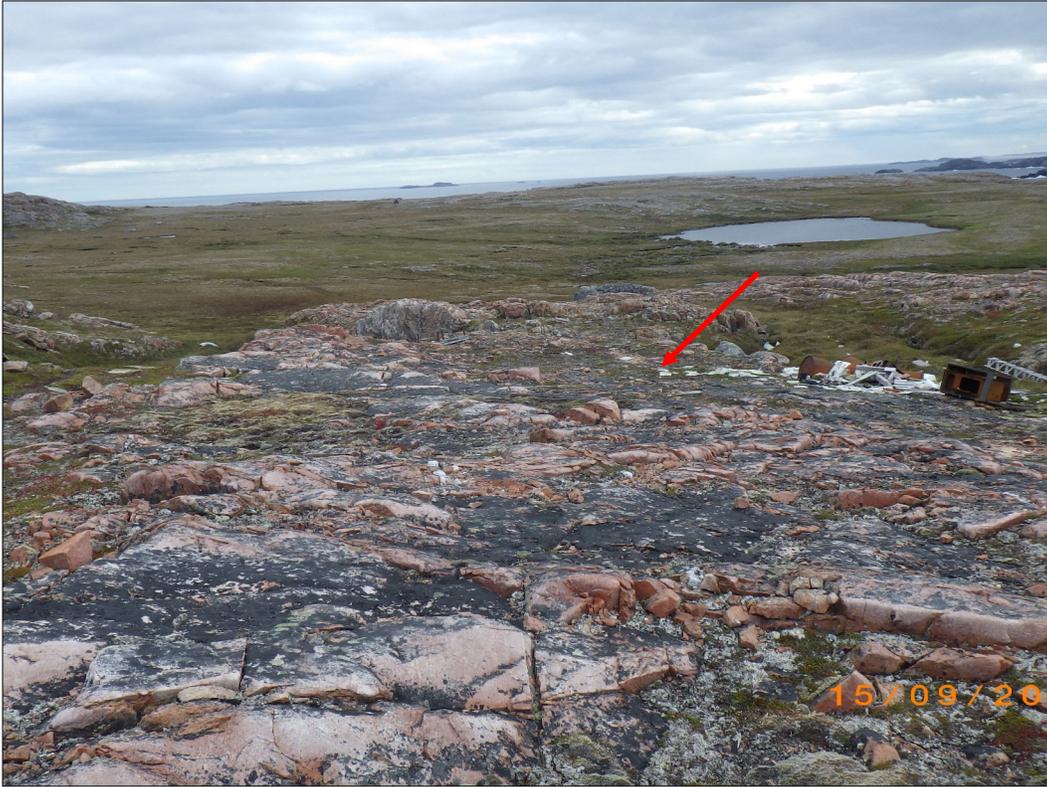
PHOTO 71– APEC #10: Bury / dump site. Debris is dumped directly on exposed bedrock thus no soil samples were collected. (September 2017)

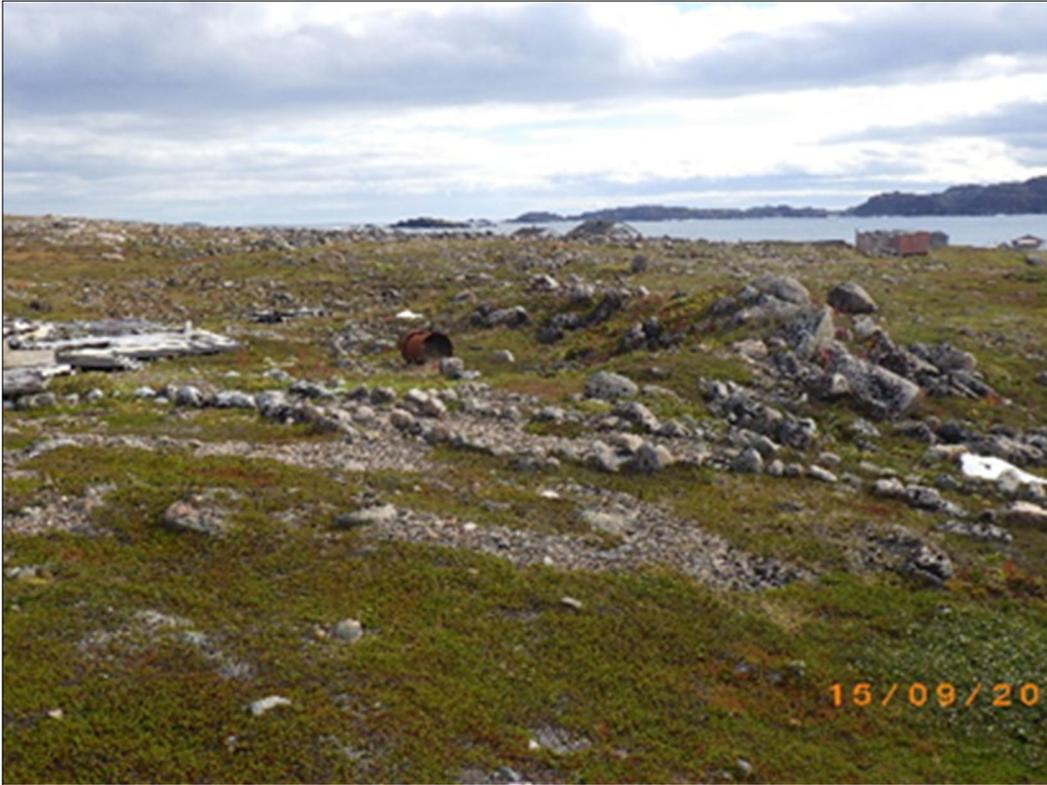
PHOTO 79– APEC #11: Remains of a painted wooded structure and scattered building material debris. Seasonal village observed in the background. (September, 2017)

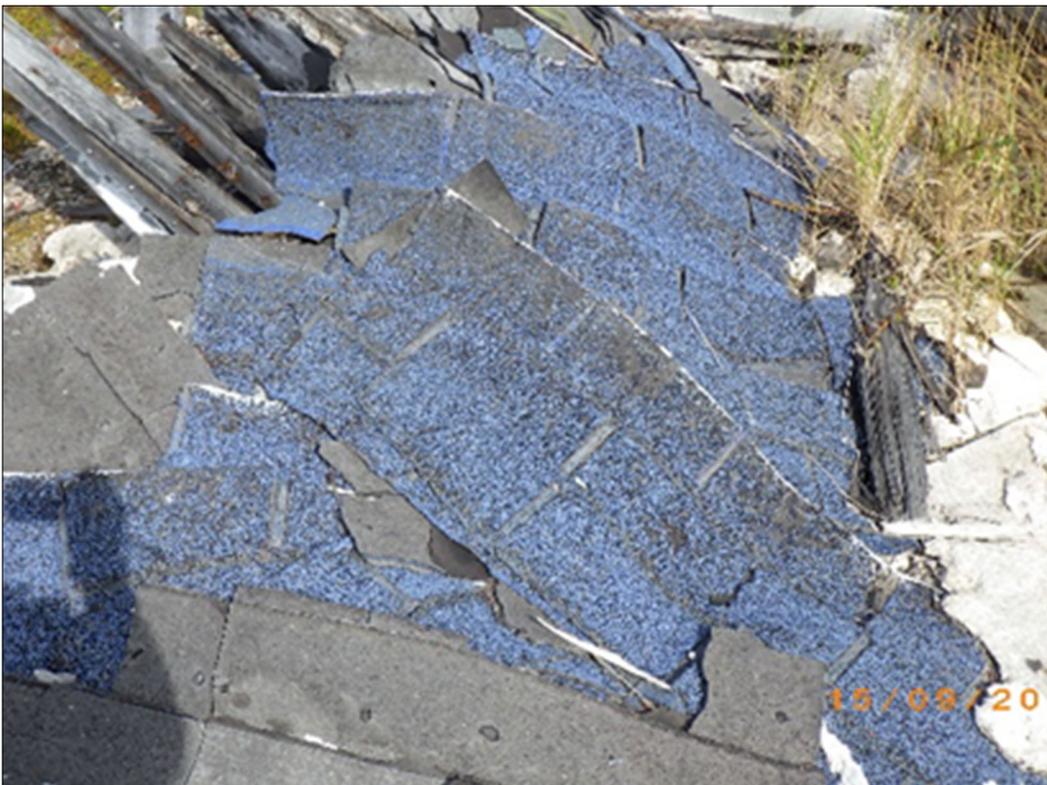
PHOTO 80 - APEC #11: View of asphalt shingles disposed of at APEC #11.  
(September 2017)

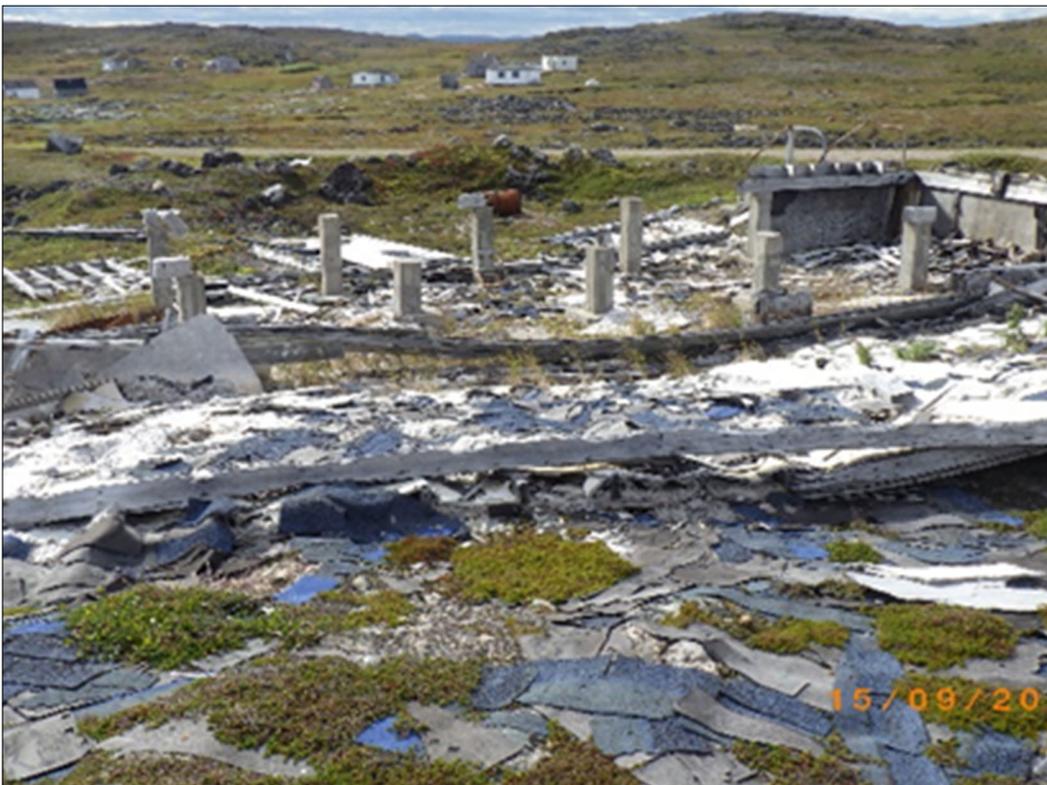
PHOTO 82 - APEC #11: View of remains of a painted wooded structured. Seasonal village observed in the background. (September 2017)

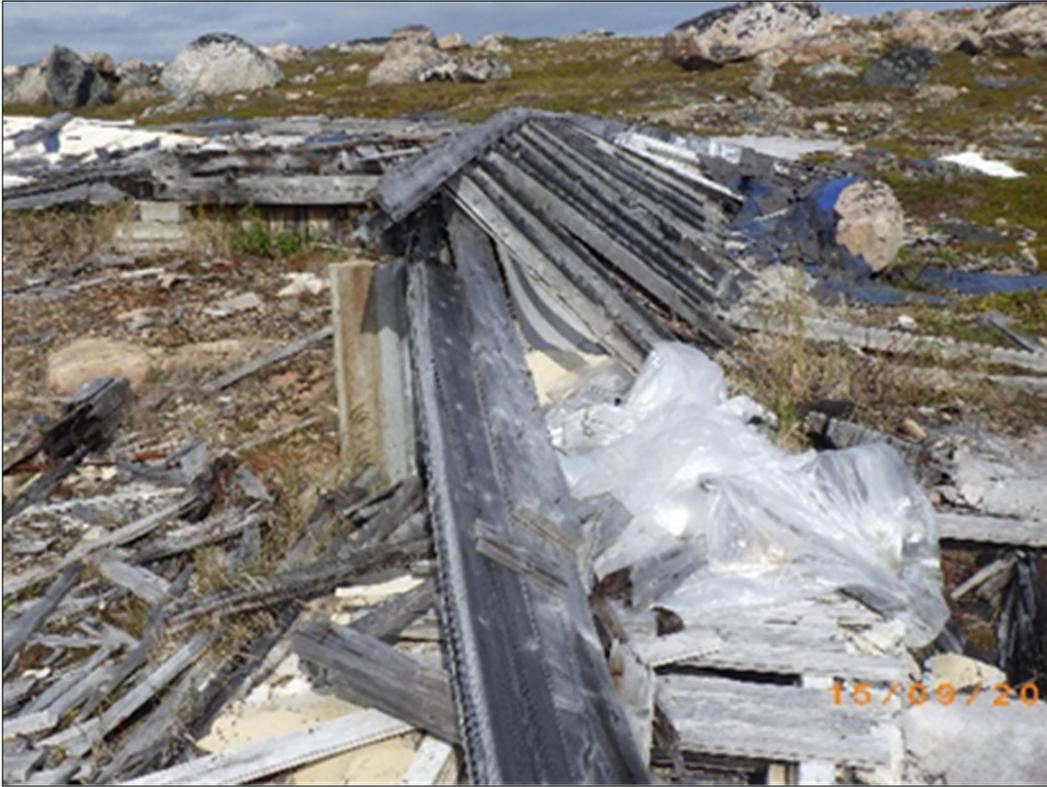
PHOTO 83– APEC #11: View of debris disposed of at APEC #11. (September, 2017)
