Exploits Generation: Proposed Goodyear's Dam Life Extension Project

Environmental Assessment Registration Pursuant to the Newfoundland & Labrador
Environmental Protection Act (Part X)

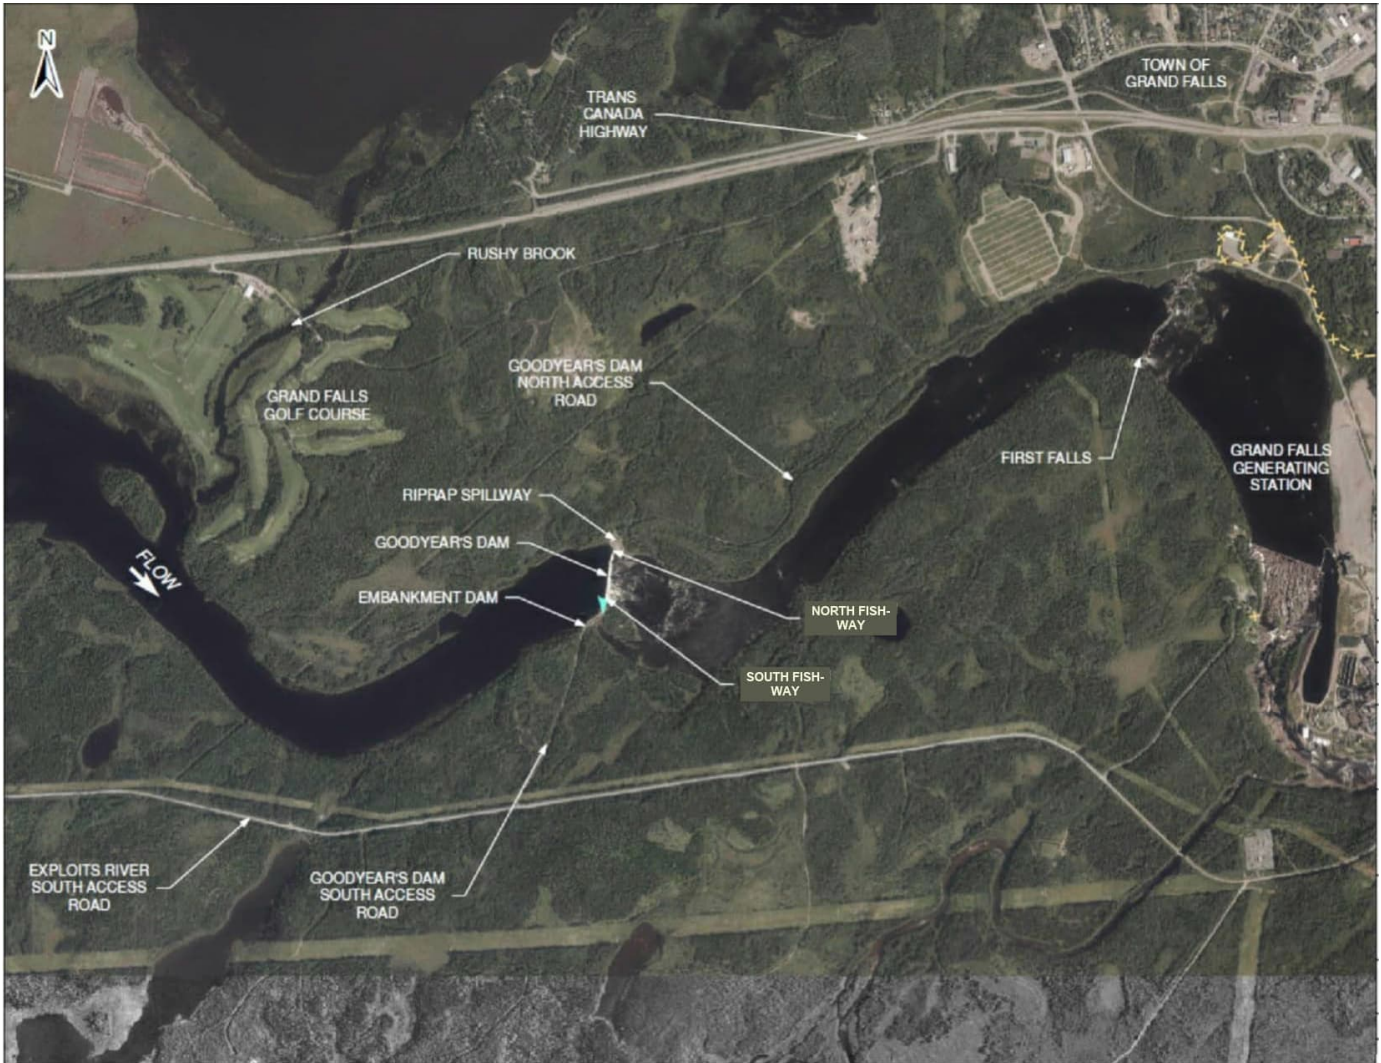
Figure 2-2 Goodyear's Dam Site Layout

Source: NLH 2022 Public Safety Plan – Grand Falls and Goodyears Systems, Figure 2)

The Grand Falls hydroelectric generation facility consists of the Grand Falls Generating Station and associated infrastructure and the Goodyear's Dam spillway and fishway, the focus of this EA Registration, located approximately 4 km upstream (Figure 2.2). The total power plant output of 80 MW is produced from a head of approximately 100 feet (30.5 m), and the facility is a run of river plant with virtually no water storage in its head pond. The total Exploits River watershed upstream of Grand Falls is approximately 8,390 km². Water is released from the main storage dam at Beothuk Lake (Millertown Dam) to maintain the required level of water flow and electrical generation at Grand Falls and other facilities. Goodyear's Dam creates a small reservoir in the river in advance of the Grand Falls facility for ice control purposes.

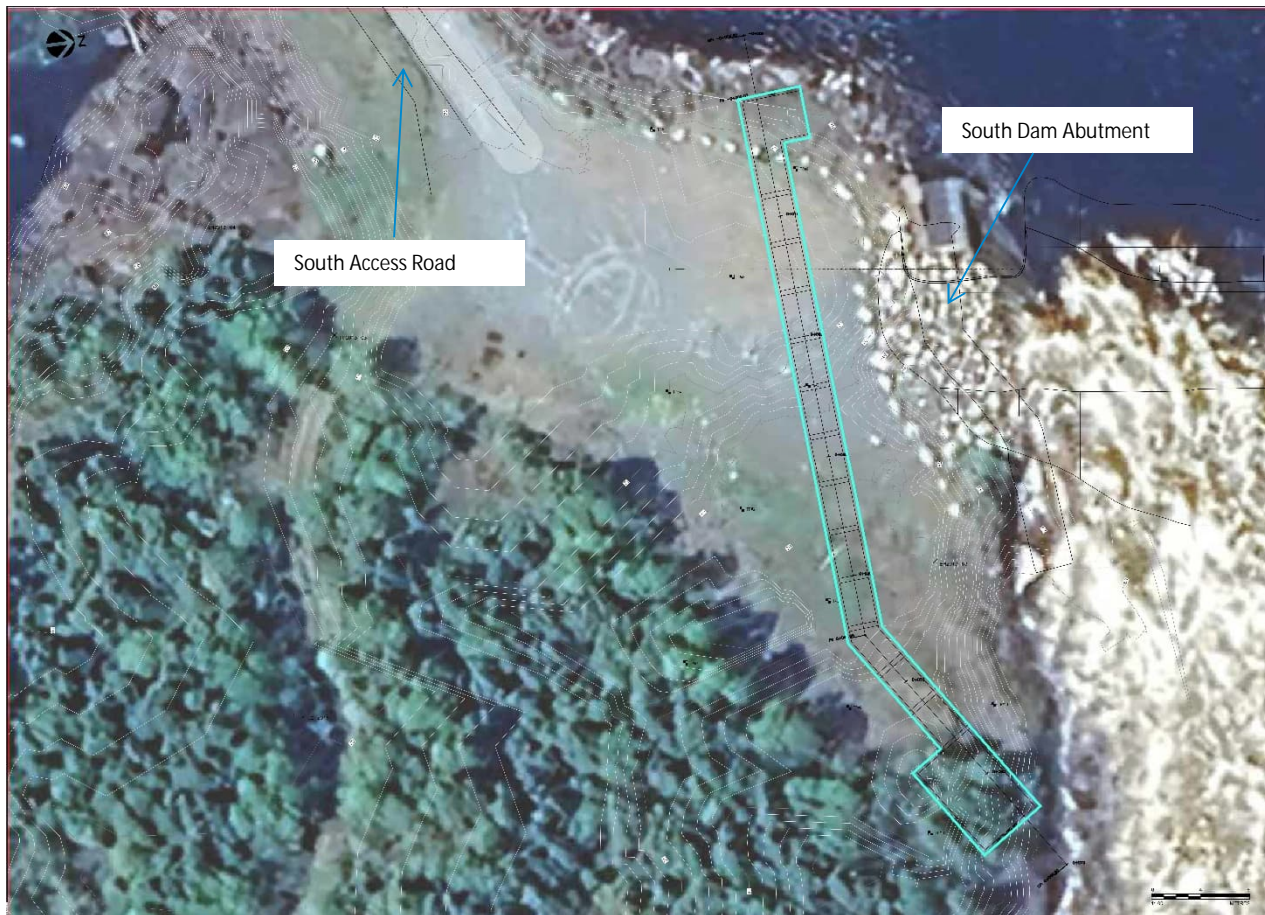
Figure 2-6 Layout of the New South Side Fishway

A new vertical slot fishway will be constructed on the southern side of Goodyear's Dam to improve fish passage for Atlantic salmon. The planned layout of the new south side fishway is shown in Figure 2.6. The footprint differs from the existing infilled south fishway to minimize in-water work and environmental impacts. The design will include an auxiliary water supply system at the fishway entrance pool with stoplogs to provide sufficient attraction-flow. The construction involves blasting through bedrock for excavation, building reinforced concrete partition and side walls, and installing galvanized steel safety guards and the auxiliary water supply system. Cofferdams will be used upstream and downstream during construction to control water and minimize environmental impacts. The fishway is designed for a 75-year service life.

The fishway environmental design criteria included suitability for passage of Atlantic Salmon and the outlet (upstream exit) of the fishway be oriented perpendicular to the river flow to minimize debris accumulation in the exit pool. The design is based on review of historical flow data provided by NLH, and consideration for climate change and the recurrence of predicted drought episodes throughout the design life. A minimum flow volume at Goodyear's Dam of 70 cm/s has been used which also matches the Exploits River flow upstream of the Sandy Brook confluence noted as of September 24, 2025, during a drought episode. A flow value of 70 cm/s equates to a water level of 69.4 m in the head pond with the new buttress; therefore, a design criterion of 69.2 m has been selected for the upstream invert elevation.

Due to the location of the proposed new fishway outside the existing river channel, blasting will be required as part of construction. Based on the existing dam construction, age, and stability, in the interest of dam safety a peak particle velocity of 50.0 mm/s is recommended (WSP 2025c). The DFO guidelines for blasting near fish habitat will also be considered when developing a blasting plan for the project.

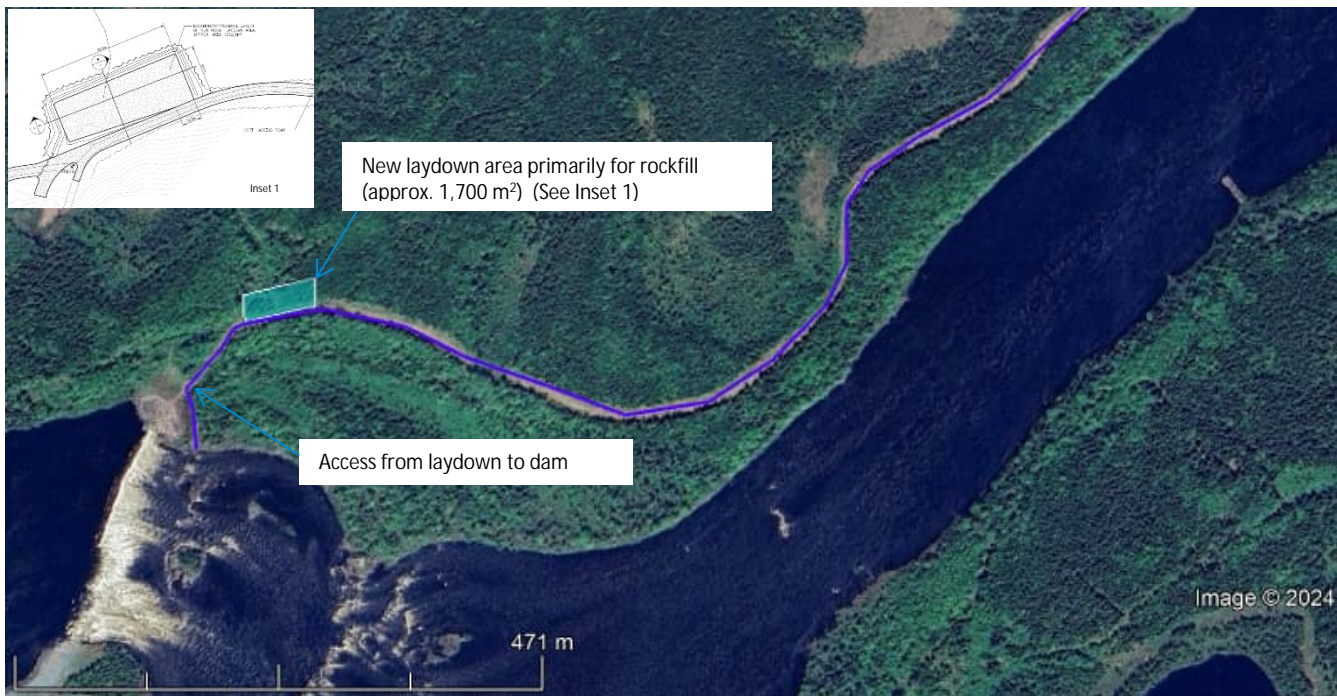
Figure 2-10 Proposed Location of North Side Laydown Area

This configuration ensures efficient material handling and site logistics while accommodating the scale and sequencing of the current rehabilitation works.

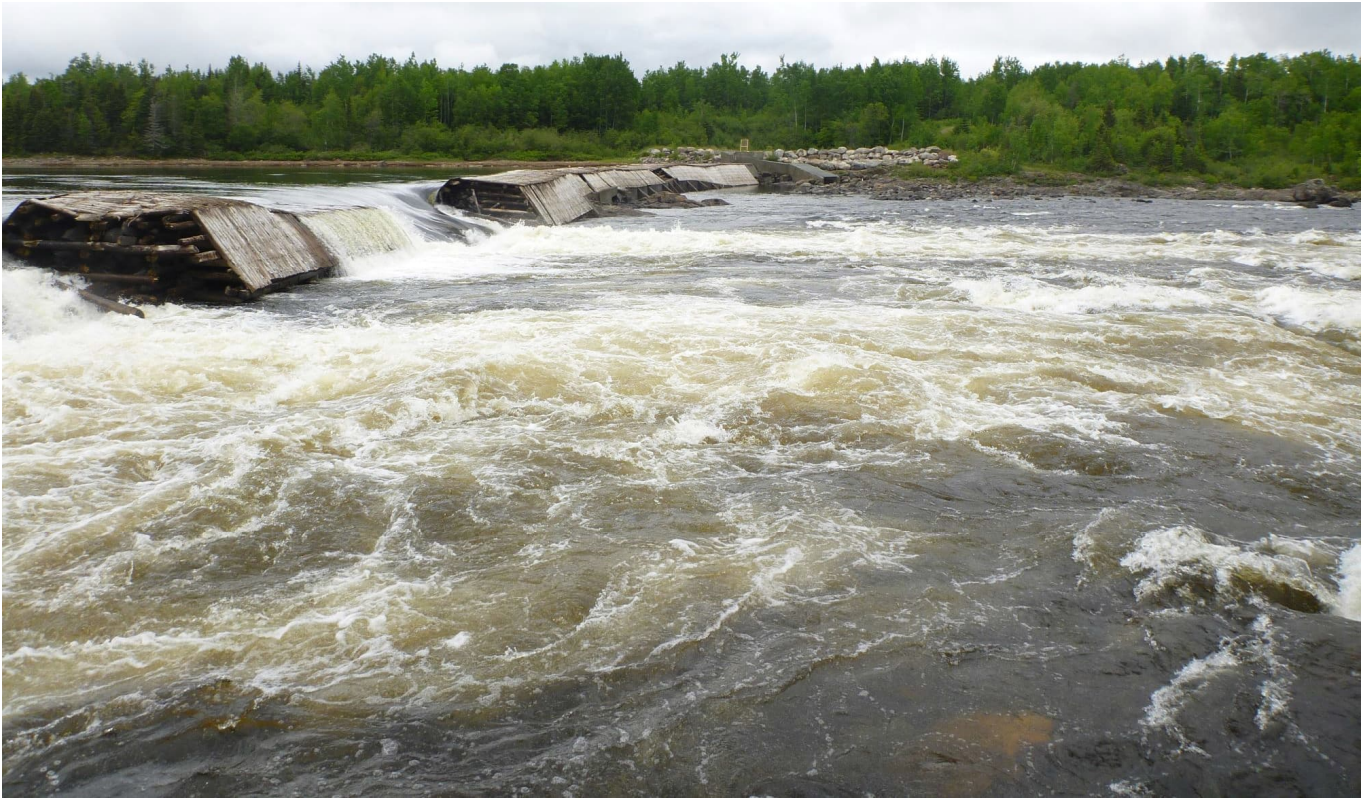
(boulders, rubble, cobble) because the majority of smaller material would be flushed downriver. It is likely that if any smaller material had accumulated prior the breach, it would have been again flushed further downriver. Figure 5-5 provides an example of the flows during the breach in 2015.

Figure 5-5: Image of Goodyears Dam (looking north) during 2015 breach (June 23, 2025) showing flows along the southern section

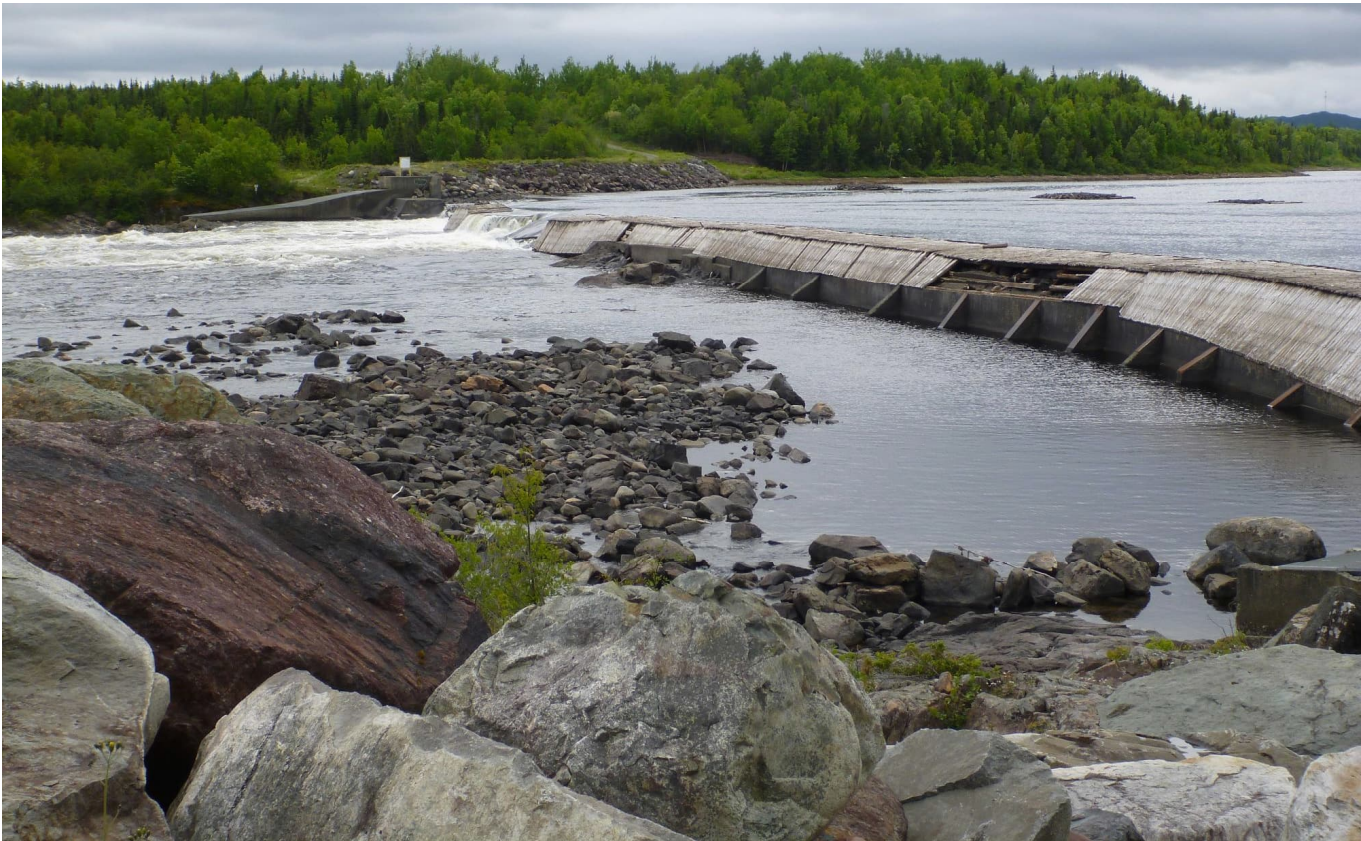
The riverbed along the northern two-thirds of the river within the footprint of the proposed structure was clearly visible during the 2015 breach as it was much shallower and therefore slightly exposed (Figure 5-6). As shown in Figure 5-6 and Drawing 79D9159 (Appendix C), the water depth of the habitat that would be within the project footprint ranges from approximately zero (substrate at the surface) to two metre (6') water depth. Visible substrates include bedrock (seen near the mid-section of the dam base), boulders, rubble, and cobble.

Figure 5-6: Image of Goodyears Dam (looking south) during 2015 breach (June 23, 2025) showing substrates and substrate depth relative to the dam crest behind the northern section

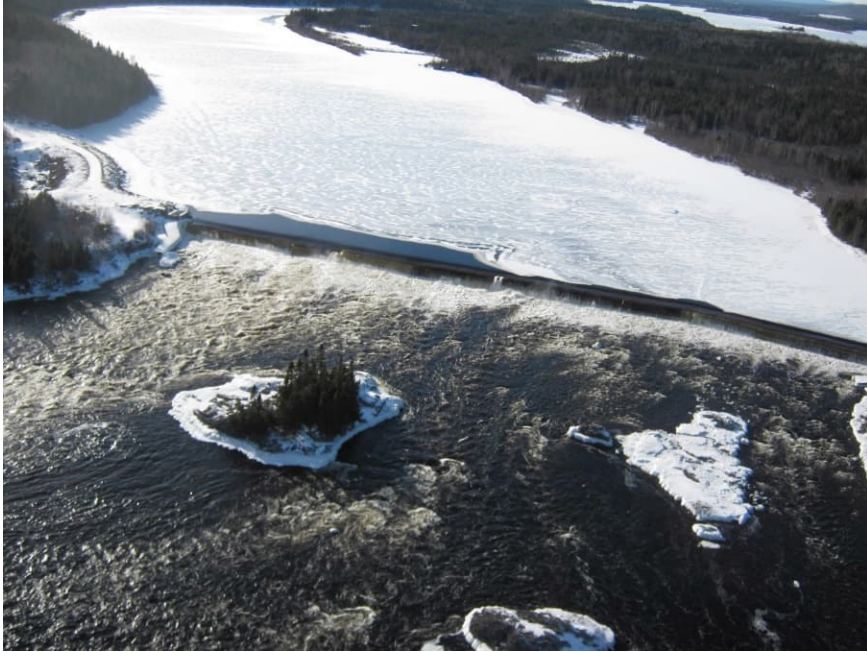
Background on Goodyears Dam

- Originally constructed in 1911, ensures reliable winter operation at the Grand Falls Generating Station by slowing the water, and controlling frazil ice development.
- 2015 - approximately one third of the dam was breached, near south abutment, and emergency/temporary repairs were completed.
- Over the past 10+ years there have been signs of movement in the structure.
- Structure requires further life extension repairs to extend life by ~10 years.
- South fishway was infilled during 2015 repairs, north fishway is still operational.

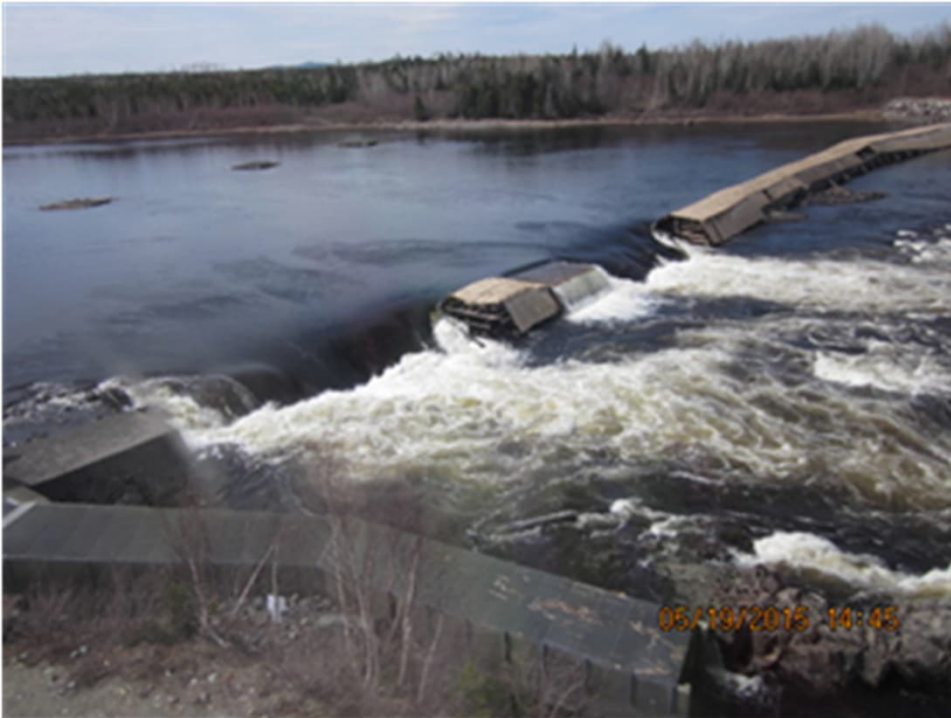
2015 Breach & Associated Repairs

Two sections of timber crib failed

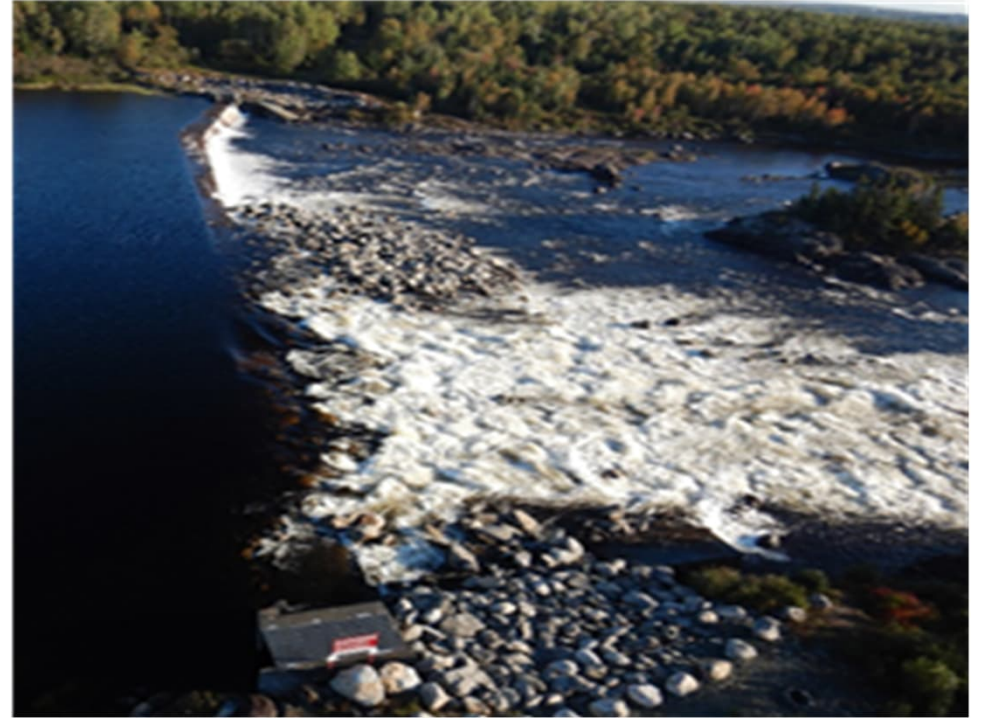
Repaired with large riprap

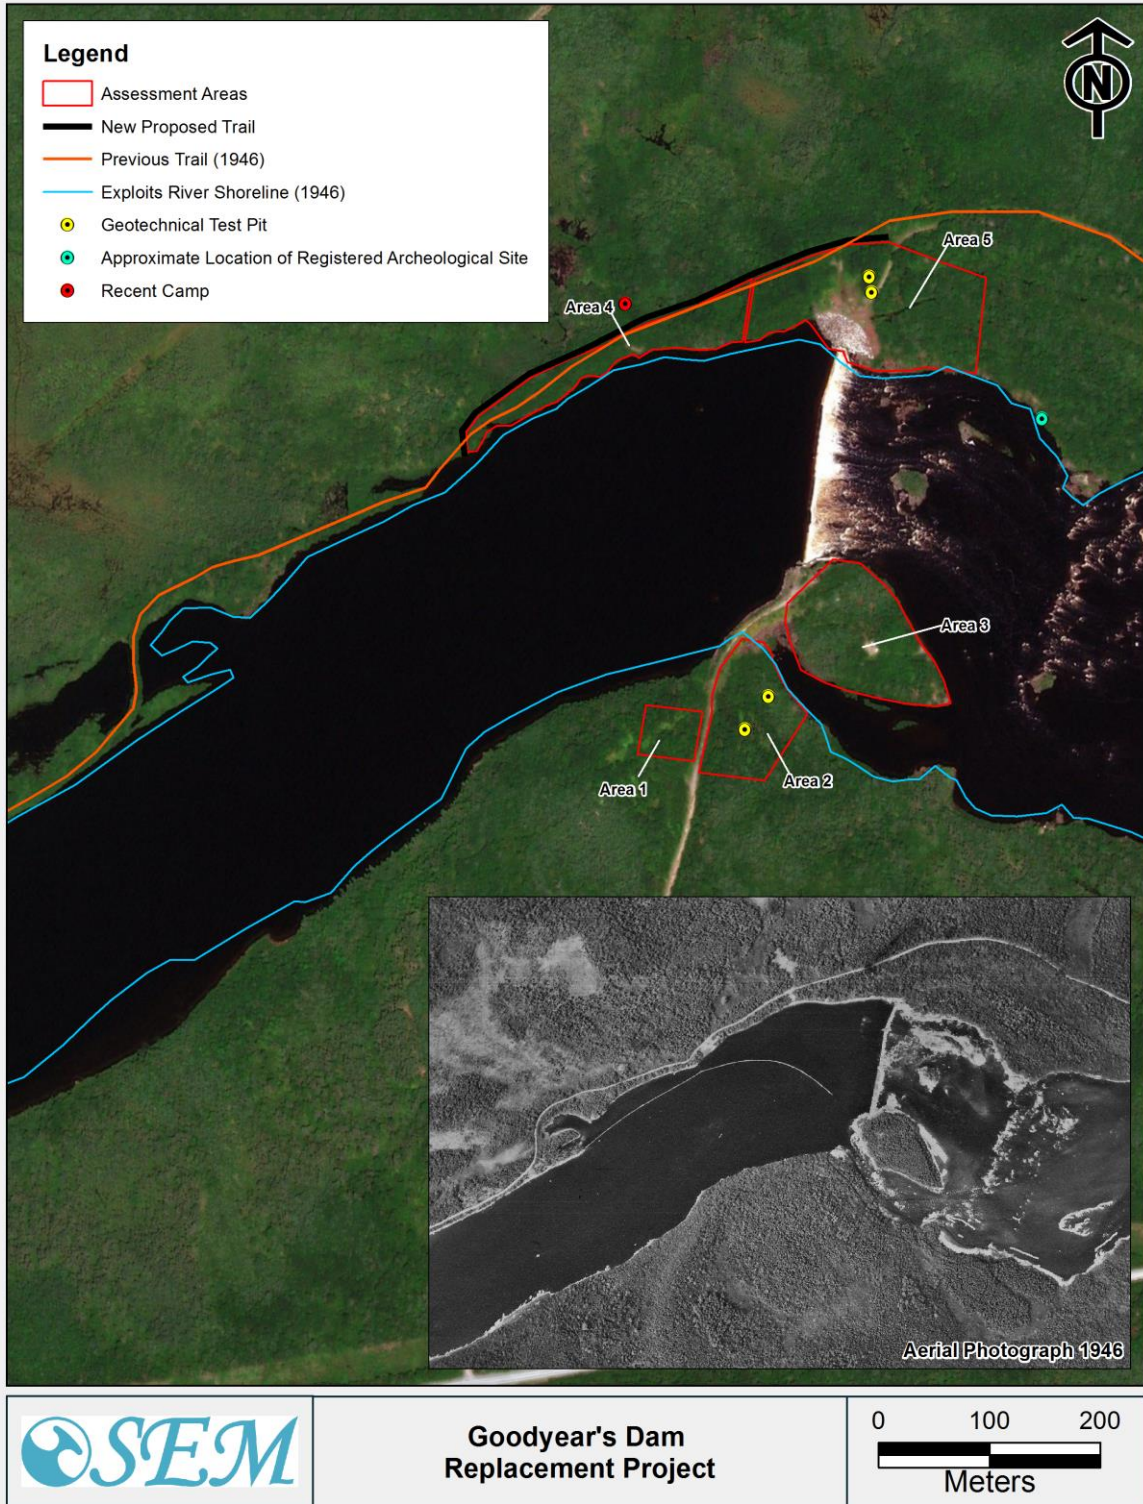
Figure 3.3. Aerial Photography and Current Aerial Imagery Analysis (note location of recent camp)

Regarding the south side of the river, the aerial photography analysis suggested that within Study Areas 2 and 3, little inundation is evident. However, without question, the northeast end of Area 2 and the northwest end of Area 3 have undergone substantial alterations due to dam construction and maintenance, thus any archaeological materials extant in those areas prior to 1911 would likely have been destroyed.

In summary, the information gleaned from the analysis of the 1946 aerial photography and comparison of it with current aerial imagery, further suggested that the historic resources / archaeological potential of the Project Area was likely Low. If any archaeological materials were present prior to 1911, they would likely have been disturbed or destroyed from dam and trail construction and maintenance, and from shoreline inundated caused by creation of the upstream reservoir and the frequent high water-levels and seasonal ice-scouring that has likely occurred over the past 70 years.

As discussed above and shown in Figure 3.3, this shoreline has undergone substantial inundation since construction of the dam in 1911, and the environmental conditions noted during the Stage 1 Assessment field study are almost certainly attributable to flooding. Even within most of the locations where shovel-testing was possible, the ground is hummocky and rocky, with few locations of interest observed.

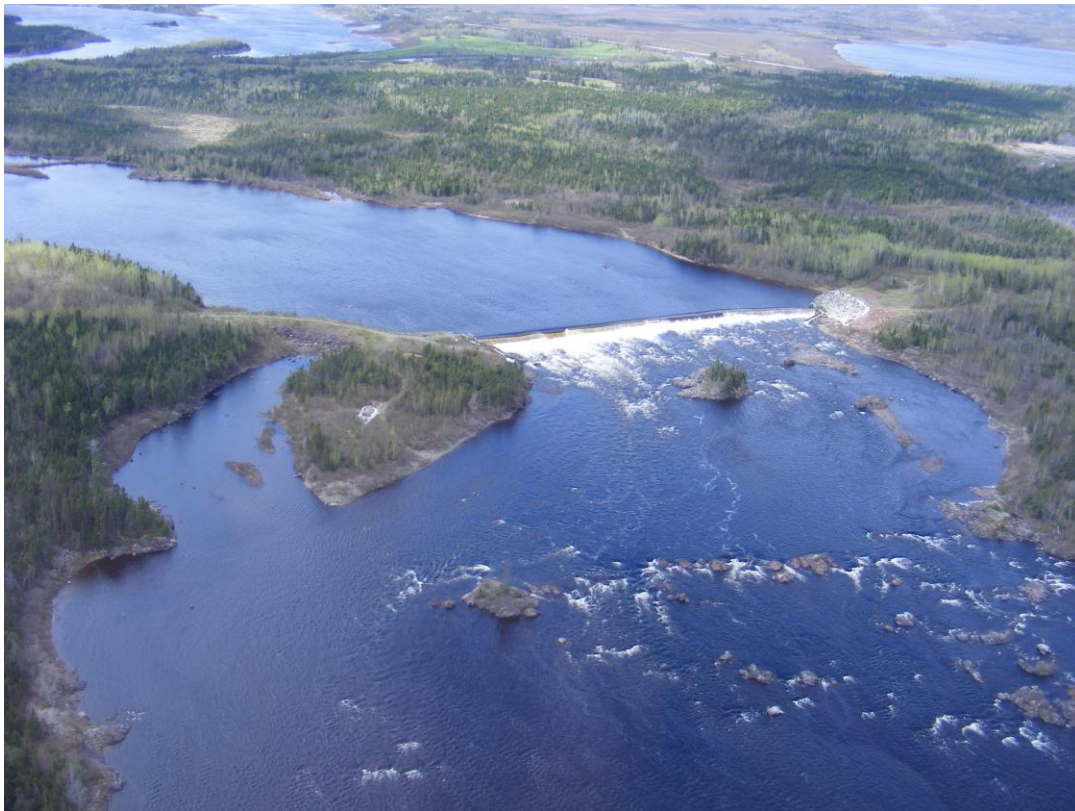
Figure 3.4. Northwest View of Project Area Showing All Study Areas (NL Hydro photo)

As discussed, the Stage 1 Assessment consisted of the investigation of five study Areas and the corridor of a New Proposed Trail, as well as four mechanically-excavated geotechnical test-pits. A description of the findings at each location is presented below. Figure 3.4 shows an aerial view of the entire Project Area, including all study Areas. Note the extensive disturbance at both ends of the dam (and in the center of the former island - Area 3 - shown toward the left-hand side of the photo), and the vegetation patterns along the shoreline on both sides of the river in what appear to be low-lying areas, which suggests inundation and potentially wet ground conditions.

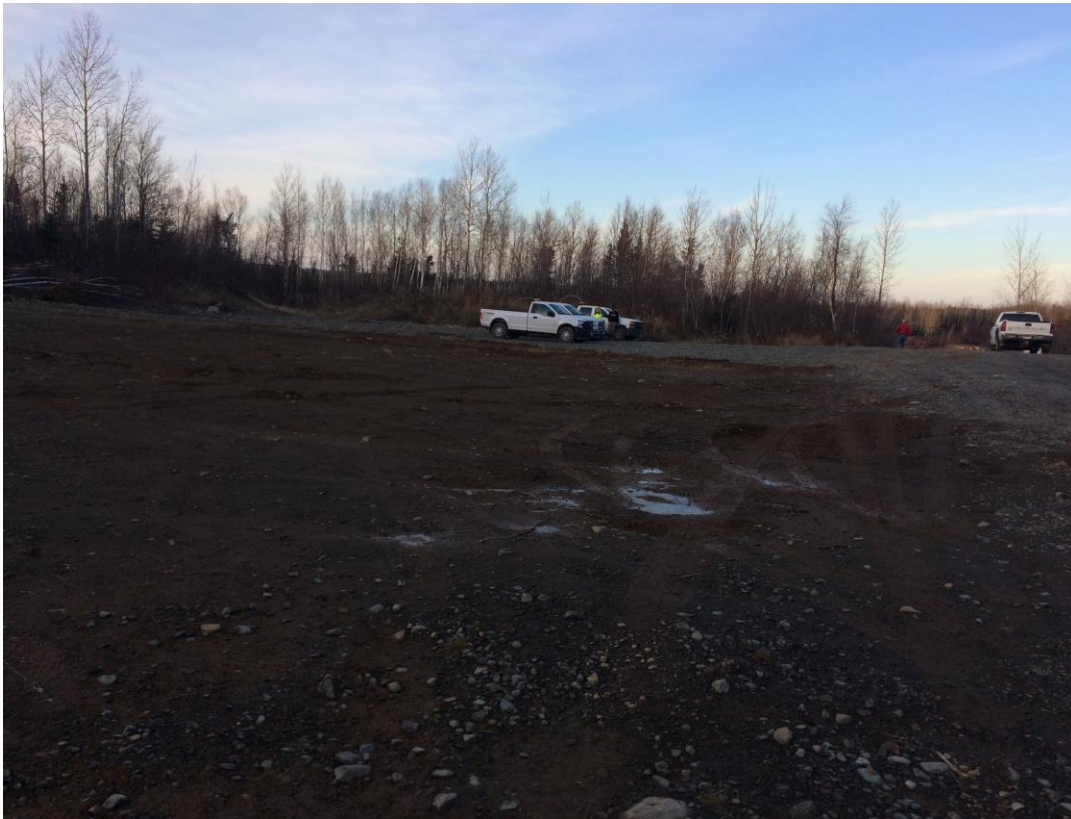
Figure 3.5. North View Across Area 1, Showing Parking Area and Wooded Terrain to be Developed

Area 1 is situated on the south side of the river and partially encompasses a cleared and developed parcel of ground used in 2015 as a lay-down area during dam maintenance (Figures 3.3 and 3.4 above). It is proposed that the level, gravel parking lot be expanded into the surrounding wooded zone for use during the up-coming dam replacement project (Figure 3.5). The embankment around Area 1 was visually inspected for archaeological materials, and the wooded zone toward the river was walked and investigated with the excavation of 10 test-pits. The terrain toward the river that will be developed is relatively steep and has been partially disturbed due to previous construction activities. No materials of historic resources significance

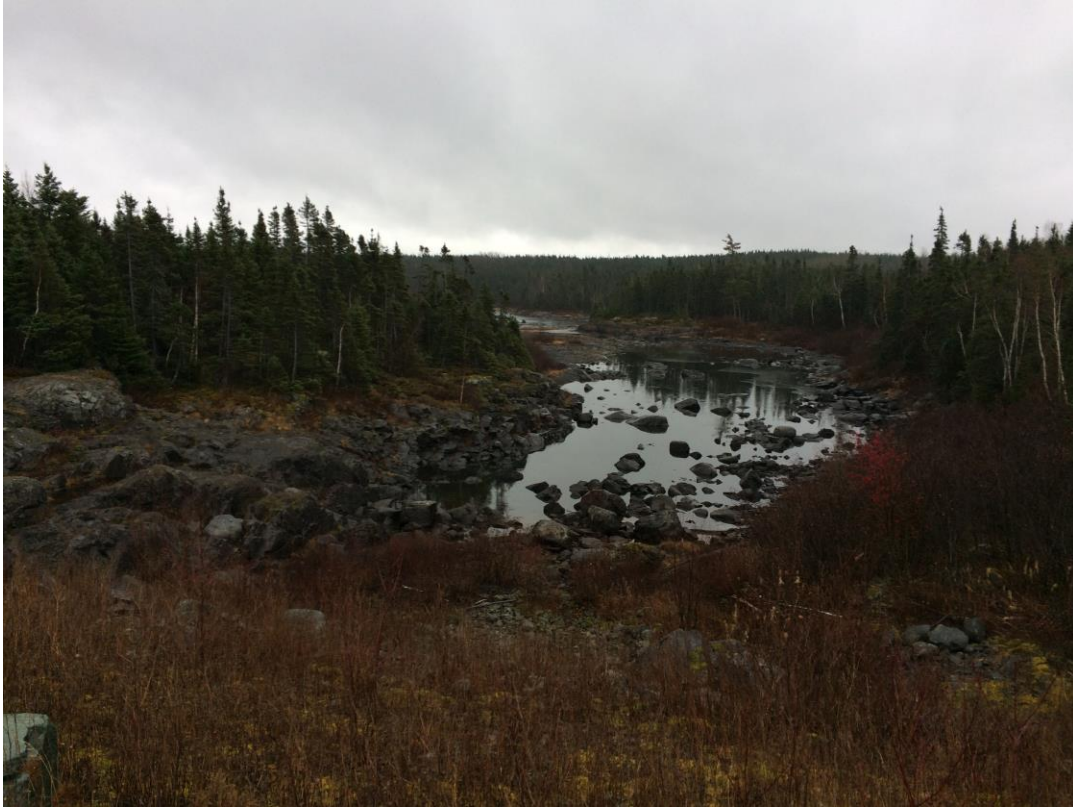
Figure 3.6. Southeast View of Area 2, Showing Northeast Shoreline (right-hand side)

Area 2 is also situated on the south side of the river to the east of Area 1 on the opposite side of the access road leading to Goodyear's Dam (Figures 3.3 and 3.4 above). Area 2 is completely wooded with birch, spruce, fir and alder trees, and the vast majority of it is positioned back from the river on elevated terrain that, in places, is relatively sloped, particularly near the shoreline (Figure 3.4 above). The inland sections of Area 2 were walked and visually inspected for archaeological materials, and the shoreline at the northeast end was walked and investigated with the excavation of 16 test-pits. The terrain within the highest area of potential, the northeast shoreline, proved to be rocky and, in places, steep, partially disturbed from earlier dam construction and maintenance, and was otherwise very hilly and hummocky, with the presence of many large boulders (Figure 3.6). No materials of historic resources significance were identified within Area 2 and the potential for any to be encountered during future construction activities appears Low.

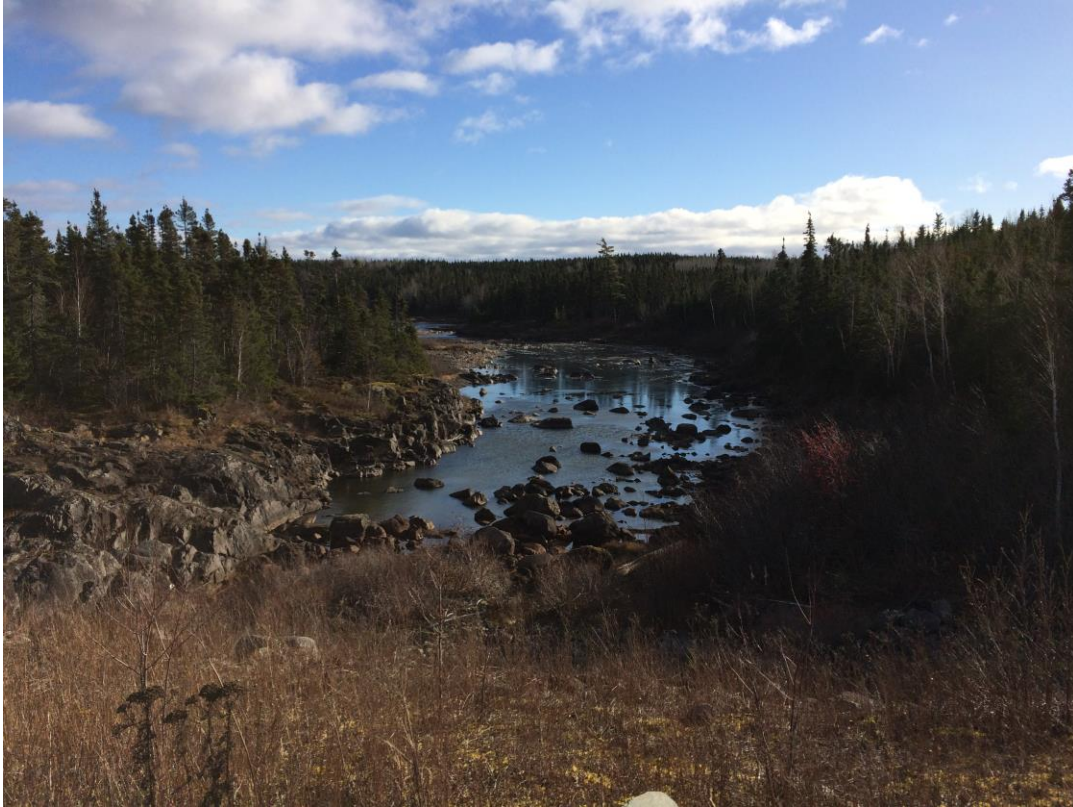
Figure 3.7. Southeast View of Shoreline of West Side of Area 3 (left-hand side)

Area 3 is also situated on the south side of the river to the northeast of Area 2, and consists of a relatively large parcel of terrain that was formerly an island (Figures 3.3 and 3.4 above). The channel that once ran between the island and the mainland was used as a spillway during construction of the original dam in 1911 and for channeling logs through during subsequent log-drives (Figure 3.3; note log-boom in 1946 photograph). Area 3 is primarily wooded, but does have a relatively wide northeast-to-southwest-oriented ATV trail running through it. Roughly in the center of the island along the trail, is a wide-open clearing that appears to be used for campfires and for discarding domestic refuse, including home appliances (Figure 3.4 above). The west side of the island along the tailrace is rocky and steep, and shows considerable evidence of seasonal flooding and possibly ice-scouring at the southeast end (Figure 3.7). All other shorelines of Area 3 are either low-lying and have, therefore, been severely washed and ice-scoured seasonally, or are rocky, steep and boulder-strewn.

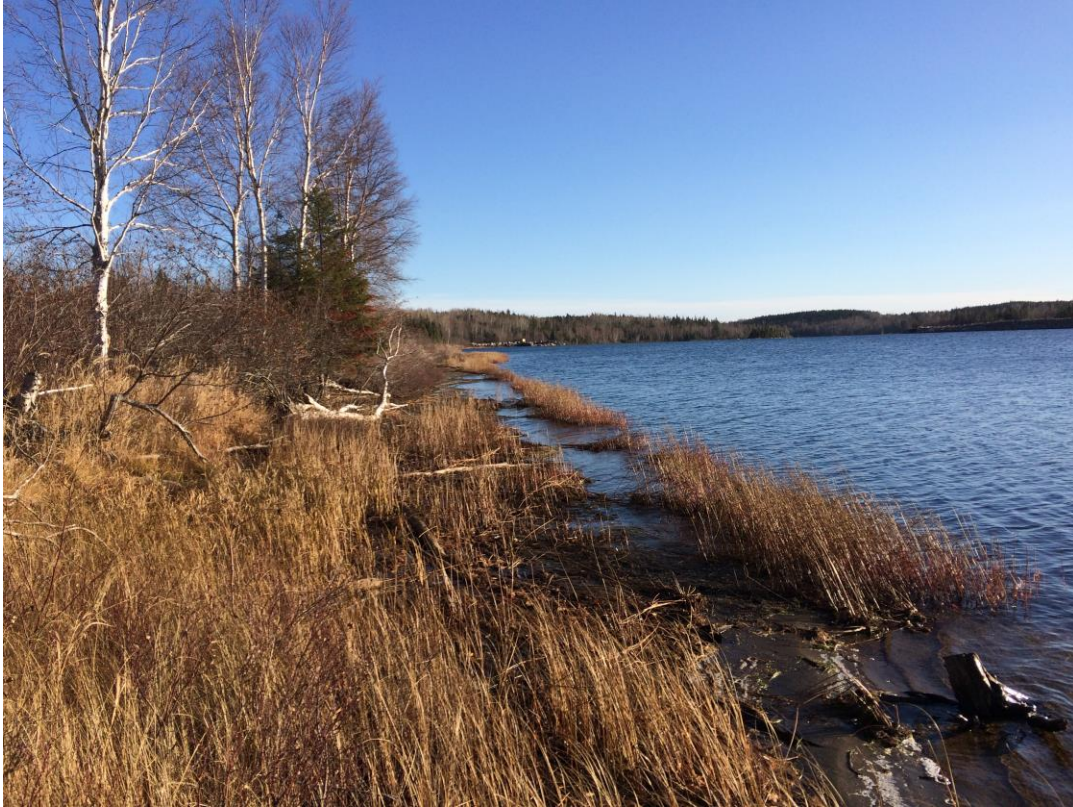
Figure 3.8. East View Toward Dam Showing Shoreline Fronting Areas 4 and 5 (note evidence of inundation)

Area 4 is situated on the north side of the river to the west of the dam, and encompasses the terrain between the New Proposed Trail and the shoreline (Figure 3.3). Assessment of this Area revealed it to be largely low-lying and wet, with numerous marshy areas back from the shore. In many places, the shoreline itself is muddy and grass-covered and, as it is currently, would not be suitable for human settlement (Figure 3.8, and Figure 3.4 above).

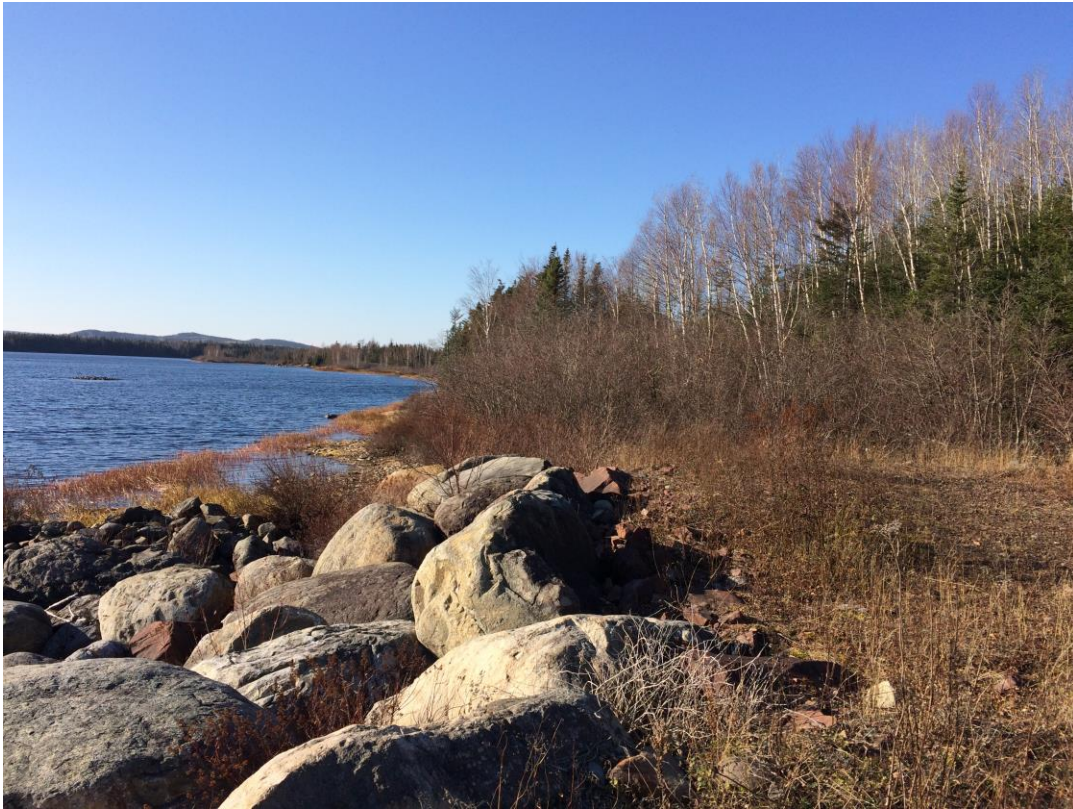
Figure 3.9. Northeast Portion of Area 5 Looking Southwest (note ground disturbance)

portion of Area 5 upstream of the dam. Most notably this includes severe inundation and potential ice-scouring of the shoreline. Additionally, a large segment of Area 5 at the northeast end has undergone significant ground disturbance from dam and access road construction and maintenance, and from infilling with large boulders and ground levelling around the north end of the existing dam (Figure 3.9, and Figure 3.4 above).

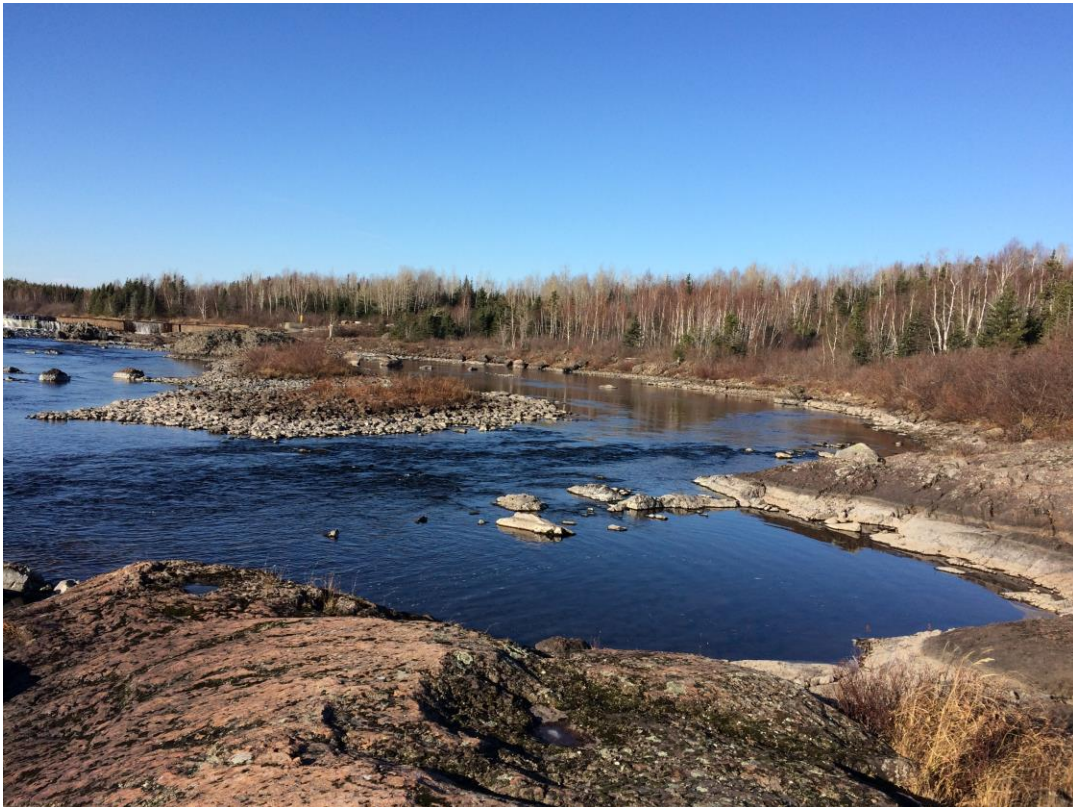
Figure 3.10. Northwest View of Area 5 Below the Dam (note rocky and steep shoreline)

Despite a search for the registered archaeological site DfAw-11 reported to be situated on the north side of the river approximately 200 m downstream of the dam, no evidence of it was identified during the visual examination, which as seen in Figure 3.10 above, encompassed all the terrain to the downstream end of the cove in which the site is supposed to be situated. Therefore, it is possible that the site is located further downstream, which seems unlikely based on the site description and location described on the Archaeological Site Record form, or it has been further disturbed by highwater and ice scouring, and, consequently, has been destroyed.
