# MARINE ATLANTIC INC.

## Port aux Basques Harbour Navigation Improvement Project Underwater Benthic Habitat Survey Port aux Basques, NL

Final

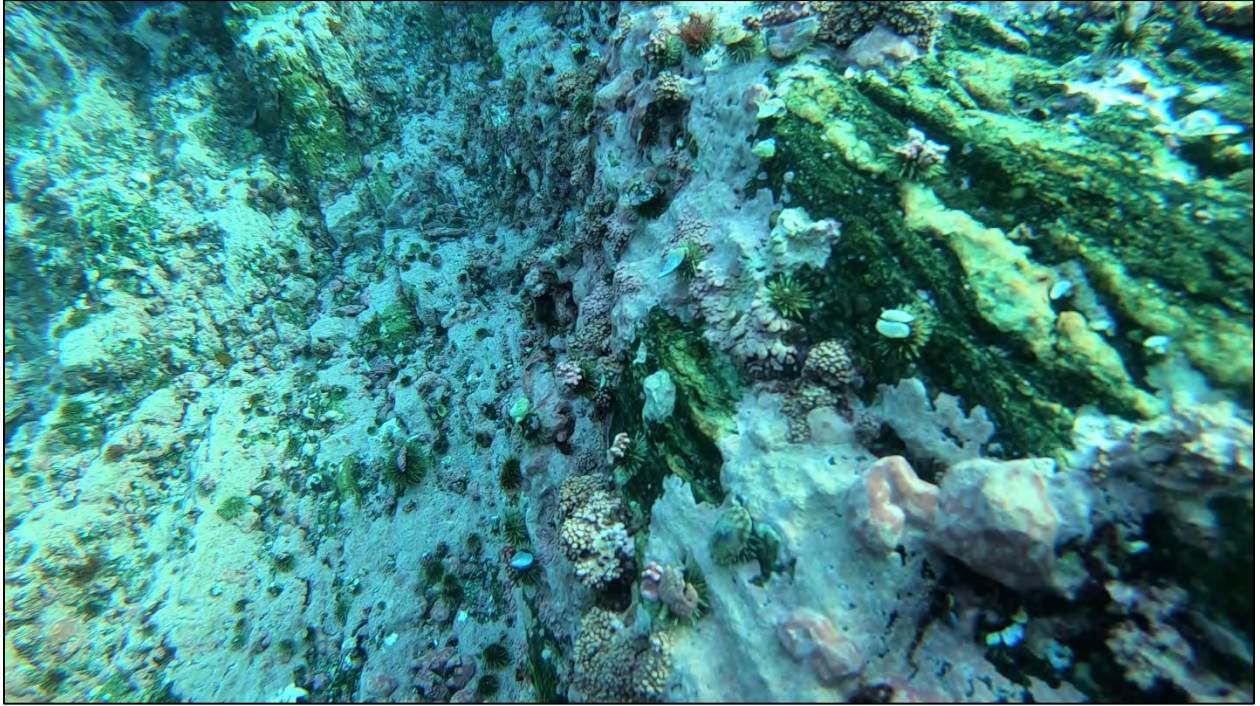
**Photo 1:** Bedrock encrusted with coralline red algae observed in Transect 1 in the Baldwin Rock dredge area. Abundant Green sea urchins (*Strongylocentrotus droebachiensis*) and occasional limpets are visible throughout the image.

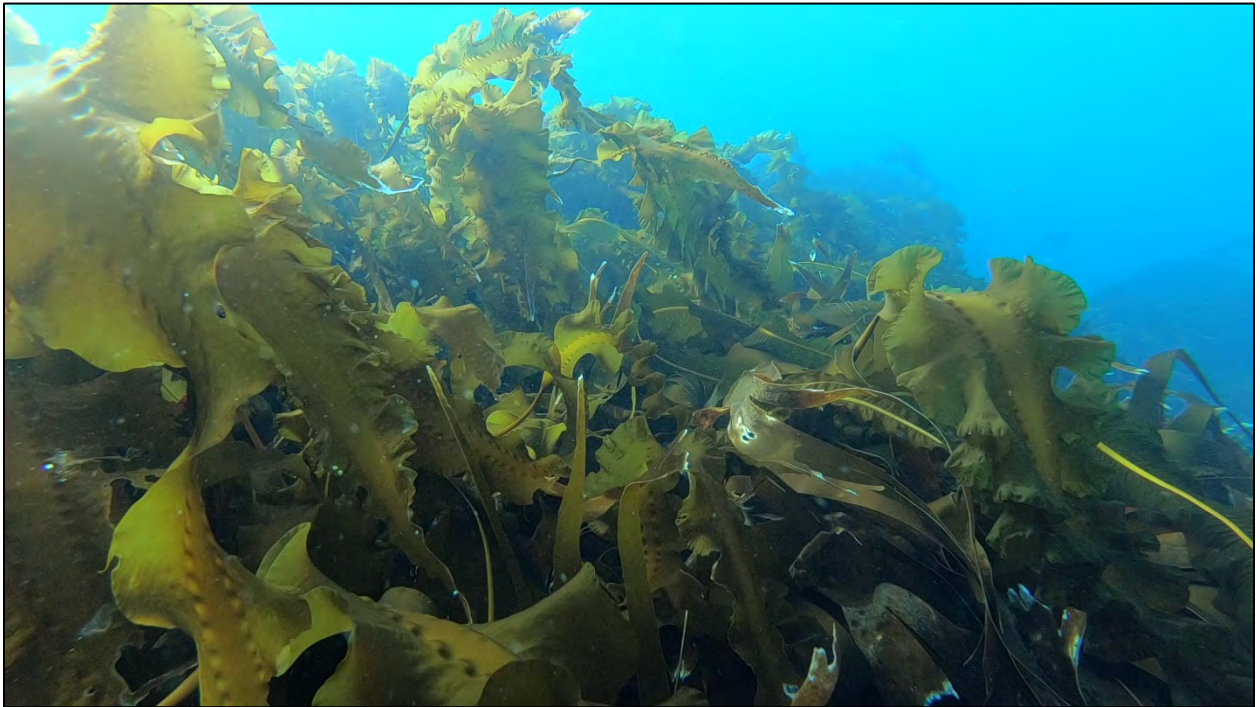
**Photo 2:** Abundant *Saccharina longicuris* and *Laminaria digitata* attached to bedrock Transect 1.

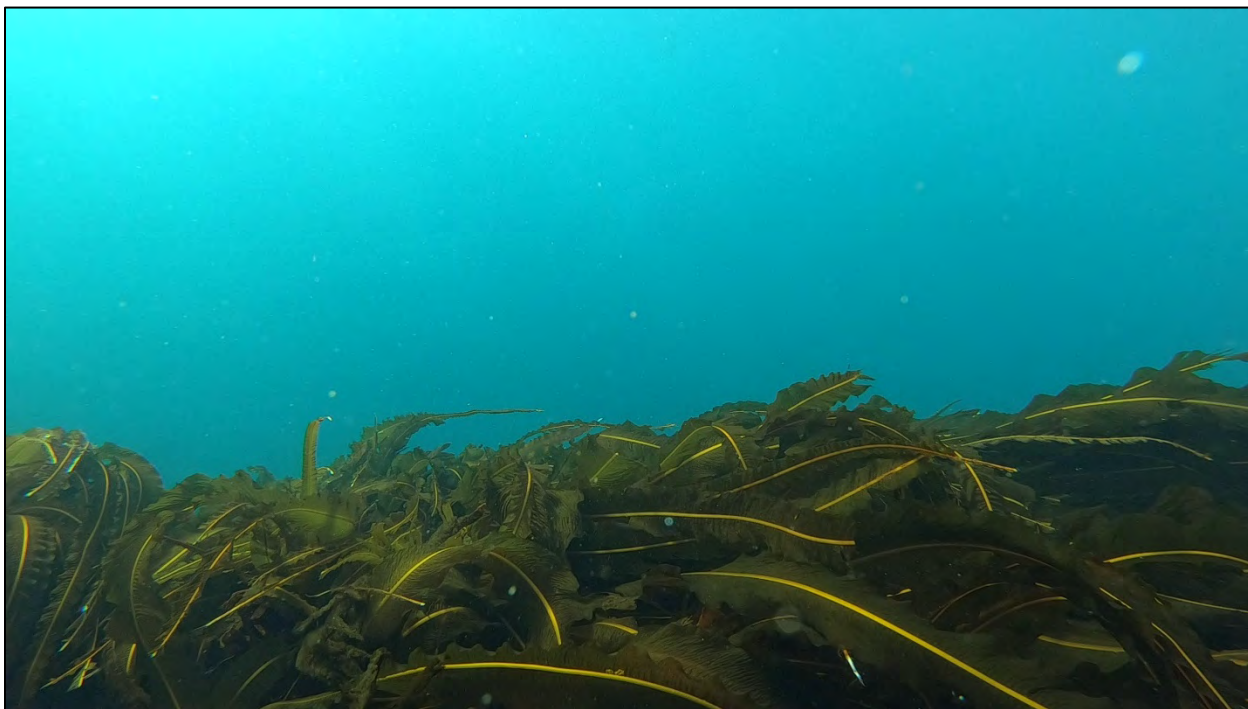
**Photo 4:** Abundant *Alaria esculenta* observed attached to bedrock in Transect 1.

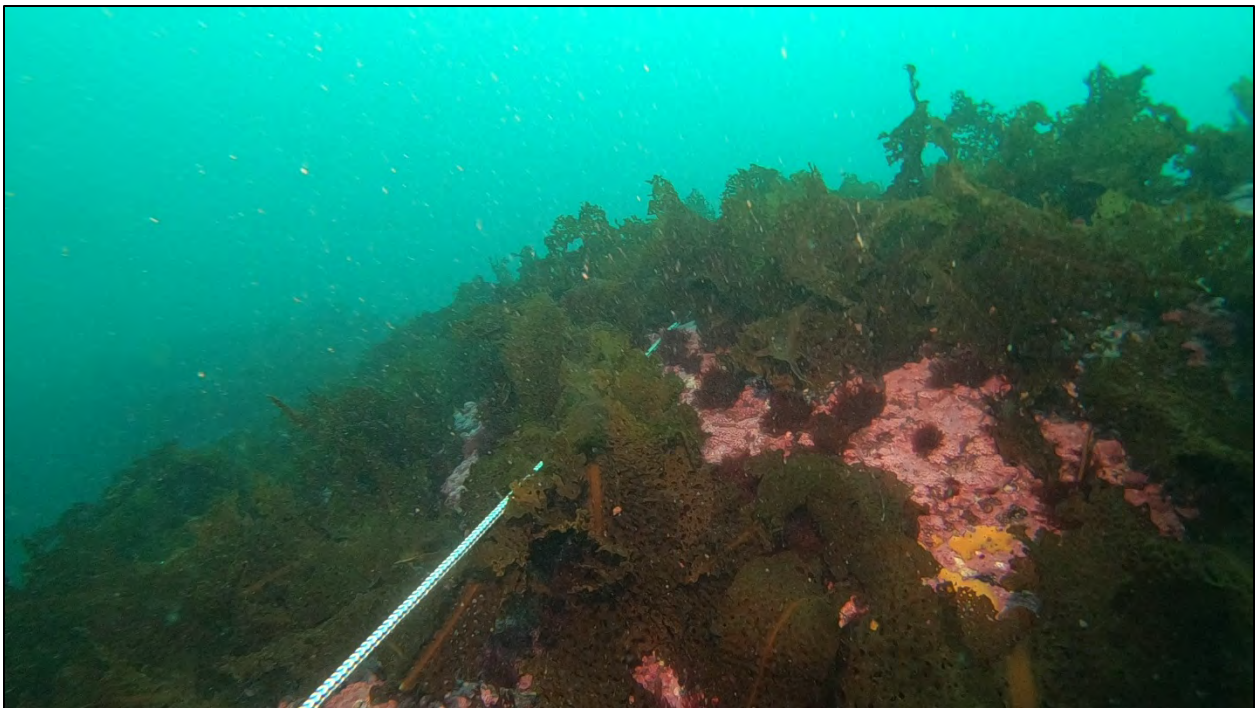
**Photo 8:** *Agarum clathratum*, encrusting red algae, and a small encrusting breadcrumb sponge on bedrock substrate in Transect 3 in the Baldwin Rock dredge area.

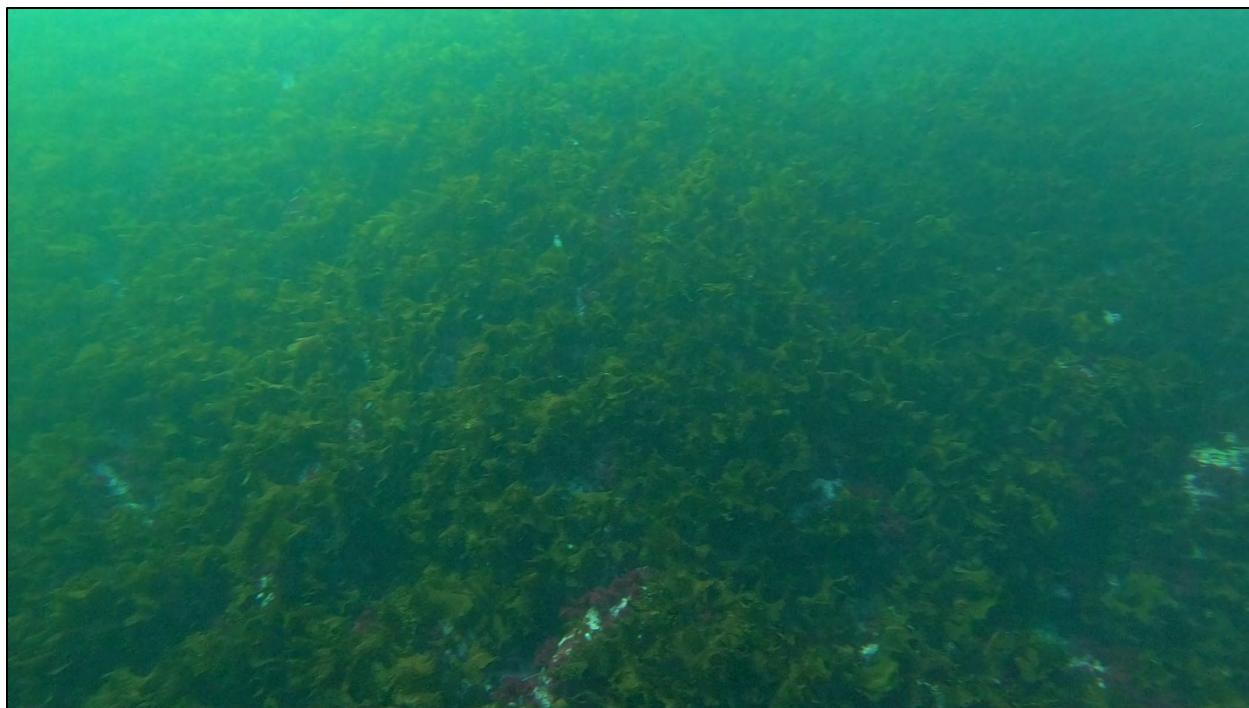
**Photo 12:** *Agarum clathratum* and *Polysiphonia* sp. covers nearly the entire boulder slope of the Graveyard Point breakwater as observed from 4 metres above the breakwater as the diver ascended to the surface in Transect 5 in the Graveyard Point area.

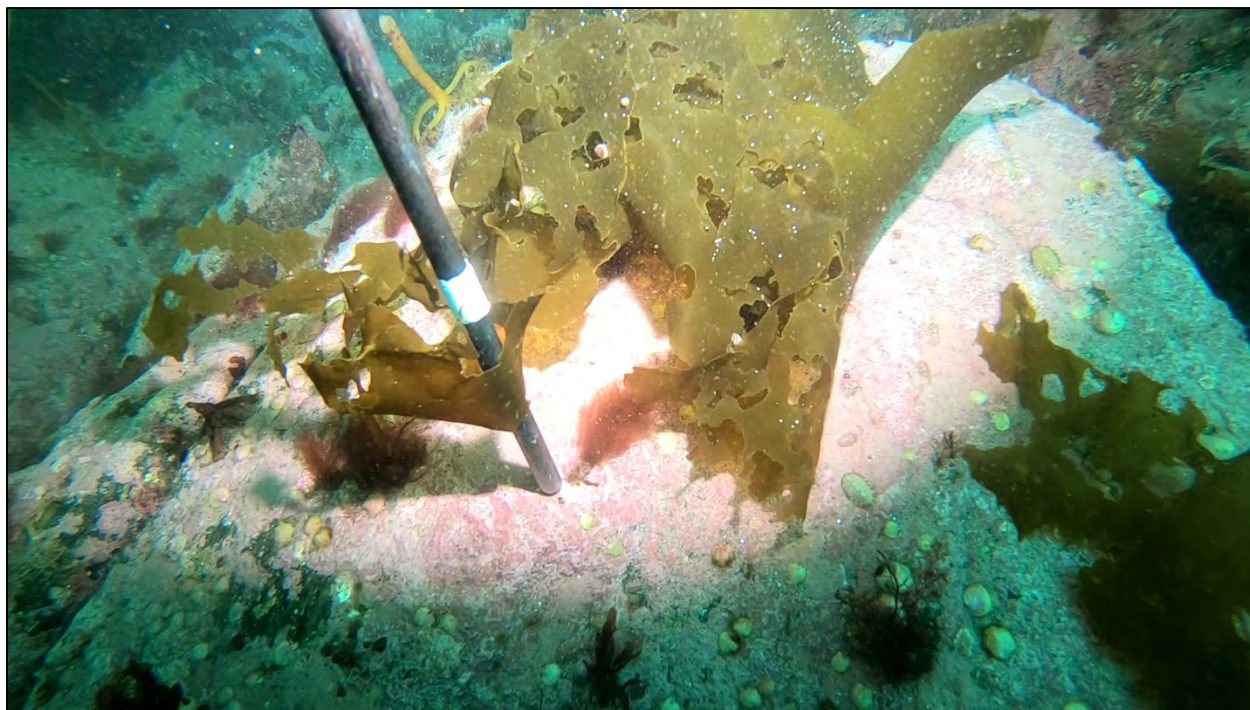
**Photo 19:** Boulder and bedrock substrate with encrusting coralline algae and a small amount of *Agarum clathratum* and *Polysiphonia* sp. observed in Transect 9 in the South Turning Basin dredge area. Several limpets and small littorines can be seen on the algae and substrate in the image.

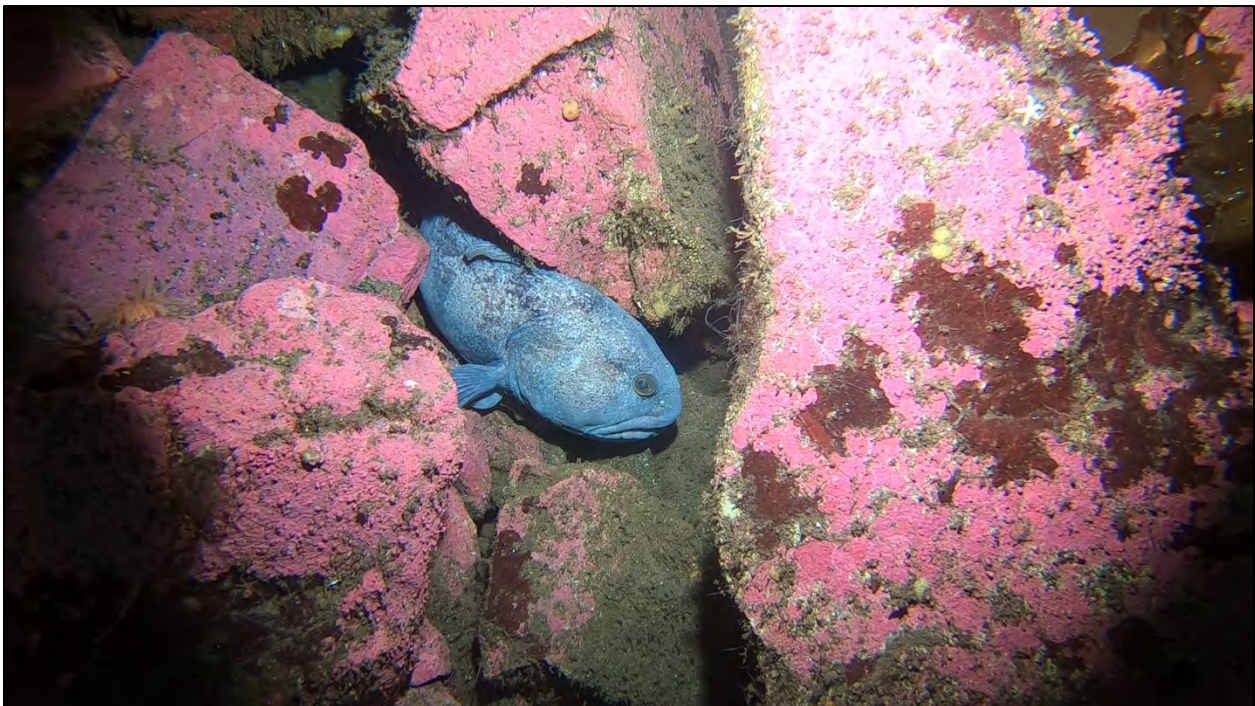
**Photo 22:** An Atlantic wolffish (*Anarhichas lupus*) observed shelter in boulder substrate located at the base of Vardy's Island in Transect 11.

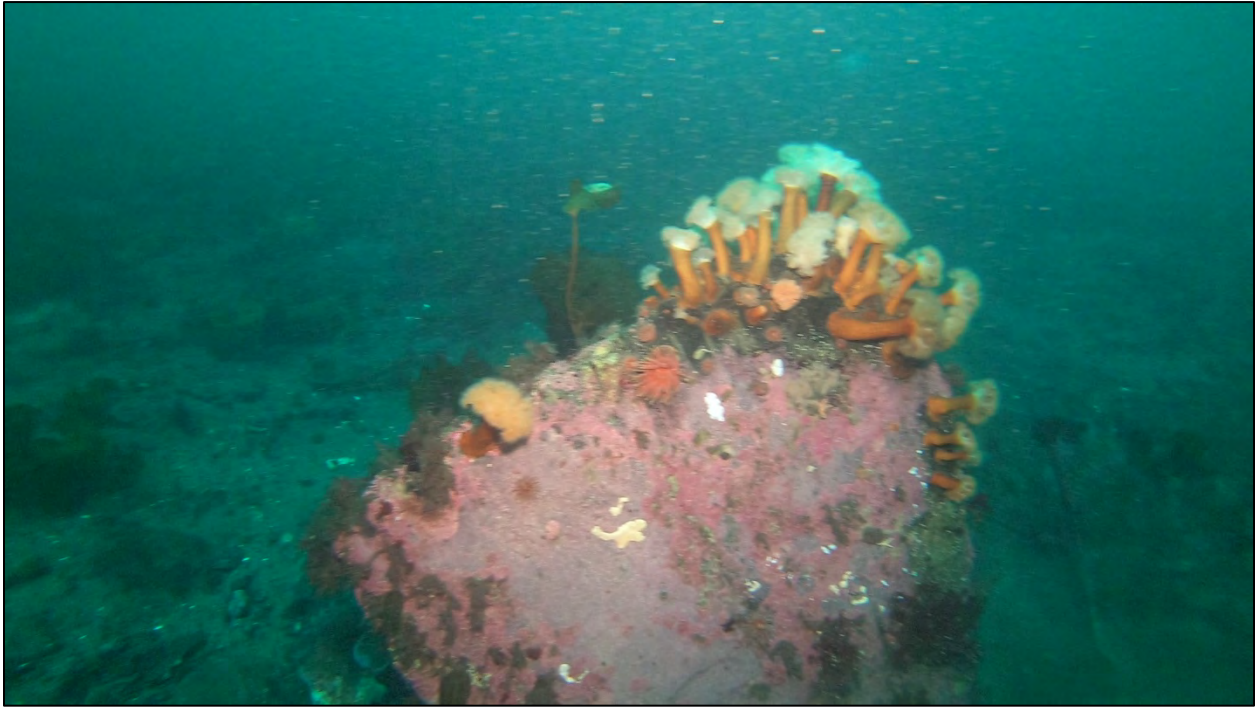
**Photo 23:** Frilled sea anemone (*Metridium senile*) and coralline red algae on a boulder located amongst otherwise fine substrate on the harbour bottom at the base of Vardy's Island in Transect 11.

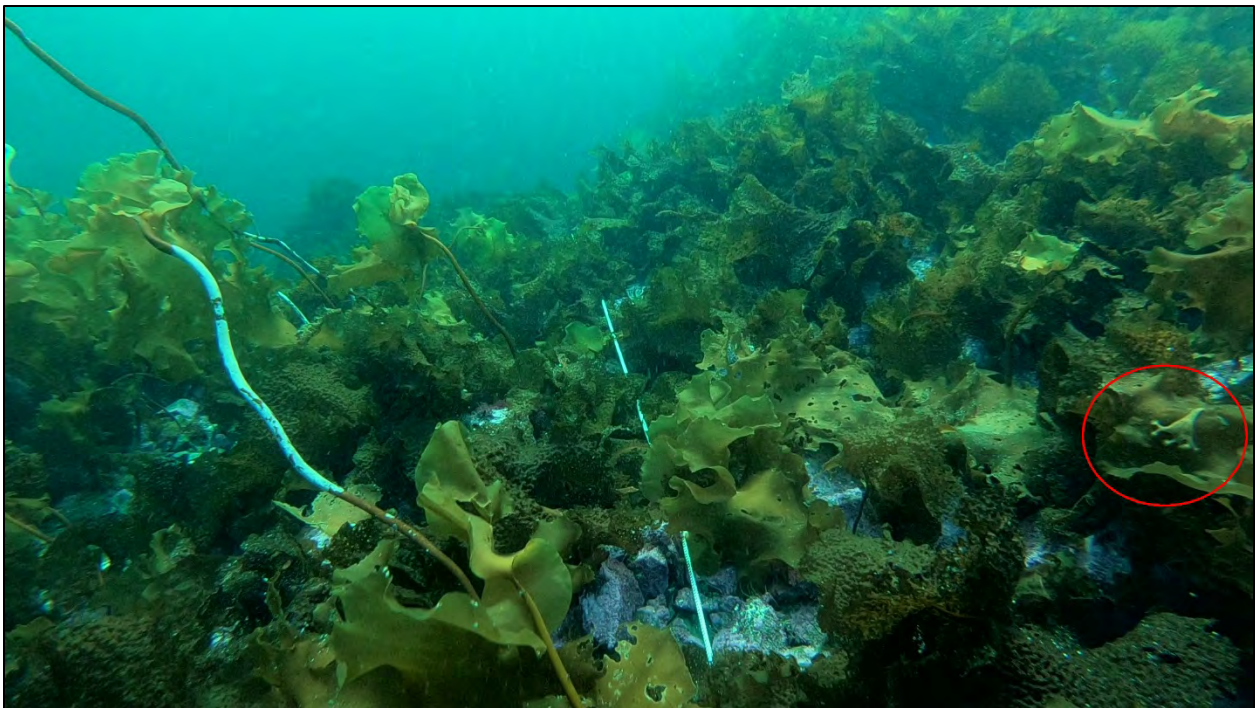
**Photo 24:** *Saccharina latissima* and *Agarum clathratum* on cobble and boulder substrate on the southwest slope of Vardy's Island in Transect 12. A stalked jellyfish (*Lucernarnia quadricomis*) is visible to the right of the image circled in red.

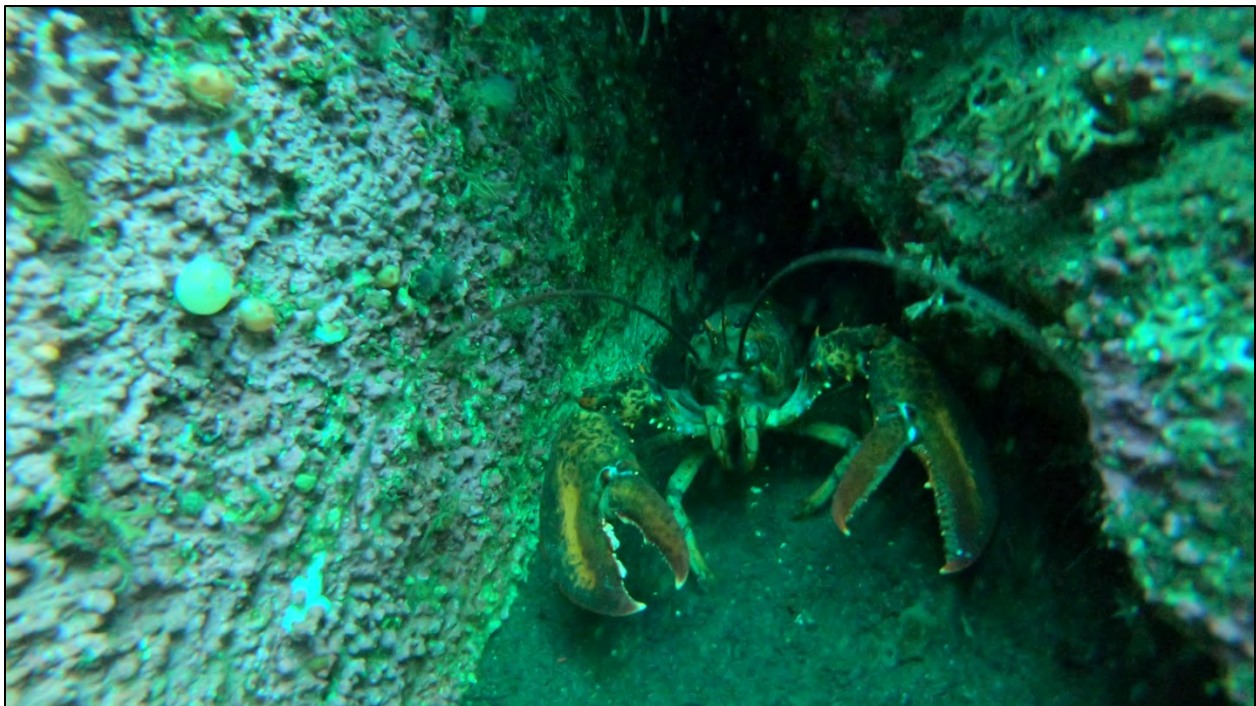
**Photo 26:** An American lobster (*Homarus americanus*) found in boulder substrate on the west slope on Vardy's Island in Transect 13.

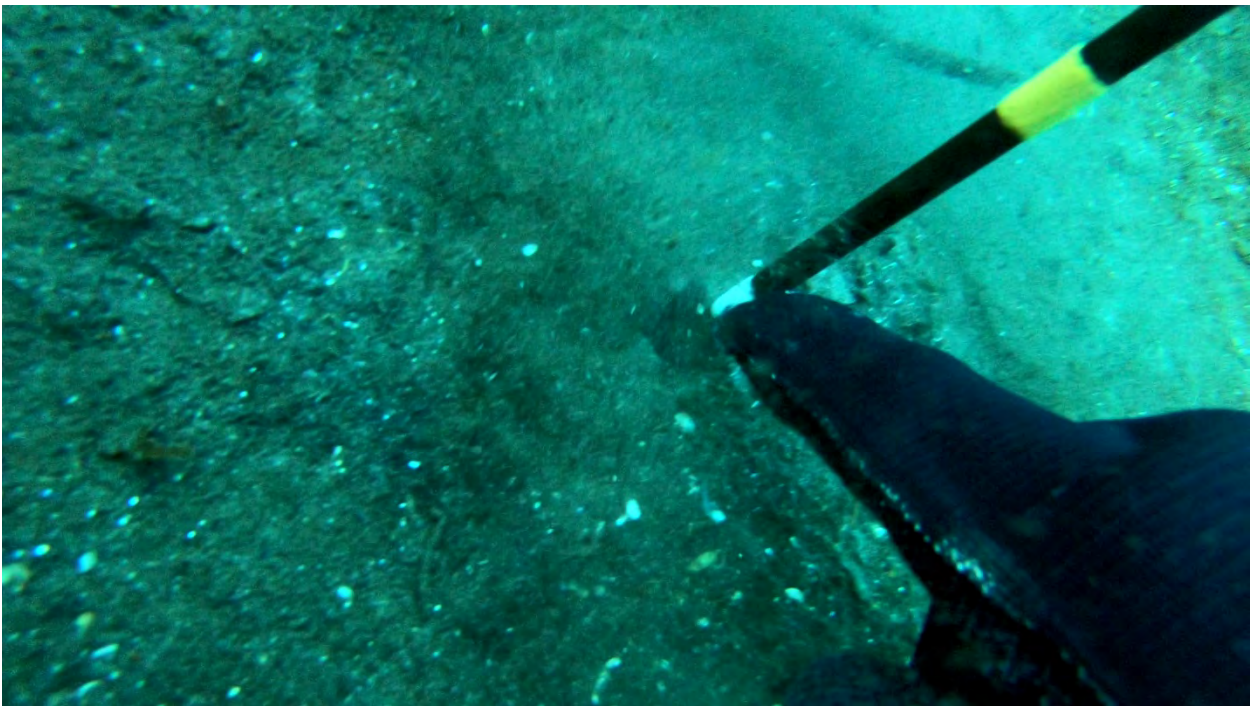
**Photo 28:** Fines-dominant substrate on the northwest slope on Vardy's Island in Transect 14.

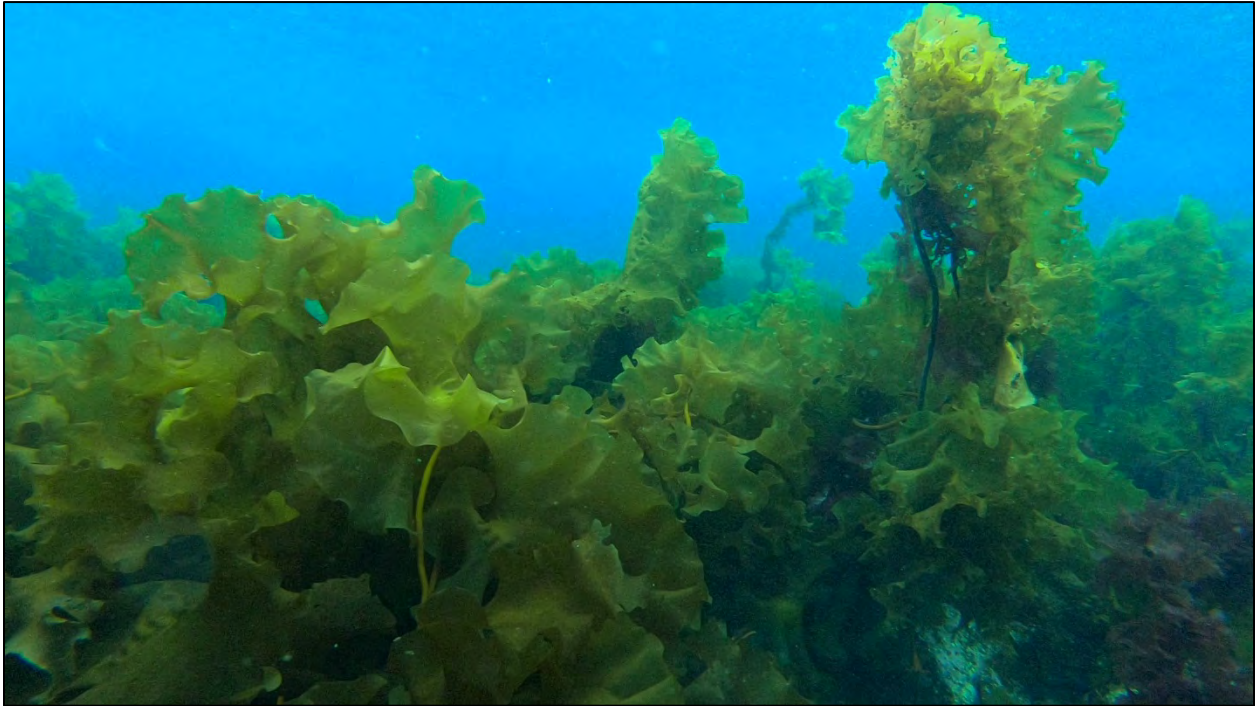
**Photo 31:** *Saccharina* sp. on rocky subtidal habitat on Vardy's Island in Transect 16.

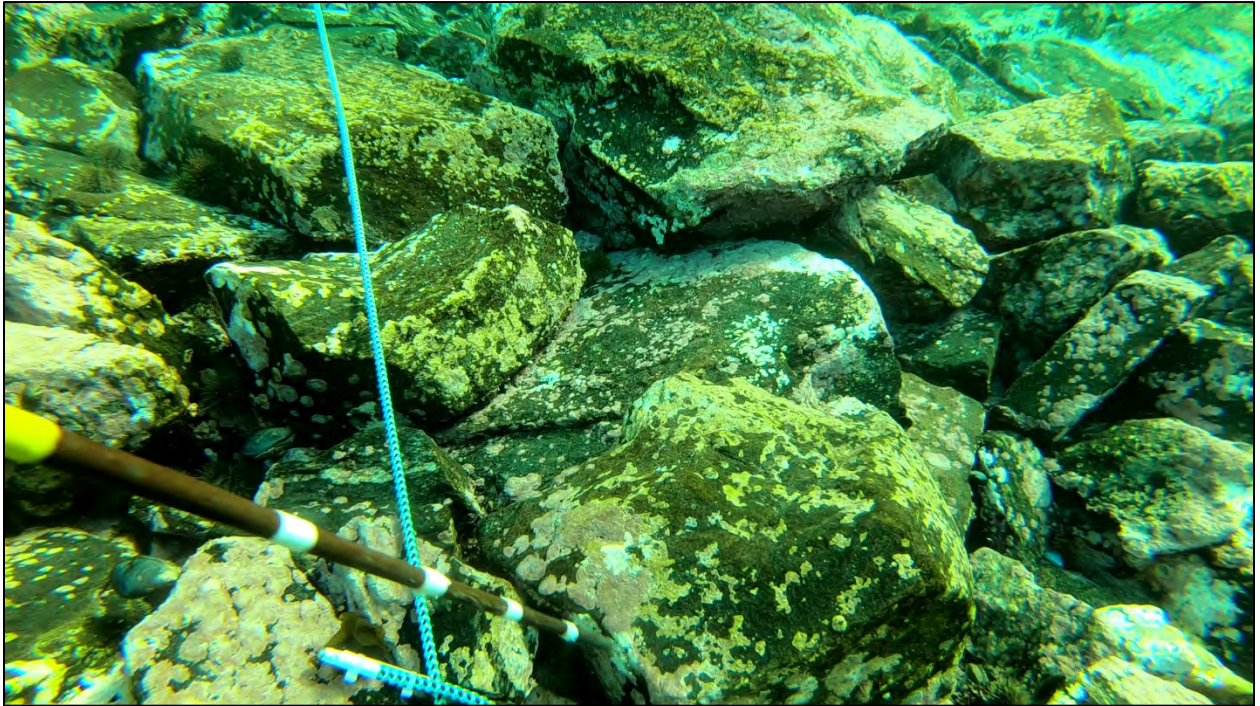
**Photo 35:** Subtidal boulder and cobble substrate on the southeast slope of Vardy's Island in Transect 18.

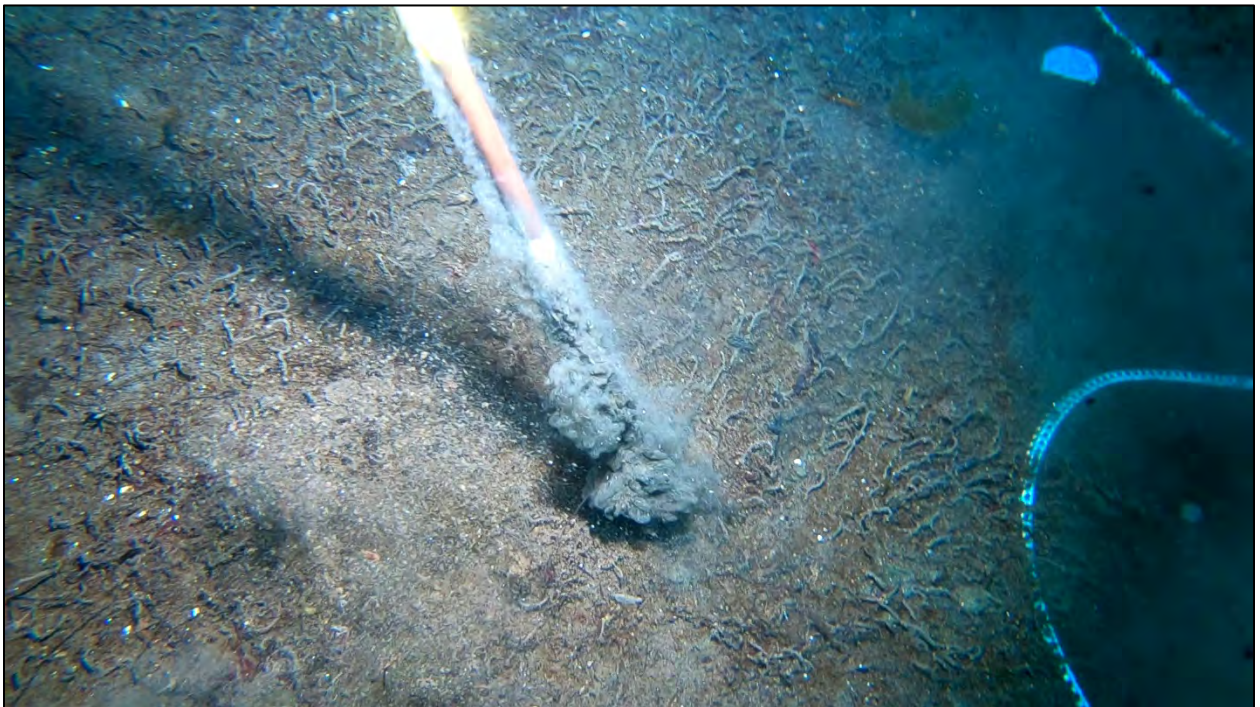
**Photo 36:** Polychaete worm casings and fines-dominant substrates on the harbour bottom southeast of Vardy's Island in Transect 18.

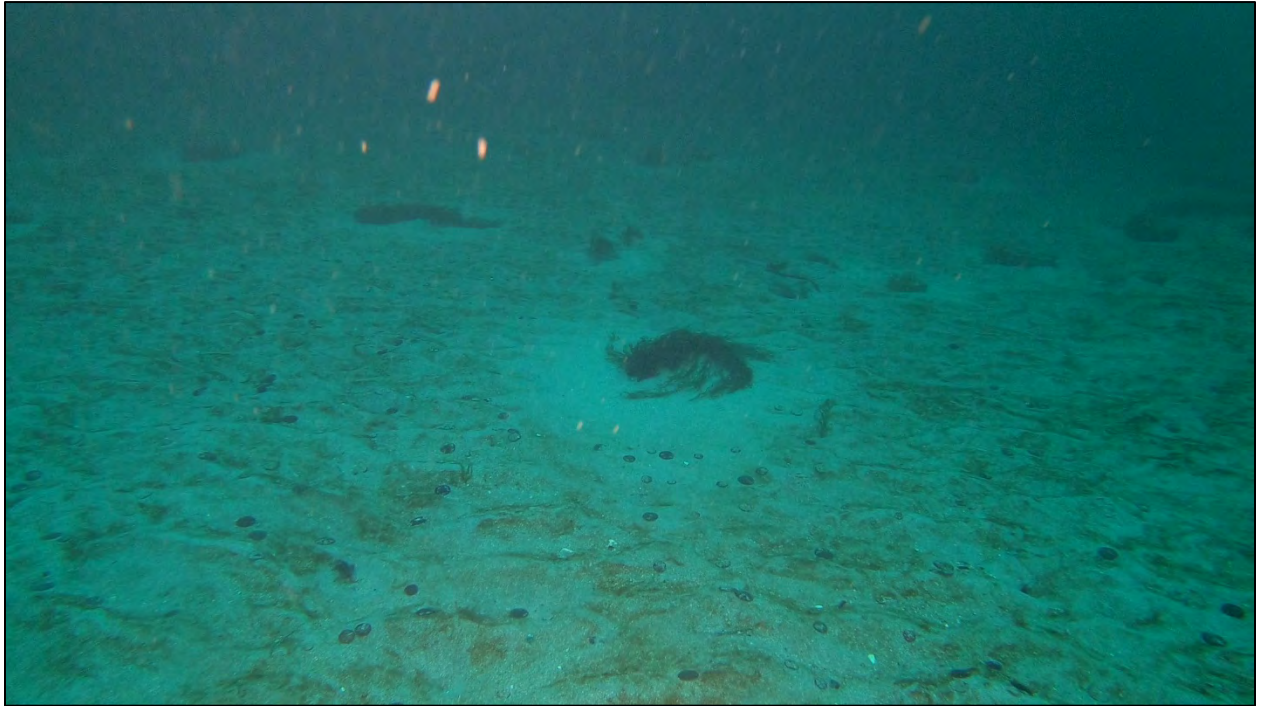
**Photo 37:** Sand dollars and fines-dominant substrates on the outer harbour bottom north of the Baldwin Rock dredge area in SC-49.

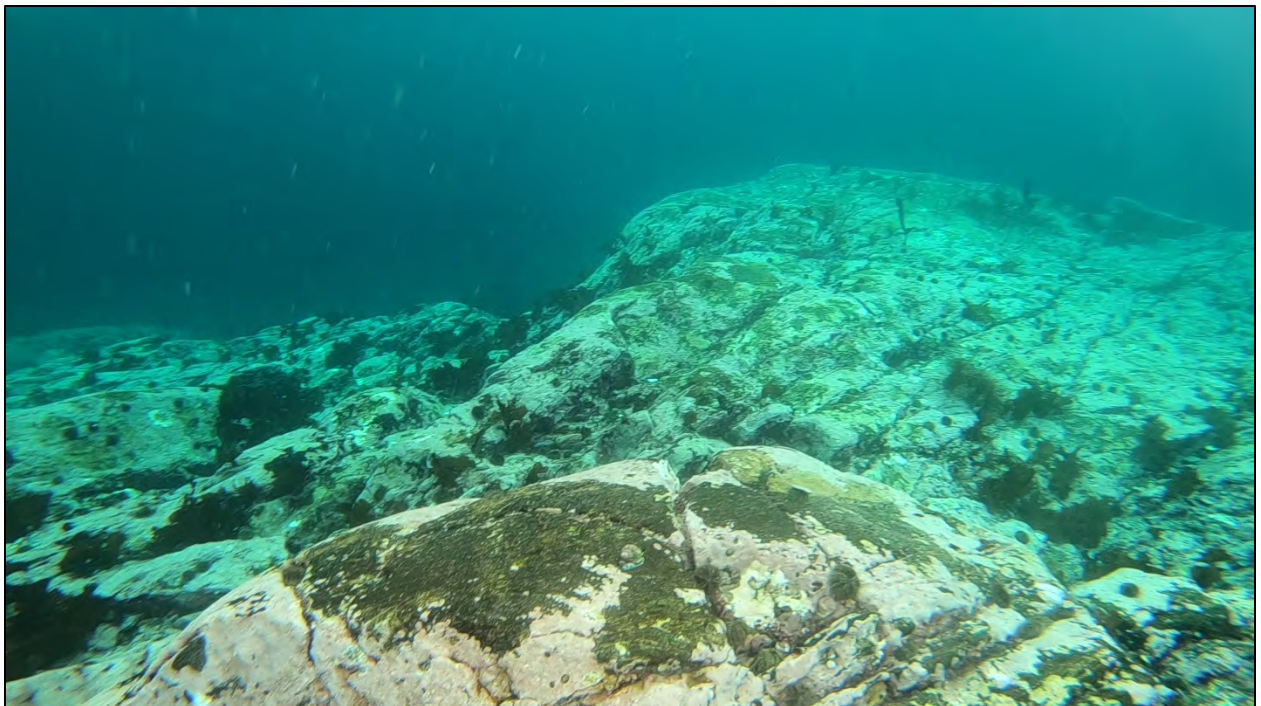
**Photo 38:** Urchin grazed bedrock with abundant green sea urchins and one waved whelk (*Buccinum undatum*) in shallow waters near Pikes Island in SC-68.

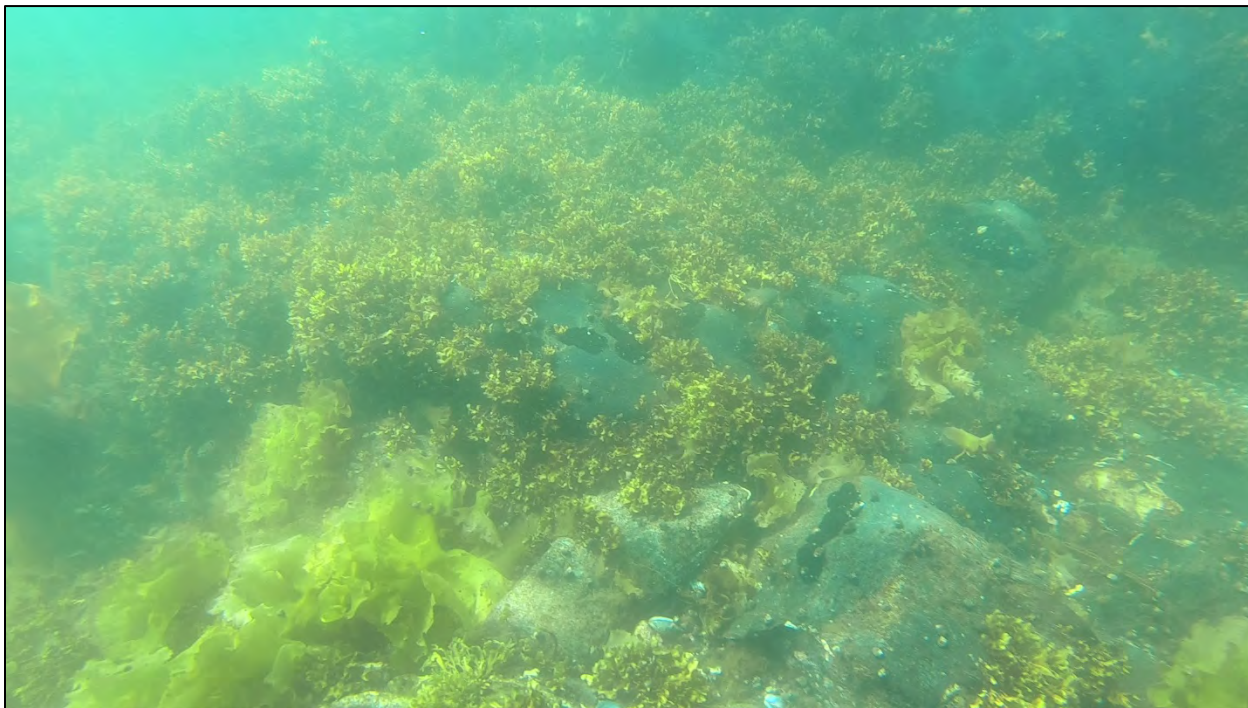
**Photo 53:** Bedrock substrate observed in ST5A

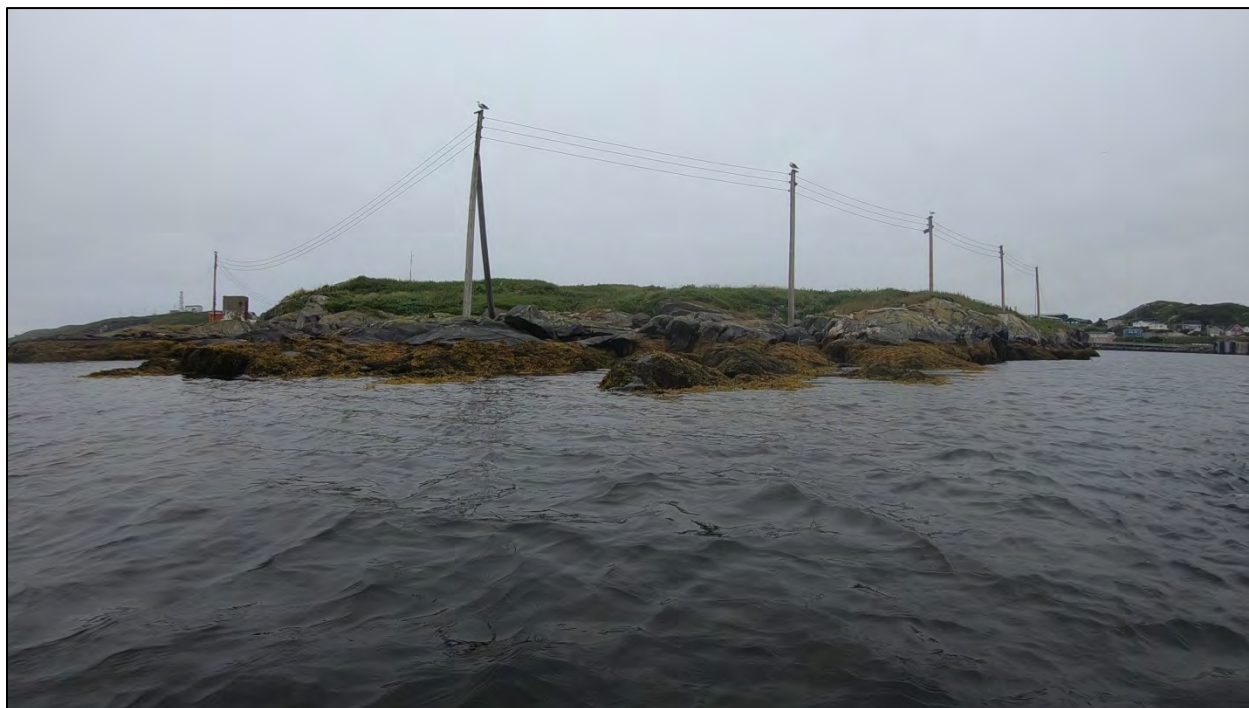
**Photo 57:** Bedrock shoreline observed in ST7

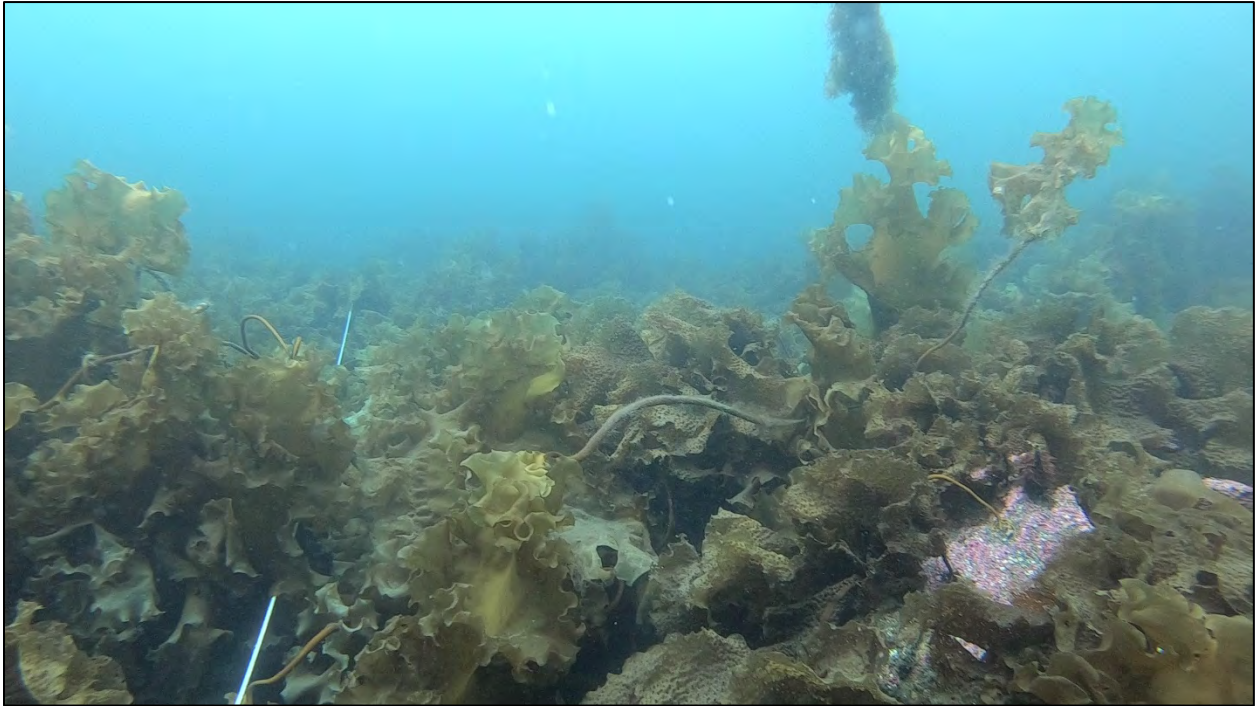
**Photo 73:** Rocky substrate with abundant kelp observed in T30 moving between Vardy's Island and the Pikes Island breakwater.
