Real-Time Water Quality Report

Outer Cove Brook Network

Deployment Period
April 8, 2014 to May 14, 2014

Outer Cove Brook, Newfoundland and Labrador

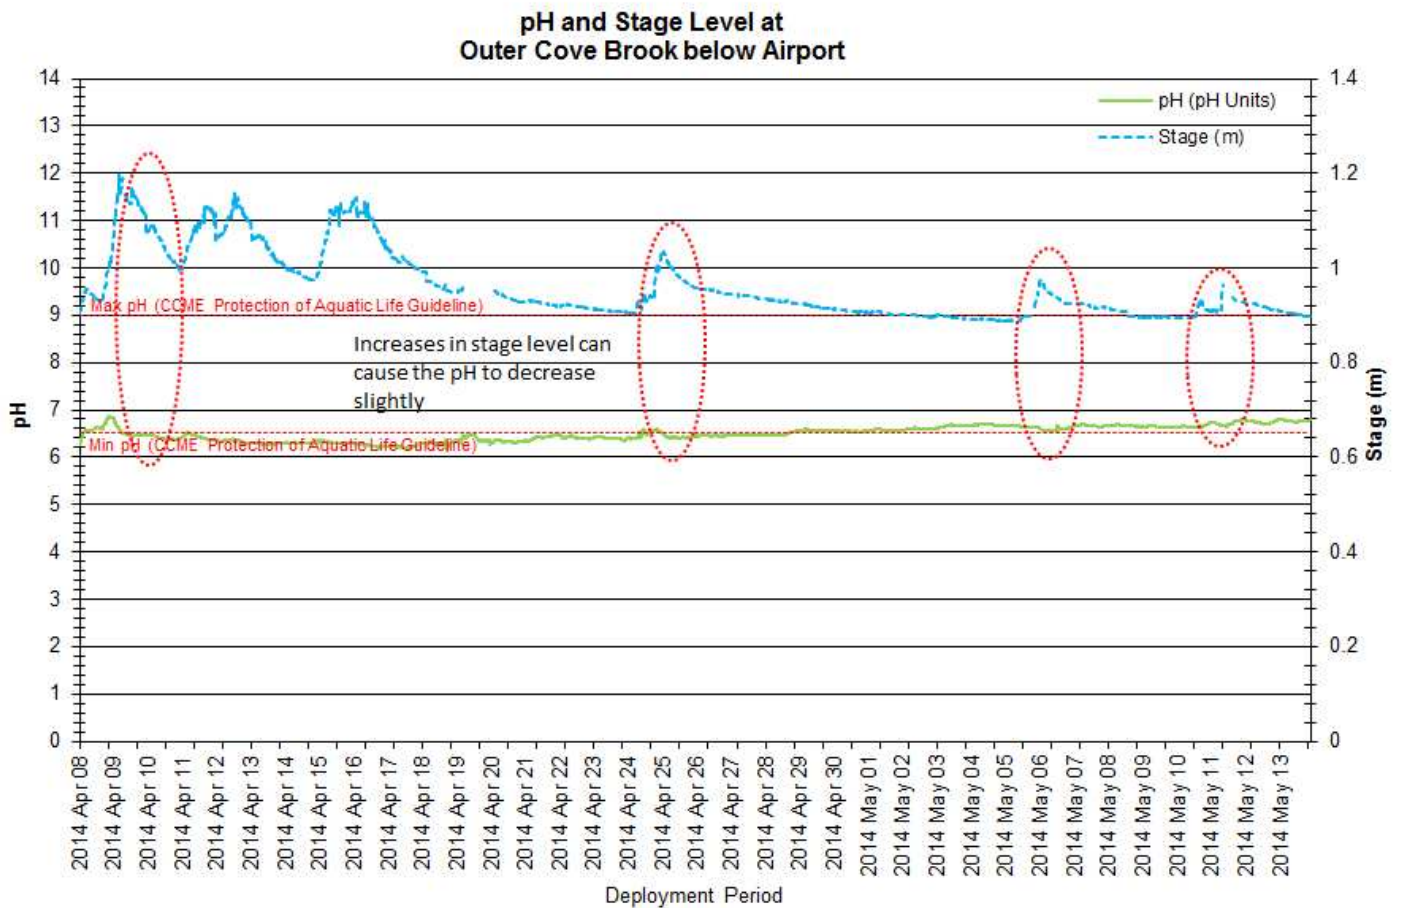
Figure 3: Quarter-hourly pH (pH units) and stage level (m) values at Outer Cove Brook below Airport

Throughout this deployment period pH values ranged between 6.12 pH units and 6.85 pH units (Figure 3). During the deployment, the pH values at this station fall just below the minimum CCME Guideline for the Protection of Aquatic Life (between 6.5 and 9 pH units) until the end of April where the pH levels increase to slightly above the minimum CCME Guideline for the Protection of Aquatic Life.

The events that where the pH levels dip on April 11th, April 25th, May 6th and May 12th correspond with stage increases. This can be explained by the natural correlation between rainfall and pH levels.

The CCME guideline provides a basis by which to judge the overall health of the brook. Naturally, all streams and brooks are different. During this deployment period the median pH level was 6.47 units, which was slightly lower than last month (more acidic than previous deployment month).

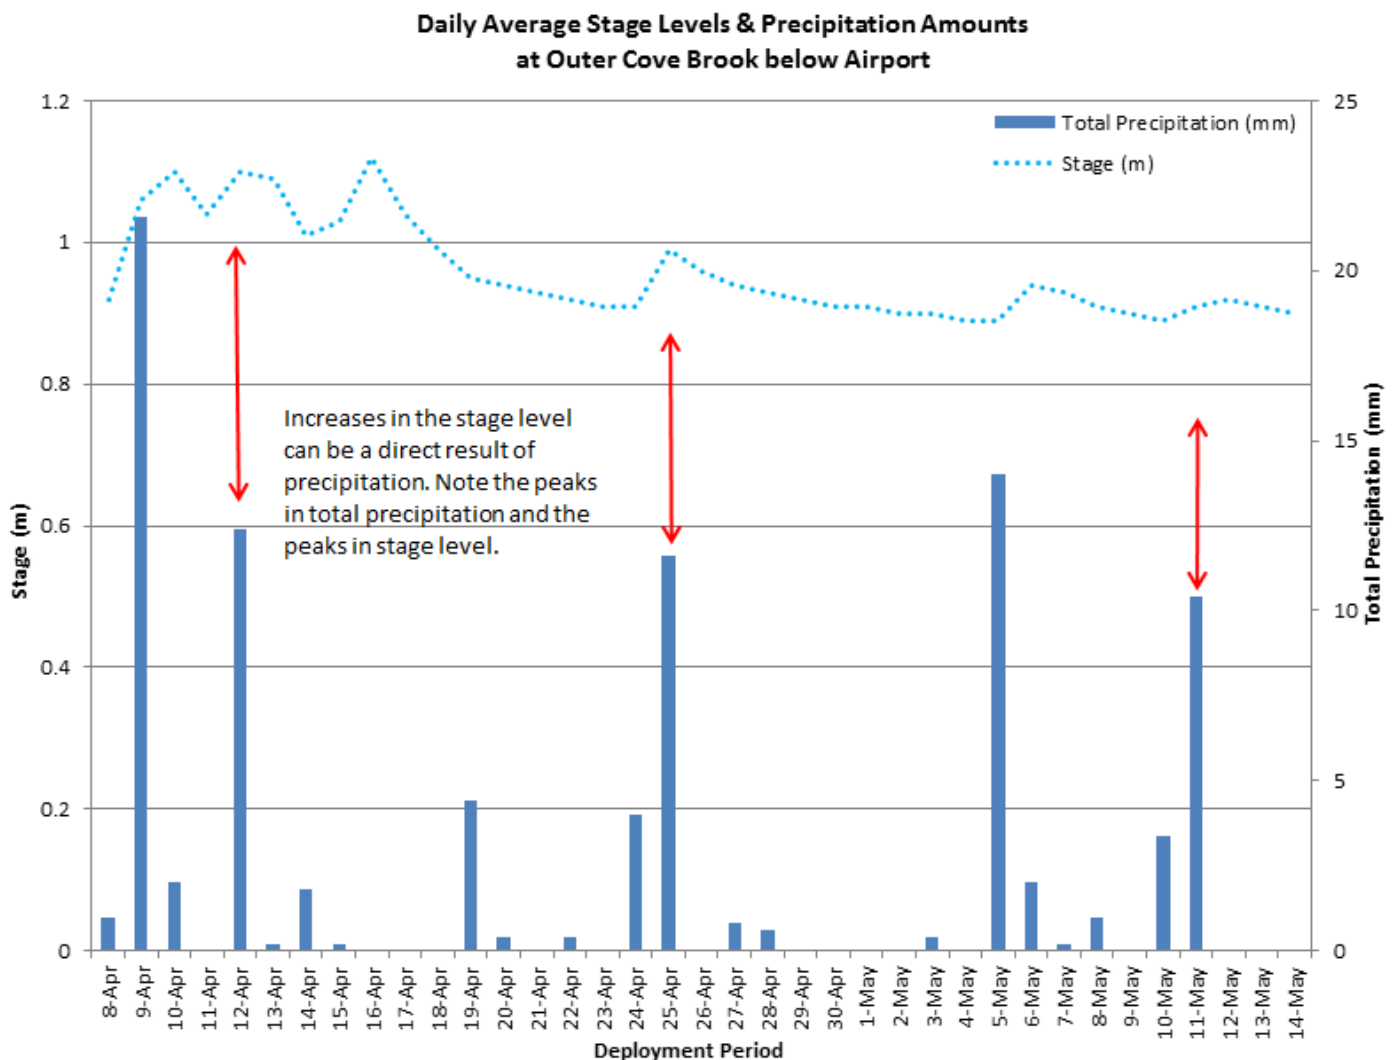
Figure 7: Daily average stage values (m) at Outer Cove Brook below Airport and daily total precipitation values (mm) from Environment Canada’s St. John’s Airport Station.

Stage will increase during rainfall events (Figure 7) and during any surrounding snow or ice melt as runoff will collect in the brooks. However, direct snowfall will not cause stage to rise significantly.

During the deployment period, the stage values ranged from 0.89m to 1.20m. The larger peaks in stage do correspond with sufficient rainfall events as noted on Figure 7.

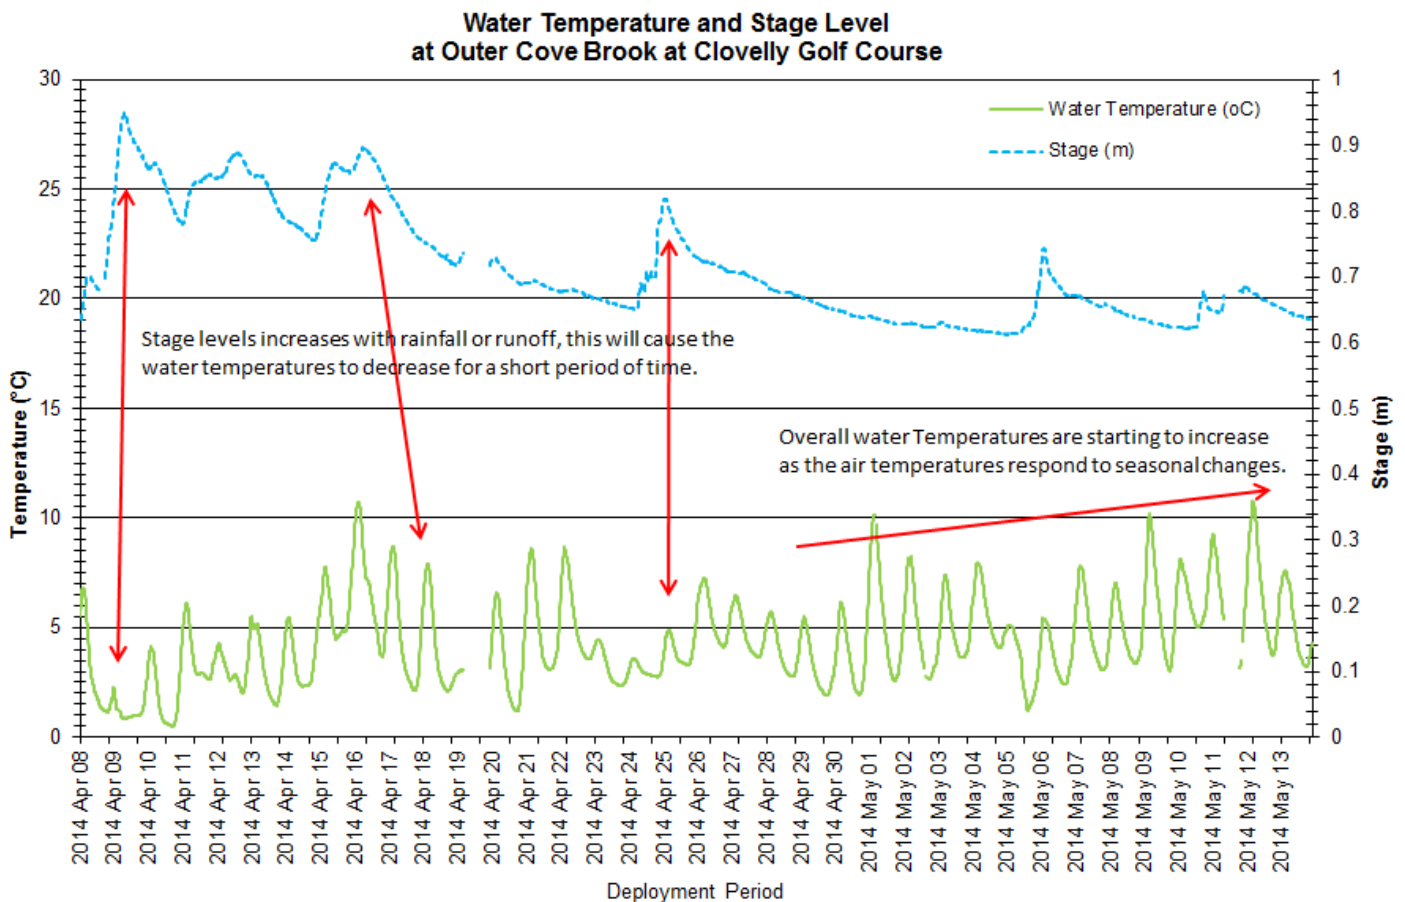
Figure 8: Quarter-hourly water temperature (°C) and stage level (m) values at Outer Cove Brook at Clovelly Golf Course.

Water temperature ranged from 0.49°C to 10.75°C during this deployment period (Figure 8).

Water temperature in this brook displays a typical variation in pattern over the deployment period. Water temperature is influenced by air temperature. Over the course of the deployment period the water temperature drops to 0°C or below several times.

The lower water temperatures indicated on the graph also correspond with increases in stage. This can indicate that there was rainfall or snow melt during those particular times. Overall the water temperature for this deployment period is slowly increasing as the air temperatures respond to seasonal changes.

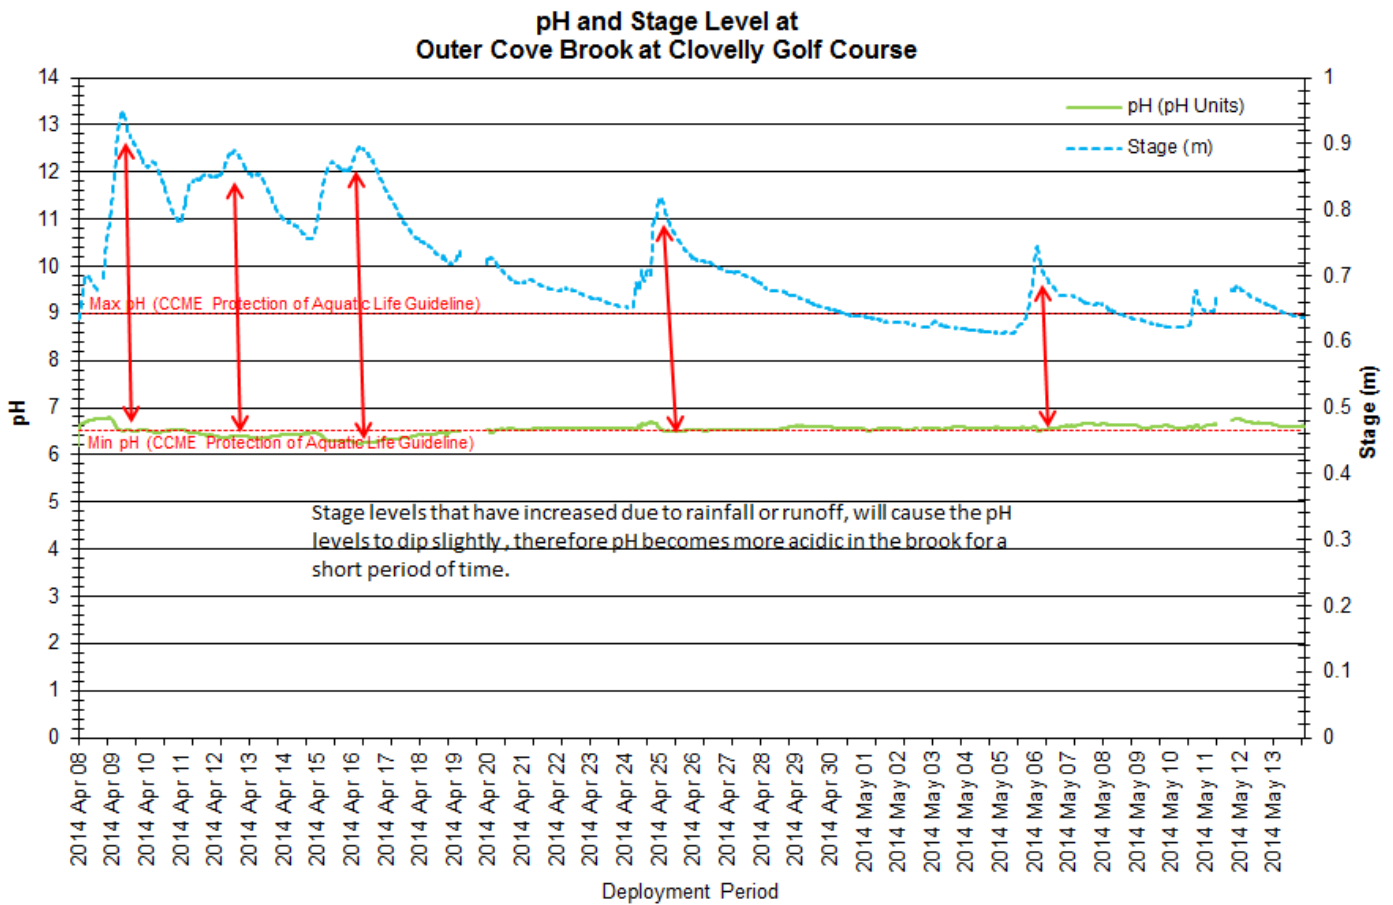
Figure 9: Quarter-hourly pH (pH units) and stage level (m) values at Outer Cove Brook at Clovelly Golf Course.

Throughout this deployment period pH values ranged between 6.20 pH units and 6.80 pH units (Figure 9).

During the deployment, the pH values at this station fall just below the minimum CCME Guideline for the Protection of Aquatic Life (between 6.5 and 9 pH units) until the end of April where the pH levels increase to slightly above the minimum CCME Guideline for the Protection of Aquatic Life.

The pH levels dip on April 10th and 13th, April 17th, April 26th and May 7th correspond with stage increases. This can be explained by the natural occurrence between rainfall and pH levels.

The CCME guideline provides a basis by which to judge the overall health of the brook. Naturally, all streams and brooks are different. During this deployment period the median pH level was 6.55 units.

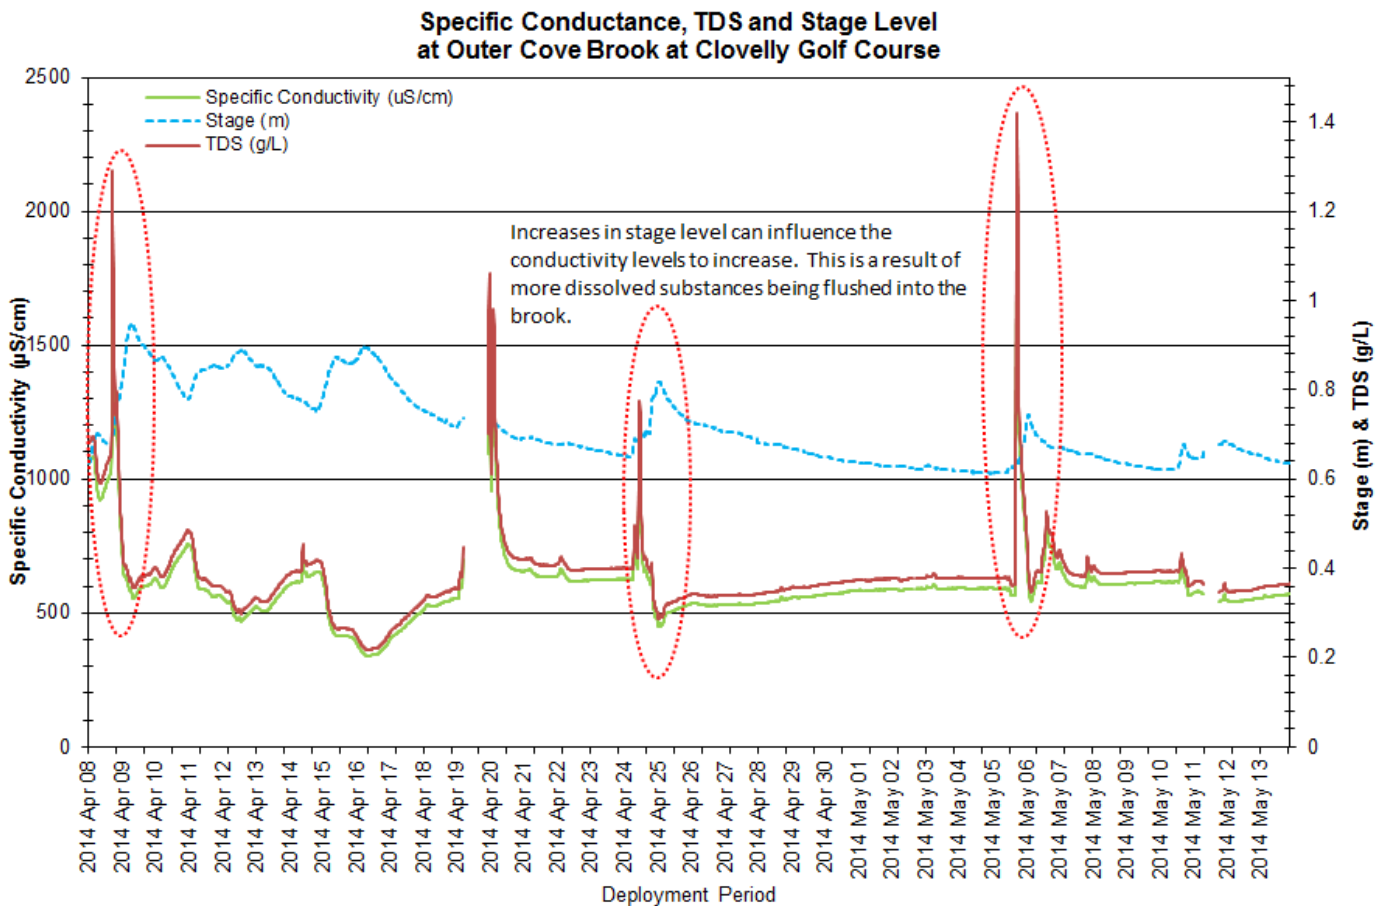
Figure 10: Quarter-hourly specific conductivity ($\mu\text{S}/\text{cm}$), TDS (g/L) and stage (m) values at Outer Cove Brook at Clovelly Golf Course.

The conductivity levels were within 339.0 $\mu\text{S}/\text{cm}$ and 2211.0 $\mu\text{S}/\text{cm}$ during this deployment period. TDS ranged from 0.2170 g/L to 1.4200 g/L.

The peaks in conductivity on April 9th, April 25th, May 6th and May 12st (see Figure 10), correspond with the higher stage levels. The presence of inorganic dissolved solids such as road salt and material are washed into the brook and increase the 'normal' levels of conductivity.

During the colder winter months of the year, the city roads are salted heavily. As the ice and snow thaws the residual salts are flushed into surrounding rivers and brooks.

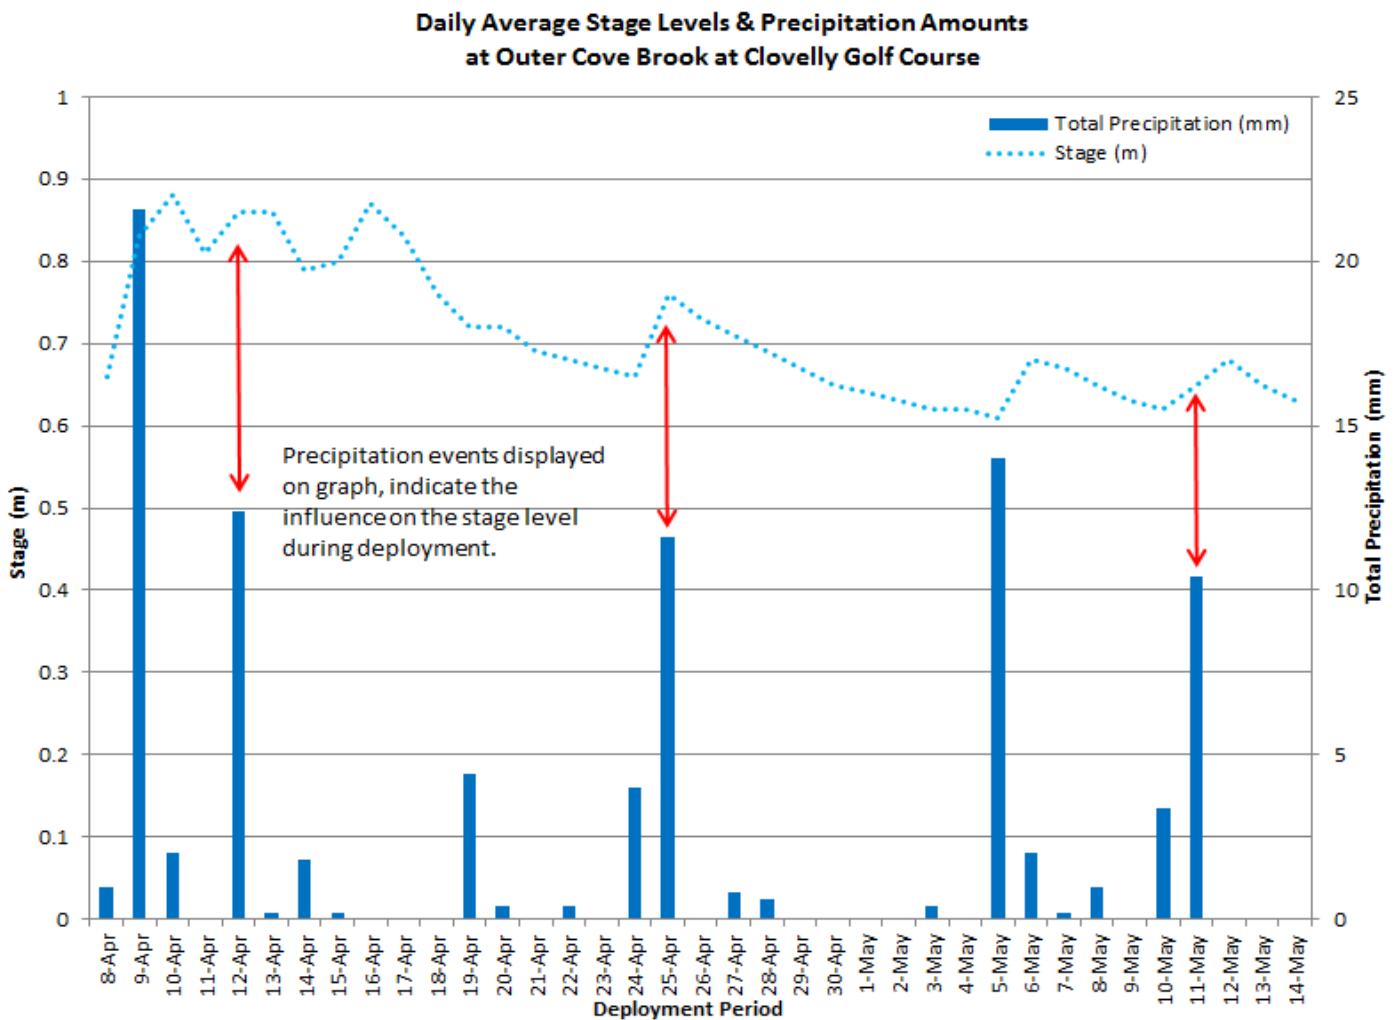
Figure 13: Daily average stage values (m) at Outer Cove Brook at Clovelly Golf Course and daily total precipitation values (mm) from Environment Canada’s St. John’s Airport Station.

It is not unusual to see Stage vary throughout the deployment period (Figure 13). Stage is directly influenced by rainfall and subsequent runoff from the surrounding environment.

The peaks in Stage in Figure 13 were a response to the rainfall events or snowmelt events that occurred during this deployment period. Stage levels during this deployment ranged within a minimum of 0.61m and a maximum of 0.95m.

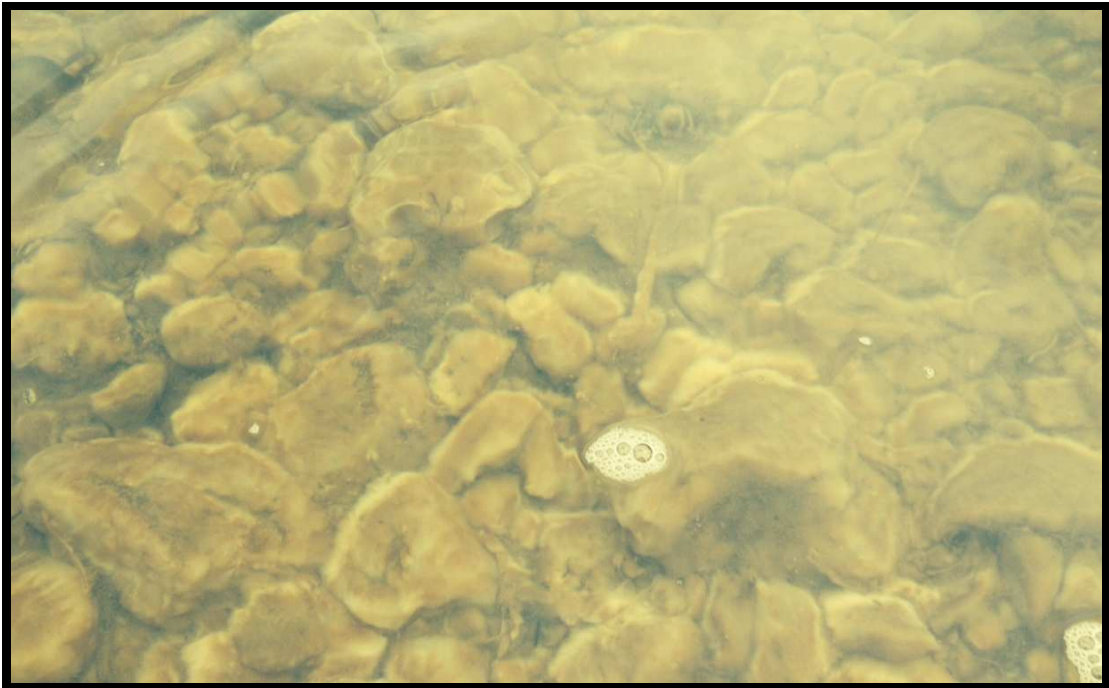
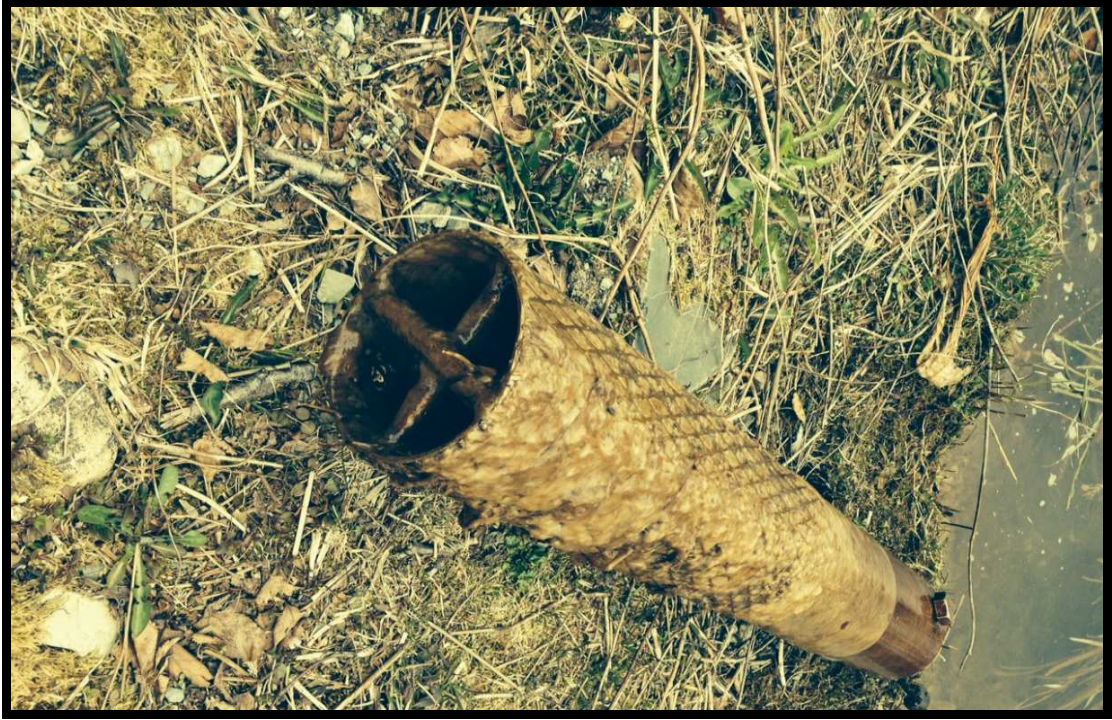
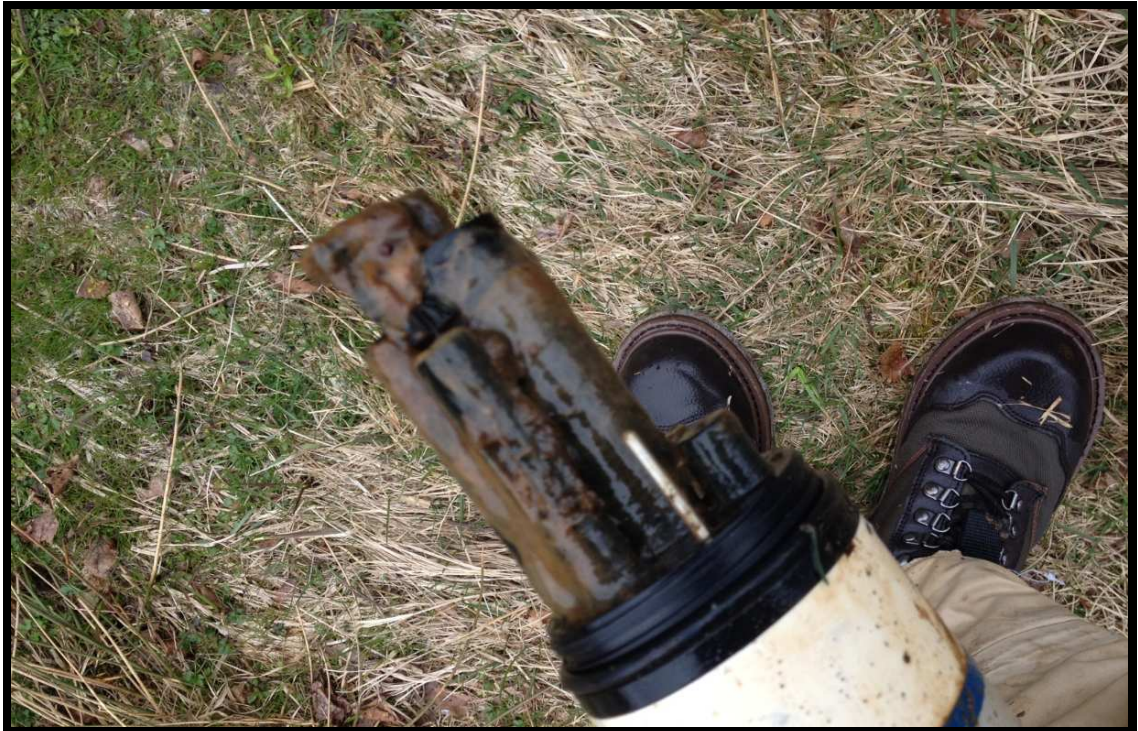
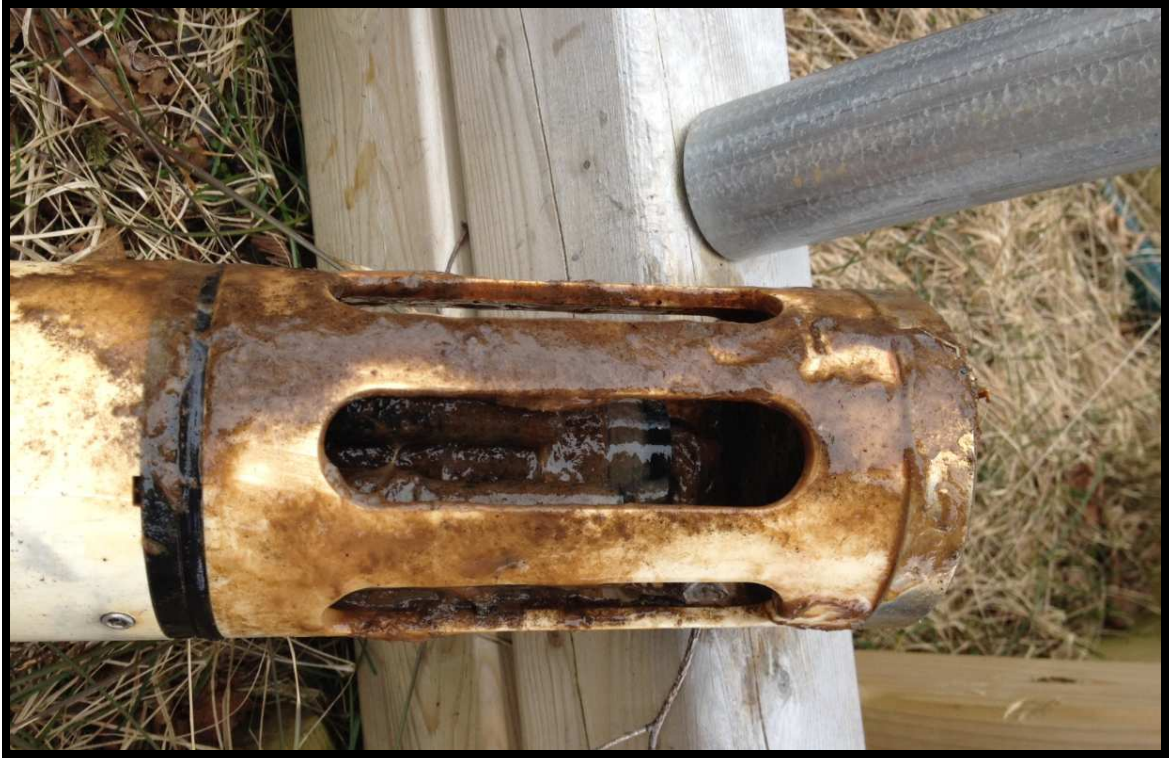
- At removal, temperature ranked as ‘fair’, pH ranked as ‘good’, conductivity ranked the highest at ‘excellent’. Dissolved oxygen and turbidity ranked ‘poor’. It should be noted that during removal the probes of the instrument were completely covered with algae. The lower rankings were likely a result of the fouling that was present on the probe at the time of removal (pictures in Appendix B).
- Deployment and removal instrument performance rankings for **Outer Cove Brook at Clovelly Golf Course** for the period of April 8, 2014 to May 14, 2014 are summarized in Table 3.

The calculated minimum levels for the dissolved oxygen are not representative of the water quality at this brook. All the sensors had fouling present, ultimately creating ‘false’ DO readings (Pictures in Appendix B).

Pictures of biofouling on Outer Cove Brook at Airport Station instrument

- Toward the end of this deployment the level of biofouling present on the instrument affected the raw data being transmitted. At this deployment there was a large amount of hair-like algae present in the brook that is not evident all year round. Environment Canada was notified of the algae and provided with pictures of the algae. Environment Canada will also be forwarded the grab sample results taken on deployment for additional investigation.

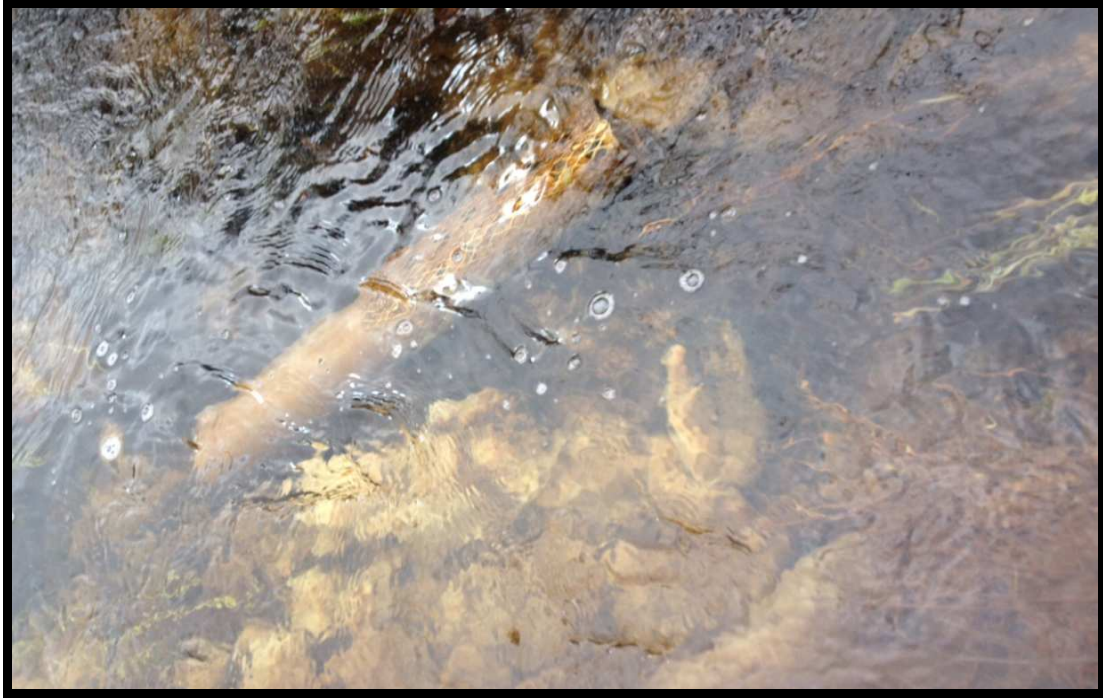
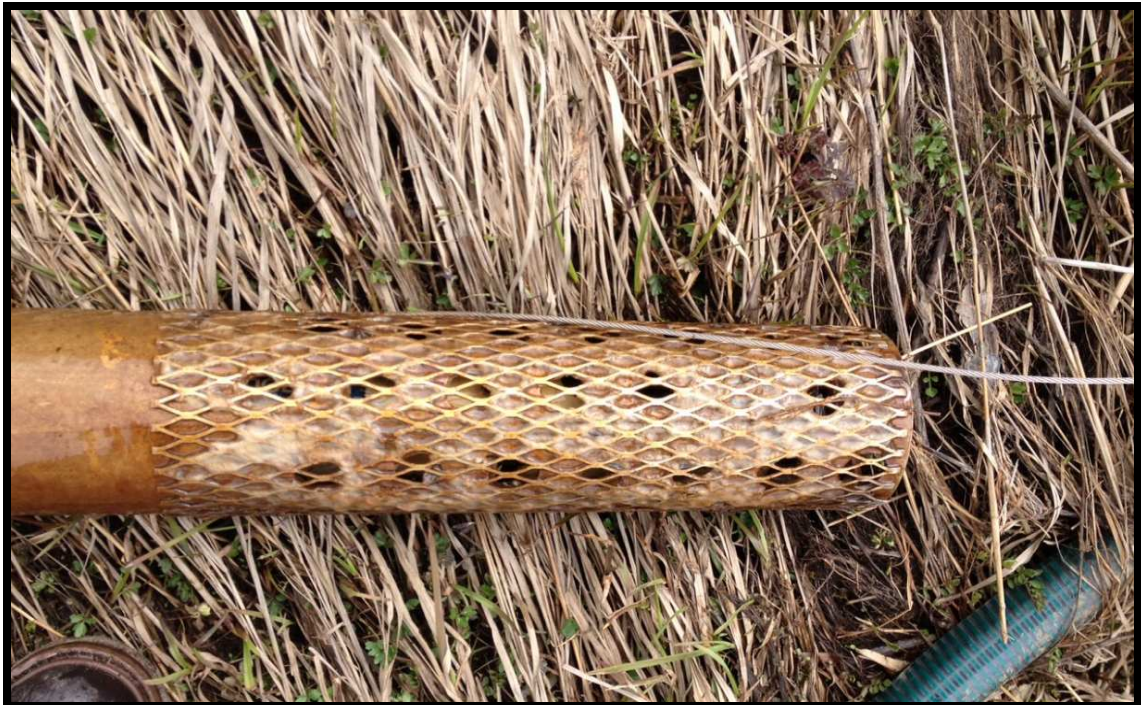
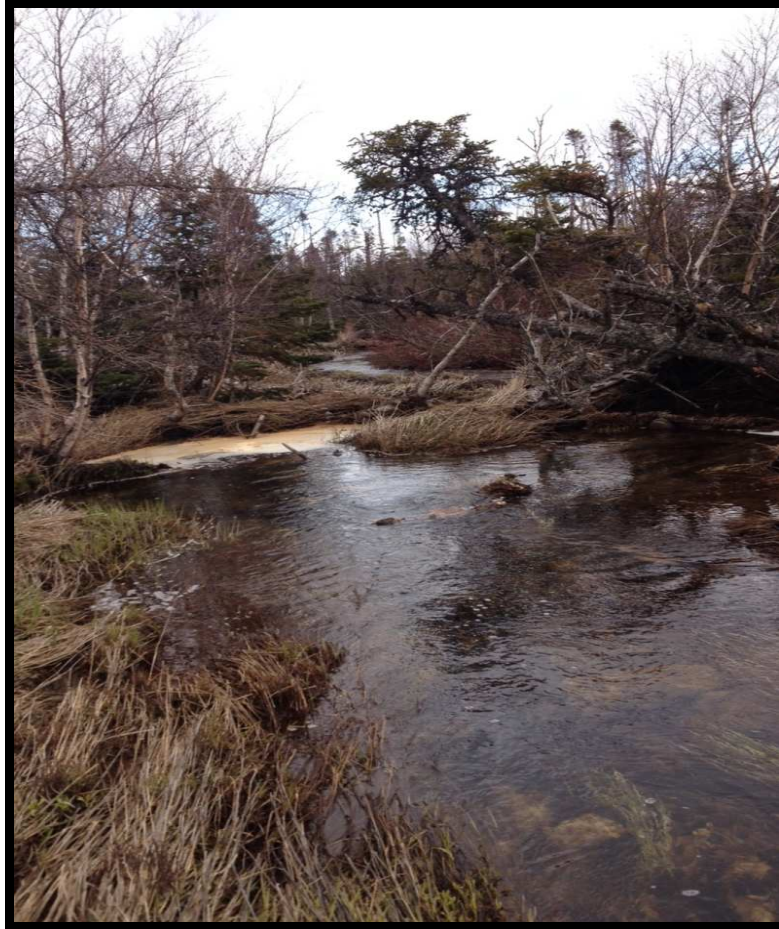
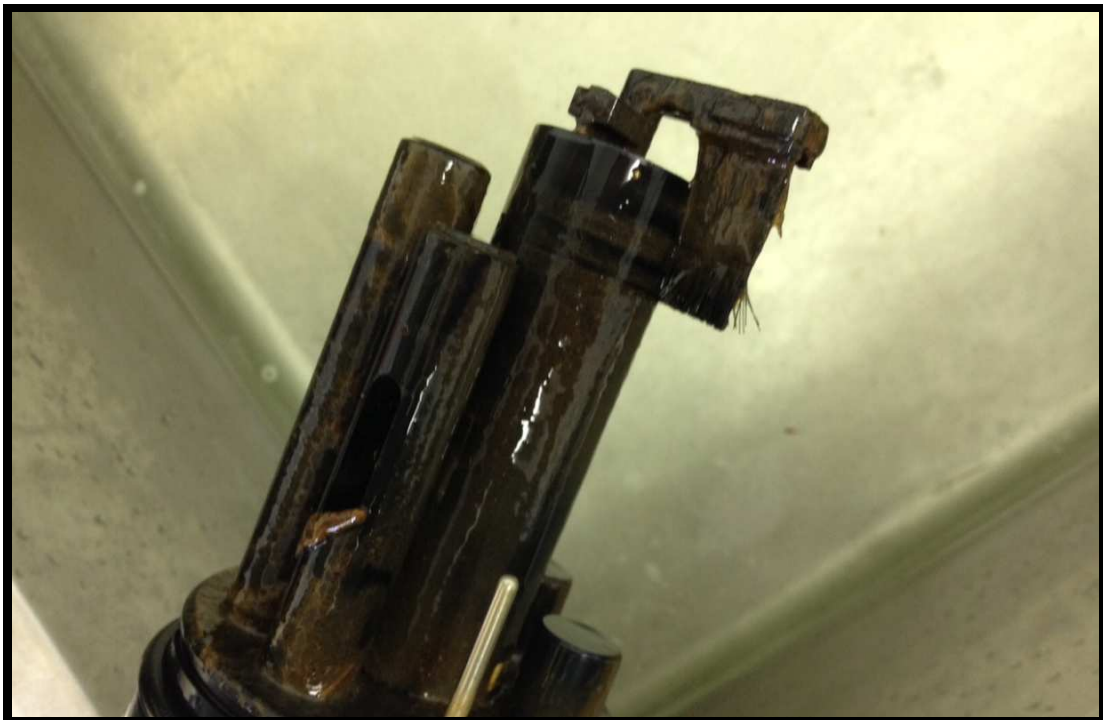
During removal of the instrument there was evidence of the similar brown hair-like algae – that was present upstream at Outer Cove Brook below Airport (Pictures in Appendix B). The coverage of the algae at this site was not as extreme (~30%) although it was still present on the sonde probes and the instrument required extensive cleaning.

**Pictures of biofouling on Outer Cove Brook at Clovelly Golf Course Station
instrument**
