# **COASTAL EROSION IN ST. GEORGE'S BAY, WESTERN NEWFOUNDLAND**

**Open File 012B/0705**

**St. John's, Newfoundland  
August, 2019**

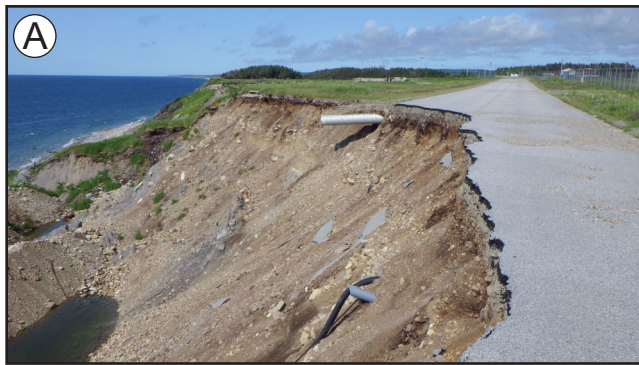
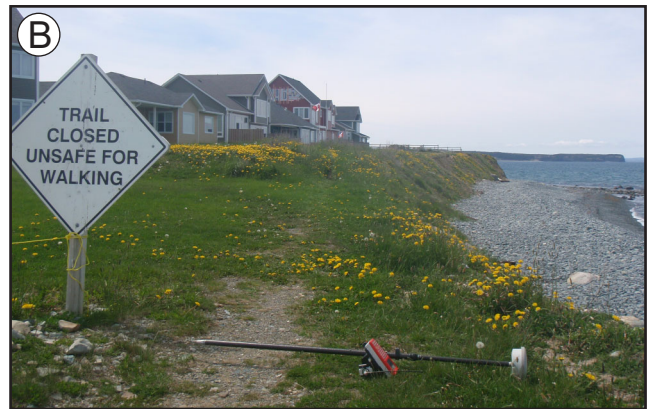
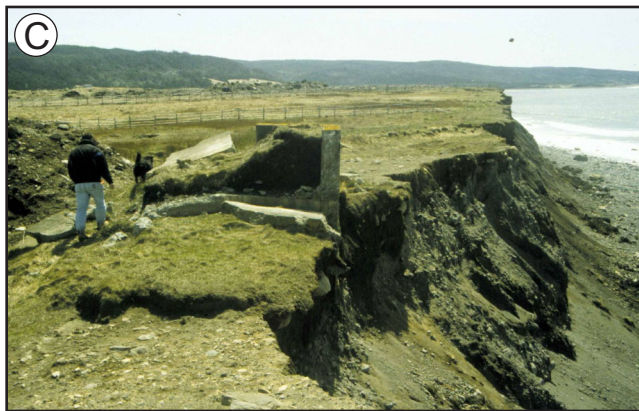
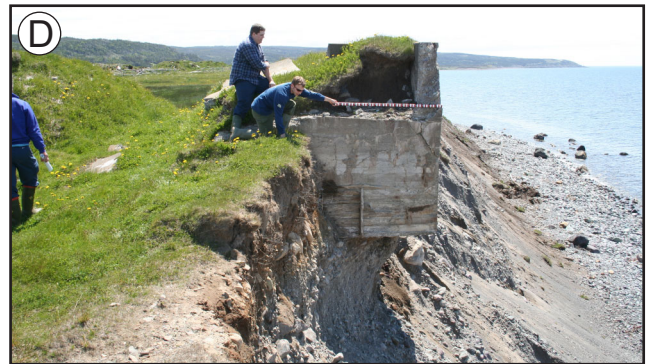
**Plate 1.** Coastal processes impacting infrastructure. A) During a landslide in Daniel's Harbour in 2013, a large amount of unconsolidated sediment was moved from the slope and deposited on the beach; the old highway was damaged and pipes were exposed; B) Coastal erosion along the top of a cliff in Conception Bay South resulted in the closure of a walking trail within a few years of being constructed. Quantifying rates of erosion is crucial to determine setback values in order to reduce the risk of this; C) Coastal cliff, Point Verde, 1995. Coastal erosion along the top of a cliff has undermined an old cement structure; D) Same portion of the coastal cliff at Point Verde as in 1C, taken in 2005. Note the amount of erosion that had occurred at the base of the structure over a ten-year period. Continued erosion, at a rate of 45 cm a year, caused the concrete structure in the photo to fall to the base of the cliff in 2011.

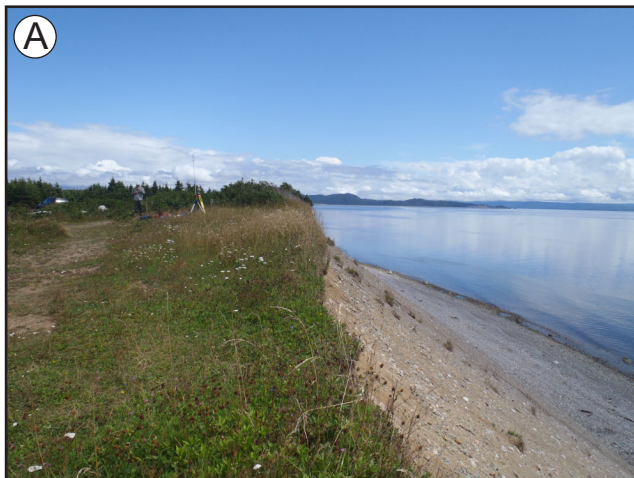
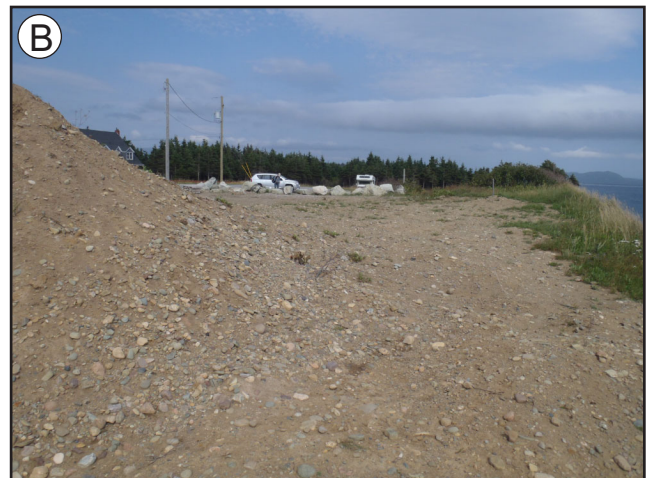
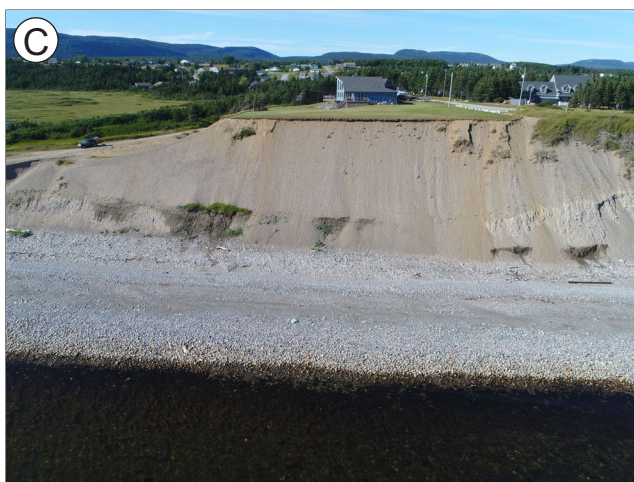
**Plate 2.** Landscape change in Kippens. A) In 2011, this area was covered by long grass, and had an ATV trail running parallel to the shore; B) Between 2011 and 2012, the land was cleared for the construction of a new home. Removal of the vegetation increases the risk of cliff erosion unless remedial action is taken; C) Same portion of the coast as in Plate 2A and B, but viewed from over the water, looking at the cliff face. Photo taken in 2017. In 2012, house construction was complete (blue house in centre of photograph). Grass was planted landward of the cliff, which will absorb surface water and reduce the vulnerability of cliff erosion.

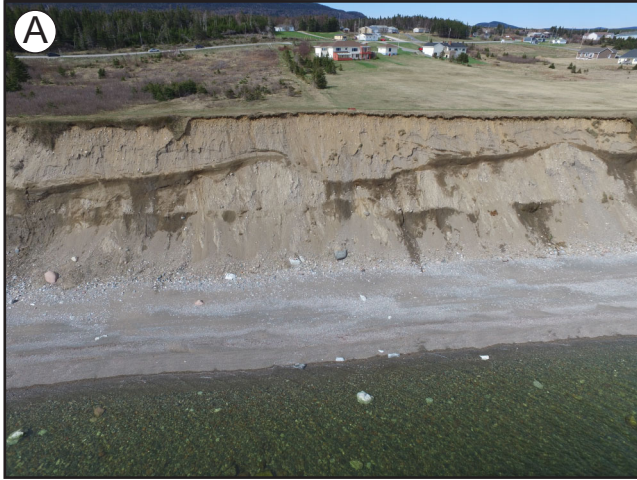
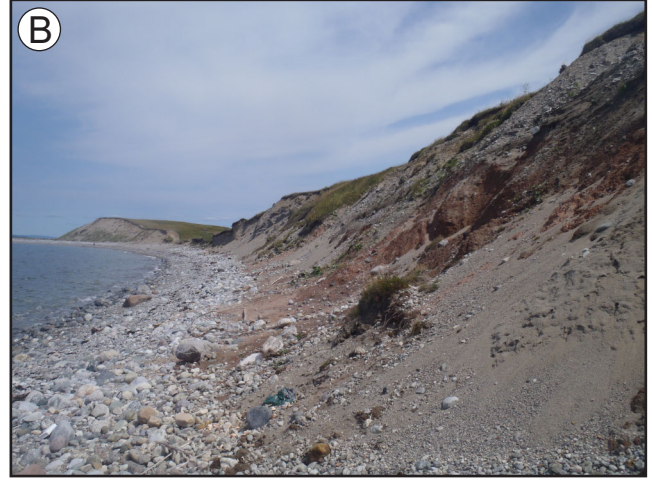
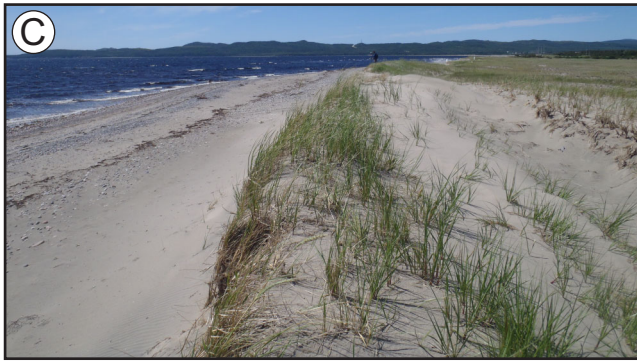
**Plate 3.** Examples of coastal environments along St. George's Bay. A) The coast between Port and Port and Stephenville consists primarily of unconsolidated cliffs, although there are variations in sediment composition and vegetation cover. This aerial view, captured in May 2016, shows the general stratigraphy and setting of the coastal cliff east of Romaines Brook. Cliff stratigraphy includes layers of sand and gravel, and silt and clay. The cliff is unvegetated and fronted by a gravel beach. Houses have been built within 100 m of the clifftop; B) Cliff of poorly sorted sand and gravel, fronted by a cobble and boulder beach at Flat Bay; C) Sand dunes at Stephenville Crossing. As the area is low-lying and exposed to the west, it is susceptible to flooding and erosion.

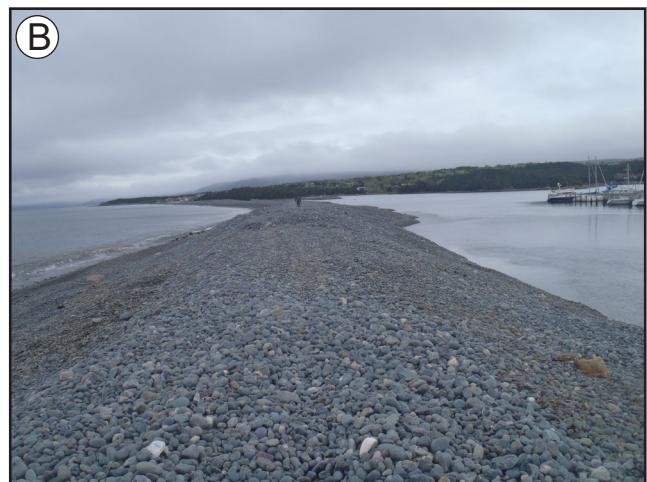
**Plate 4.** Impact of a storm surge, Conception Bay South. A) In the spring of 2013, a storm surge occurred during a high tide, and resulted in morphological changes to the barrier near the yacht club at Conception Bay South. Waves breached the barrier, moving sediment from the top and seaward face, forming washover fans and depositing sediment on the landward side of the barrier and in the lagoon; B) As the barrier provides protection from flooding to infrastructure landward, and the channel provides boat access from the lagoon to Conception Bay, sediment was dredged from the lagoon to rebuild the barrier.

Beaches undergo cyclical short-term changes (*i.e.*, seasonal to annual), undergoing erosion and subsequent accretion but no long-term net changes. Sand-dune environments under normal conditions have sediment moved from the foredune (*e.g.*, storm waves, high-water events), to the nearshore, before being transported onshore to re-establish the dune system through wave and *aeolian* processes (Figure 2A, B). Dunes serve as sand reserves, from which wind transports the sand to the foredune or beach. In barrier beaches, waves breach barriers, move sediment and deposit it landward (Plate 4A).

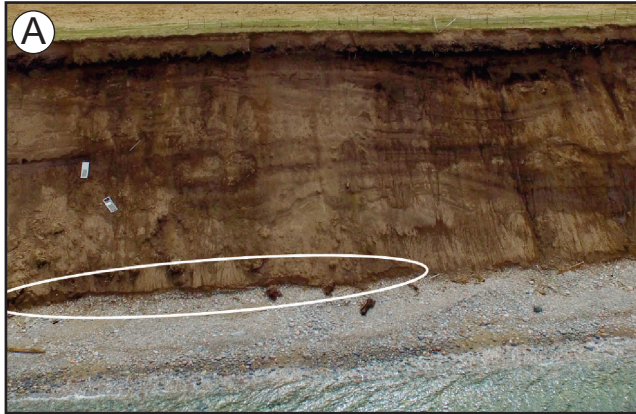
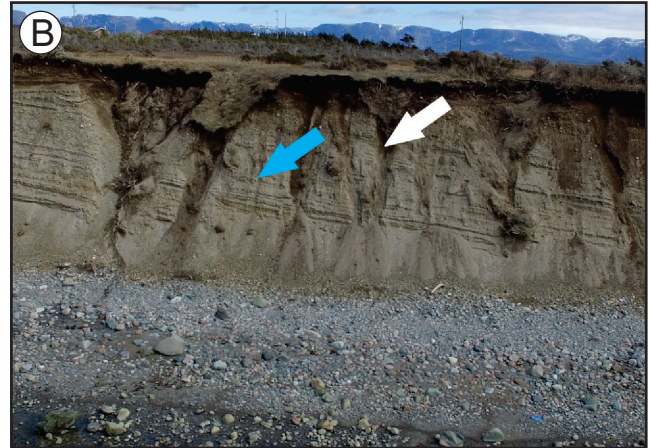
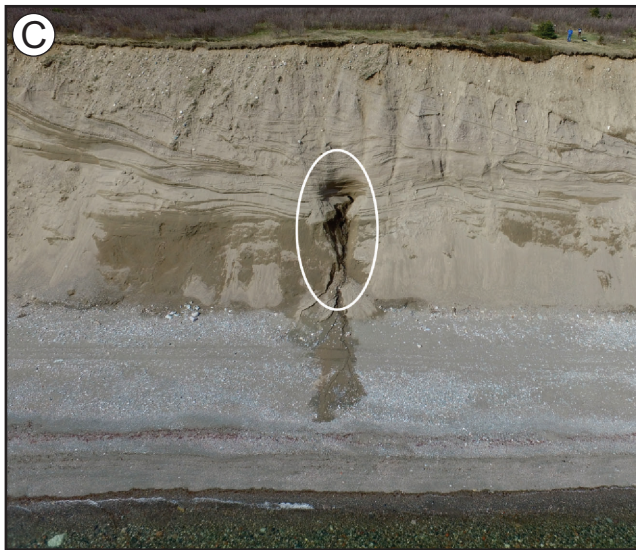
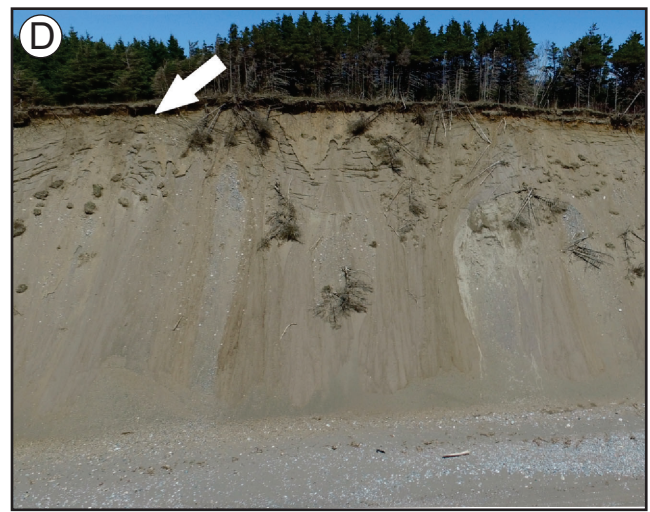
**Plate 5. Erosional agents.** A) In exposed areas with a narrow beach backed by a cliff, such as St. David's, waves can remove sediment from the cliff base, forming wave notching (circled); B) Rain and snowmelt result in rills (blue arrow) and gullies (white arrow), moving sediment to the base of the cliff; this is occurring at Parsons Pond; C) Groundwater is an influential agent causing erosion; seepage occurs at the contact of permeable coarse-grained material and non-permeable material. At Marine Drive a spring (circled) has formed at the contact of the sand and gravel layer, which is underlain by silt and clay; D) Wind has blown sand particles off the cliff face, creating overhangs (white arrow).

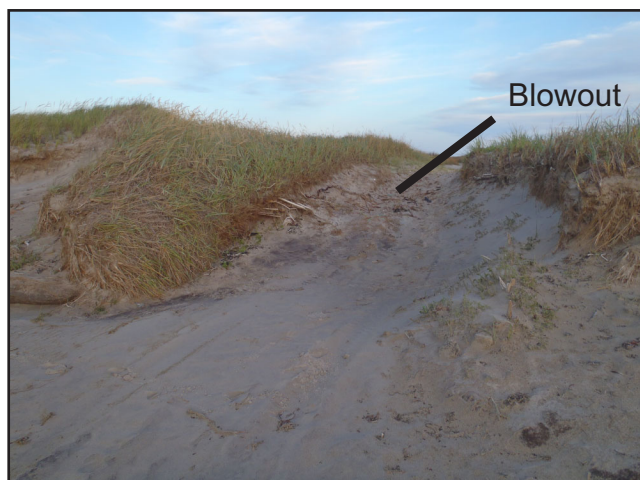
**Plate 7.** The passage of ATVs and foot traffic impacts sand dunes by instigating wind erosion, which can result in blowouts. This example is from Lumsden, in northeastern Newfoundland (not in current study area).

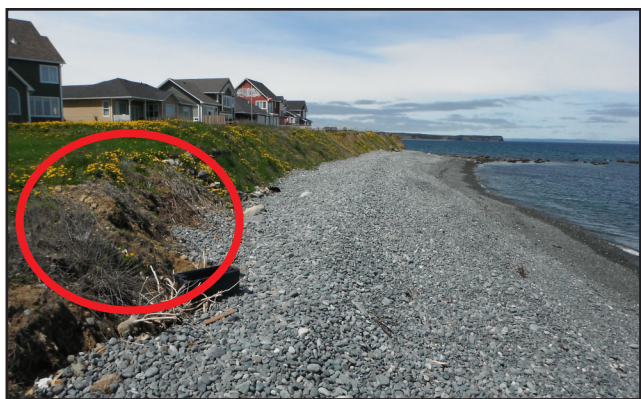
**Plate 8.** Homeowners placed grass, woody debris and soil (circled) to advance the face of the cliff in Conception Bay South. As this material is loose, it is very vulnerable to erosion during a period of high wind or elevated water, and will likely be displaced during the next storm event.

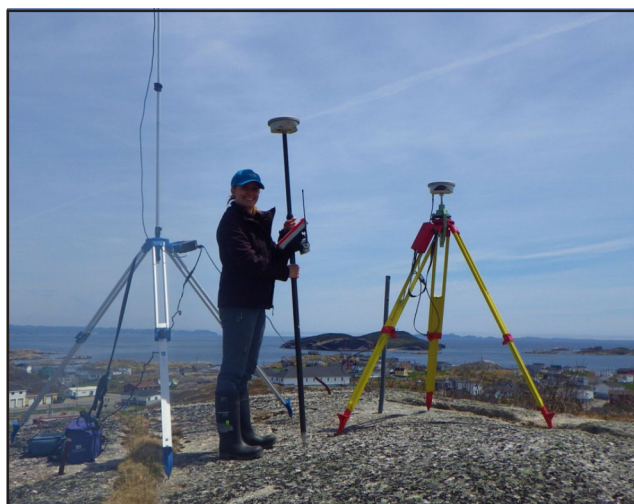
**Plate 9.** Real Time Kinematics survey equipment. The base station (yellow tripod) is set up over a previously established survey monument with known coordinates. The base station transmits reference position information to the roving receivers through the radio (blue tripod). The hand-held roving receiver, consisting of an antenna and field controller attached to a telescopic pole, is used during surveying.

Berry Head and St. David's. Real Time Kinematic equipment collected precise (cm-scale) location data (Plate 9). The RTK equipment comprises a stationary base receiver (referred to as a 'base station'), one or more roving receivers, and a radio link. The base station is set up within 10 km of the monitoring site, over a permanent survey benchmark, and is in line-of-sight of the roving receivers. It continually collects satellite signals of its static location, and the positional errors (e.g., satellite orbit errors) are transmitted to the roving receivers, allowing for the coordinates of the roving receivers to be corrected in real time, resulting in precise relative and absolute location data (Pardo-Pascual *et al.*, 2005).

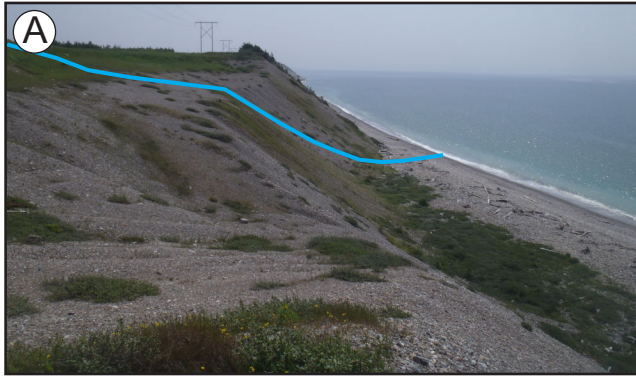
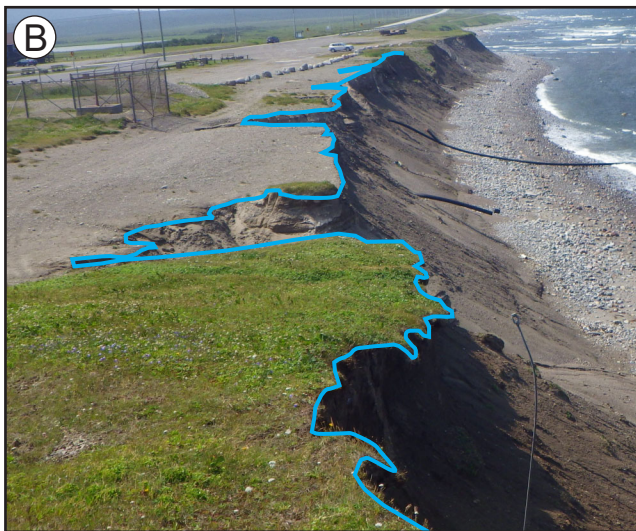
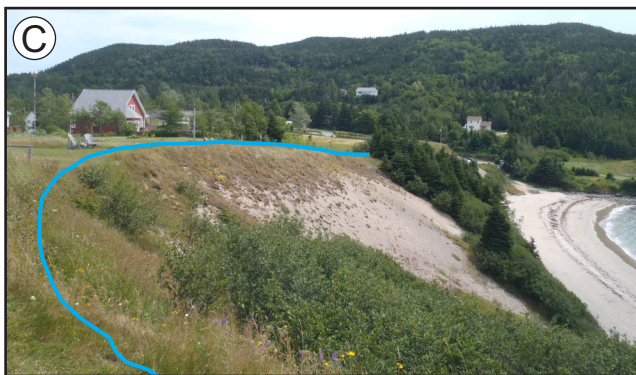
**Plate 10.** Surveys can be conducted on shore-normal transects, cliff tops or breaks in slope, indicated in blue. A) Shore-normal transect at Port au Port; B) Well-defined cliff top at Parsons Pond; C) Break in a vegetated slope at Sandy Cove.

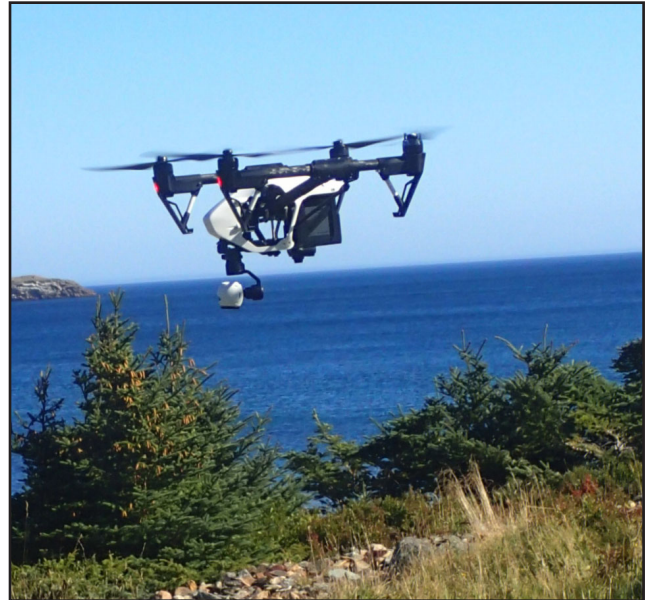
**Plate 11.** The DJI Inspire 1 Quadcopter is a light UAV equipped with a digital camera, and is controlled by an operator on the ground using a hand-held controller.

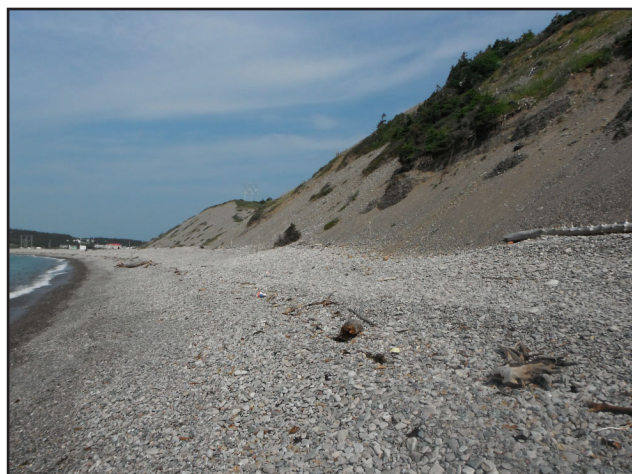
**Plate 12.** Partly vegetated gravel and sand cliff at Port au Port fronted by a gravel beach, July 2011. Erosion has been minimal along this coastline. Typically, waves do not reach the base of the cliff and groundwater is not present.

- The cliff face has approximately 30% grass and shrub coverage; the cliff is less susceptible to erosion from wind and water.
- The beach is wide (25 to 40 m); there is a well-defined beach *berm* on the beach face, and wave *notching* at the base of the cliff was not noted.
- There are boulders in the nearshore.

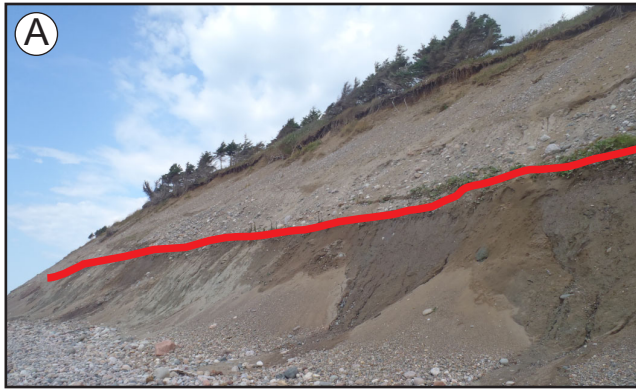
**Plate 14.** Seaside Drive, Kippens, May 2016. A) View of the cliff face. Groundwater is coming out of the cliff face at the contact (shown by the red line) between the silt and clay layer and the overlying sand and gravel layer. The water is removing sediment from the cliff face, which is being deposited at the base of the cliff; B) A portion of the hillshade of the DSM, showing the beach berm, boulders, gully, rills, slumped material, overhangs and turf mats. The left to right distance of the DSM is 330 m; C) Orthophoto of the western portion of the site. The central portion of the site has eroded at an accelerated rate. Note the truck circled for scale. The left to right distance of the orthophoto is 515 m.

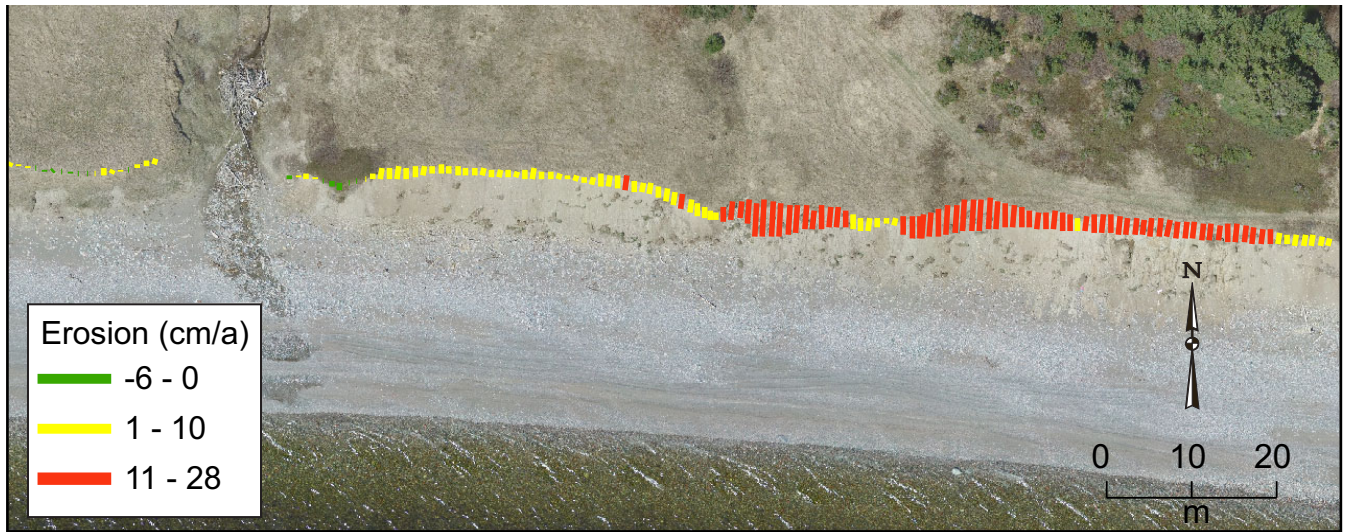
**Figure 10.** The DSAS analysis of coastal erosion from 2000 to 2016 along Seaside Drive, Kippens. Only the coastline west of Williams Lane (Figure 8) is displayed, to allow the coloured bars to be visible. Colour and bar length represent the spatial variation in erosion. The length of the bars represents the total amount (measured in cm) of cliff-top erosion for the period of analysis; the longer the bar length, the greater the amount of coastal erosion. Red, yellow and green bars denote accelerated, moderate and minor erosion respectively.

The average erosion rate for Area A in Figure 8 between 2000 and 2016 is 9 cm/a (Figure 10; Table 5). Based on digital photogrammetry, between 1974 and 1986, the same receded at a faster rate of 16 cm/a (Table 5; Forbes *et al.*, 1995). It would appear that erosion is slowing, the cause of which is not clear.

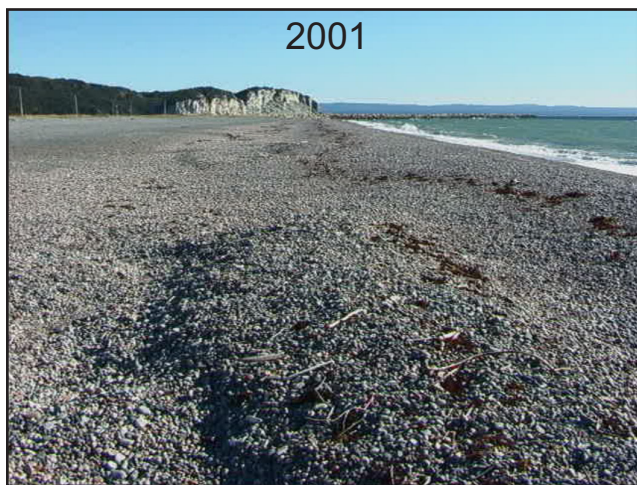
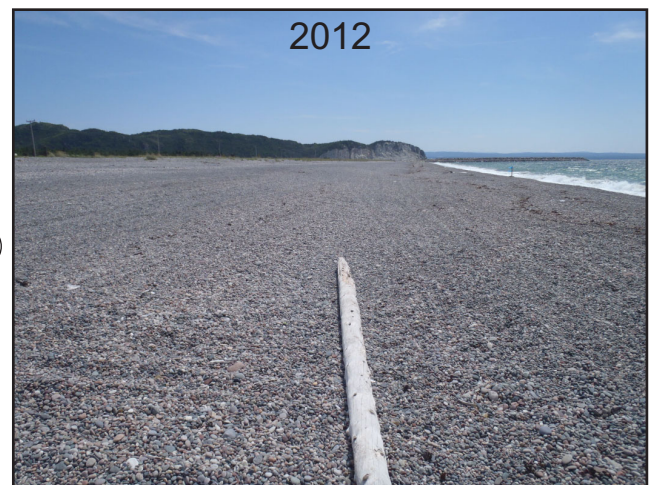
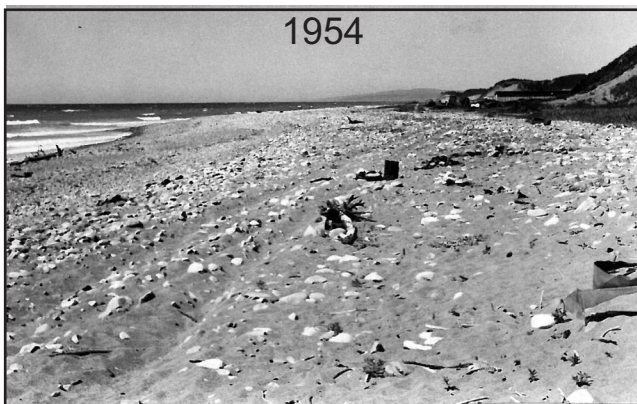
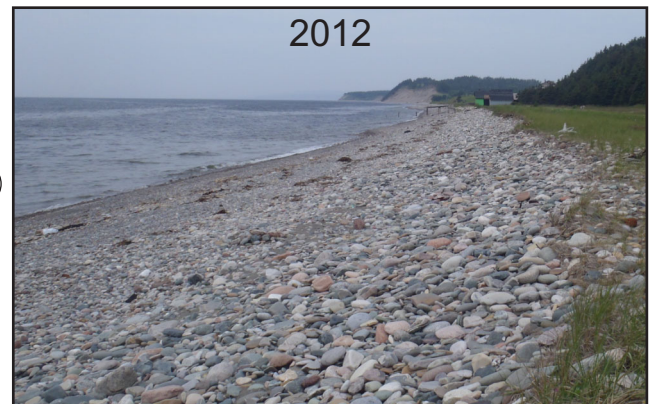
**Plate 16.** Stephenville. A) Stephenville beach in 2001 (left) and 2012 (right) looking southeast, with Indian Head and the break-water in the background. In the last 20 years, there has been accumulation of gravel on the beach face; B) Northern beach in 1954 (left) and 2012 (right). In 1954, there was more sand on the foreshore, whereas gravel is currently the dominant type of sediment.

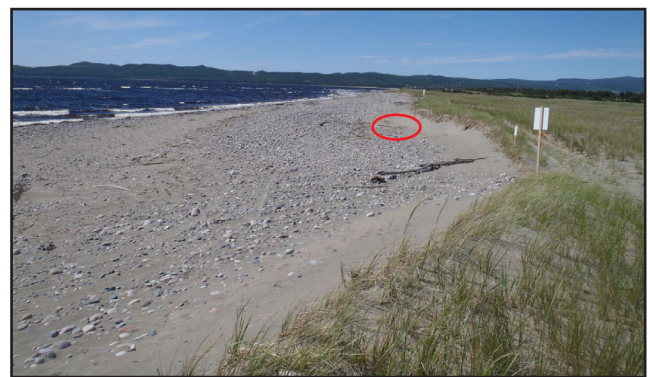
**Plate 17.** Stephenville Crossing, June 2014. The dune field is well-vegetated, and embryo dunes have formed on the beach (example circled in red).

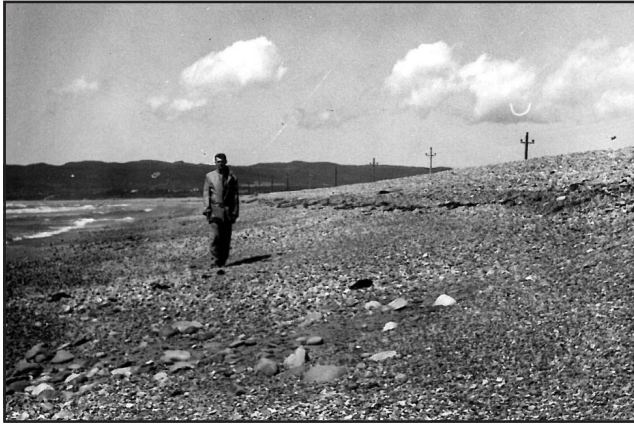
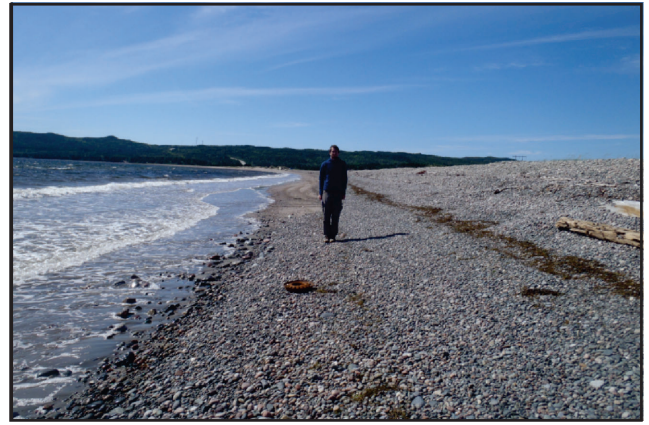
**Plate 18.** The beach north of the Gut in Stephenville Crossing in 1954 (left) and 2013 (right). The beach has remained stable; the foreshore is dominated by gravel, backed by a steep ridge.

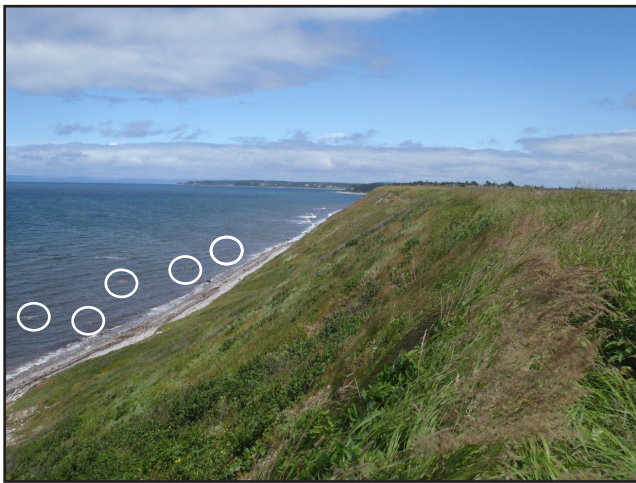
**Plate 20.** Vegetated cliff at Berry Head. As evident from the seaweed line along the beach face, waves typically do not reach the cliff base. The boulders (circled) near the waterline dissipate incoming wave energy.

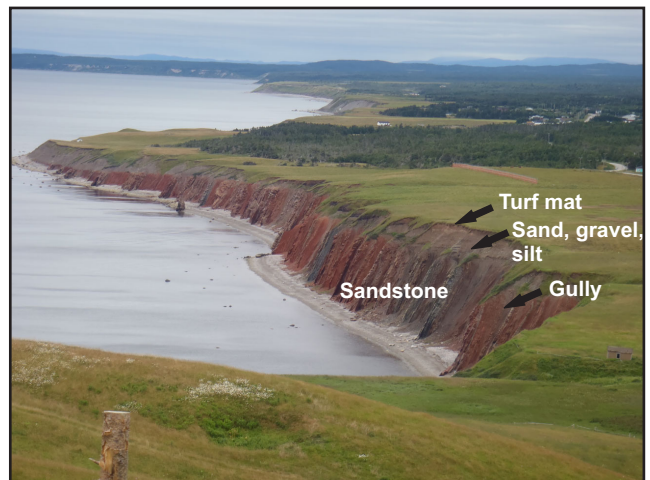
**Plate 21.** Coastal cliff at Robinsons, June 2013. In contrast to the other monitored sites, the cliff is composed of sedimentary rocks overlain by sand and gravel. Although the sedimentary rocks are soft compared to many other types of bedrock, they are harder and more resistant to erosion than unconsolidated sediment. Wind and water can loosen and move rock fragments from the cliff face.
