GRANULAR AGGREGATE-RESOURCE MAPPING OF THE GRAND FALLS (NTS 2D/13) AND MOUNT PEYTON (NTS 2D/14) MAP AREAS

M.J. Ricketts and T. Christopher
Terrain Sciences Section

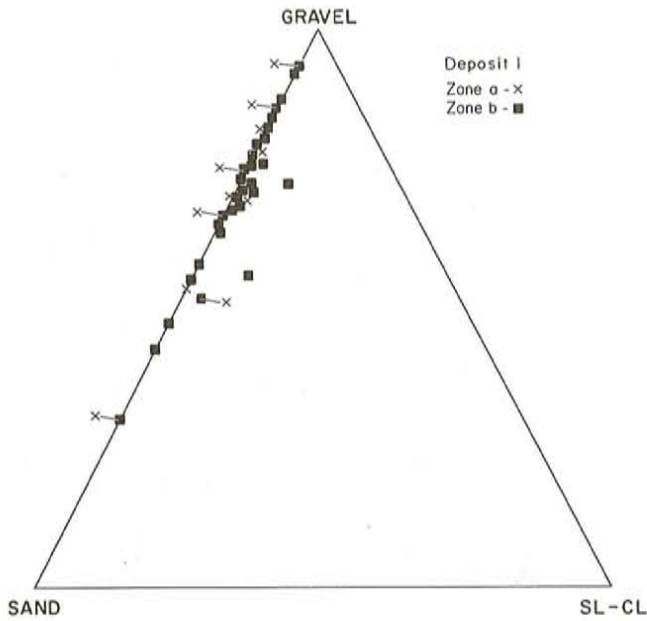
Figure 3. Ternary diagram showing granular distribution of samples collected in the northwest Exploits River deposit.

Grain-size analyses of sampled material indicate both zones are moderately sorted and contain high gravel content, moderate amounts of sand and low percentages of fines (Table 2). Two samples in zone A contain silt-clay in the 9 and 10 percent range (Figure 3) but this is a minor problem considering the overall size of the deposit. Most samples collected from this deposit were from backhoe-dug pits and supplemented by hand-dug pits and river-bank exposures. Petrographic numbers of the 16- to 32-mm pebble fraction generally have high values. Kirby (1991) attributes the poor petrographic quality to moderately weathered conglomerate pebbles and to a lesser extent, weathered acidic volcanic pebbles.

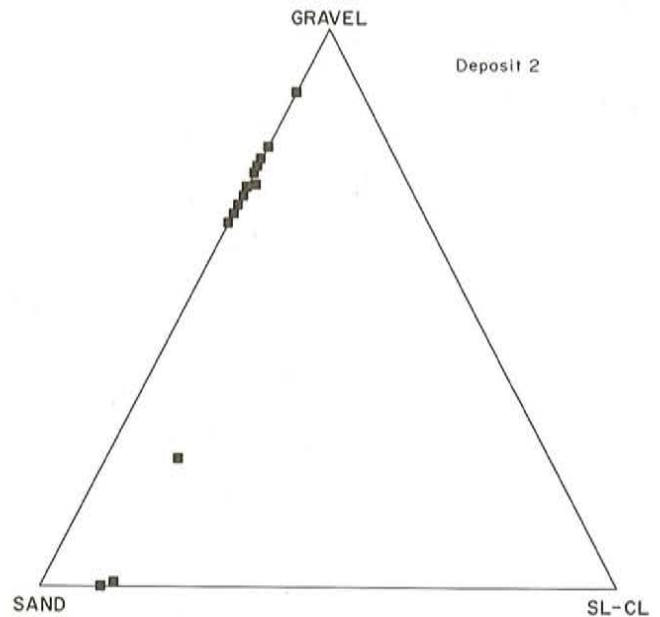
Figure 4. Ternary diagram showing granular distribution of samples collected in Aspen Brook-Leech Brook deposit.

The Aspen Brook-Leech Brook deposit is located along the north bank of the Exploits River between Aspen Brook and Leech Brook in the western part of map area NTS 2D/13 (Figure 2). The deposit is 8 km long, has a width between 0.2 km and 0.8 km, and a thickness of 2 to 9 m increasing eastward toward Leech Brook. The Leech Brook area has been the site of a large quarry operation in the past (Plate 1). It is a coarse-grained, moderately sorted deposit (Table 2). Three samples collected with silt-clay contents of 10.7, 12.7 and 12.8 percent (Figure 4), are not typical of material in the area and were not included in average analyses. Petrographic numbers range from good to poor in this deposit based on the analyses of 14 samples. Samples with poor petrographic quality are the result of weathered siltstone and sandstone. There were also a number of highly weathered undefined pebbles, which contributed significantly to poor petrographic quality in some samples.

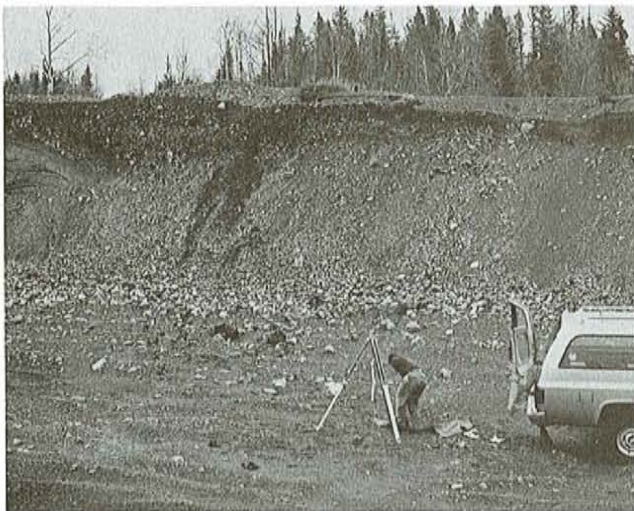
Plate 1. Inactive quarry in the Aspen Brook-Leech Brook deposit.

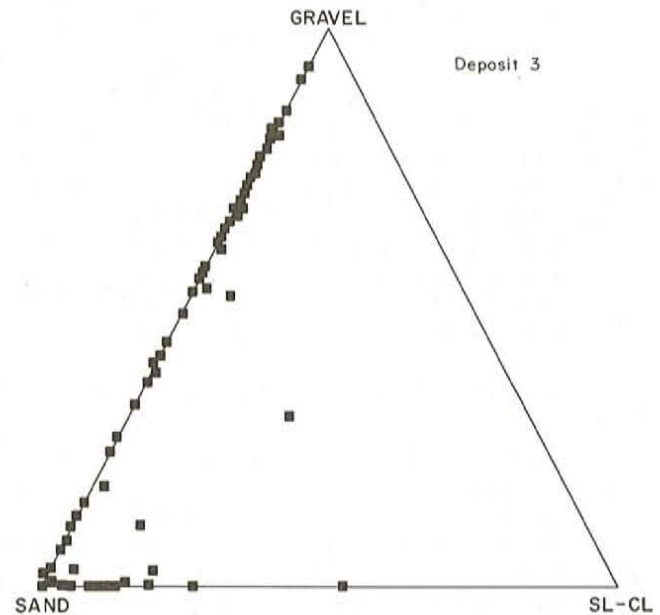
Figure 5. Ternary diagram showing granular distribution of samples collected in the southwest Exploits River deposit.

The southwest Exploits River deposit is a partly dissected glaciofluvial terrace located at the west end of map area NTS 2D/13 on the south bank of the Exploits River (Figure 2). It is one of the largest deposits in the study area, beginning 3 km west of Tom Joe Brook and extending for 14 km eastward along the Exploits River to Sandy Brook. It has an average width of approximately 0.7 km, and thicknesses of between 3 and 10 m. Grain-size data of 94 samples indicate this deposit is variably sorted and contains equal amounts of sand and gravel, and generally has less than 1 percent silt-clay (Table 2). Eleven other samples had silt-clay contents between 10 and 52 percent (Figure 5). Some of these samples having high silt-clay concentrations were taken from thin units within gravel beds or from sites away from the larger gravel sources within the deposit. Due to the extensive area covered by this deposit, silt-clay concentrations should not be a major concern if quarrying occurs. Petrographic numbers are generally high throughout the deposit. Poor petrographic quality is due to 25 percent, slightly weathered pebbles consisting of siltstone, sandstone and some volcanic rocks.

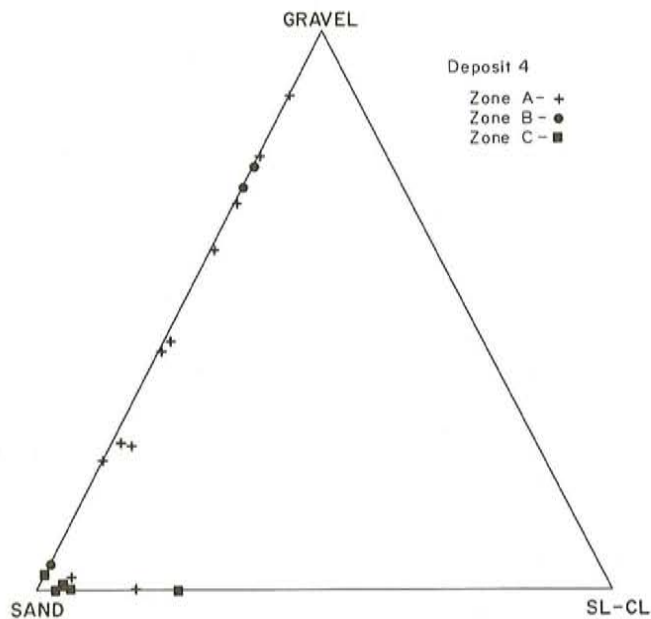
Figure 6. Ternary diagram showing granular distribution of samples collected in the Red Cliff deposit.

Zone A consists of an esker complex located north of the Trans Canada Highway on the west side of Wigwam Brook, and is the largest of the three zones. Grain-size analyses of samples indicate that this area is composed of a sandy-gravel, which has a low silt-clay content. Stratified units in quarry exposures show poorly sorted gravel and moderately to well-sorted sand. Petrographic analyses of sampled material range from very good to poor. High petrographic numbers are the result of weathered sandstone and siltstone. This zone has been extensively quarried in the past, but has a considerable amount of material remaining for future quarry activity. However, consideration should be given to poor petrographic quality, when considering this material for concrete and road-paving projects.

Zone B is located along the north side of the Exploits River, south of zone A. It is a thin outwash deposit (generally < 3 m thick) consisting of poorly sorted sandy gravel generally greater than 0.125 mm in diameter (97.5 percent). A petrographic number of 148 was determined from the petrographic analyses of one sample. Petrographic quality of this zone is reduced by the presence of moderately weathered to weathered siltstone. Past quarry activity in this area has nearly depleted the resource. It has a low potential for future quarry development.

Zone C is a moderately to well-sorted sand deposit located between zones A and B, extending east between Rushy Pond and the Exploits River. This zone is estimated to be between 3 and 5 m thick but may locally reach thicknesses of 8 m. It contains in excess of 90 percent sand (grain-size diameter is generally less than 0.5 mm) with the silt-clay content ranging from 0.5 to 24.4 percent in 5 samples analyzed. Due to the fine texture of this deposit there were no pebbles to conduct petrographic analyses. Based on volume alone, the potential for a sand quarry in this area is high, however, the high silt-clay content and fine sand texture may reduce its usefulness for most construction purposes.

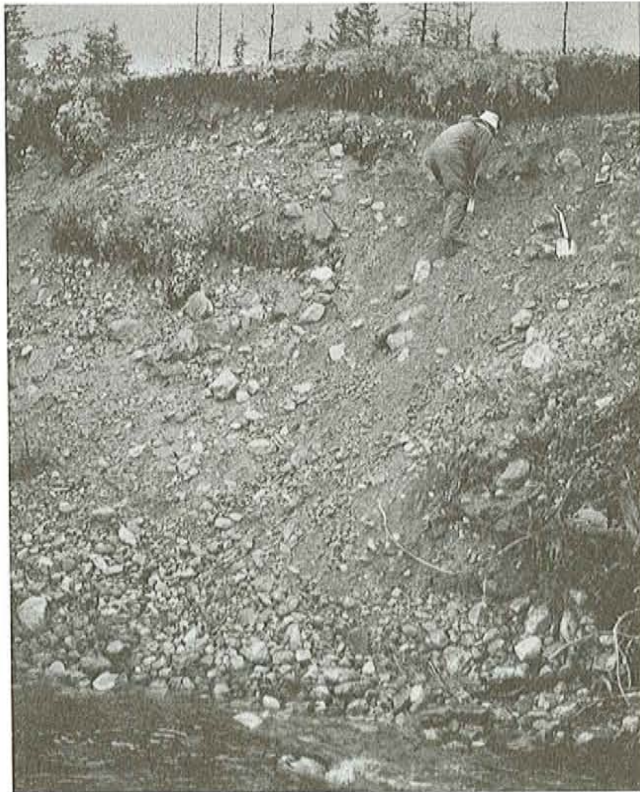
Plate 3. A 6-m-high river-bank exposure in the Stony Brook south deposit.

The Stony Brook south deposit, located along Stony Brook in map area NTS 2D/13 (Figure 2), consists of a large glaciofluvial terrace over 8 km long having an average width of 1 km. River-bank exposures (Plate 3) observed during field investigations indicate that thicknesses of 6 m to 12 m is common. It is a poorly sorted gravel and sand deposit having low silt-clay content (Table 2; Figure 9). Petrographic quality is poor and variable, resulting from weathered sandstone, siltstone and a few weathered, granite pebbles.

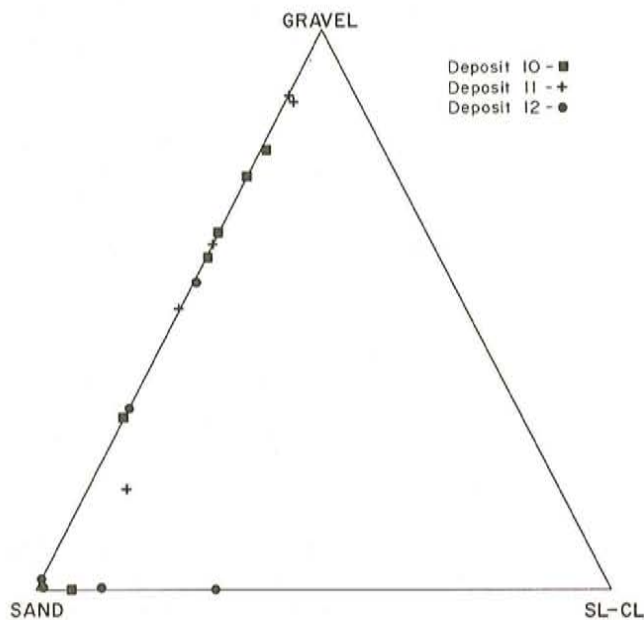
Figure 9. Ternary diagram of granular distribution of samples collected in deposits along Stony Brook south and north and West Stony Brook; deposits 10, 11 and 12, respectively.

The Stony Brook north deposit is located on the northwest bank of Stony Brook in the south-central part of map area NTS 2D/13 (Figure 2) and consists of an esker ridge complex (Plate 4). Glaciofluvial outwash sediment is found in adjoining areas and in thin layers between the esker ridges. The esker complex is 1.4 km long and 0.6 km wide and is generally less than 5 m thick. Grain-size analyses of samples collected from this (poorly sorted) deposit show it is composed of a sandy gravel with low silt-clay content (Table 2). Four of five samples have < 1 percent silt-clay and the other sample has 7.5 percent silt-clay (Figure 9). Petrographic analyses indicate poor-quality material, resulting from weathered siltstone and sandstone. Some weathered basalt and tuff clasts are also present.

The West Stony Brook deposit is situated along the south side of West Stony Brook in the central part of map area NTS 2D/13 (Figure 2). This is a glaciofluvial terrace deposit, approximately 1.7 km long, having an average width of 0.7 km. Grain-size analyses of four samples collected from quarry exposures (Plate 5) and road cuts indicate this deposit is a moderately to poorly sorted sand with low amounts of gravel and silt-clay (Table 2). Two other samples with silt-clay contents of 11.8 and 31.2 percent (Figure 9) were not included in average analyses. These sites appeared to be localized and should not affect quarry operations in other parts of the deposit. Petrographic analysis was conducted on only one sample due to the fine texture in most of the deposit. It produced a petrographic number of 260, the poor petrographic quality being principally the result of weathered volcanic rocks.

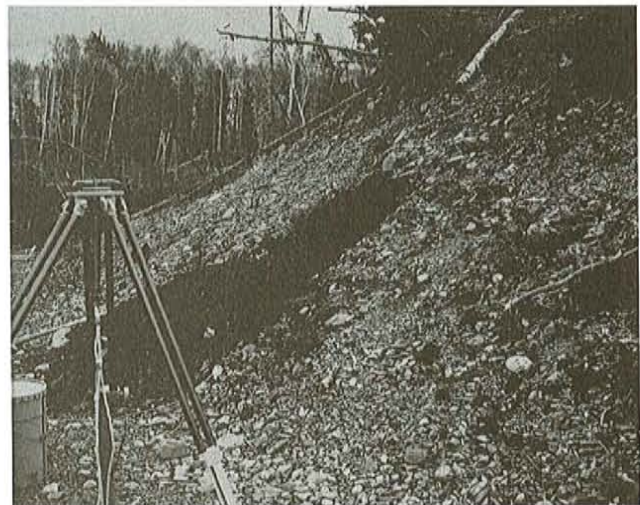
Plate 4. Road-cut through esker ridge in the Stony Brook north deposit.

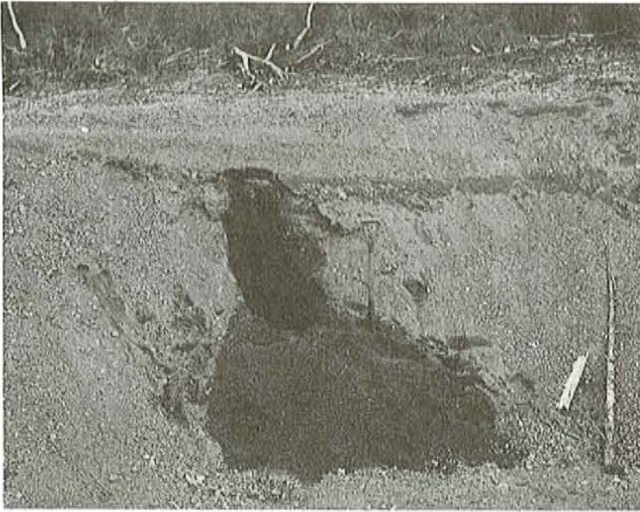
Plate 5. Abandoned quarry in the West Stony Brook deposit.

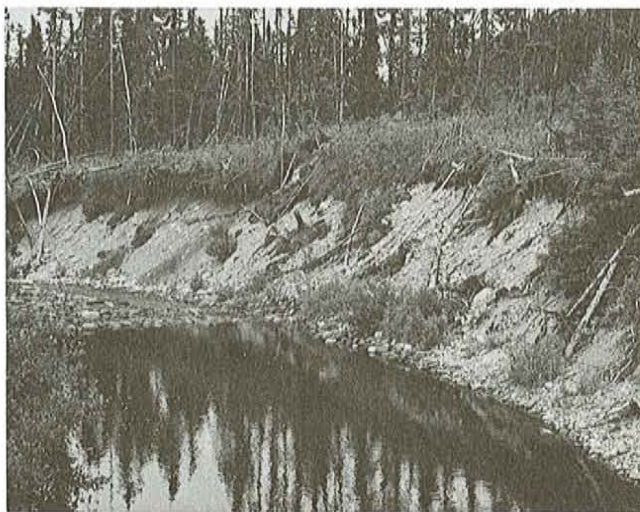
Plate 6. A 3-m-high river-bank exposure in the Three Brooks deposit.

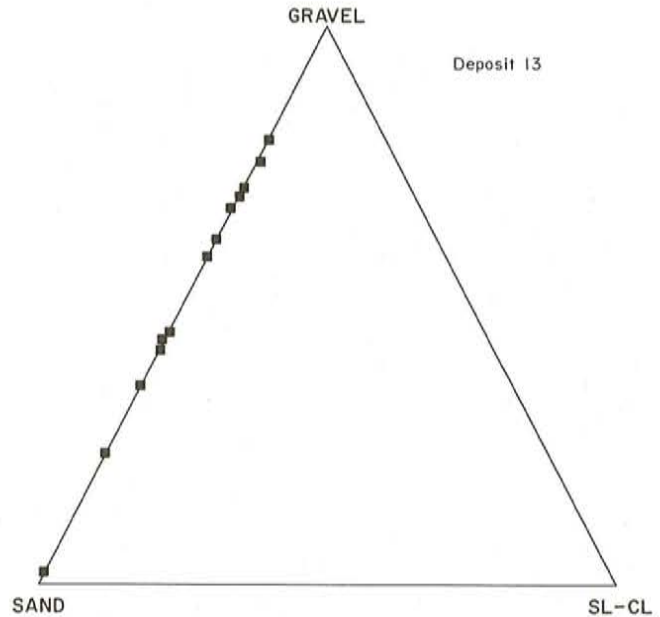
Figure 10. Ternary diagram of granular distribution of samples collected in the Three Brooks deposit.

The Three Brooks deposit is situated on the east side of map area NTS 2D/13. It consists of four small glaciofluvial terraces, accessible along a 4 km section of forest access road. The largest terrace is approximately 1 km long, 10 m wide and 4 to 6 m thick. The other three terraces are approximately 400 m long, 300 m wide and 2 to 4 m thick. Samples collected from backhoe-dug pits, stream cuts (Plate 6) and road cuts indicate that all four areas consist of poorly sorted sandy gravel and low silt-clay concentrations (Table 2; Figure 10). Petrographic quality is poor resulting from weathered sandstone, siltstone and shale. Weathered volcanic rocks, granite, gabbro and conglomerate also contribute to the poor quality.

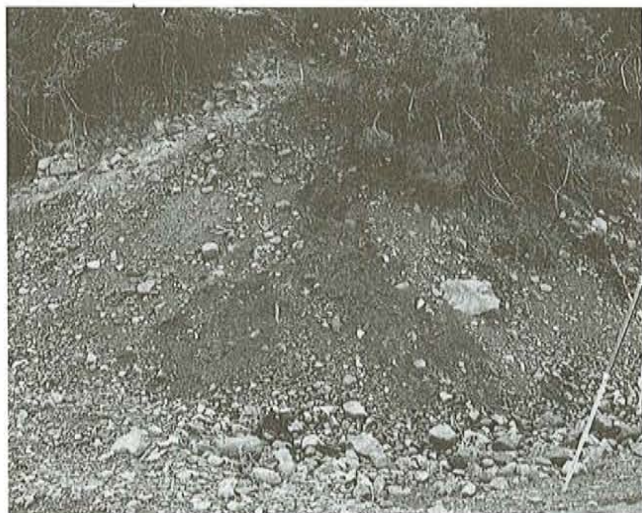
Plate 7. A 3 m road-cut in zone B along the Northwest Gander River.

Zone B is located on the west side of the Northwest Gander River, south of Red Rock Brook. It is approximately 1 km long and 1 km wide. Road-cut exposures (Plate 7) indicate it is approximately 3 m thick but may locally reach a thickness of 7 m. Zone B is a poorly to moderately sorted gravel with low sand and silt-clay contents (Figure 11). Petrographic numbers of 128 and 158 were calculated from
