GRANULAR AGGREGATE-RESOURCE MAPPING OF THE WEST AND NORTHERN TIP OF THE GREAT NORTHERN PENINSULA, NEWFOUNDLAND

M.J. Ricketts and F. House
Geochemistry, Geophysics and Terrain Sciences Section

ABSTRACT

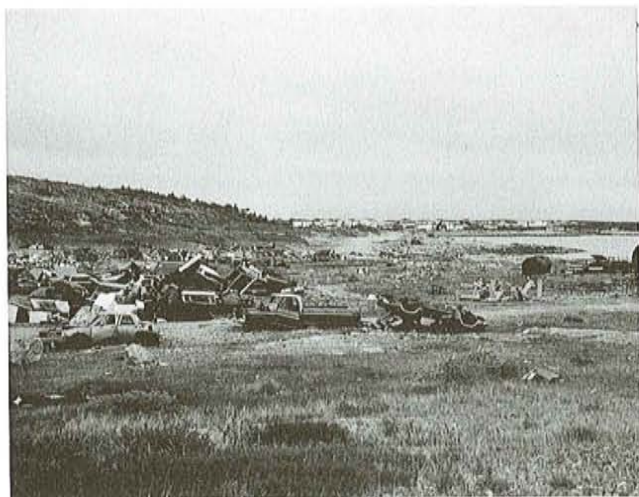
Plate 1. *Abandoned quarry in Brig Bay used as dumping ground for car wrecks and other discarded items.*

In many areas, there is concern about roadside quarries being used as dumping grounds for household garbage, car

wrecks (Plate 1) and other discarded items, as well as waste material associated with quarrying operations and the impact it may have on tourism along the Great Northern Peninsula. By finding alternative aggregate sources, away from road sides, and regulating quarry activity it may be possible to minimize these problems in the future.

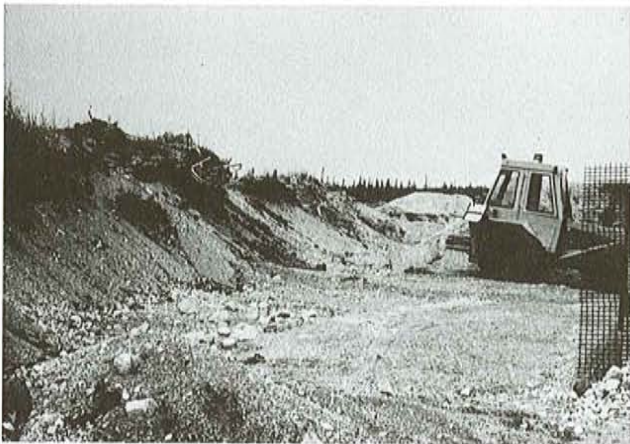
Plate 2. Pebble-gravel quarry near Shallow Bay.

The Shallow Bay deposit is a thin marine gravel located 3 km southwest of Shallow Bay at the intersection of Routes 73 and 93 in the NTS map area 2M/12 (Figure 1). The deposit was originally sampled by Kirby *et al.* (1983) and detailed sampling from backhoe-dug pits took place in 1990 (Kirby, 1991).

The deposit is 1700 m long and up to 400 m wide, but is mostly thin (<1 m) making it unsuitable for quarrying. A large part of the thicker sand and gravel units (2 to 3 m) have been quarried in the past (Plate 2). Analyses of 5 samples (Table 2; Figure 3) taken from quarry exposures and backhoe pits indicate this to be a moderately sorted pebble gravel having the greatest amount (70 percent) of material in the 2 to 32 mm range. In some areas of the deposit, pebble content is near 40 percent. Good petrographic quality was determined from sampled material consisting of 100 percent fresh hard limestone, which resulted in low petrographic numbers.

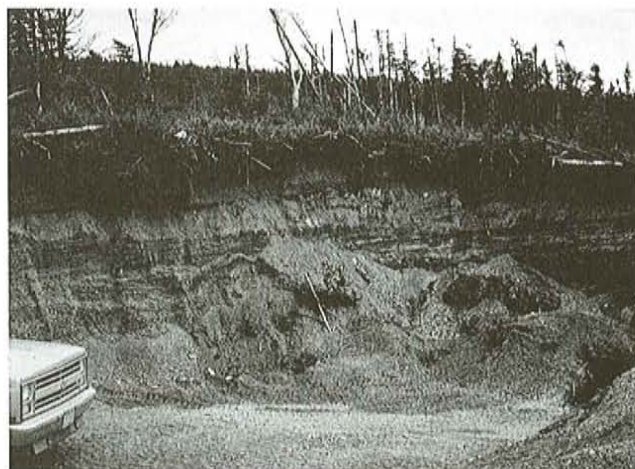
Plate 5. Four-metre-thick sandy, pebble gravel quarry exposure in marine delta.

The Portland Hill deposit is a marine delta situated near the south end of Portland Creek on the east side of Route 73 in the NTS map area 12I/4 (Figure 2). The deposit is approximately 400 m long, 200 m wide and over 8 m thick. Analyses of six samples (Table 2; Figure 4) collected from backhoe pits and a quarry exposure (Plate 5) indicate this is a moderately sorted pebble gravel with 93 percent of material ranging between the 0.25 and the 63 mm diameter.

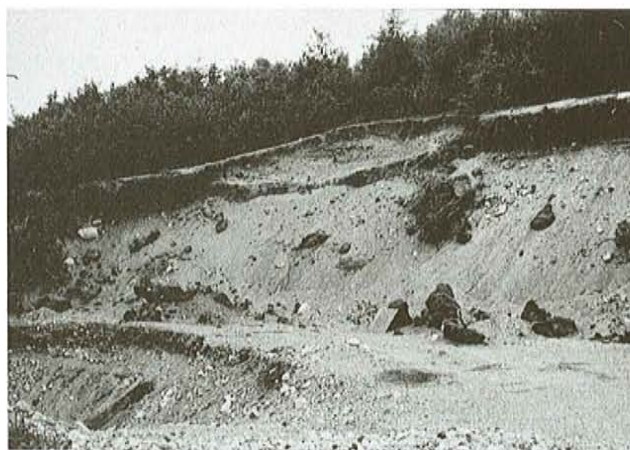
Plate 6. Nine-metre-thick sand and pebble sand in deposit 1 near Portland Creek Pond.

The Portland Creek Pond #1 deposit is situated near the west end of Portland Creek Pond in NTS map area 12I/4 (Table 2). The deposit is approximately 1400 m long and 700 m wide. Thickness generally ranges from 4 to 8 m. It has a medium to fine sandy texture and contains minor pebble-cobble gravel at the one exposure observed (Plate 6). Approximately 96 percent of grain sizes occurs between the 0.25 to 63 mm diameter. Petrographic analysis could not be conducted due to the fine texture of material.

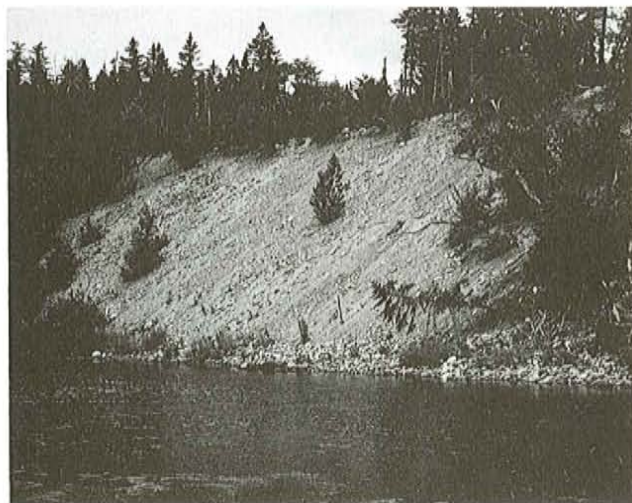
Plate 7. Gravel-sand exposure along 9-m-high river bank through a glaciofluvial terrace in deposit 1 near Eastern Blue Pond #1.

Deposit 1 near the Eastern Blue Pond deposit is a glaciofluvial terrace situated near the southeast corner of Eastern Blue Pond in NTS map area 12I/5 and 6 (Figure 2). The deposit is approximately 1000 m long, 200 m wide and has variable thickness up to 9 m. Site investigations along two stream exposures (Plate 7) identified two units. The top

unit is a 4-m-thick, moderately sorted gravel, varying in grain size from sand to cobbles, and the lower unit is a 5-m-thick, fine to medium sand. Petrographic analyses of two samples (Table 2) taken from the gravel unit indicate a good aggregate source containing 88 percent fresh, hard alkali-feldspar granites.

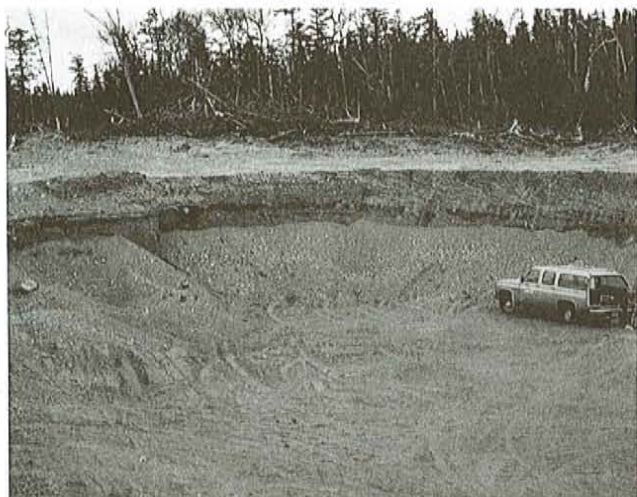
Plate 8. Four-metre-thick sandy, pebble gravel exposure in marine delta in Deposit #1 along Bowaters Road.

12I/5 and 6. It is approximately 400 m long, 200 m wide and up to 8 m thick. The deposit consists of pebble gravel with moderate amounts of sand and cobble. Ninety percent of material is in the 0.25 mm to 63 mm size range, and is based on analyses of three samples collected from quarry exposures (Plate 8) and backhoe pits.

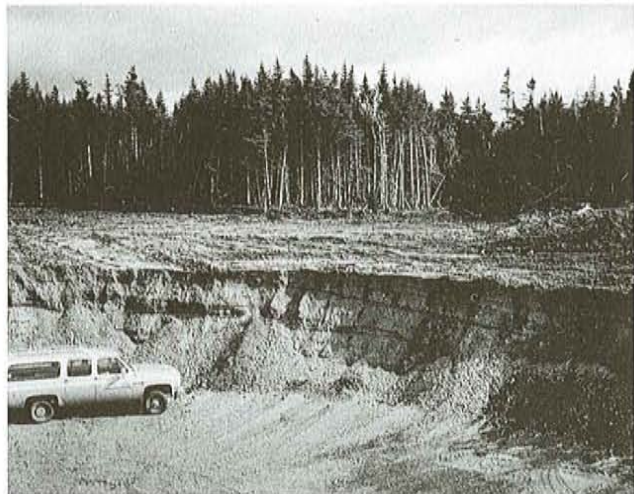
Plate 9. *Pebble gravel along 4-m-high quarry exposure in marine delta in deposit 1 along Zinc Mine Road.*

quarried and about 50 percent of remaining material is likely composed of boulder gravel. Well-sorted sand was sampled in the north part of this deposit and good-quality pebble gravel was sampled near the intersection of Zinc Mine Road and Route 73, where quarrying is presently occurring (Plate 9).

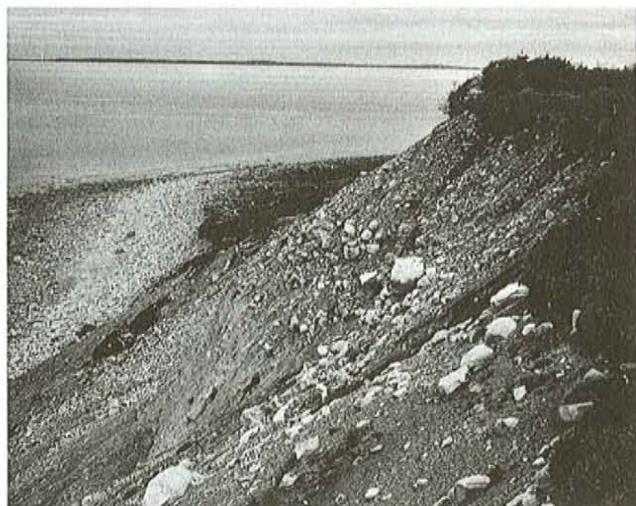
Plate 10. Boulder gravel similar to that in the Spirity Cove deposit.
