THE ASSESSMENT OF GEOLOGICAL HAZARDS AND DISASTERS IN NEWFOUNDLAND

M. Batterson, D. Liverman and D. Taylor
Geochemistry, Geophysics and Terrain Sciences Section

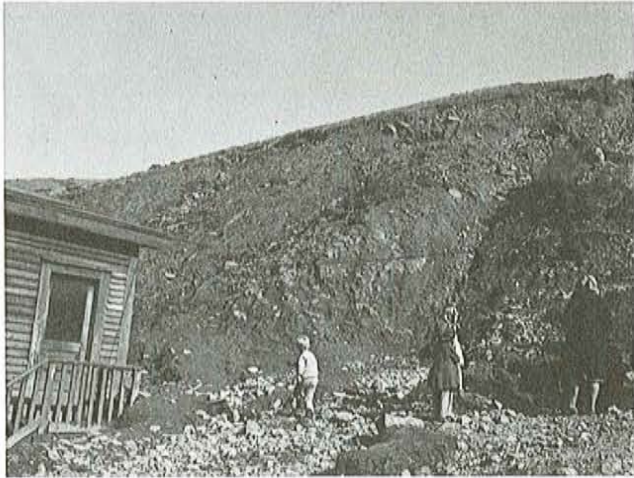
Plate 1. A gully behind the Windsor house on Southside Road. Material washed down this gully caused considerable damage to the house. Photograph courtesy of the City of St. John's archives.

On September 15, 1948, following a rainstorm that dumped 11.5 cm (4.5") of rain in 18 hours on the St. John's area, a debris torrent damaged a number of houses on Southside Road (Plate 1), and caused a young fatality. The site of this tragedy was one of four landslide events reported over a 20 year period at this location. An earlier landslide, on February 23, 1936, killed a young child, and other

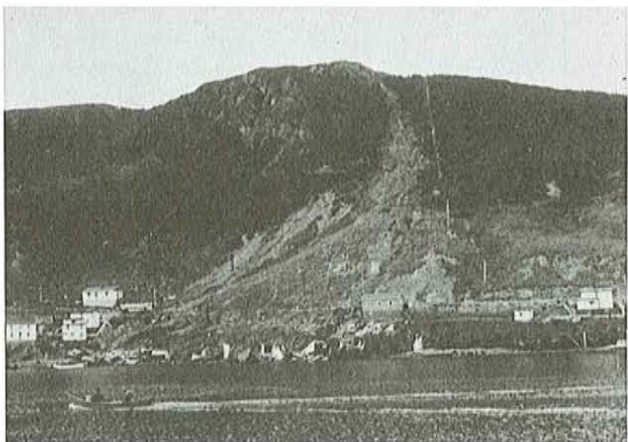
Plate 2. Landslide scar in Harbour Breton, August 1973. Wreckage from the remains of four houses caught in the landslide's path is seen at the water line.

On August 1, 1973, following several weeks of heavy rainfall, a debris torrent occurred at about 3 a.m. in a gully

above the community of Harbour Breton (Plate 2). Four houses were swept into the harbour and destroyed, resulting in four young fatalities. Slope movements continued for days following the disastrous slide. The families who lost their houses during the landslide, and 11 other families whose homes were thought to be at risk from further landslides, were resettled. On at least three subsequent occasions, in November 1982, February 1984 and June 1986, government geologists visited Harbour Breton to examine slope movements. The area in which the tragedy occurred had been the site of a previous landslide, in about 1953. In 1953, however, there were no houses located in the area, and consequently there was no incidence report filed on which to base future planning decisions.

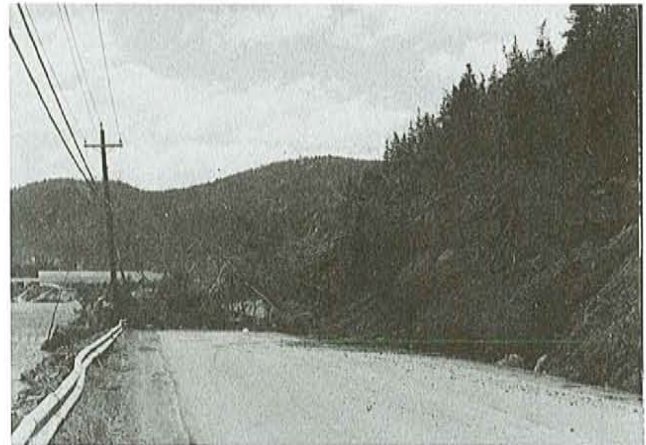
Plate 3. Landslide at Riverside Drive, Corner Brook, April 1994. Debris from the landslide was observed on the telephone wires. The road was not re-opened until mid-summer 1994.

Riverside Drive in Corner Brook (Plate 3). The slides originated on a north-facing slope having a stratigraphy consisting of bedrock overlain by a compact glacial diamicton, and fluvial sand and gravel. The failure occurred along the interface between the fluvial sediments and the till in the upper part of the slope, whereas the lower slope was frozen. The cause of the slides was attributed to inadequate drainage from the newly constructed Trans-Canada Highway in the area (Newfoundland Geosciences, 1994). During construction, a major drainage ditch was truncated by the new highway. Following a period of intense snowmelt, water normally carried by this ditch was redirected through the subsurface to the adjacent slopes above Riverside Drive, triggering the landslides. No injuries resulted from the slides, but Riverside Drive was closed until mid-summer. Remedial measures included the construction of sealed ditches to direct water from slopes susceptible to failure. The Department of Works, Services and Transportation assumed responsibility for the slide and absorbed the \$63 000 estimated cost of remedial measures.

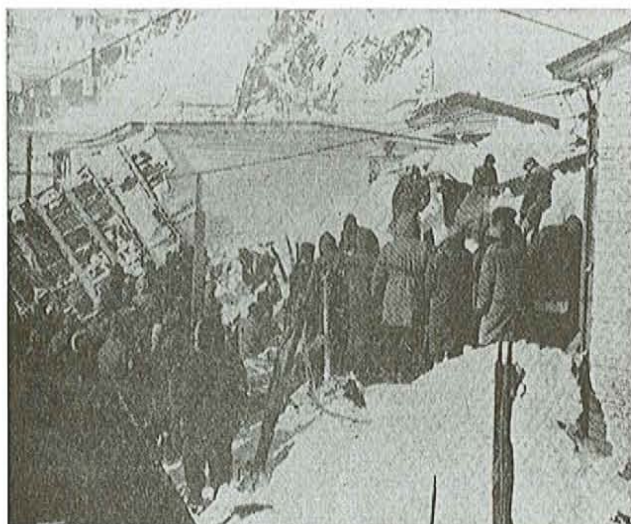
Plate 5. View of rescue efforts following The Battery avalanche, February 1959. This was the second major avalanche to have effected The Battery in 40 years. Photograph from the *Daily News*, February 17, 1959.

Two avalanches occurred in the Outer Battery, on Monday, February 16, 1959, during a snow storm that dumped 55 cm of snow on the city, accompanied by winds recorded at up to 220 km/hr. A first avalanche buried a family in their home, but all survived. The main avalanche was at 1:05 a.m. It destroyed two homes and damaged many others (Plate 5), and resulted in the death of five people and injury to at least nine others. This was one of the worst natural disasters in Newfoundland. It was the second avalanche incident at The Battery in 40 years, the first being February 7, 1921 when several people were injured and possibly one killed.

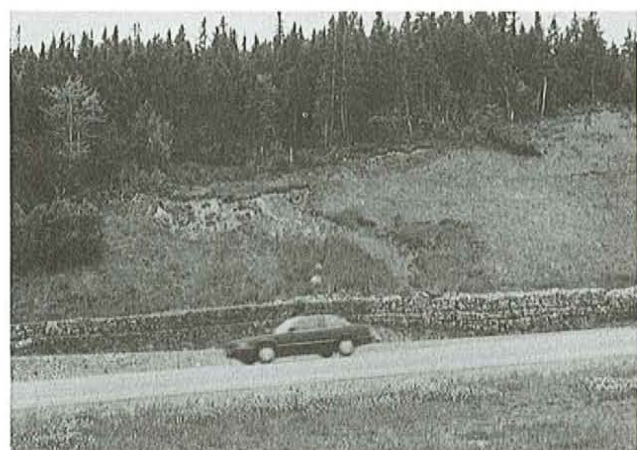
Plate 7. Slope failure occurring behind a newly constructed retaining wall at Gambo.

have problems with gullying and minor debris flows on road cuttings. New highway expansion and construction near Gambo incurred major difficulties where the highway abutted a steep slope of unconsolidated sediments (Plate 7). Considerable remedial engineering work has been undertaken to protect the road in this area at estimated costs of \$650 000 or more (S. Skoda, Department of Works, Services and Transportation, personal communication, November 1994).

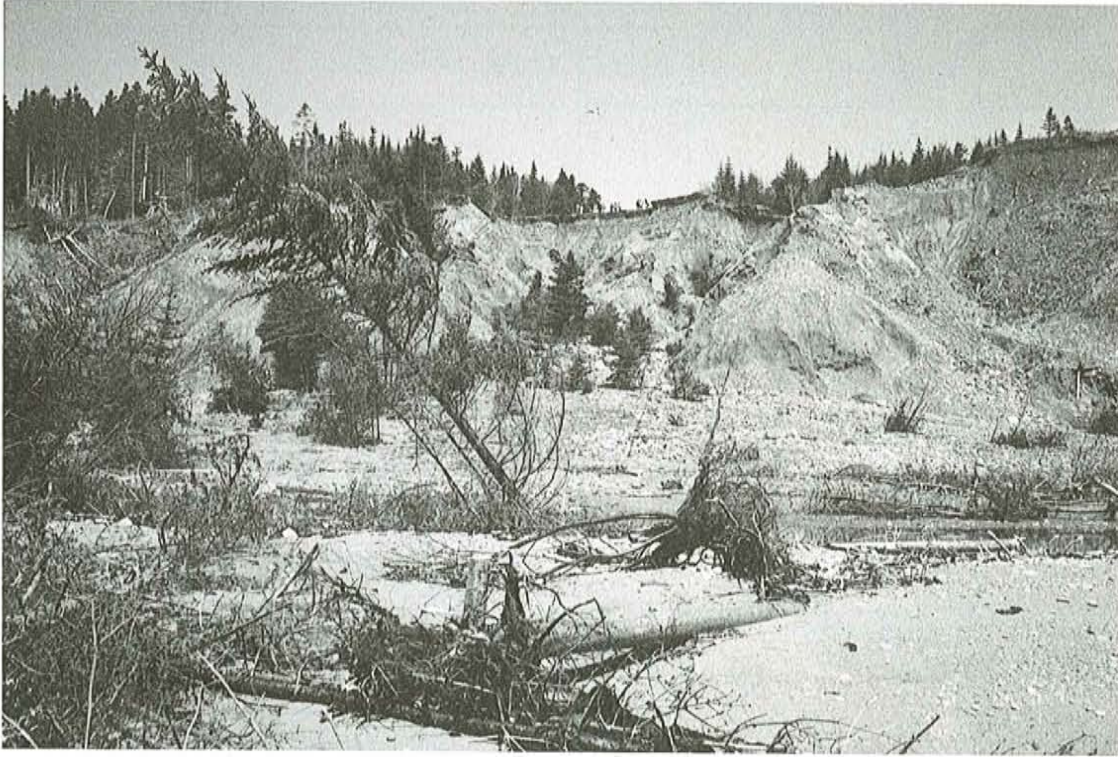
Plate 8. *Landslide in coastal cliffs at Port au Port East. Note the alluvial fan that developed on the beach as debris was washed from the gully.*
