GRANULAR AGGREGATE-RESOURCE MAPPING IN THE RODDICKTON-MAIN BROOK AREA, GREAT NORTHERN PENINSULA, NEWFOUNDLAND

M.J. Ricketts and S.V. Vatcher Geochemistry, Geophysics and Terrain Sciences Section

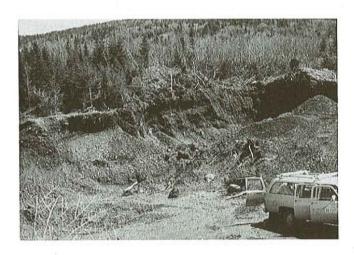
Plate 1. Gravel quarry in marine terrace deposit near the communities of Conche and Southwest Crouse (NTS 2L/13).

A marine terrace (Plate 1), located in the vicinity of an abandoned airfield between the communities of Conche and Southwest Crouse, is being used as an aggregate source for these two communities. It is approximately 500 m long, 70 m wide and 4 to 8 m thick. Grain-size analyses of three samples taken from quarry exposures show an average 82.2 percent gravel, 17.4 percent sand and 0.4 percent silt-clay. The quarry is 200 m long and 50 to 70 m wide indicating that more than half of this deposit remains for future aggregate use.

The pebble fraction generally consists of low sphericity, subangular pebbles having 4 to 6 fracture faces. Pebble types include siltstone, medium and coarse sandstone, dolomite and highly weathered undefined pebbles. Petrographic quality is poor with petrographic numbers ranging from 300 to 479 (Table 2). These high petrographic numbers are mainly the result of intensely to highly weathered undefined pebbles (25 percent) and weathered to highly weathered siltstone and sandstone (50 percent).

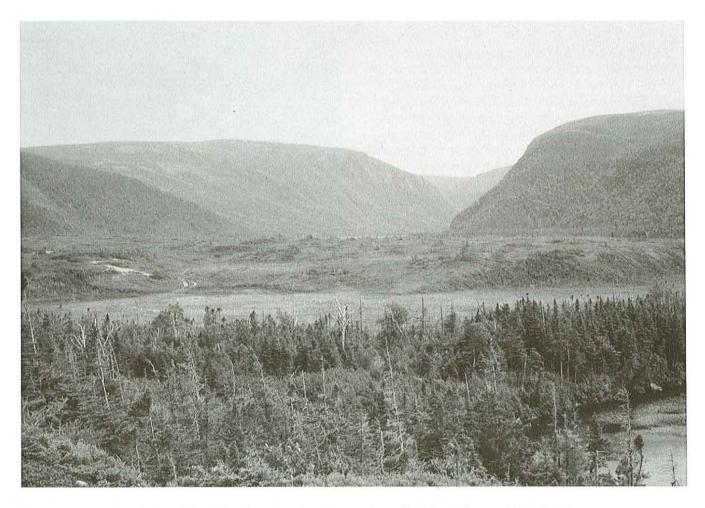
Plate 7. Glaciofluvial terrace deposit near the end of Five Mile Road (NTS 121/4).

The NTS map area 12I/4 contains granular aggregate sources consisting of marine, glaciofluvial and aeolian deposits (Grant, 1986; Kirby *et al.*, 1983; Proudfoot and St. Croix, 1991). In 1992, a sampling program was conducted in most of these areas. Update work in 1995 focused on the Five Mile Road deposit (Ricketts and House, 1993) southeast of Portland Creek (Figure 3, Plate 7). This deposit is 5.5 km east of Route 73 and is accessible by a poorly maintained gravel road. The deposit covers a 2- to 3-km² area and is up to 18 m thick. It is possibly the largest deposit of sand and gravel on the Great Northern Peninsula, north of Gros Morne National Park.
