MAPPING AND ASSESSING RISK OF GEOLOGICAL HAZARD ON THE NORTHEAST AVALON PENINSULA AND HUMBER VALLEY, NEWFOUNDLAND

M. Batterson, S. McCuaig and D. Taylor
Geochemistry, Geophysics and Terrain Sciences Section

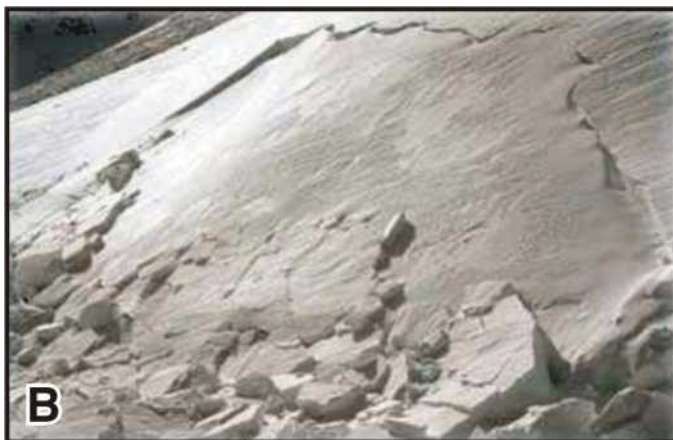
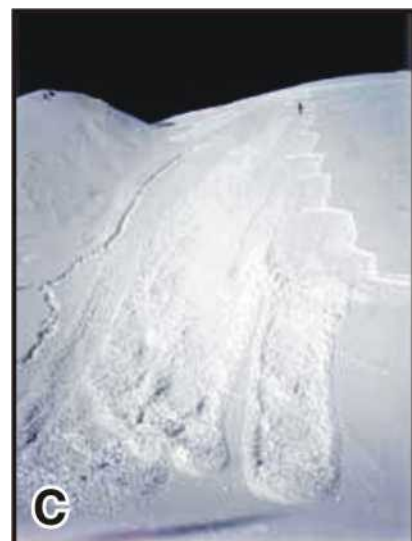
Figure 3. Avalanches. A) components of an avalanche zone; B) slab avalanche; C) loose snow avalanche. (Source: New Zealand Avalanche Centre)

Avalanches are another form of rapid slope movement and consist of a combination of snow and ice (Figure 3), but also may include sediment, rock, and vegetation; they require heavy snowfall, either introduced by precipitation or wind, and a steep slope. The trigger for avalanche is commonly heavy snowfall over a smooth surface, produced from either a rapid fall in temperature in the days preceding the snowfall or from a period of freezing rain or burial of a weak layer in the snow. Alternatively, high winds blowing over a slope may create a cornice which may break off, falling to the slope below and triggering an avalanche (Figure 4).

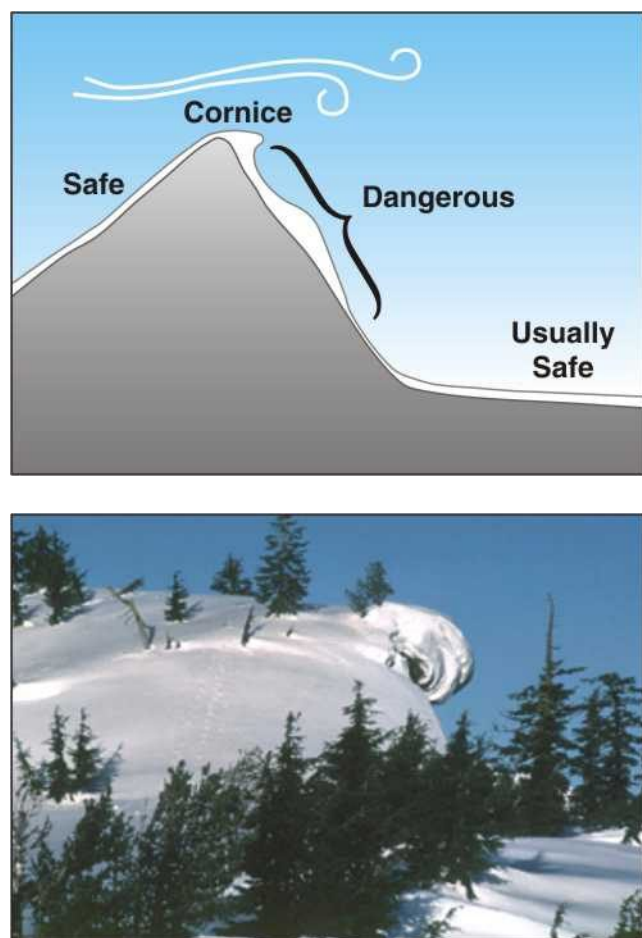
Figure 4. *Development of a cornice.*

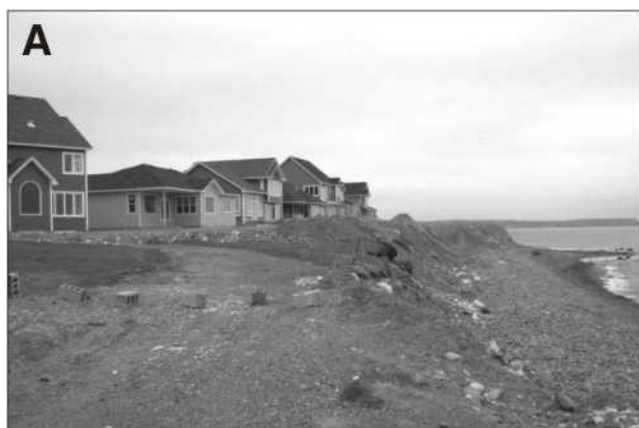
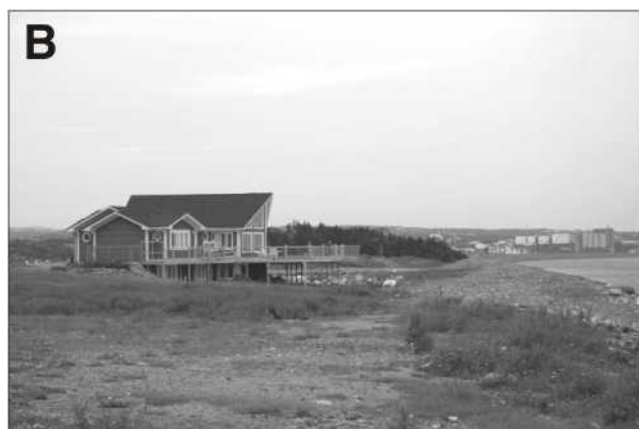
Plate 1. Coastal hazard in Conception Bay South. A) Houses constructed atop eroding coastal cliff. B) Newly constructed house adjacent to modern beach.

Eroding unconsolidated cliffs are common features in the northeast Avalon Peninsula area. The communities of Holyrood, Conception Bay South, Portugal Cove–St. Philips, Torbay, Outer Cove–Middle Cove–Logy Bay and Witless Bay all contain areas of eroding coastline (Plate 1).

Erosion rates are uncertain, although cliffs monitored over a 12-year period in Conception Bay South showed erosion of up to 50 cm per year. Coastal cliffs with a complete vegetation cover appear generally stable and show no evidence of recession. Similarly, the retreat of coastal beaches with the consequent threat of increased coastal flooding requires further monitoring. Barachois beaches provided a measure of protection for residential development inland, and therefore must be preserved.

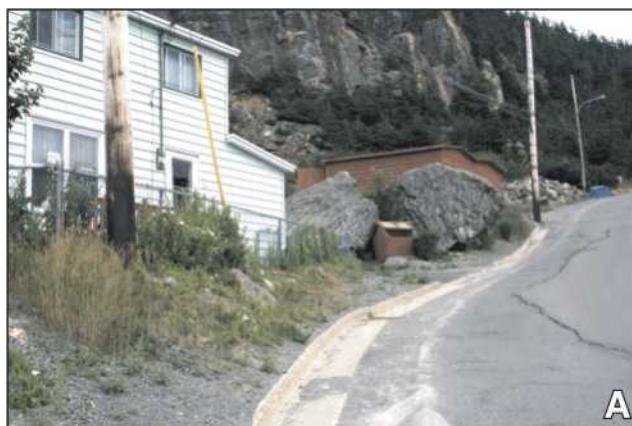
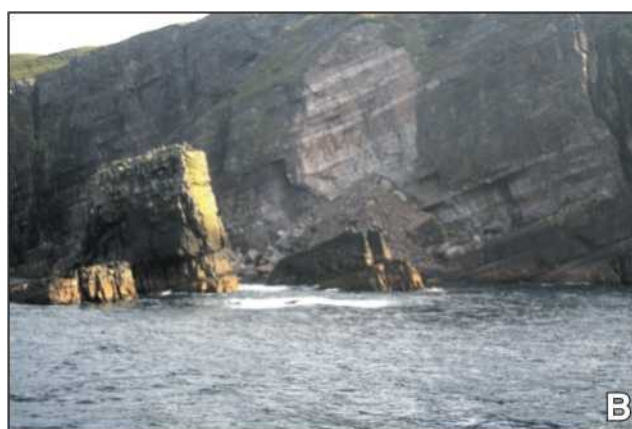
Plate 2. Rockfall in the northeast Avalon area: A. Historic incidence in Bauline incorporated into residential landscaping. B. Recent rockfall along coast near Bay Bulls.

Occurrence of rockfall is common (Plate 2). Steep slopes dominated by sedimentary bedrock that is susceptible to freeze-thaw activity is the likely cause. For single-block rock falls, the concept of a "shadow angle" is well established. The shadow angle is defined by the angle below horizontal formed by the line lying between the apex of the slope subject to rock fall and the extreme position of rock fall debris (boulders) (Evans and Hungr, 1993). Numerous studies have shown this to be between 22° and 30°. Vegetation on a slope may have the effect of reducing risk of rockfall extending to the maximum shadow angle. Construction adjacent to steep slopes should consider rockfall potential.

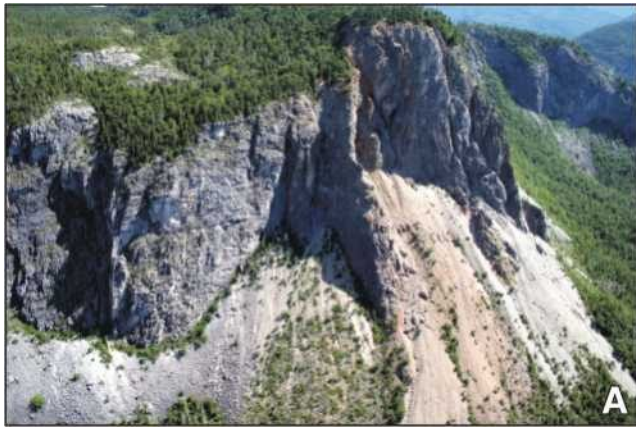
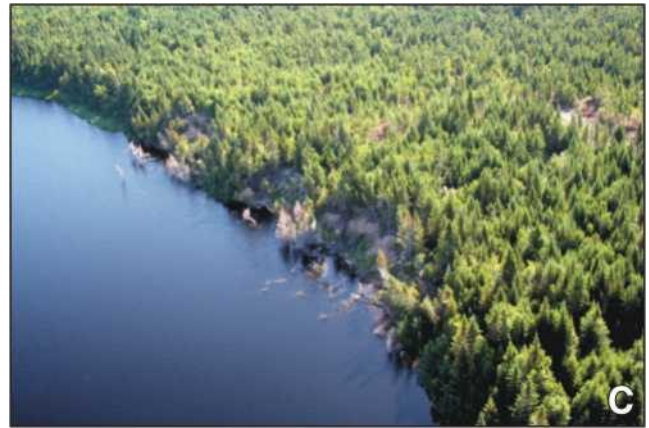
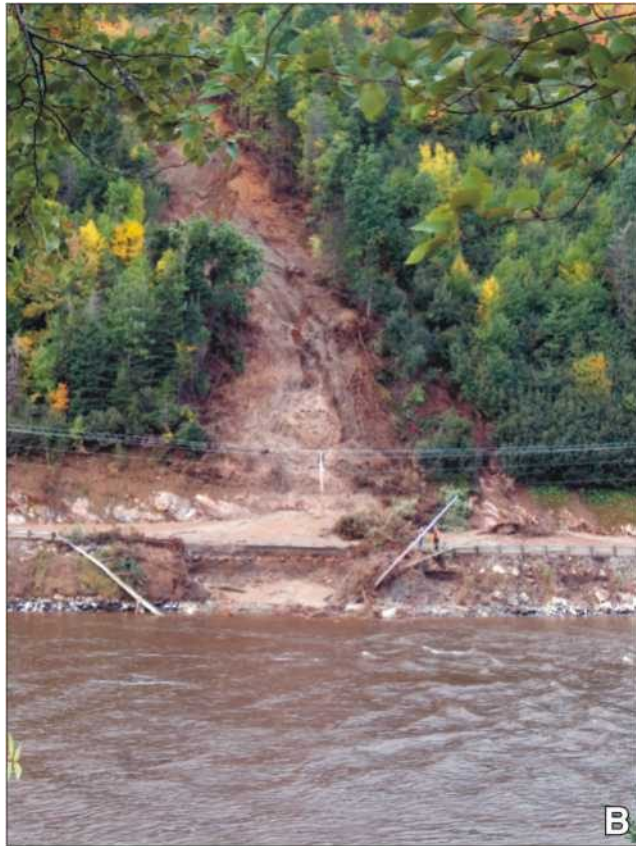
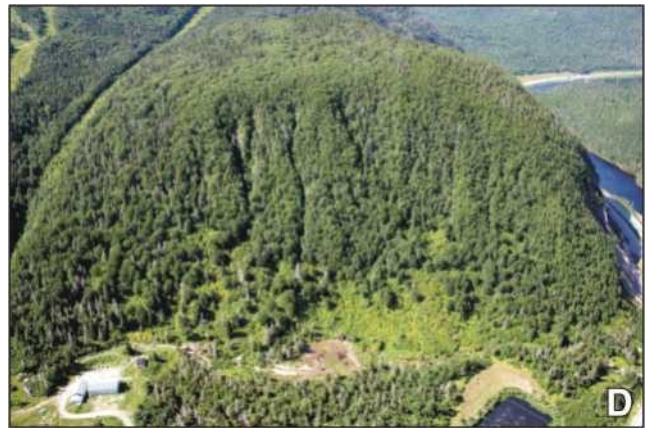
Plate 3. Mass movement in the Humber valley. A. Talus slope below 'Man in the Mountain' in the Humber gorge; B. Debris flow blocking Riverside Drive in 2005; C. Active slumping along the Humber River; D. Landslide scars on hillside adjacent to Marble Mountain ski resort.

The Humber Valley area experiences numerous slope-stability problems, river bank erosion and flooding (Plate 3). Some of the most obvious, and potentially most dangerous hazards, are rockfalls and avalanches. Both occur on steep slopes and are thus common in the same areas. They are most prevalent in the Humber Gorge–Steady Brook area and Corner Brook (Plate 3). Areas within the shadow angle of rockfall slopes and those within potential run-out zones of avalanches are considered to be at risk. Rockfalls, landslides and avalanches tend to re-occur in places where they have happened previously. A landslide (rotational slump) in sandy

sediments occurred in 2005 on Riverside Drive in Corner Brook, at the same site as a landslide in 1994 (Plate 3B).
