COASTAL MONITORING IN NEWFOUNDLAND AND LABRADOR: 2013 UPDATE

M. Irvine

Geochemistry, Geophysics and Terrain Sciences Section

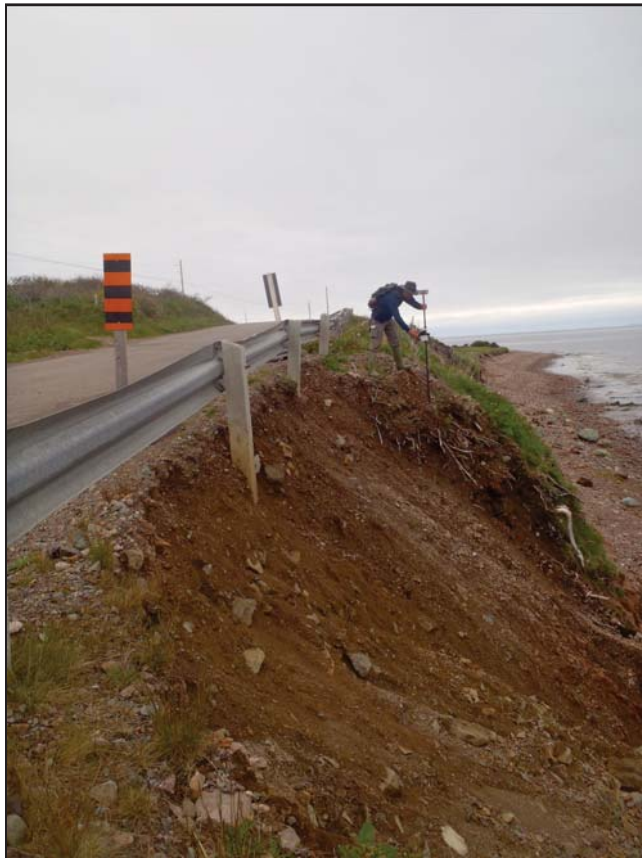
Plate 1. Surface water flow has resulted in coastal erosion along the main road in Grand Beach, Burin, June 2013. Note the scale of erosion adjacent to geologist standing with a survey pole.

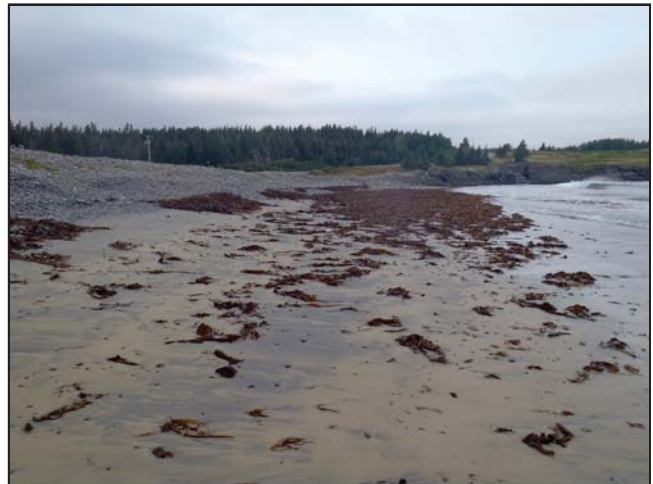
Plate 2. Sandy Cove beach, near Elliston, photographed in September 2011. As seen in the photo, during the summer months, Sandy Cove is a cobble and gravel beach with a sand apron. During the winter large waves from the north-east transport the sand off the beach face where it is deposited in the embayment. The sand remains in the embayment, and during the spring, waves return the sand to the beach face.

Generally, during the winter months, larger, higher energy waves will transport sediment seaward from a beach face, resulting in the beach becoming steeper and a decrease in sediment volume. In the summer months, lower energy waves deposit this sediment back up onto the beach face as long as the sediment is still in the embayment. This cyclical pattern of erosion during the winter months and accretion during the summer months occurs at beaches surveyed in this program including Great Barasway (Site #316) and Ship Cove (Site #169; Liverman *et al.*, 1994) and Sandy Cove (Site #309, Plate 2).

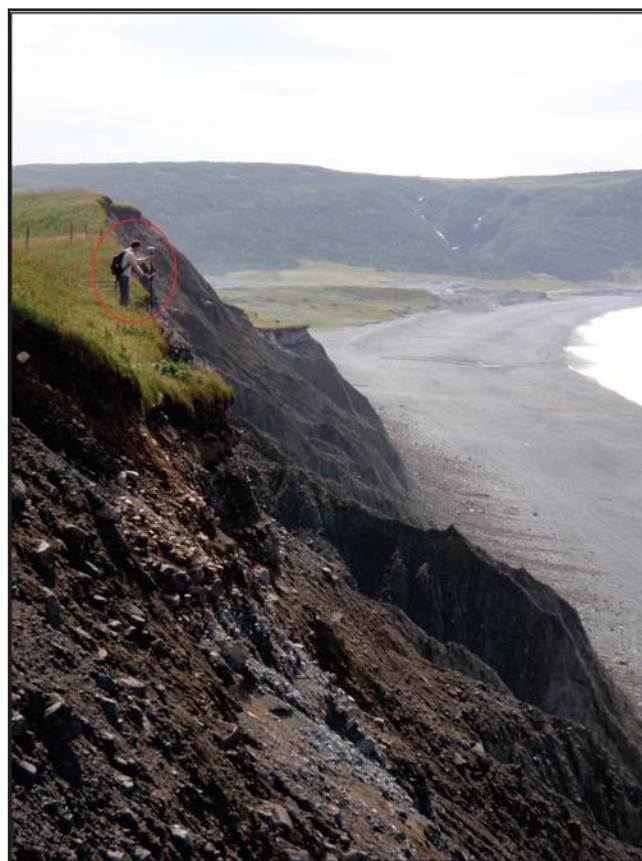
Plate 5. Surveying the cliff edge (surveyor is circled in red for scale) of the unconsolidated bluffs at Holyrood Pond, August 2013. View looking southeast toward the community of St. Stephens. Surface run-off is causing gulying and erosion on the cliff face, and waves are removing sediment from the base of the cliff. Longshore transportation of the sand and gravel is feeding sediment to the Holyrood Pond barrier to the west of the bluffs. Location of photo is marked with a star on Figure 2.

Southeast of the barrier are bluffs of glaciofluvial sediment that are eroding, and feeding the barrier beach system (Forbes, 1984, 1985; Liverman and Taylor, 1994; Plate 5). The bluffs are 25 to 35 m high, are non-vegetated, and composed of gravel and sand beds overlying till. Gullying is visible on the cliff face. Cliffs west of St. Vincent's are also

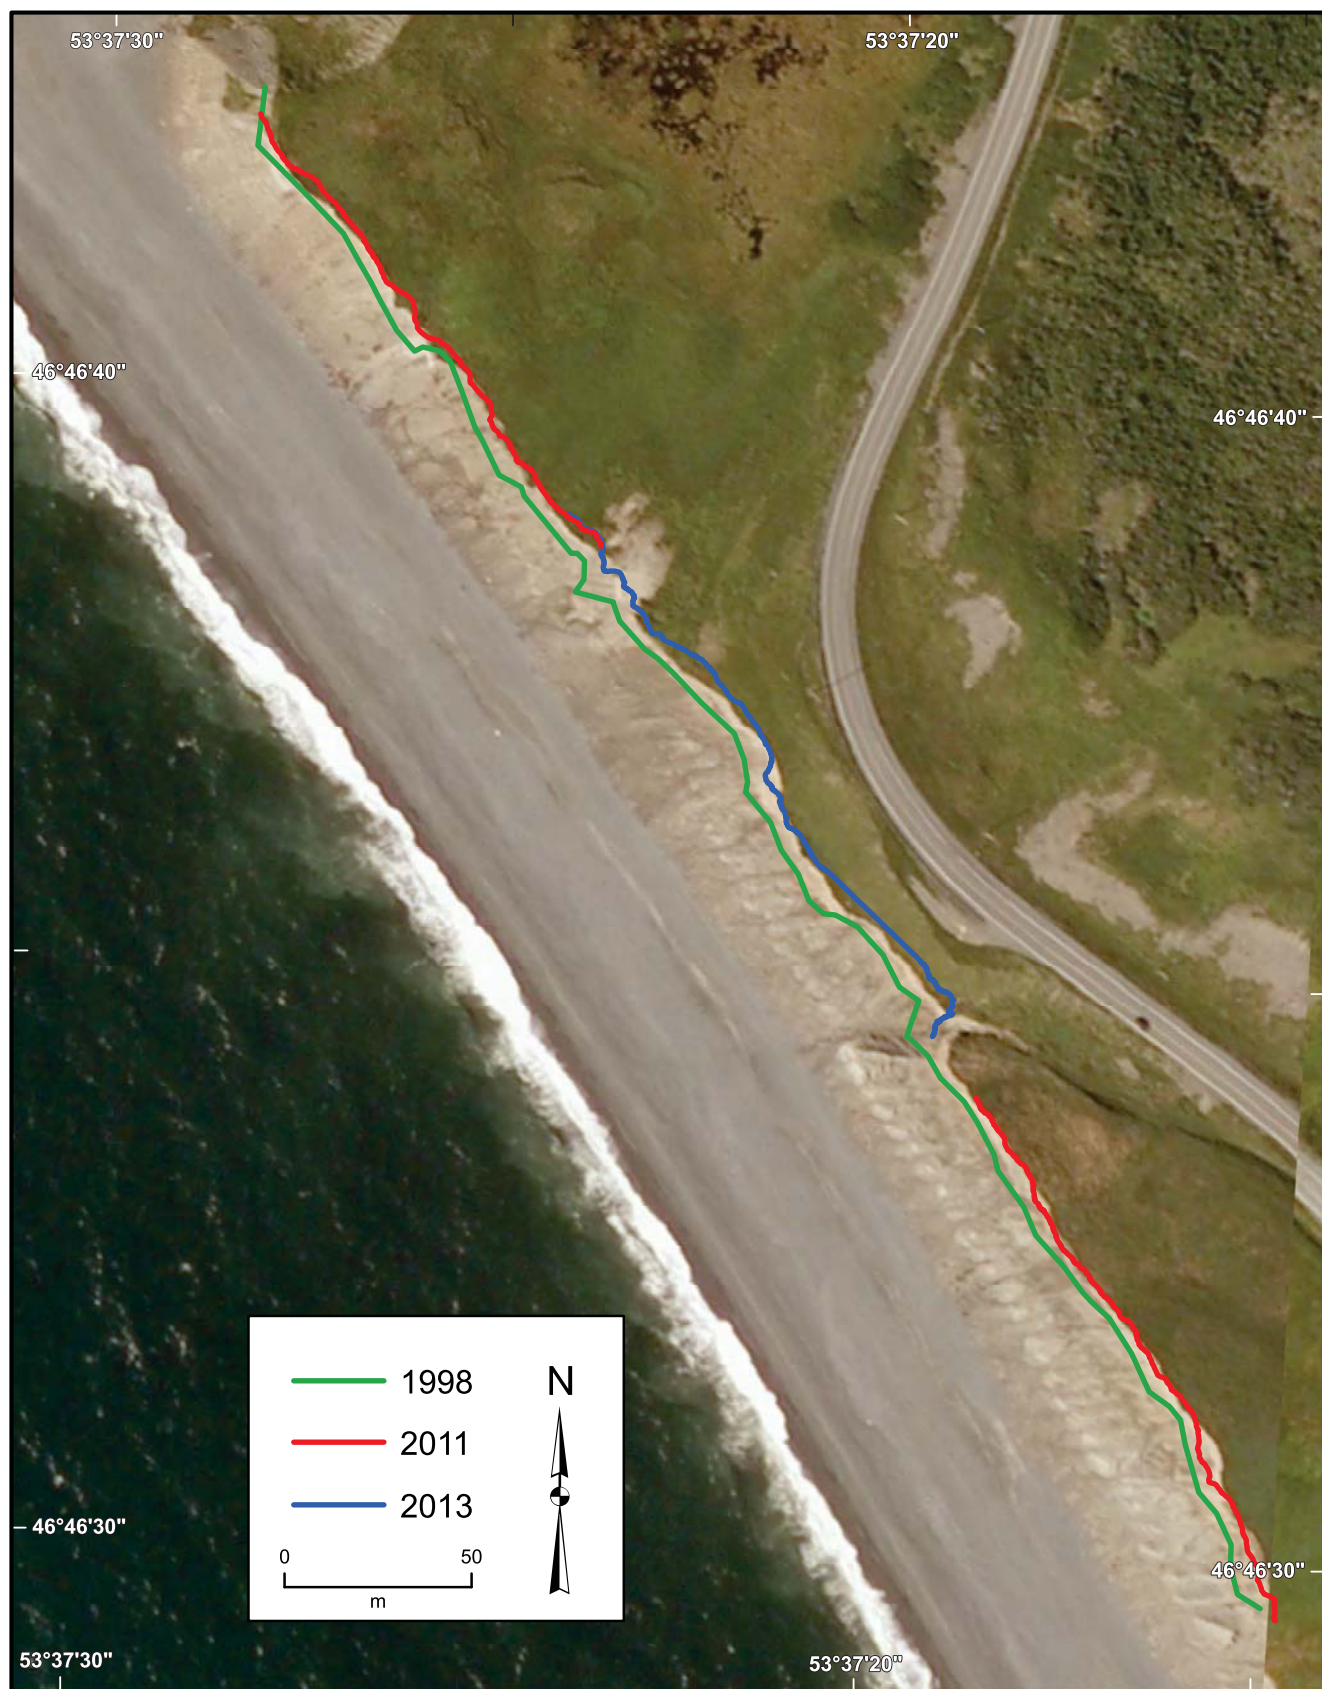
Figure 3. Location of cliff edge at Holyrood Pond in 1998 (green), 2011 (red) and 2013 (blue) superimposed on an airphoto.

as well; the central section was surveyed in 2013 (Figure 2). Based on GSC and GSNL data from 1998, 2011 and 2013, a comparison was made between the clifftop position from 1998 to 2011 (flanking sections) and 1998 to 2013 (central section) (Figures 3, 4). Between 1998 and 2011, the flanking section of the cliff edge at Holyrood Pond eroded, having an average retreat rate of 44 cm/a, ranging from 22 to 74 cm/a (Figures 3, 4). Between 1998 and 2013, the central section of the cliff edge eroded at an average rate of 59 cm/a, ranging from 19 to 100 cm/a.

At Holyrood Pond, surface water is creating gullies in the permeable sand and gravel of the cliff, and waves are eroding sediment from the base of the cliff. The average rate of cliff erosion for the period between 1998 and 2011 (44 cm/a) and 1998 and 2013 (59 cm/a) was higher than the average rate of erosion measured by the GSC between 1982-1984 (30 cm/a), suggesting that rates of cliff erosion are increasing. The similarity in the profile of the transect of Line 1 in 1998, 2002 and 2013 supports Forbes's (1984) conclusion that the sediment eroding from the cliffs south of the beach is being transported to the Holyrood Pond barrier. As long as the cliff continues to erode and contribute sediment, the barrier will be maintained and will continue to provide flood protection to the road.

Route 10, the only road connecting the communities on the southern Avalon, is within 18 m of the current cliff edge, and will be at risk of erosion in approximately 30 years if current erosion rates continue. Projected impacts of climate change for eastern Newfoundland include more intense precipitation, with an increase in extreme precipitation and an increase in the maximum precipitation over 3-, 5- and 10-day periods. The winter months are expected to be warmer, consequently winter precipitation will move away from snow and fall as rain (Finnis, 2013). These changes will likely result in an increase in cliff erosion due to increased surface water flow and relative sea-level rise will result in an increase in the risk of erosion of the base of the slope from waves.

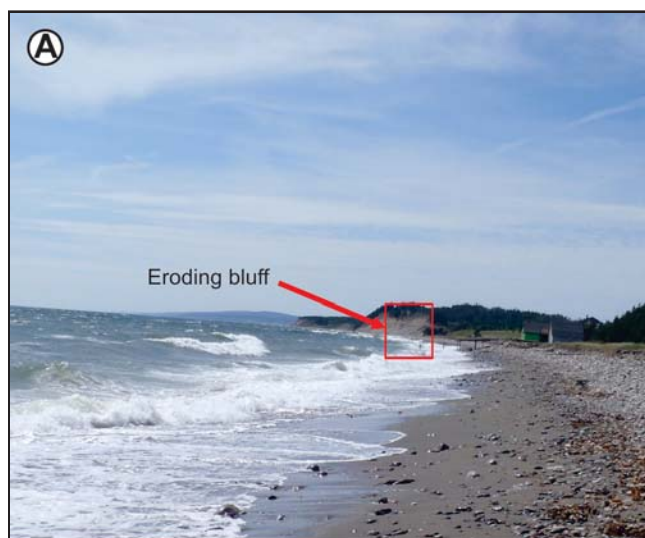
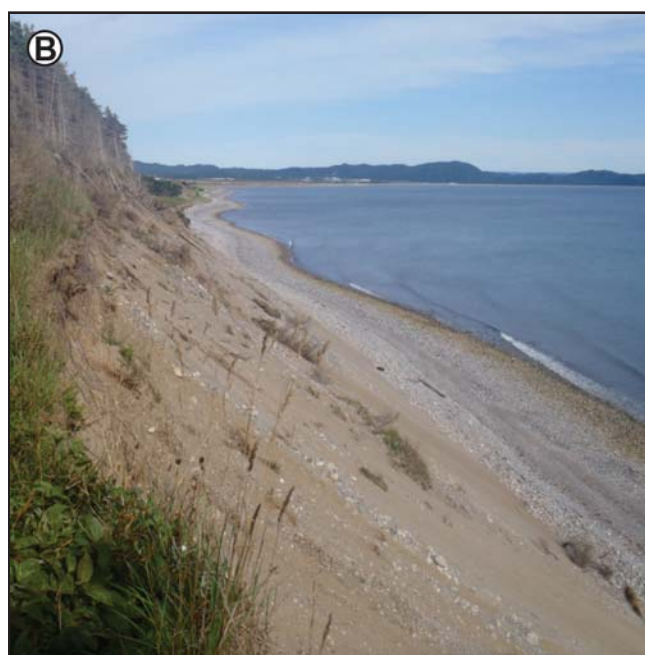
Plate 6. A) The beach at Stephenville, on St. George's Bay, looking west toward bluffs. B) Detailed view of the eroding bluff in Kippens, looking east toward the beach at Stephenville. The beach at Stephenville is being fed by eroding glaciofluvial bluffs along the outer portion of the bay, as long as sufficient sediment is supplied to the beach it will be maintained.

Beaches may be fed from coastal cliff sources, with rocky headlands restricting longshore transport of sands and gravel. This occurs at Stephenville beach, where the unconsolidated cliffs on the outer portion of St. George's Bay are feeding sediment to the beach at Stephenville, and Indian Head restricts farther transport of the sediment (Site #97, Plate 6). Barrier beach systems on the Avalon Peninsula, such as the barrier beach system at Holyrood Pond (Site #20), are also maintained by longshore transportation of material.

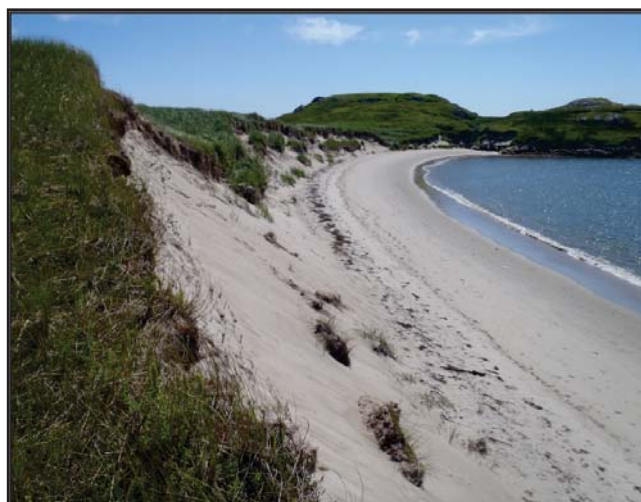
Plate 7. This coastline at Sandbanks Provincial Park is at risk of erosion from waves and wind. The beach is narrow and there is kelp along the base of the banks, providing evidence that waves reach the toe of the sand banks during high tide, resulting in erosion. As the beach is sandy, the sediment is transported off the beach by waves. High winds also cause erosion of sand off the dunes.

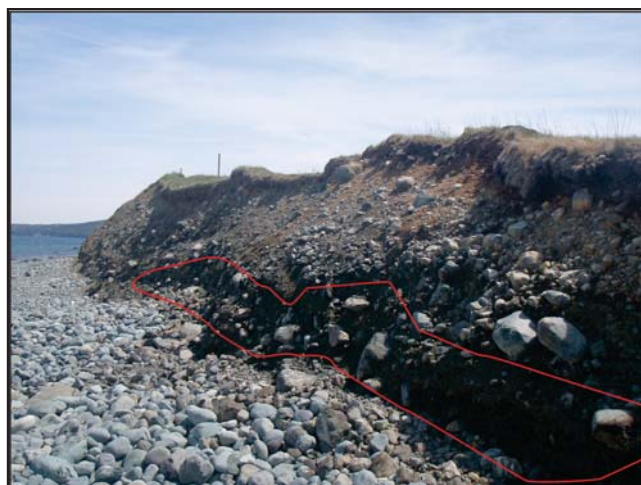
Plate 8. Erosion (outlined in red on photo) from wave action is occurring at the base of a coastal bluff in Conception Bay South. During winter months, waves reach the base of the coastal bluff and remove the finer grained sediment from the toe of the slope, causing the bluff to be undercut. The boulders on the beach provide protection from waves, as they dissipate the incoming wave energy. As the fine sediment in the bluff erodes, the boulders will fall out of the bluff, and rest at the base of the bluff, providing protection to the toe of the slope.

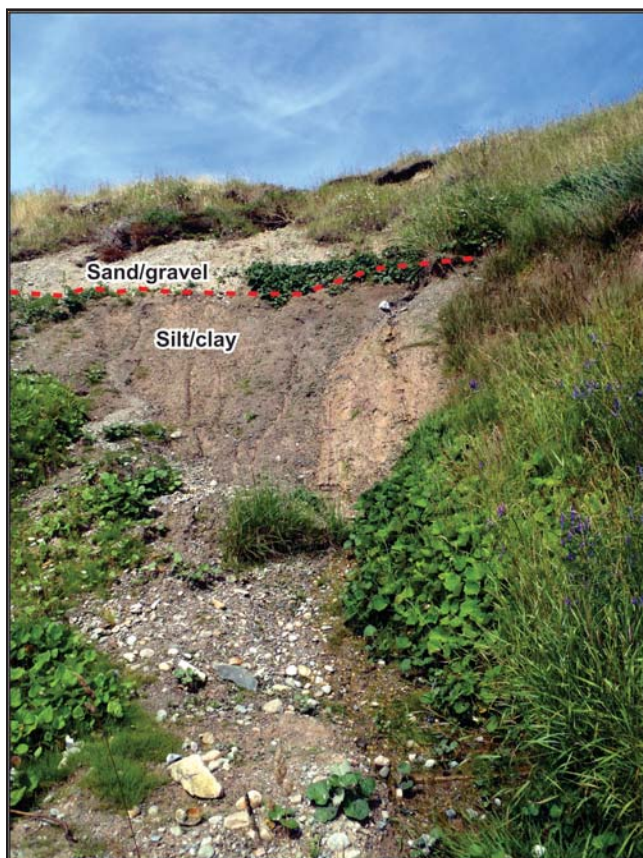
Plate 10. Cliff at Norris Point showing the contact (dotted red line) between two sediment types: sand and gravel overlying silt and clay. Sand and gravel are more susceptible to erosion from water and wind than the silt and clay. Silt and clay are more cohesive and will have a steeper slope angle, but will slump and fail if saturated or undercut.

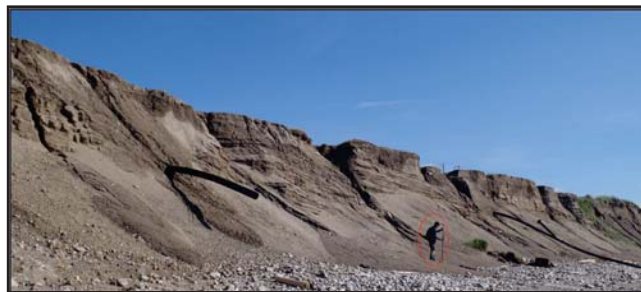
Plate 11. Gullying in the coastal bluffs at Parsons Pond. These bluffs are composed of silt and clay (darker sediment with a steeper slope angle) and sand and gravel (lighter sediment with a shallow slope angle). Sand and gravel are highly susceptible to erosion from water and wind. Silt and clay are more resistant, but may fail when saturated. Note surveyor at base of cliff (circled in red) for scale, and exposed pipes.

face due to surface run-off, as observed in the unconsolidated bluffs along St. George's Bay (Site #73), Romaines Brook (Site #165), Grand Codroy (Site #72), Parsons Pond (Site #374, Plate 11), and on the Avalon Peninsula at Point Verde (Site #35 (see Figure 1)).

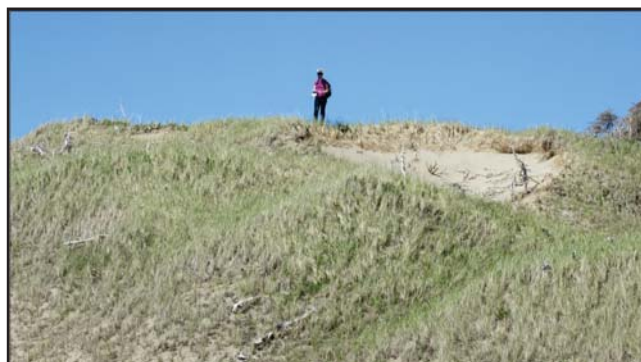
Plate 12. Surveying a blow-out in Western Brook-Broom Point, Gros Morne National Park.
