MONITORING COASTAL CHANGE IN NEWFOUNDLAND AND LABRADOR: 2014 UPDATE

M.L. Irvine
Geochemistry, Geophysics and Terrain Sciences Section

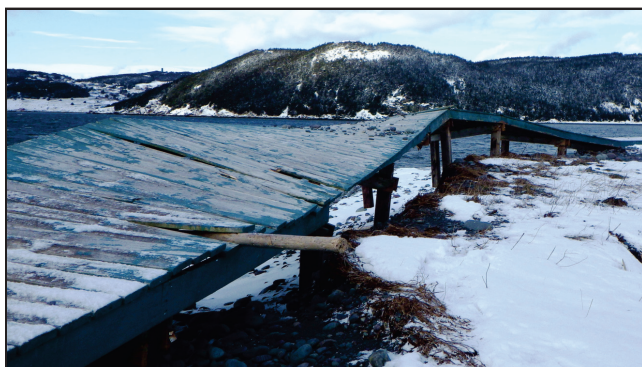
Plate 1. The modern beach in Placentia is a 1.2-km-long pebble-cobble beach. There is a long history of flooding in Placentia, with the area directly landward of the beach at risk from inland flooding and from water overwashing the beach during storm surges and high tides (Liverman et al., 1994). In December 2013 large waves associated with a storm surge caused significant damage to the boardwalk and Beach Road was flooded.

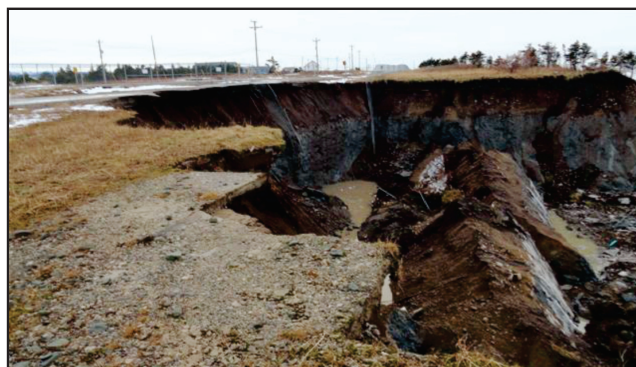
Plate 2. In November 2013, a large amount of sediment was displaced in Daniel's Harbour during a landslide, damaging part of the old roadway that was closed in 2007 due to a previous landslide in the area.

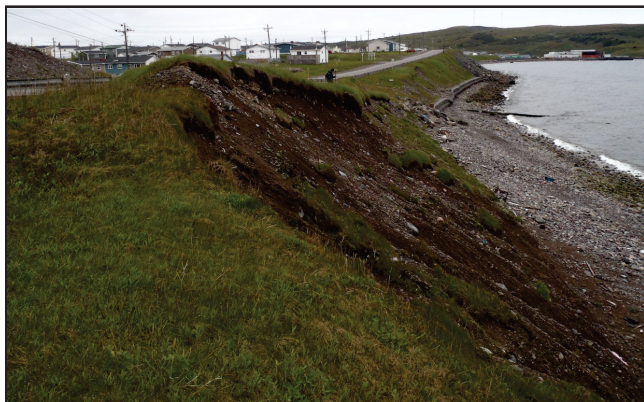
Plate 3. The glaciofluvial cliffs adjacent to the highway between Fortune and Grand Bank on the Burin Peninsula are eroding.

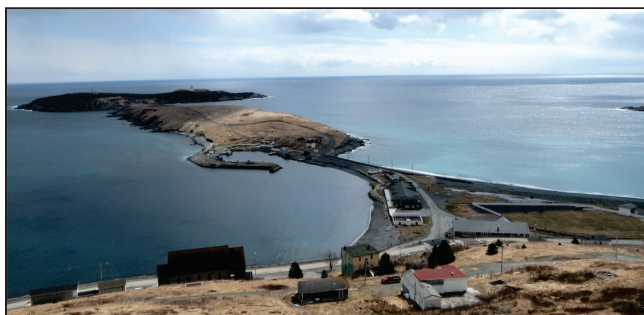
Plate 4. The main beach and tombolo in Ferryland (Figure 1, Site #310) are highly sensitive to erosion and flooding caused by combination of local factors; the tombolo has a low elevation, is narrow, is frequently exposed to storm surges and large waves, and lacks natural protection from sea ice (Catto, 2012a, b). The area has a history of flood events, which have caused extensive and repeated damage to the road leading out to the headland. Photo credit: Eric Watton.

Coastal areas that are particularly sensitive to change include low-lying areas, *e.g.*, Ferryland (Plate 4); unconsolidated cliffs of sand and/or silt, *e.g.*, Parson's Pond and Point Verde; and sand dunes in southwestern Newfoundland *e.g.*, Sandbanks Provincial Park (Plate 5).

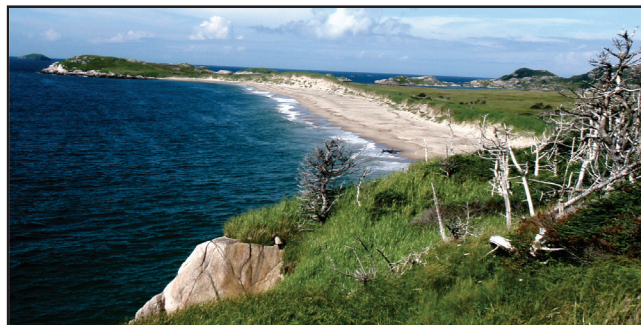
Plate 5. Sand dunes are not common in coastal environments in Newfoundland and Labrador, but where present these environments are vulnerable to relatively rapid change. At Sandbanks Provincial Park (Figure 1, Site #363), the seaward edge of the sand dunes eroded up to 6 m between 2013 and 2014. This coastline is highly vulnerable to erosion as it has a narrow beach, is exposed to large waves and storm surges from the south, and is composed of sandy material.

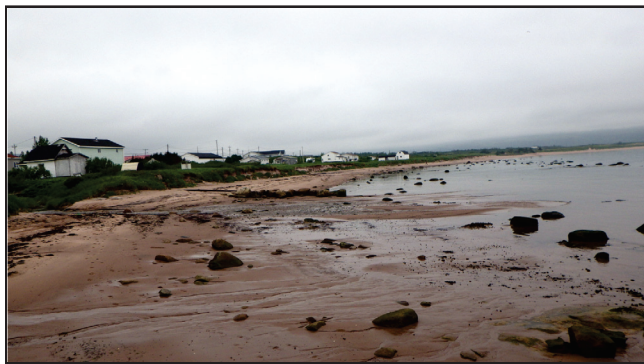
Plate 6. View looking northeast across the sandy foreshore with some boulders in Forteau, southern Labrador. Note the overhanging grass mats and the slumps, both signs of erosion, visible at the base of the sandy banks. The backshore is composed of grass with sand underlying, and residential homes border the shoreline along portions of the site.

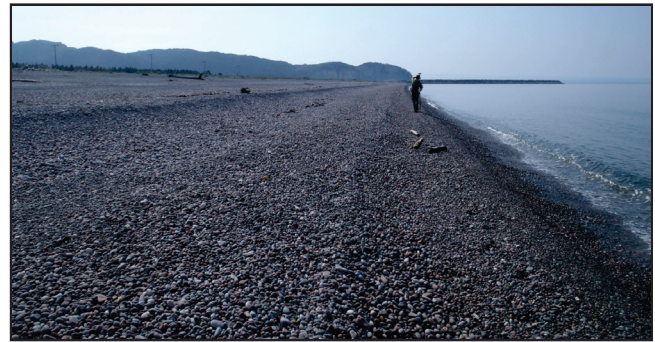
Plate 7. View looking east over the rounded gravel beach at Stephenville. The point of land in the distance indicates the man-made channel that opens into Port Harmon. Indian Head, which limits the eastward longshore transport of material, is in the background.

The Stephenville site (Figures 1 and 5, Site #97) is situated on the north shore of St. George’s Bay and is about 5 km long. The site includes a barrier complex of Holocene beach ridges composed of well-rounded, flat gravel. A sea-wall runs parallel to the beach along the south-eastern section. At the northern portion of the site, in the vicinity of Line 4, there is sand and gravel in the foreshore, and vegetation (grasses) overlying a sand substrate in the backshore. At the southern end of the beach is a man-made channel, providing boat access to Port Harmon (Plate 7).

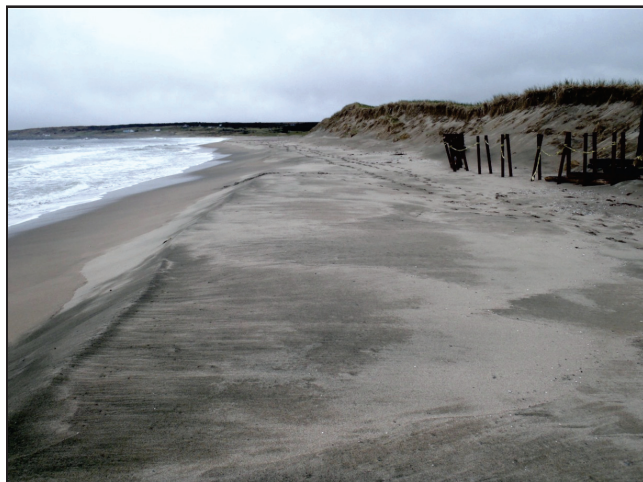
Plate 8. Sand dune at J.T. Cheeseman Provincial Park. The seaward edge of the sand dune eroded 922 cm between 2013 and 2014, exposing an old section of railway.

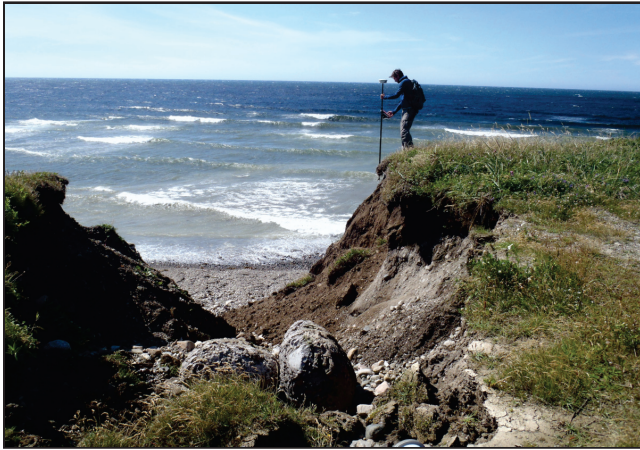
Plate 9. One of the large gullies that are forming in the glaciomarine sand, clay and gravel cliff at Parson's Pond.

The high rates of erosion at Parson's Pond compared to other locations are due to a combination of factors. Due to the narrow foreshore, waves reach the base of the cliff and remove sediment; evidence of this includes the presence of driftwood, seaweed and wave notching at the base of the cliff. Although the slope of the beach is low, the incoming waves have a high potential to cause erosion as the site has a large fetch and is exposed to the effective storm direction. The composition of the cliff, which is mainly sandy, allows water to create large gullies in the cliff face (Plate 9), and groundwater is visible in contact between the sandy-gravel and silty-clay layers. The cliff is exposed to wind, which is removing sand from the cliff, as evident from the overhanging tuff mats along the top of the cliff.
