Coastal Monitoring in Newfoundland and Labrador

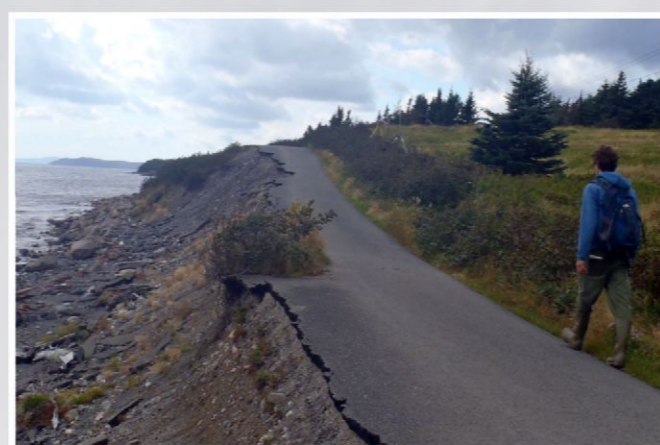
Coastal erosion undercutting a road in O'Donnells.

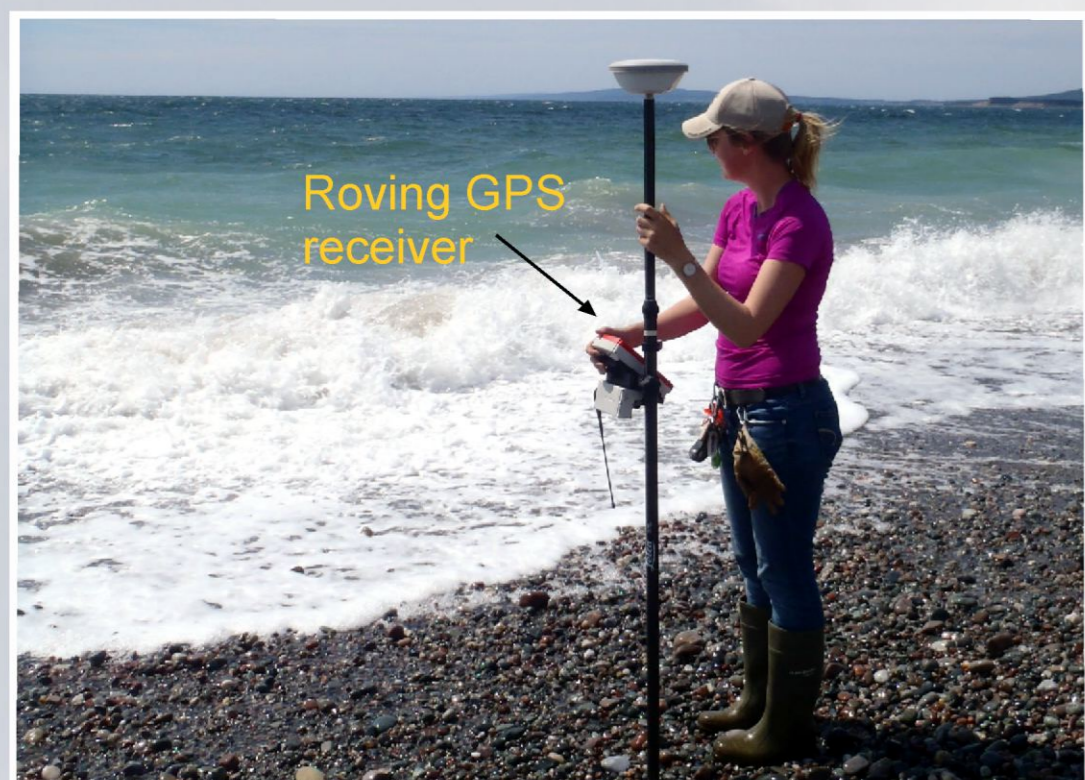
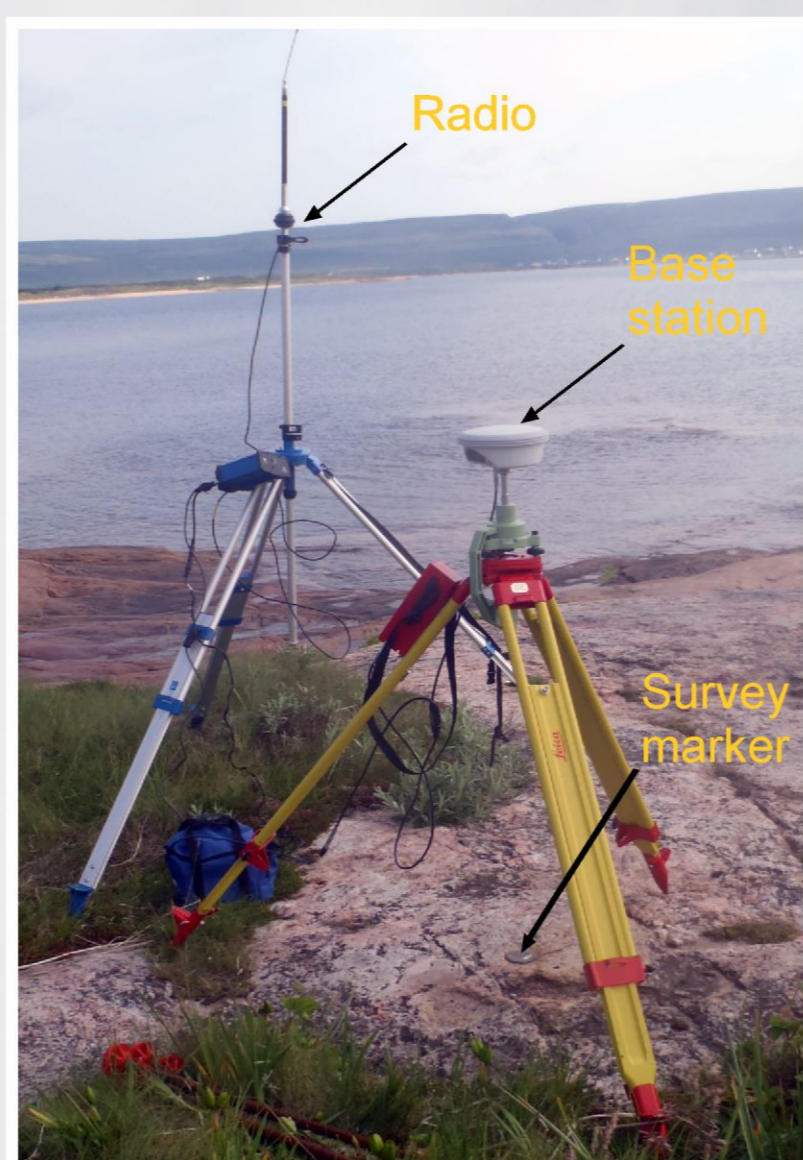
Roving GPS receiver

Radio

Base station

Survey marker

RTK equipment has three main components: A base station, radio link and roving GPS receivers. The base station is set up over a survey marker. The base station sends its reference position to the roving receiver through the radio, allowing for the position of the rover to be corrected.

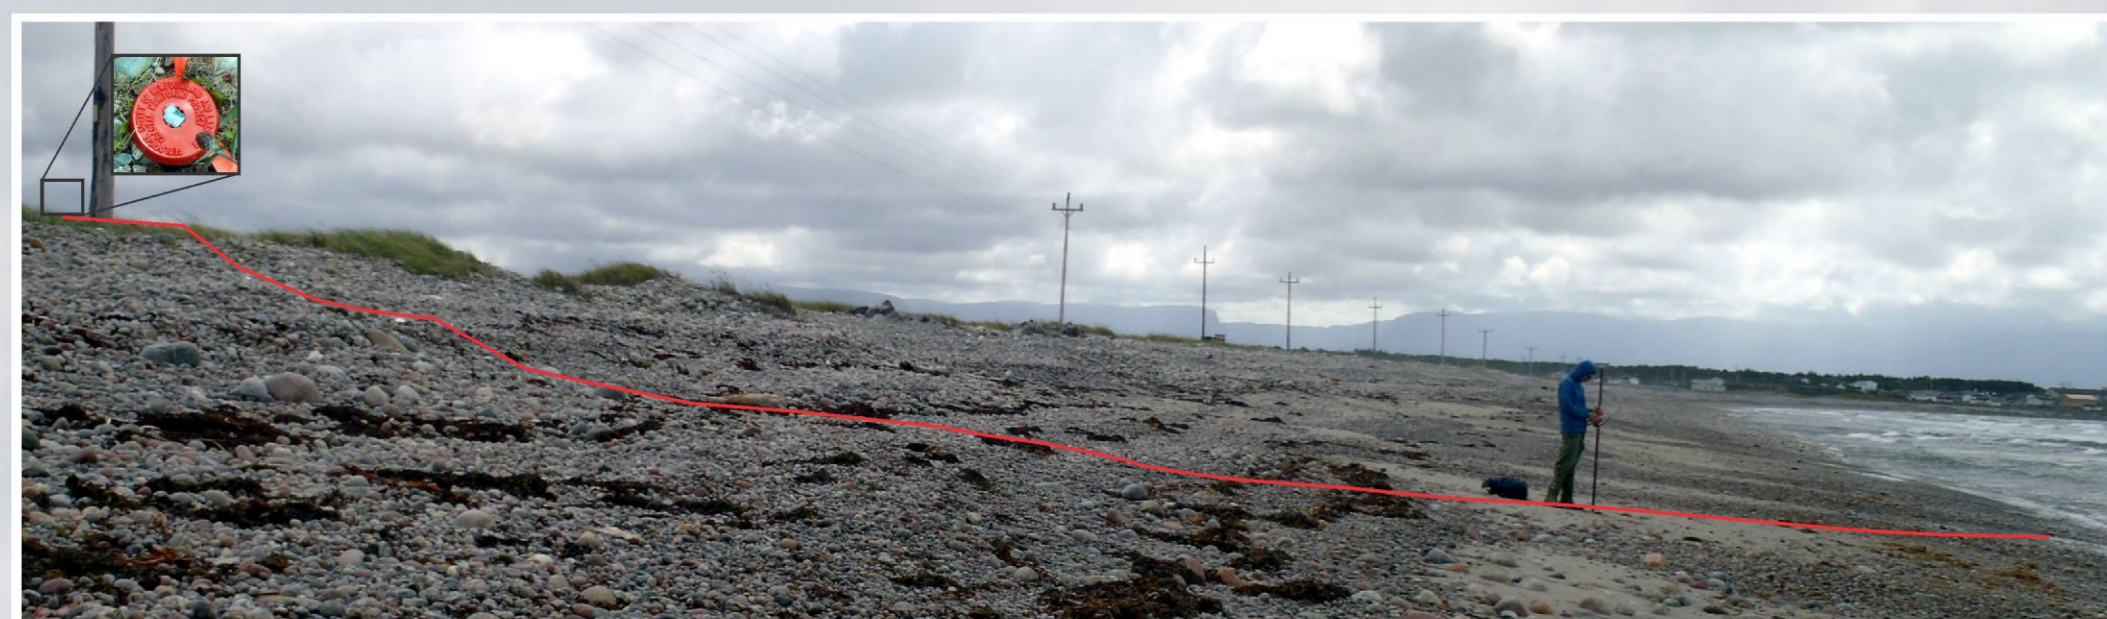
Red survey pins are installed at the landward end of transects. A transect, shown by the red line, is surveyed from the pin to the water. By comparing surveys of different years, changes in the site can be accurately determined.

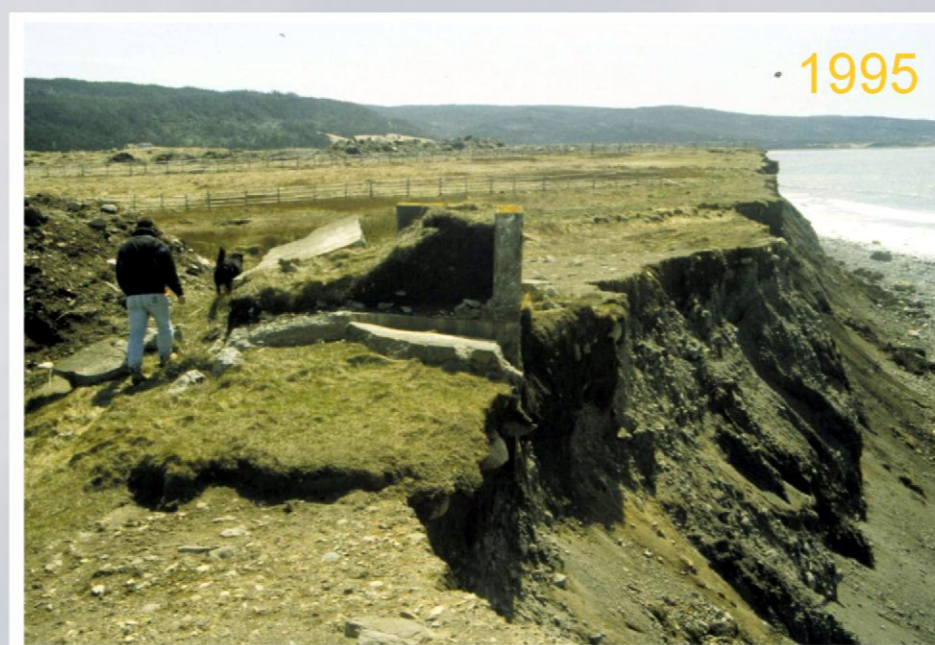
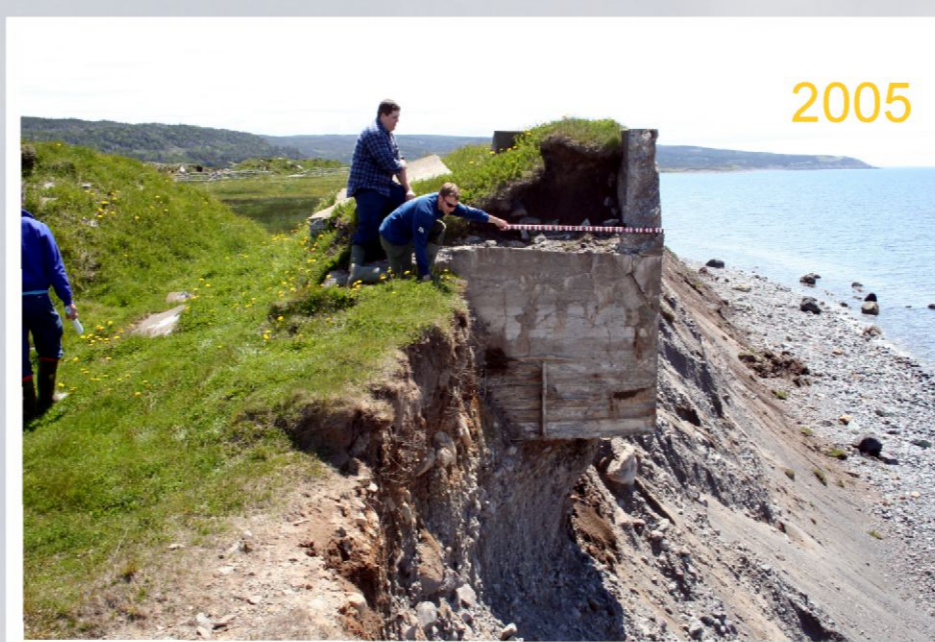
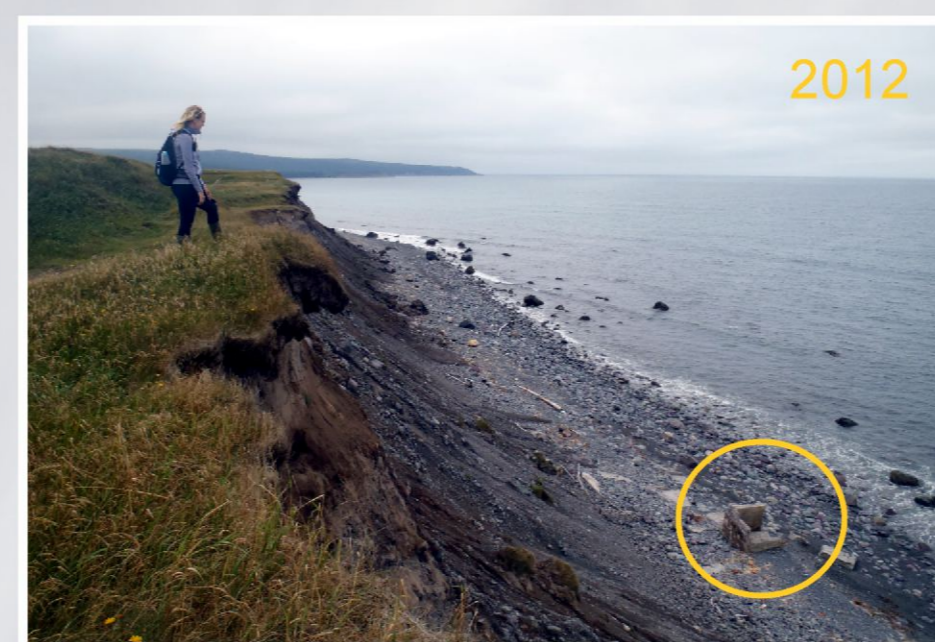
Cliff at Point Verde in 1995, 2005 and 2012. Note the concrete structure, shown in the top two photos, is now at the base of the cliff.

Point Verde is a gravel peninsula which provides protection to Placentia from coastal storms. There is a lighthouse on the northern end, residential houses on the inland side, and an active aggregate operation. The peninsula is eroding, and if the site is breached, the area, including Placentia, could be at greater risk from coastal storms.

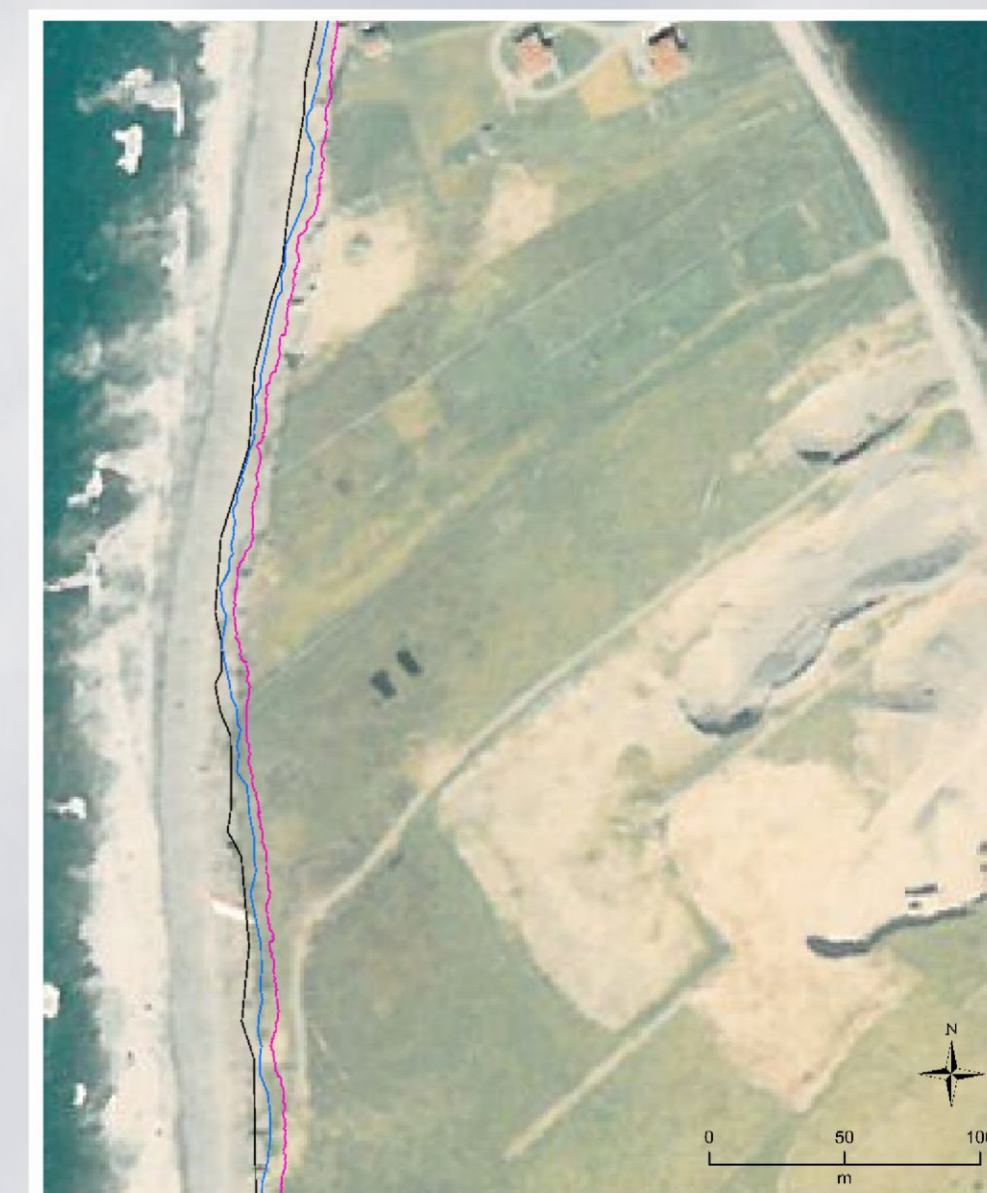
Cliff top in 1991 (black), 2000 (blue) and 2012 (pink) superimposed on an airphoto. Cliff erosion varies between 0.5 m/a to 1 m/a.
