Coastal Monitoring Parson's Pond

Site

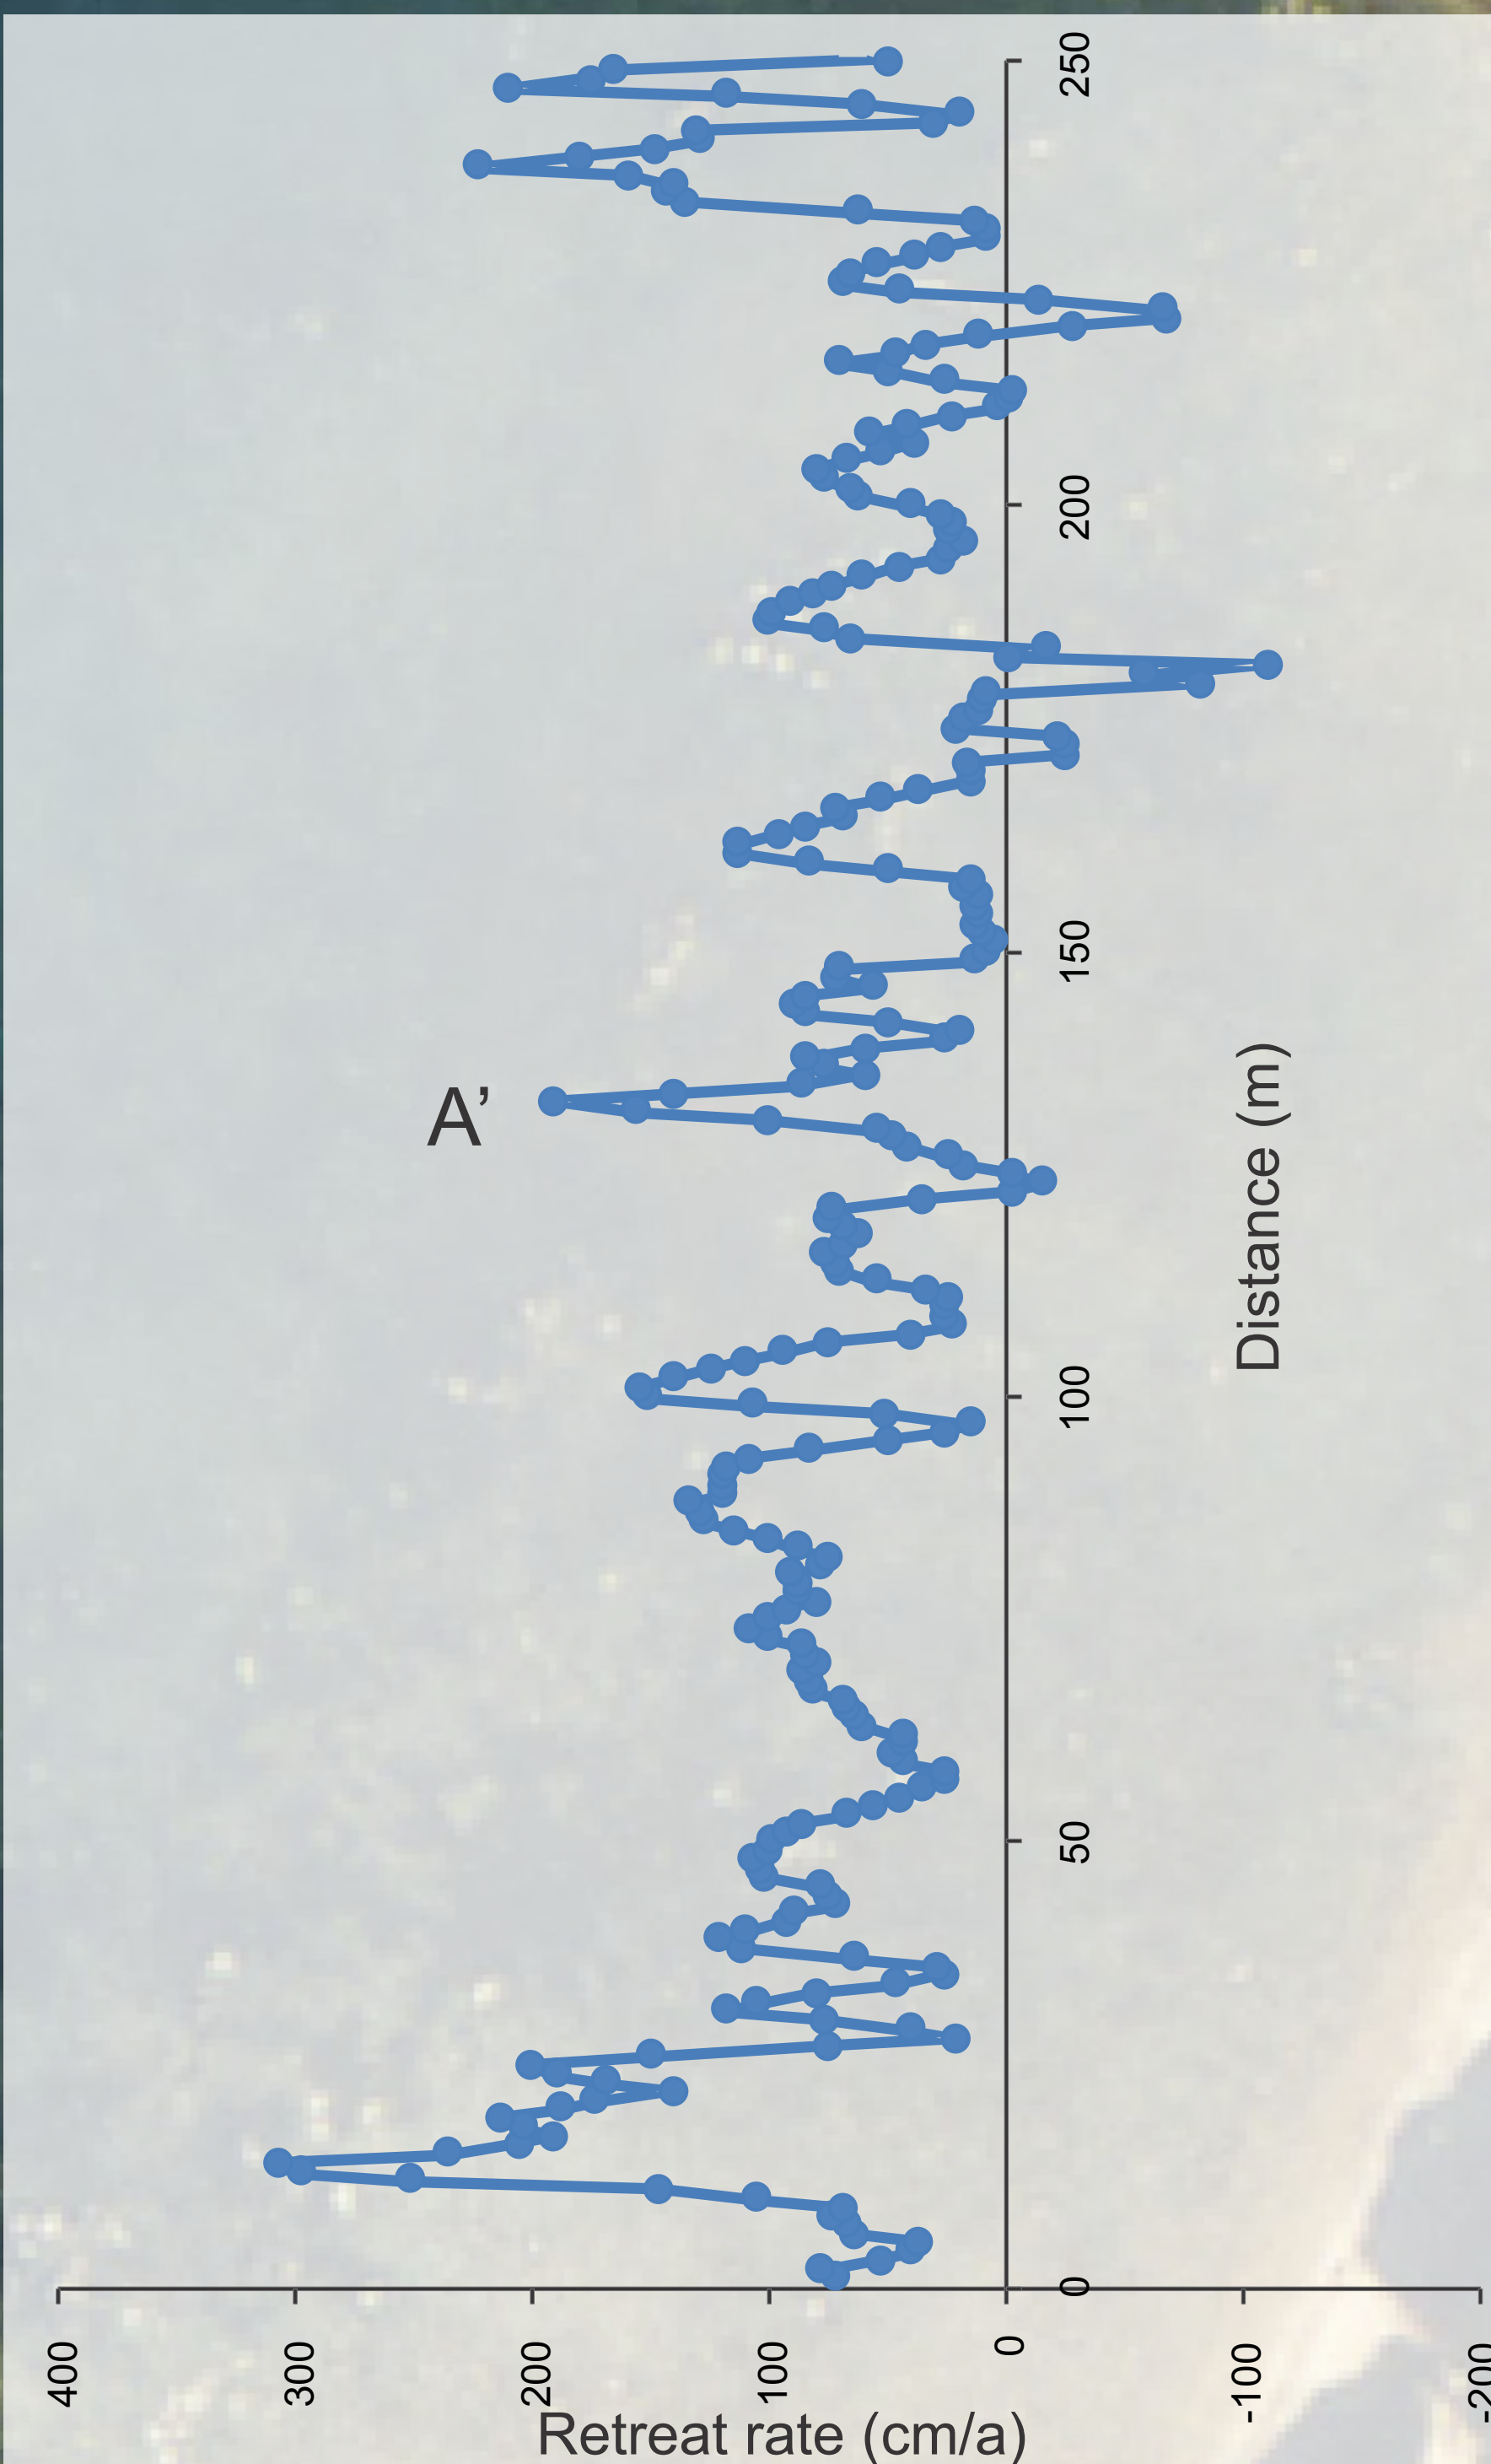
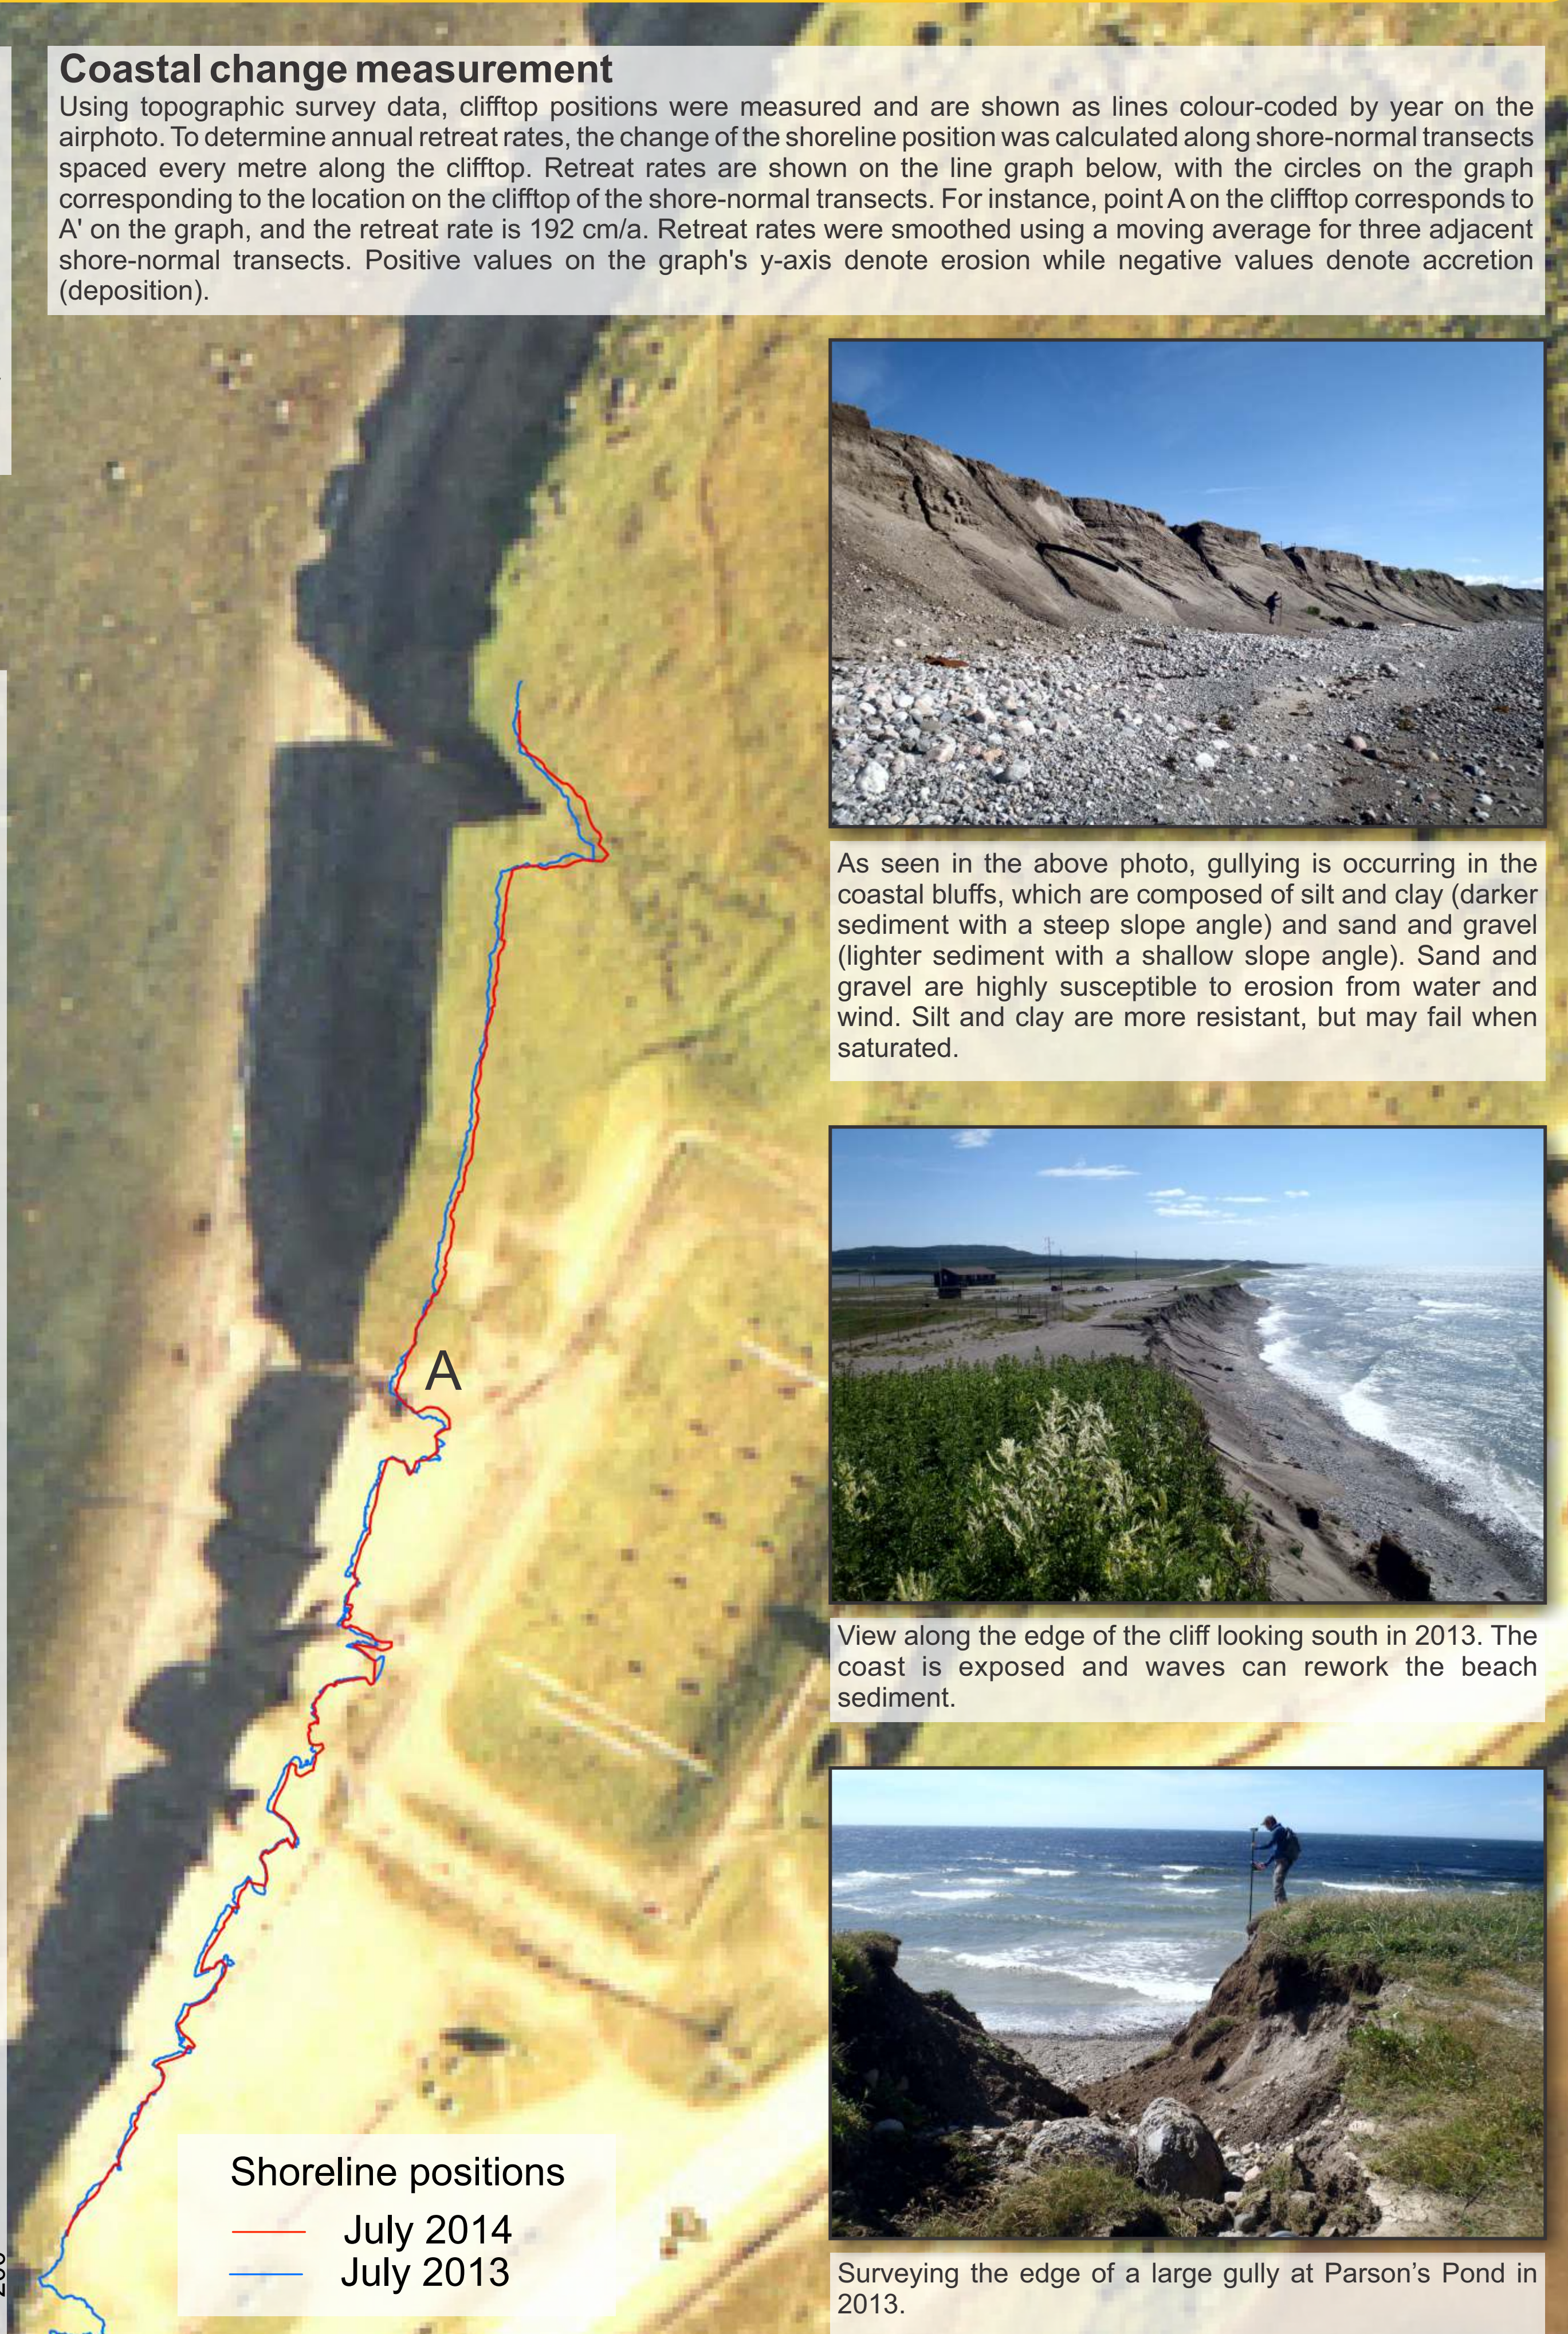
Overall, between 2013 and 2014 the area underwent erosion. The average recession rate of the surveyed interval was 73 cm, ranging from -100 cm (indicating advance) to 300 cm (blue line on graph below). Areas of accretion (negative retreat-rate values) are likely the result of slumping along the cliff edge. Surface run-off and groundwater flow are causing gullying in the permeable sediment. The cliff is exposed to the wind, which is removing sediment from the cliff face.

Using topographic survey data, cliff-top positions were measured and are shown as lines colour-coded by year on the airphoto. To determine annual retreat rates, the change of the shoreline position was calculated along shore-normal transects spaced every metre along the cliff-top. Retreat rates are shown on the line graph below, with the circles on the graph corresponding to the location on the cliff-top of the shore-normal transects. For instance, point A on the cliff-top corresponds to A' on the graph, and the retreat rate is 192 cm/a. Retreat rates were smoothed using a moving average for three adjacent shore-normal transects. Positive values on the graph's y-axis denote erosion while negative values denote accretion (deposition).

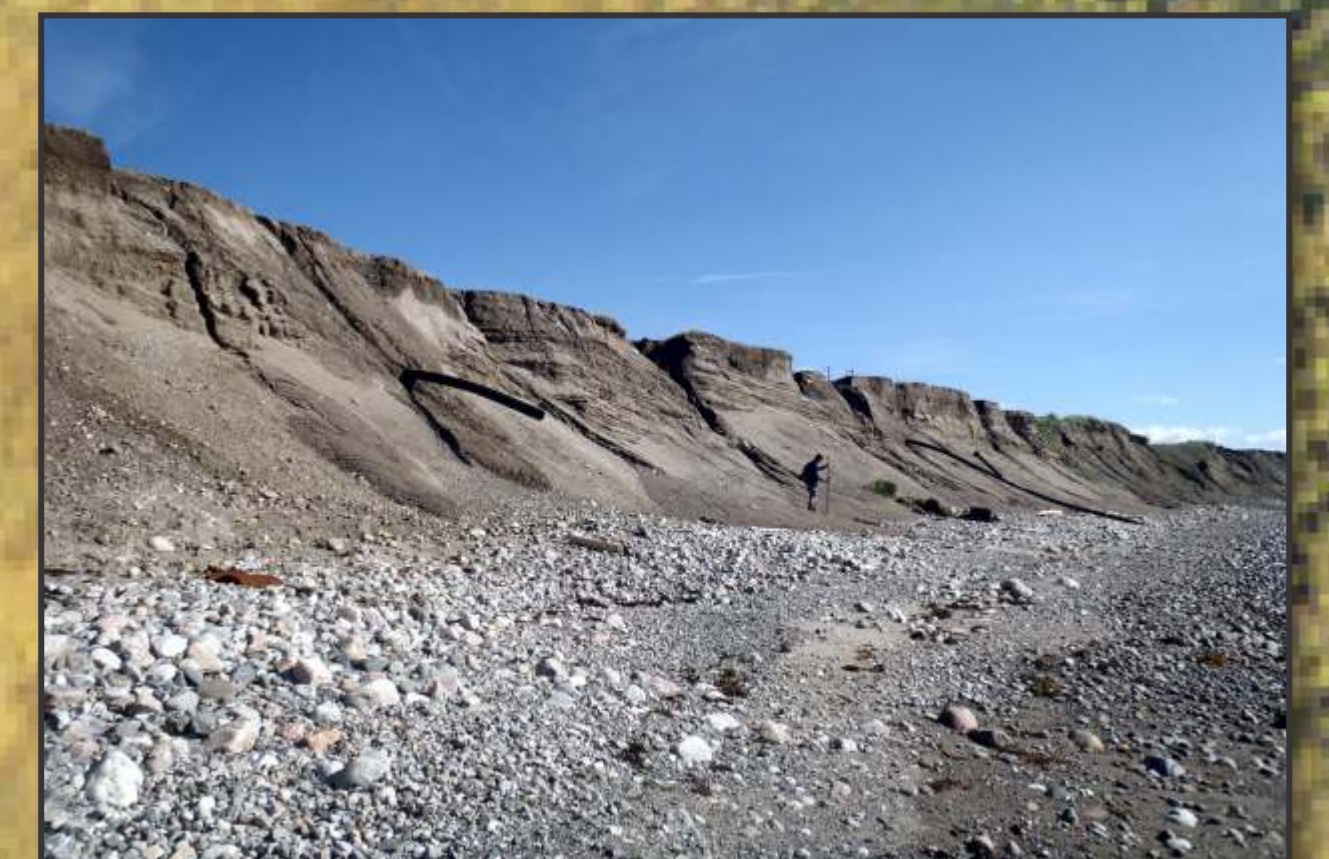
As seen in the above photo, gullying is occurring in the coastal bluffs, which are composed of silt and clay (darker sediment with a steep slope angle) and sand and gravel (lighter sediment with a shallow slope angle). Sand and gravel are highly susceptible to erosion from water and wind. Silt and clay are more resistant, but may fail when saturated.

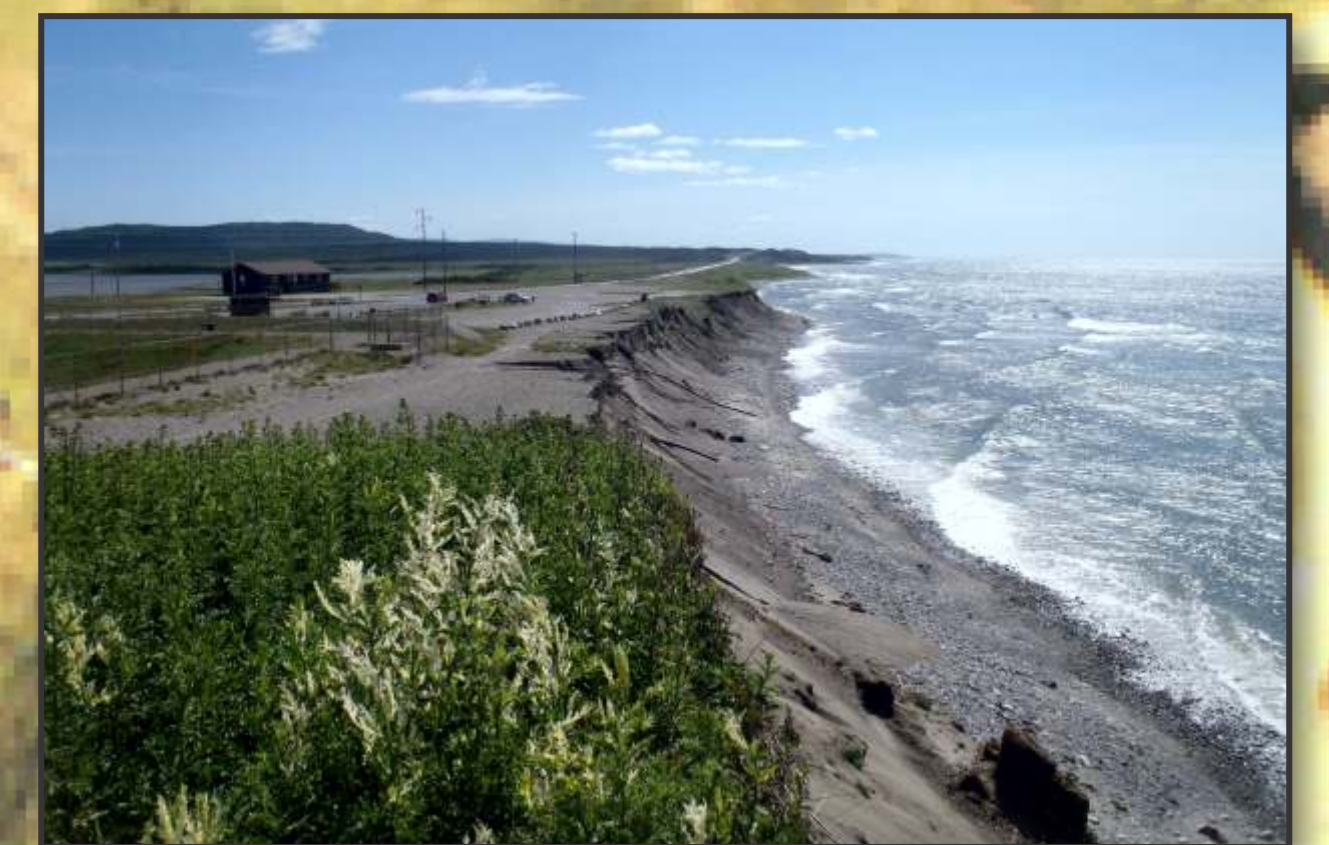
View along the edge of the cliff looking south in 2013. The coast is exposed and waves can rework the beach sediment.

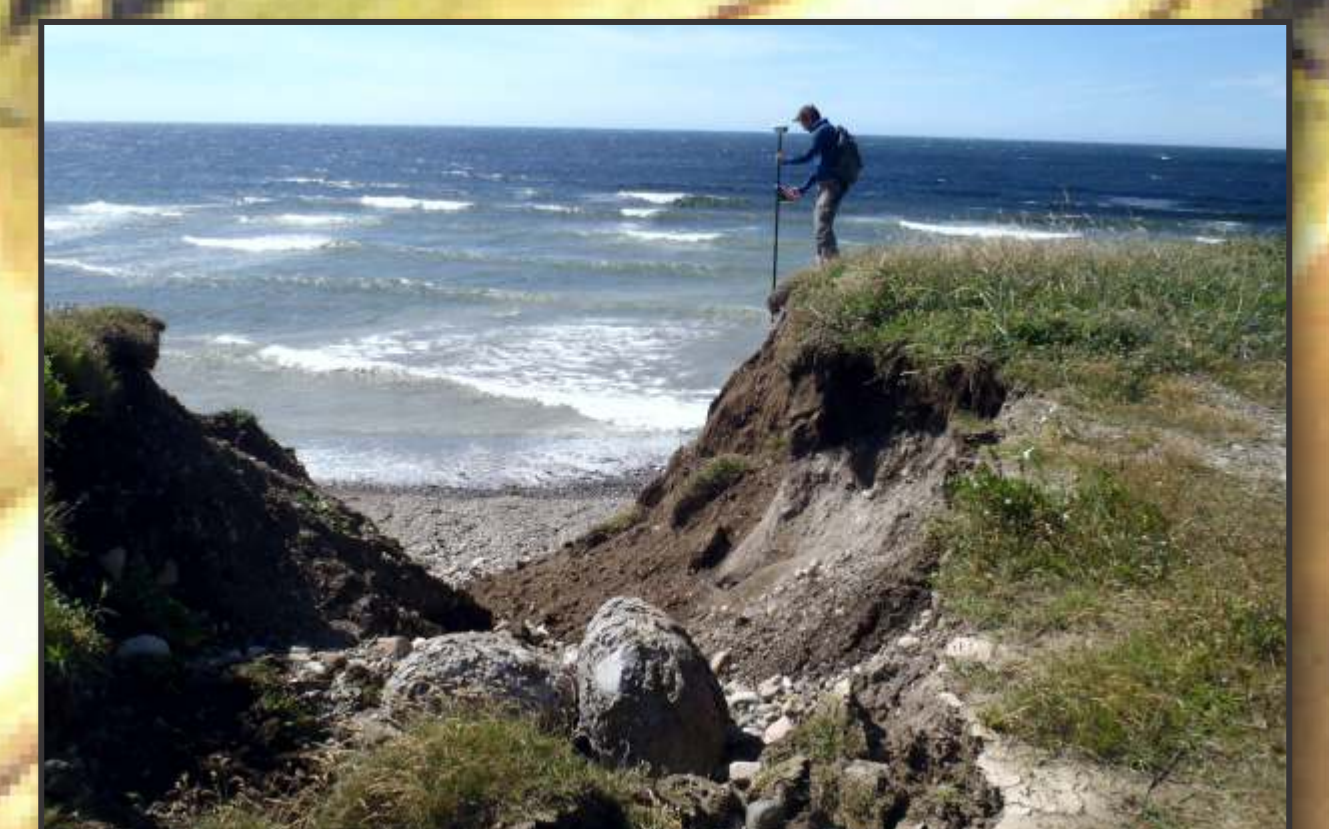
Surveying the edge of a large gully at Parson's Pond in 2013.
