# **COASTAL EROSION IN ST. GEORGE'S BAY, WESTERN NEWFOUNDLAND**

**Open File 012B/0705**

**St. John's, Newfoundland  
August, 2019**

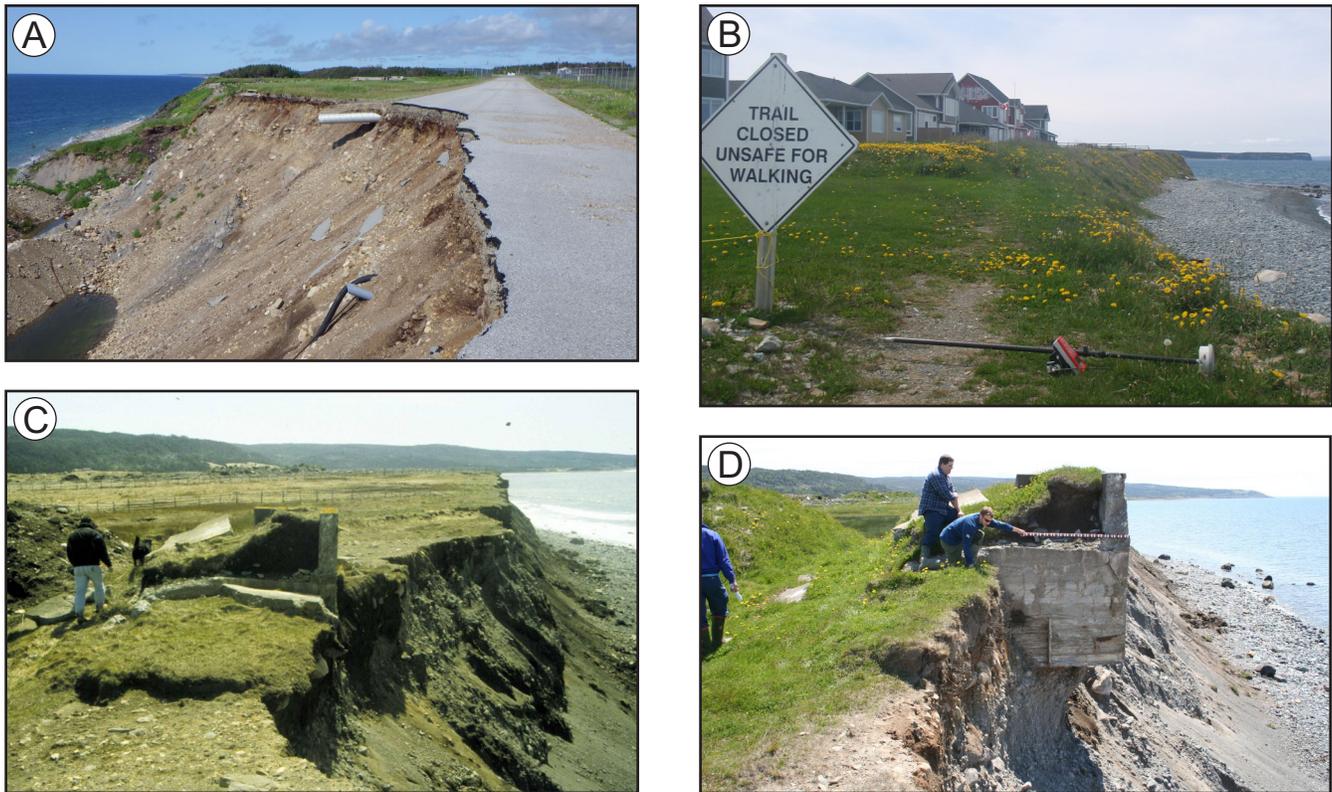
**Plate 1.** Coastal processes impacting infrastructure. A) During a landslide in Daniel's Harbour in 2013, a large amount of unconsolidated sediment was moved from the slope and deposited on the beach; the old highway was damaged and pipes were exposed; B) Coastal erosion along the top of a cliff in Conception Bay South resulted in the closure of a walking trail within a few years of being constructed. Quantifying rates of erosion is crucial to determine setback values in order to reduce the risk of this; C) Coastal cliff, Point Verde, 1995. Coastal erosion along the top of a cliff has undermined an old cement structure; D) Same portion of the coastal cliff at Point Verde at 1C, taken in 2005. Note the amount of erosion that had occurred at the base of the structure over a ten-year period. Continued erosion, at a rate of 45 cm a year, caused the concrete structure in the photo to fall to the base of the cliff in 2011.

communities, the determination of current and future landscape changes is integral in making constructive land-use decisions. Coastal erosion, *slope movement* and flooding affect communities and consequent damage to roads, trails, cabins, wharfs, breakwaters, and houses require costly repairs (Plate 1; Batterson *et al.*, 1995, 1999; Liverman *et al.*, 2001, 2003).

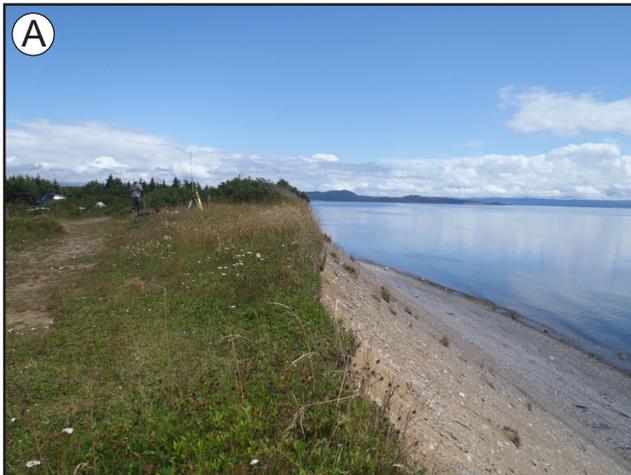
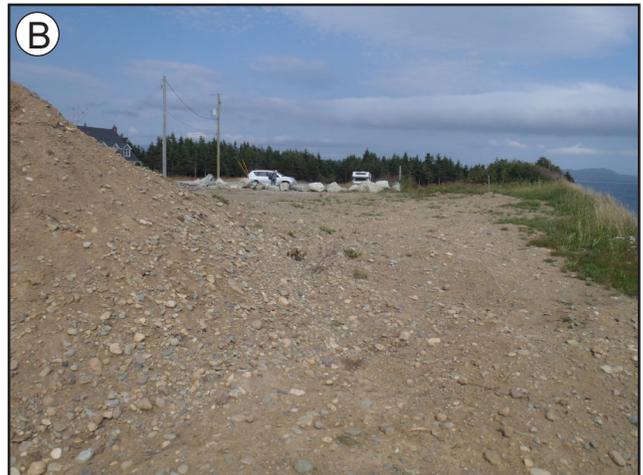
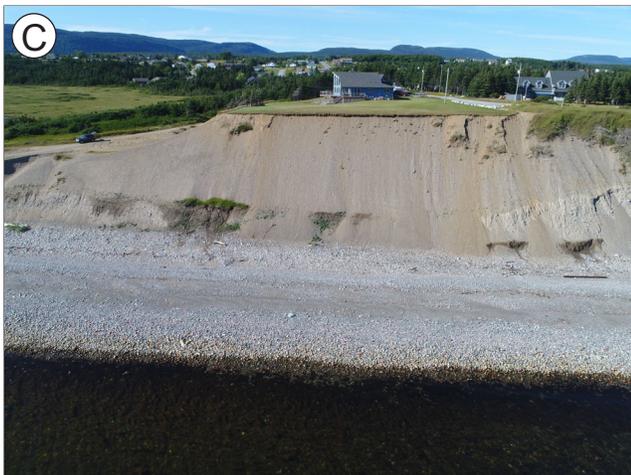
**Plate 2.** *Landscape change in Kippens. A) In 2011, this area was covered by long grass, and had an ATV trail running parallel to the shore; B) Between 2011 and 2012, the land was cleared for the construction of a new home. Removal of the vegetation increases the risk of cliff erosion unless remedial action is taken; C) Same portion of the coast as in Plate 2A and B, but viewed from over the water, looking at the cliff face. Photo taken in 2017. In 2012, house construction was complete (blue house in centre of photograph). Grass was planted landward of the cliff, which will absorb surface water and reduce the vulnerability of cliff erosion.*

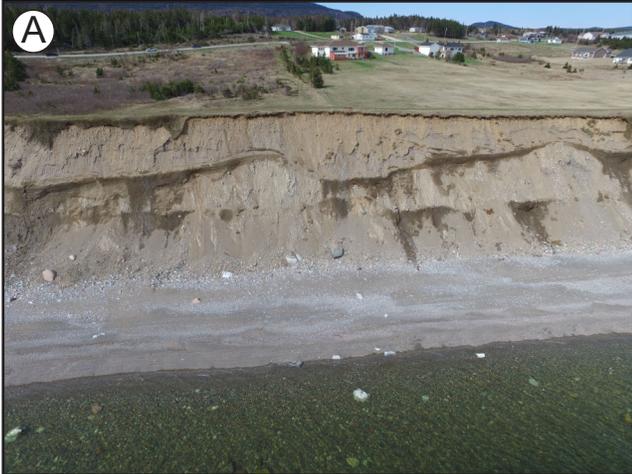
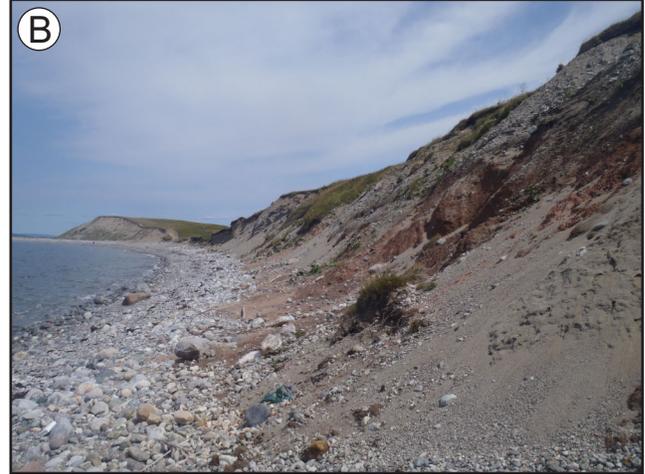
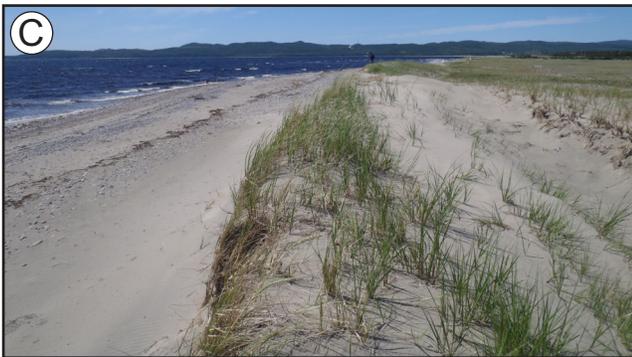
**Plate 3.** Examples of coastal environments along St. George’s Bay. A) The coast between Port and Port and Stephenville consists primarily of unconsolidated cliffs, although there are variations in sediment composition and vegetation cover. This aerial view, captured in May 2016, shows the general stratigraphy and setting of the coastal cliff east of Romaines Brook. Cliff stratigraphy includes layers of sand and gravel, and silt and clay. The cliff is unvegetated and fronted by a gravel beach. Houses have been built within 100 m of the cliff top; B) Cliff of poorly sorted sand and gravel, fronted by a cobble and boulder beach at Flat Bay; C) Sand dunes at Stephenville Crossing. As the area is low-lying and exposed to the west, it is susceptible to flooding and erosion.

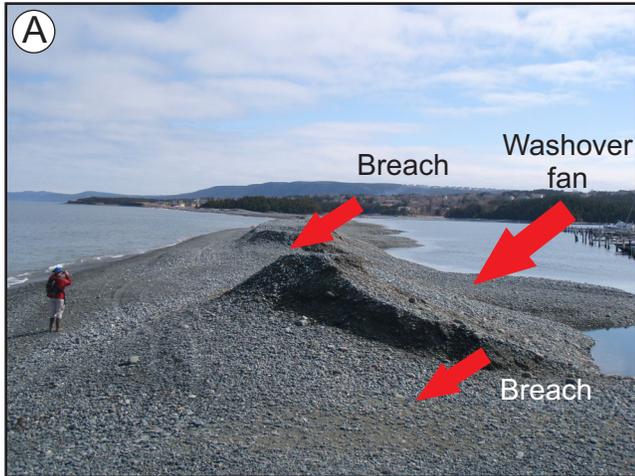
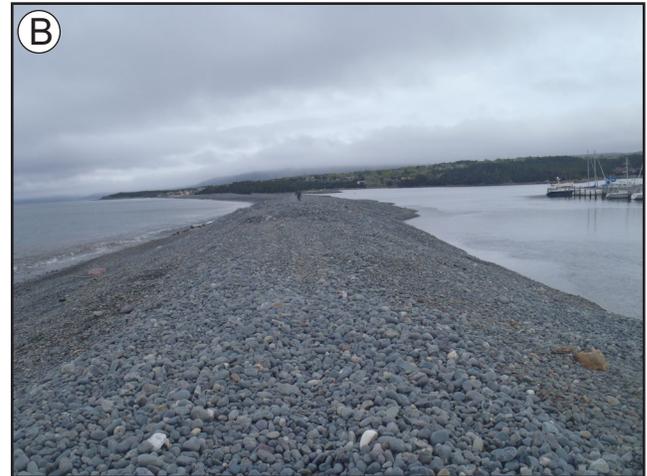
**Plate 4.** Impact of a storm surge, Conception Bay South. A) In the spring of 2013, a storm surge occurred during a high tide, and resulted in morphological changes to the barrier near the yacht club at Conception Bay South. Waves breached the barrier, moving sediment from the top and seaward face, forming washover fans and depositing sediment on the landward side of the barrier and in the lagoon; B) As the barrier provides protection from flooding to infrastructure landward, and the channel provides boat access from the lagoon to Conception Bay, sediment was dredged from the lagoon to rebuild the barrier.

Beaches undergo cyclical short-term changes (*i.e.*, seasonal to annual), undergoing erosion and subsequent accretion but no long-term net changes. Sand-dune environments under normal conditions have sediment moved from the foredune (*e.g.*, storm waves, high-water events), to the nearshore, before being transported onshore to re-establish the dune system through wave and *aeolian* processes (Figure 2A, B). Dunes serve as sand reserves, from which wind transports the sand to the foredune or beach. In barrier beaches, waves breach barriers, move sediment and deposit it landward (Plate 4A).

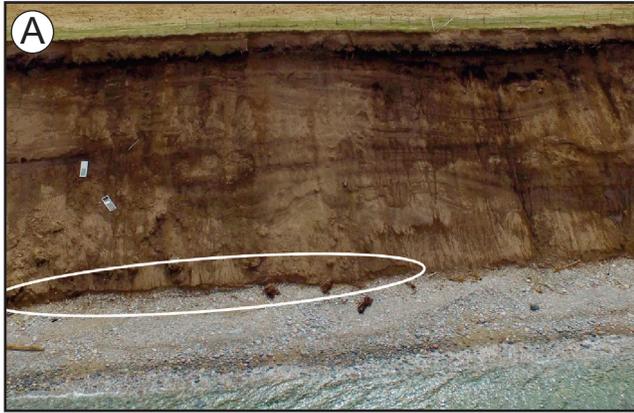
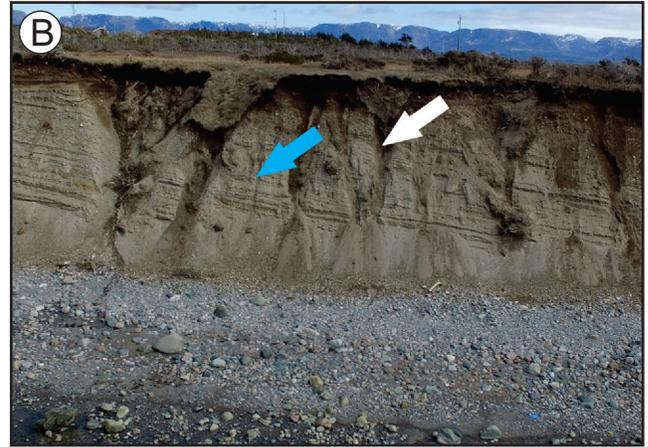
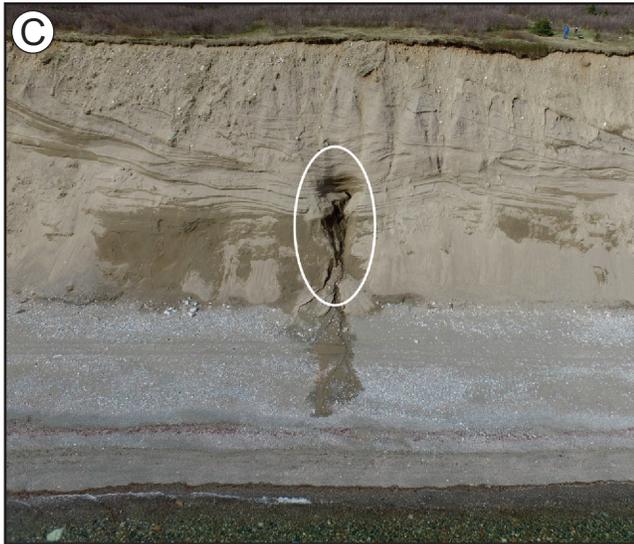
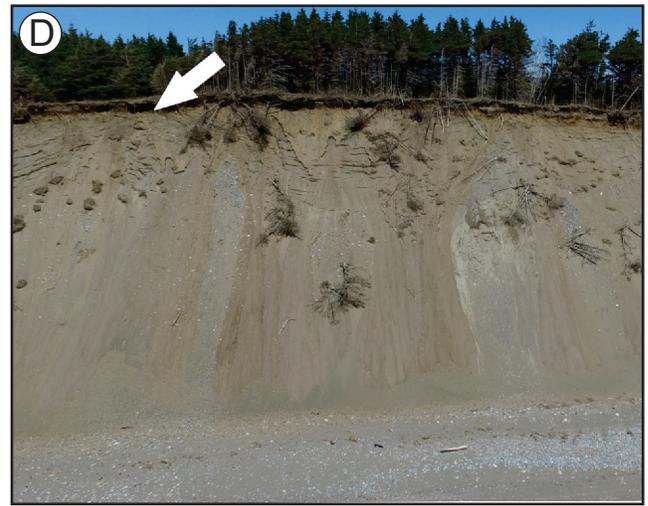
**Plate 5. Erosional agents.** A) In exposed areas with a narrow beach backed by a cliff, such as St. David's, waves can remove sediment from the cliff base, forming wave notching (circled); B) Rain and snowmelt result in rills (blue arrow) and gullies (white arrow), moving sediment to the base of the cliff; this is occurring at Parsons Pond; C) Groundwater is an influential agent causing erosion; seepage occurs at the contact of permeable coarse-grained material and non-permeable material. At Marine Drive a spring (circled) has formed at the contact of the sand and gravel layer, which is underlain by silt and clay; D) Wind has blown sand particles off the cliff face, creating overhangs (white arrow).

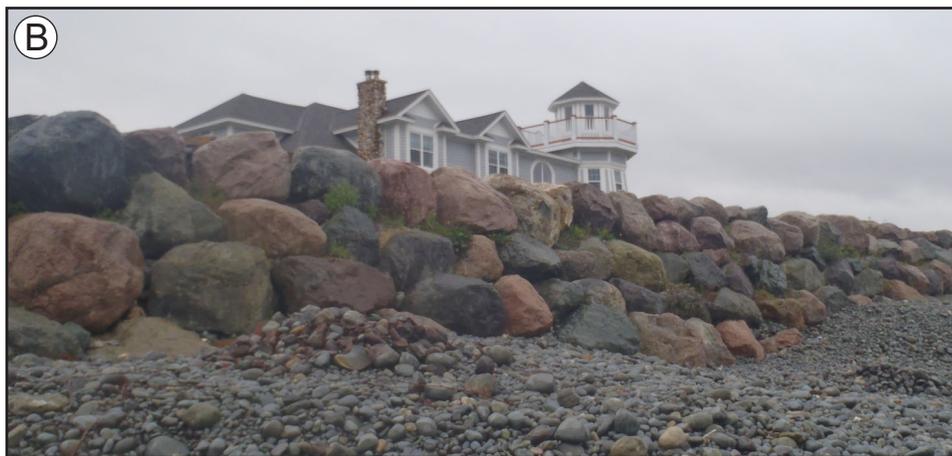
**Plate 6.** Modifications to sediment dynamics in coastal environments. A) A jetty can cause disruption of sediment transport along the shore, resulting in the accumulation of sediment on the up-drift side of the structure, and erosion on the down-drift side. At Grand Beach, the jetty is limiting the amount of sediment entering the entrance to the community’s harbour. The harbour entrance is to the right of the photograph; B) Large boulders were placed along the bank to prevent bank erosion in Conception Bay South. This modification impacts surrounding areas; by hardening the shoreline, sediment will no longer be supplied to beaches down-drift, leading to long-term erosion.

to be starved of sediment (Plate 6B). The passage of all-terrain vehicles (ATV) and foot traffic on dunes cause erosion and enhance *blowouts* (Catto, 2002; Plate 7) and barrier beaches can also be artificially lowered by ATV use, resulting in an increased susceptibility to overwashing and breaching. Cliffs can be artificially advanced when material, such as grass or sediment, has been pushed or dumped over the edge; however, this seaward extension will likely only be temporary (Forbes *et al.*, 1995; Plate 8). The building of infrastructure on the top of a slope adds weight, which increases the *shear stress* on the slope; if the shear stress impacting a slope exceeds the shear strength, the slope will fail (Batterson and Stapleton, 2011). Housing, industrial and agricultural developments change the

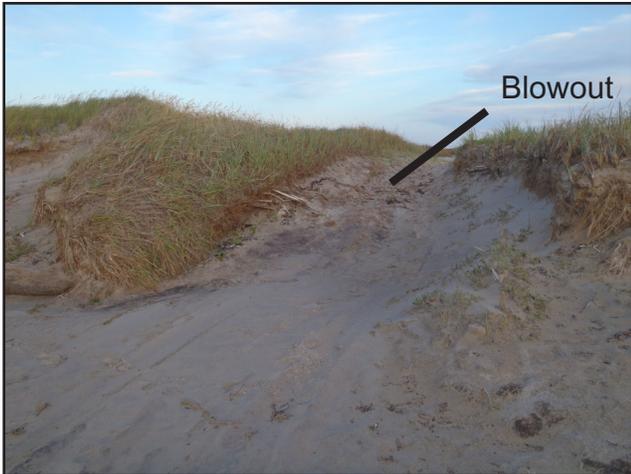
**Plate 7.** The passage of ATVs and foot traffic impacts sand dunes by instigating wind erosion, which can result in blowouts. This example is from Lumsden, in northeastern Newfoundland (not in current study area).

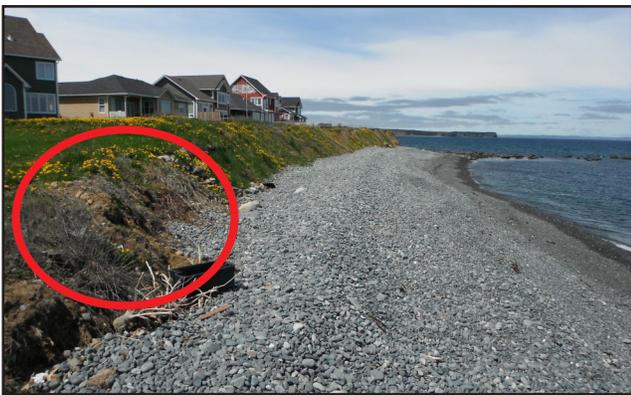
**Plate 8.** Homeowners placed grass, woody debris and soil (circled) to advance the face of the cliff in Conception Bay South. As this material is loose, it is very vulnerable to erosion during a period of high wind or elevated water, and will likely be displaced during the next storm event.

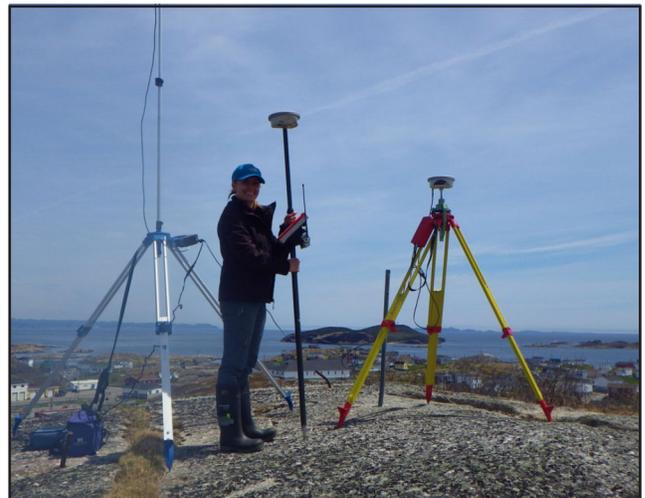
**Plate 9.** Real Time Kinematics survey equipment. The base station (yellow tripod) is set up over a previously established survey monument with known coordinates. The base station transmits reference position information to the roving receivers through the radio (blue tripod). The hand-held roving receiver, consisting of an antenna and field controller attached to a telescopic pole, is used during surveying.

Berry Head and St. David's. Real Time Kinematic equipment collected precise (cm-scale) location data (Plate 9). The RTK equipment comprises a stationary base receiver (referred to as a 'base station'), one or more roving receivers, and a radio link. The base station is set up within 10 km of the monitoring site, over a permanent survey benchmark, and is in line-of-sight of the roving receivers. It continually collects satellite signals of its static location, and the positional errors (e.g., satellite orbit errors) are transmitted to the roving receivers, allowing for the coordinates of the roving receivers to be corrected in real time, resulting in precise relative and absolute location data (Pardo-Pascual *et al.*, 2005).

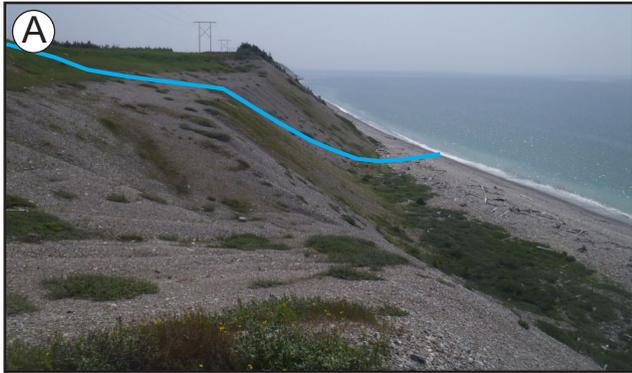
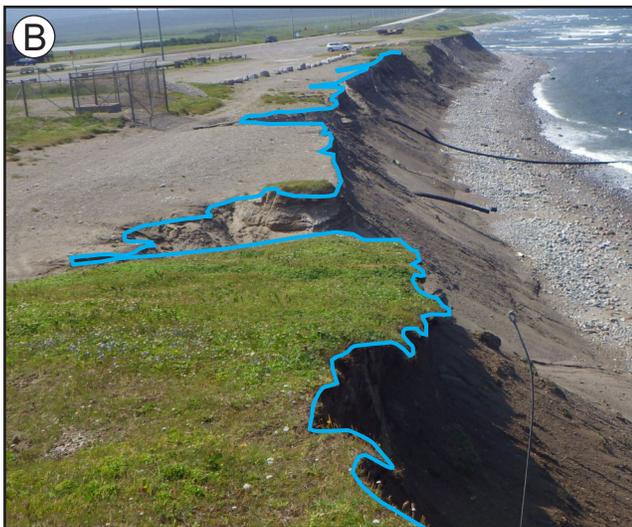
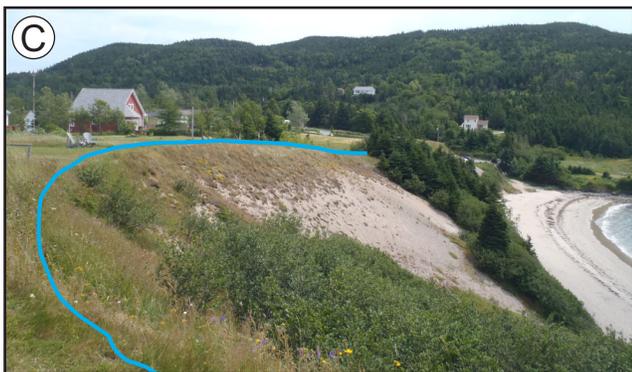
**Plate 10.** Surveys can be conducted on shore-normal transects, clifftops or breaks in slope, indicated in blue. A) Shore-normal transect at Port au Port; B) Well-defined clifftop at Parsons Pond; C) Break in a vegetated slope at Sandy Cove.

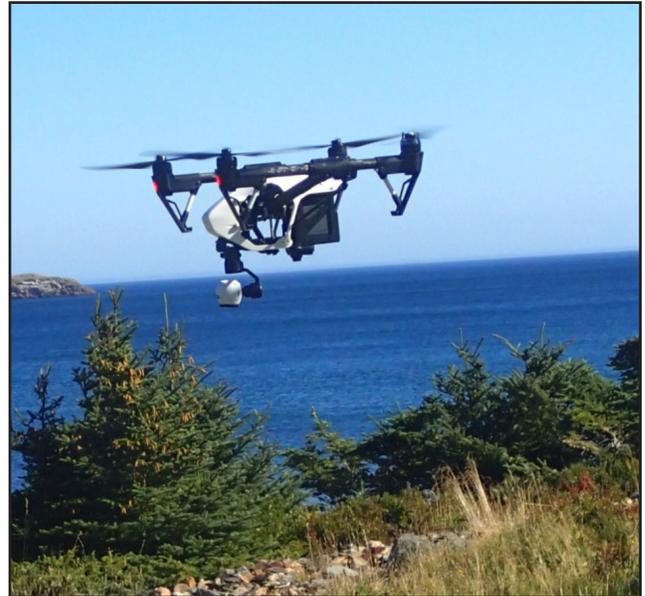
**Plate 11.** The DJI Inspire 1 Quadcopter is a light UAV equipped with a digital camera, and is controlled by an operator on the ground using a hand-held controller.

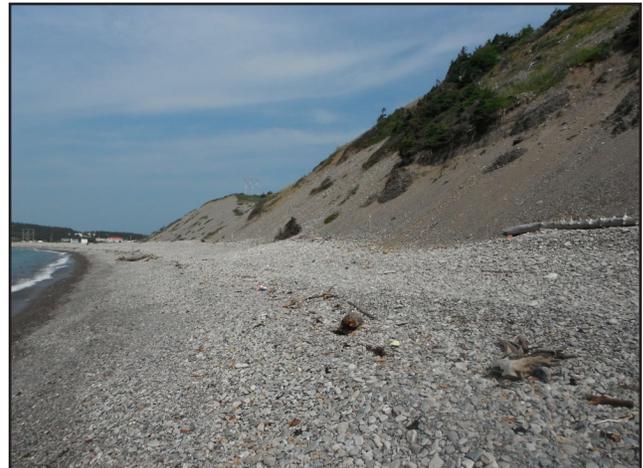
**Plate 12.** Partly vegetated gravel and sand cliff at Port au Port fronted by a gravel beach, July 2011. Erosion has been minimal along this coastline. Typically, waves do not reach the base of the cliff and groundwater is not present.

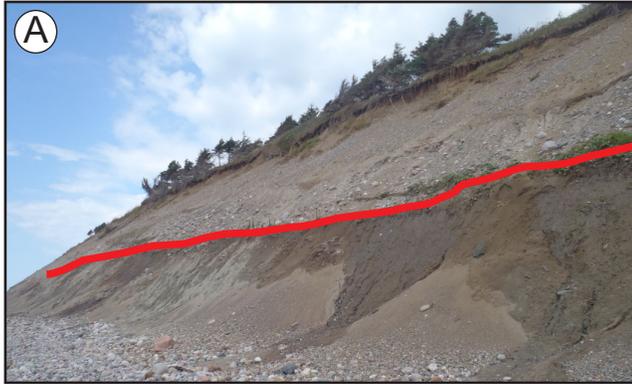
**Plate 14.** Seaside Drive, Kippens, May 2016. A) View of the cliff face. Groundwater is coming out of the cliff face at the contact (shown by the red line) between the silt and clay layer and the overlying sand and gravel layer. The water is removing sediment from the cliff face, which is being deposited at the base of the cliff; B) A portion of the hillshade of the DSM, showing the beach berm, boulders, gully, rills, slumped material, overhangs and turf mats. The left to right distance of the DSM is 330 m; C) Orthophoto of the western portion of the site. The central portion of the site has eroded at an accelerated rate. Note the truck circled for scale. The left to right distance of the orthophoto is 515 m.

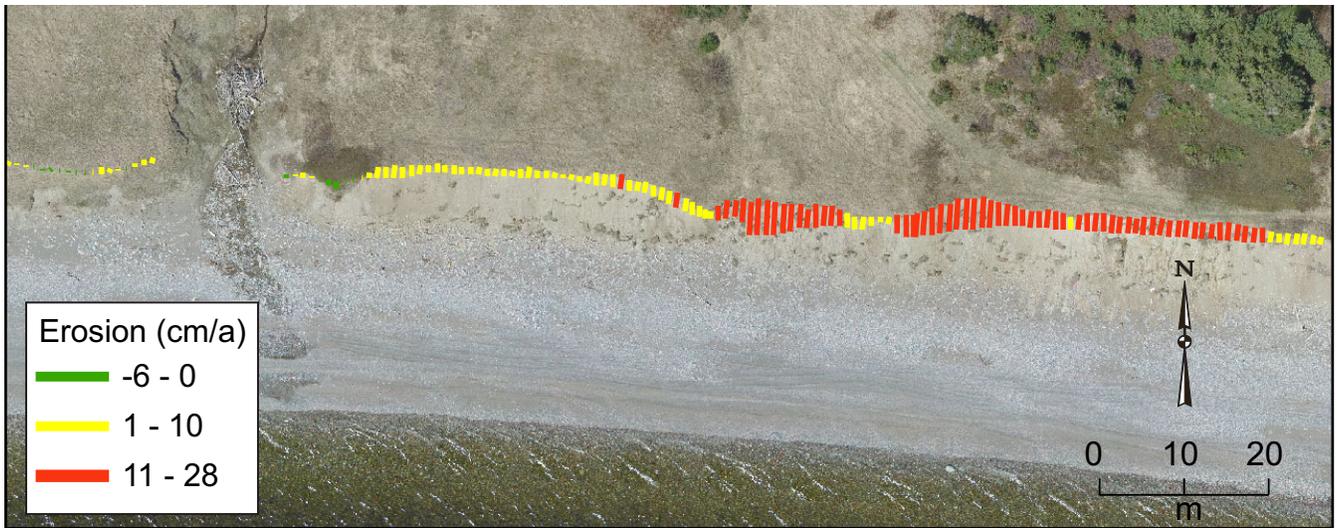
**Figure 10.** The DSAS analysis of coastal erosion from 2000 to 2016 along Seaside Drive, Kippens. Only the coastline west of Williams Lane (Figure 8) is displayed, to allow the coloured bars to be visible. Colour and bar length represent the spatial variation in erosion. The length of the bars represents the total amount (measured in cm) of cliff-top erosion for the period of analysis; the longer the bar length, the greater the amount of coastal erosion. Red, yellow and green bars denote accelerated, moderate and minor erosion respectively.

The average erosion rate for Area A in Figure 8 between 2000 and 2016 is 9 cm/a (Figure 10; Table 5). Based on digital photogrammetry, between 1974 and 1986, the same receded at a faster rate of 16 cm/a (Table 5; Forbes *et al.*, 1995). It would appear that erosion is slowing, the cause of which is not clear.

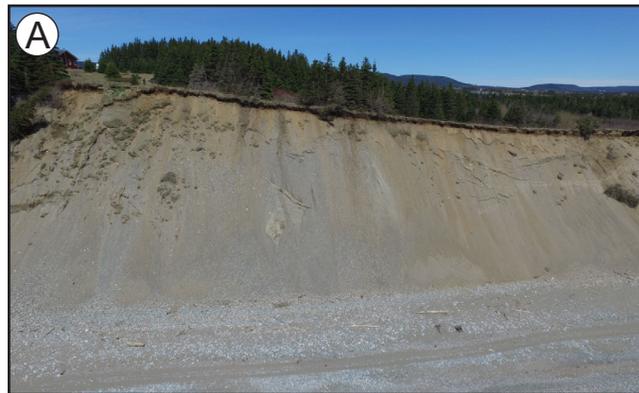
**Plate 15.** Marine Drive, Kippens, May 2016. A) Sand and gravel cliff near Marine Drive, Kippens. Wind blows the sand from the cliff, and has created overhangs along the cliff-top. Surface water is also resulting in cliff erosion; B) In the hill-shade of the DSM a well-defined berm is visible, providing evidence that waves do not frequently reach the toe of the cliff. Boulders are visible in the nearshore, as well as turf mats on the cliff face and an overhang along the cliff-top. The left to right distance of the DSM is 530 m; C) In the orthophoto, ATV tracks and the evidence of the exploitation of sand near the top of the cliff are visible. The left to right distance of the orthophoto is 530 m.

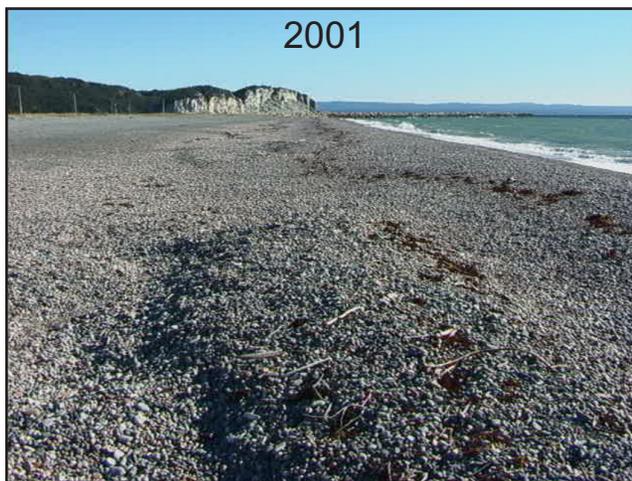
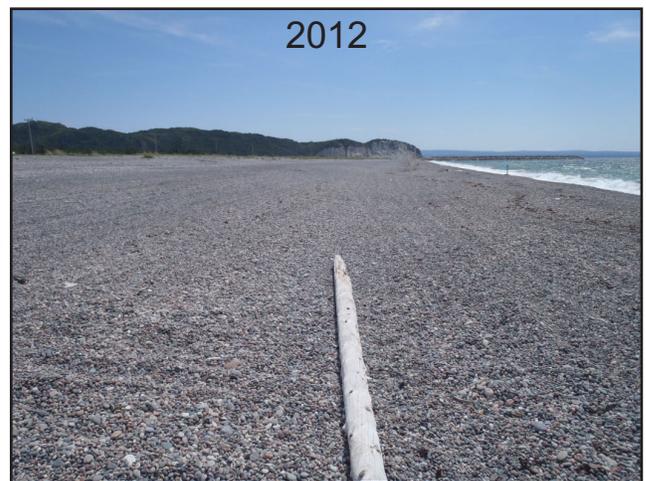
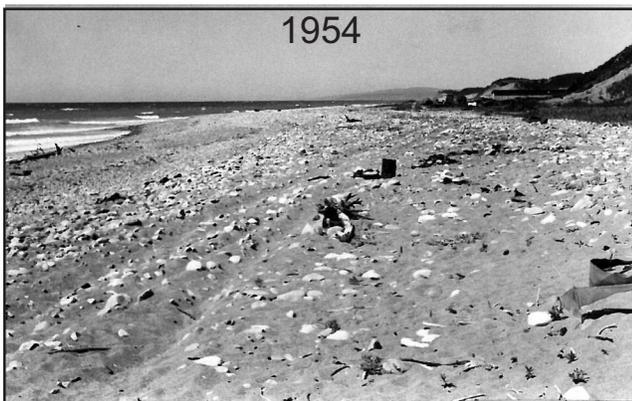
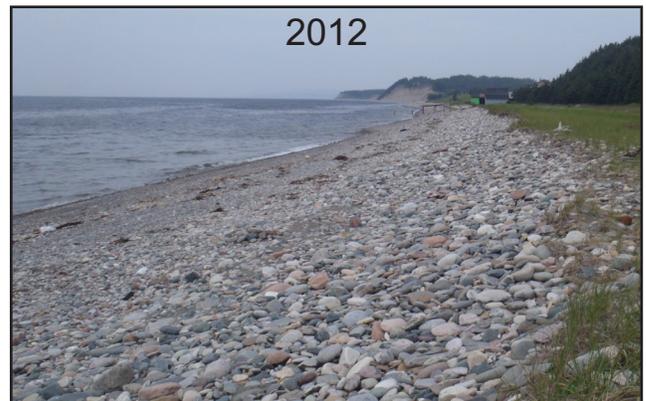
**Plate 16.** Stephenville. A) Stephenville beach in 2001 (left) and 2012 (right) looking southeast, with Indian Head and the break-water in the background. In the last 20 years, there has been accumulation of gravel on the beach face; B) Northern beach in 1954 (left) and 2012 (right). In 1954, there was more sand on the foreshore, whereas gravel is currently the dominant type of sediment.

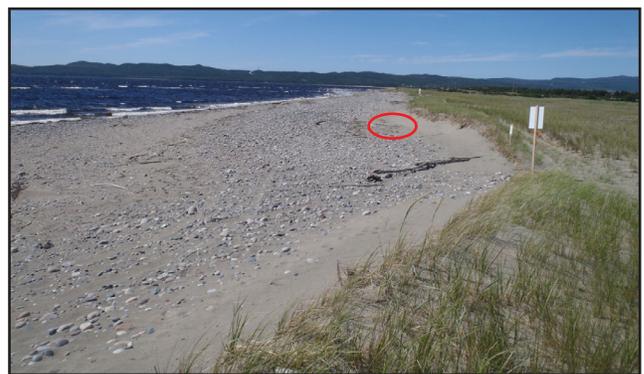
**Plate 17.** Stephenville Crossing, June 2014. The dune field is well-vegetated, and embryo dunes have formed on the beach (example circled in red).

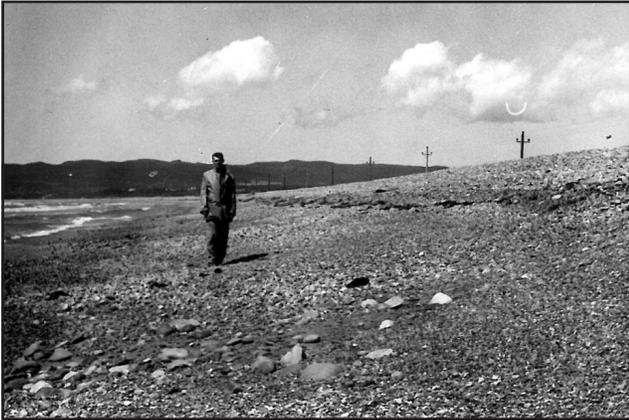
**Plate 18.** The beach north of the Gut in Stephenville Crossing in 1954 (left) and 2013 (right). The beach has remained stable; the foreshore is dominated by gravel, backed by a steep ridge.

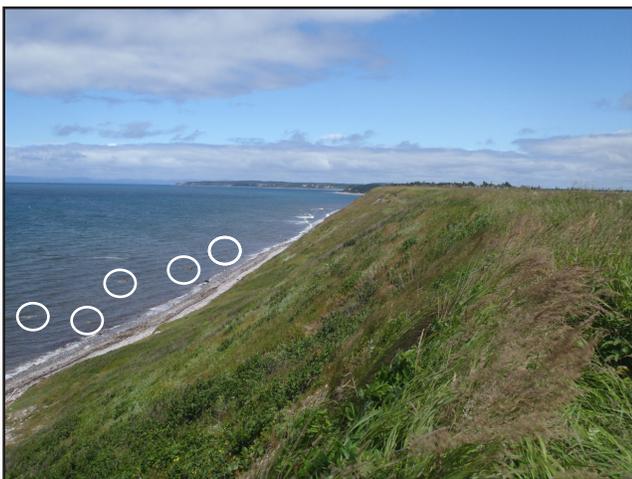
**Plate 20.** Vegetated cliff at Berry Head. As evident from the seaweed line along the beach face, waves typically do not reach the cliff base. The boulders (circled) near the waterline dissipate incoming wave energy.

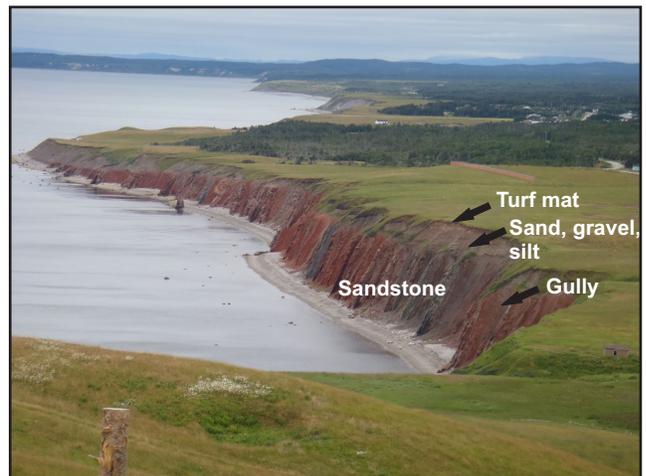
**Plate 21.** Coastal cliff at Robinsons, June 2013. In contrast to the other monitored sites, the cliff is composed of sedimentary rocks overlain by sand and gravel. Although the sedimentary rocks are soft compared to many other types of bedrock, they are harder and more resistant to erosion than unconsolidated sediment. Wind and water can loosen and move rock fragments from the cliff face.
