GOVERNMENT OF NEWFOUNDLAND AND LABRADOR Department of Transportation and Infrastructure	BRIDGE INSPECTION REPORT B07302018-1	
Date: 7/23/2018	Inspected By: Parsons R	Category: Maint. - Maintenance	
BRIDGE INFORMATION			
Site:	1-084 - NORTHERN BAY BROOK BRIDGE		
Route:		Overall Length:	22.4 m
Year Built:	1971	Est: No	Overall Width: 9.4 m
Year Last Rehab.:		Est: No	Roadway Width: 6.3 m
Region:	AVALON PENINSULA	Sidewalk Width:	0 m
Jurisdiction:	Provincial	Clearance to R.D. or N.W.L.:	2.5 m
Type of Structure:	01 - AASH to Girder	Max Depth of N.W.L.:	1 m
Purpose of Structure:	04 - Over Non-Navigable Waters	Spans:	
Type of Handrail:	04 - Steel Rail	<u>Span No.:</u>	<u>Length</u>
Roadway Surface:	02 - Asphalt	1	14.8
Alignment Vertical:	01 - Good	2	0
Alignment Horizontal:	03 - Poor	3	0
Restrictions:	No	<u>Span No.:</u>	<u>Length</u>
		4	0
		5	0
		6	0
BRIDGE PHOTOS

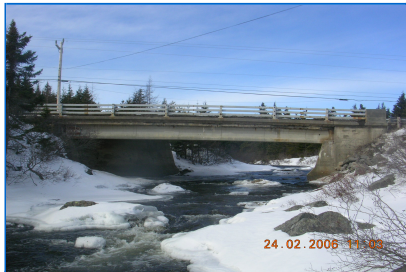
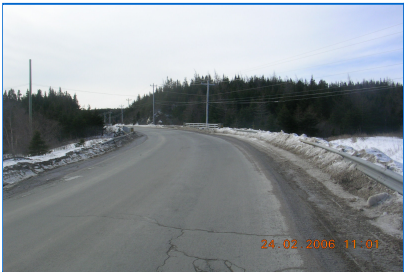
Bearing Seat:	G - Good
Comments:	- Minor scouring of footings.		
SUPERSTRUCTURE			
Condition:	G - Good	Expansion Joints:	U - Uninspectable
Comments:	- Expansion joints paved over. - Expansion joints need levelling with asphalt. - T beams in good condition.		
DECK			
Condition:	G - Good	Curbs:	G - Good
Hand Rail:	G - Good	Roadway Condition:	G - Good

Approach Rail:	F2 - Fair		
Comments:	- Approach rail needs repair on north approach.		
HYDROLOGY			
Water Velocity:	0 m/s	Ice Problem:	P - Possible Problem
Water Depth:	0.75 m	Scour Problem:	P - Possible Problem
Waterway:	01 - Adequate	Debris Problem:	P - Possible Problem
Comments:			
REPLACEMENT/REHABILITATION			
Next Rehab. Date:	2018	Replacement Year:	2018
Antic. Rehab. Cost:	\$0	Replacement Cost:	\$0
Recommendations:			
OBSERVATIONS			
Overall Condition:	G - Good	Requires Further Inspection:	No
Additional Observations:			
LEGEND:			
Condition Definitions:			
1 - *Good - [discontinued code].	F2 - Fair.	C - Unsafe (Closed to Public).	Problem Definitions:
2 - *Fair - [discontinued code].	F1 - Fair.	U - Uninspectable.	N - No Problem.
3 - *Poor - [discontinued code].	P3 - Poor.	I - Inapplicable.	P - Possible Problem.
4 - *Unsafe - [discontinued code].	P1 - Poor.		K - Known Problem.
G - Good.	P - Poor.		NA - Not Applicable.
