GOVERNMENT OF NEWFOUNDLAND AND LABRADOR Department of Transportation and Infrastructure	BRIDGE INSPECTION REPORT B06092015-15	
Date: 5/13/2015	Inspected By: G. Stuckless/J. Sharron	Category: Eng. - Engineering	
BRIDGE INFORMATION			
Site:	3-174 - BROWNS ARM BRIDGE		
Route:	341	Overall Length:	6.1 m
Year Built:	1950	Est: Yes	Overall Width: 5.6 m
Year Last Rehab.:		Est: No	Roadway Width: 5.6 m
Region:	CENTRAL WEST	Sidewalk Width:	0 m
Jurisdiction:	Provincial	Clearance to R.D. or N.W.L.:	1 m
Type of Structure:	13 - Other	Max Depth of N.W.L.:	1 m
Purpose of Structure:	04 - Over Non-Navigable Waters		
Type of Handrail:	06 - None		
Roadway Surface:	01 - Concrete	Spans:	
Alignment Vertical:	01 - Good	<u>Span No.:</u>	<u>Length</u>
Alignment Horizontal:	01 - Good	1	6.1
Restrictions:	No	2	0
		3	0
		<u>Span No.:</u>	<u>Length</u>
		4	0
		5	0
		6	0
BRIDGE PHOTOS

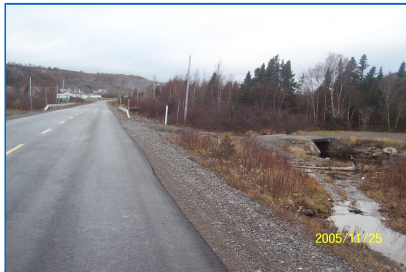
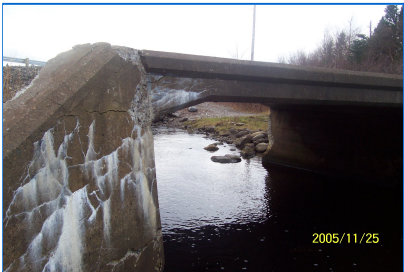
Bearing Seat:	I - Inapplicable
Comments:	Abutment spalling and delaminating. Scouring at the footings.		
SUPERSTRUCTURE			
Condition:	P1 - Poor	Expansion Joints:	I - Inapplicable
Comments:	Wing wall spalling and delamination beyond repair.		
DECK			
Condition:	P1 - Poor	Curbs:	I - Inapplicable
Hand Rail:	I - Inapplicable	Roadway Condition:	I - Inapplicable

Approach Rail:	I - Inapplicable		
Comments:	large cracking where deck meets asphalt and delamination		
HYDROLOGY			
Water Velocity:	steady m/s	Ice Problem:	N - No Problem
Water Depth:	>1.0 m	Scour Problem:	P - Possible Problem
Waterway:	03 - Not Applicable	Debris Problem:	N - No Problem
Comments:			
REPLACEMENT/REHABILITATION			
Next Rehab. Date:		Replacement Year:	
Antic. Rehab. Cost:	\$0	Replacement Cost:	\$0
Recommendations:	Replace with new structure. Pipes are currently still used by locals.		
OBSERVATIONS			
Overall Condition:	P1 - Poor	Requires Further Inspection:	No
Additional Observations:	Signs of use by vehicles, atvs and snowmobiles.		
LEGEND:			
Condition Definitions:		Problem Definitions:	
1 - *Good - [discontinued code].	F2 - Fair.	C - Unsafe (Closed to Public).	N - No Problem.
2 - *Fair - [discontinued code].	F1 - Fair.	U - Uninspectable.	P - Possible Problem.
3 - *Poor - [discontinued code].	P3 - Poor.	I - Inapplicable.	K - Known Problem.
