GOVERNMENT OF NEWFOUNDLAND AND LABRADOR Department of Transportation and Infrastructure	BRIDGE INSPECTION REPORT B02142023-5	
Date: 5/16/2022	Inspected By: Mike Fleming	Category: Eng. - Engineering	
BRIDGE INFORMATION			
Site:	4-144 - EASTERN BROOK POND BRIDGE		
Route:	437	Overall Length:	20.5 m
Year Built:	1987	Est: No	Overall Width: 9.61 m
Year Last Rehab.:		Est: No	Roadway Width: 8.9 m
Region:	WEST COAST/NORTHERN		Sidewalk Width: 0 m
Jurisdiction:	Provincial	Clearance to R.D. or N.W.L.:	1.6 m
Type of Structure:	04 - Rigid Frame	Max Depth of N.W.L.:	0.5 m
Purpose of Structure:	03 - Over Navigable Waters		
Type of Handrail:	01 - Aluminum Rail	Spans:	
Roadway Surface:	02 - Asphalt	<u>Span No.:</u>	<u>Length</u>
Alignment Vertical:	01 - Good	1	15.9
Alignment Horizontal:	01 - Good	2	0
Restrictions:	No	3	0
		<u>Span No.:</u>	<u>Length</u>
		4	0
		5	0
		6	0
BRIDGE PHOTOS

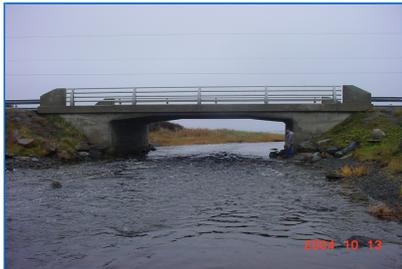
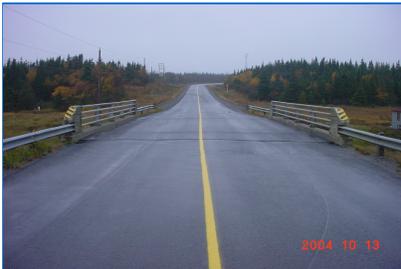
Bearing Seat:	I - Inapplicable
Comments:			
SUPERSTRUCTURE			
Condition:	F2 - Fair	Expansion Joints:	I - Inapplicable
Comments:	Concrete starting to delaminate on the deck soffit.		
DECK			
Condition:	F2 - Fair	Curbs:	F2 - Fair
Hand Rail:	F2 - Fair	Roadway Condition:	F1 - Fair

Approach Rail:	P3 - Poor		
Comments:	Moderate transverse cracking/asphalt potholes and delamination at the approach slab/deck transition.		
HYDROLOGY			
Water Velocity:	0 m/s	Ice Problem:	N - No Problem
Water Depth:	0 m	Scour Problem:	N - No Problem
Waterway:	01 - Adequate	Debris Problem:	N - No Problem
Comments:			
REPLACEMENT/REHABILITATION			
Next Rehab. Date:		Replacement Year:	
Antic. Rehab. Cost:	\$0	Replacement Cost:	\$0
Recommendations:	Patch potholes		
OBSERVATIONS			
Overall Condition:	F2 - Fair	Requires Further Inspection:	No
Additional Observations:	Pics on file		
LEGEND:			
Condition Definitions:			
1 - *Good - [discontinued code].	F2 - Fair.	C - Unsafe (Closed to Public).	Problem Definitions:
2 - *Fair - [discontinued code].	F1 - Fair.	U - Uninspectable.	N - No Problem.
3 - *Poor - [discontinued code].	P3 - Poor.	I - Inapplicable.	P - Possible Problem.
4 - *Unsafe - [discontinued code].	P1 - Poor.		K - Known Problem.
