GOVERNMENT OF
NEWFOUNDLAND
AND LABRADOR
Department of Transportation and Infrastructure

**BRIDGE INSPECTION REPORT
B06012022-2**

Site:	4-187 - HARRY'S RIVER BRIDGE (GALLANTS)		
Route:		Overall Length:	36.9 m
Year Built:	1994	Est: No	Overall Width: 9.4 m
Year Last Rehab.:		Est: No	Roadway Width: 7.5 m
Region:	WEST COAST/NORTHERN		Sidewalk Width: 0 m
Jurisdiction:	Provincial		Clearance to R.D. or N.W.L.: 1.4 m
Type of Structure:	01 - AASH to Girder		Max Depth of N.W.L.: 0.7 m
Purpose of Structure:	03 - Over Navigable Waters		Spans:
Type of Handrail:	01 - Aluminum Rail		<u>Span No.:</u> <u>Length</u> <u>Span No.:</u> <u>Length</u>
Roadway Surface:	01 - Concrete		1 24.2 4 0
Alignment Vertical:	02 - Adequate		2 0 5 0
Alignment Horizontal:	02 - Adequate		3 0 6 0
Restrictions:	No

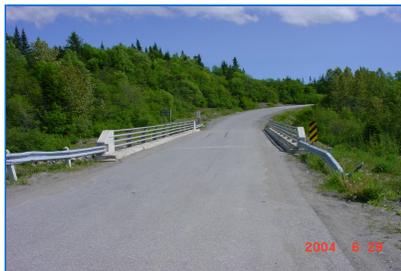
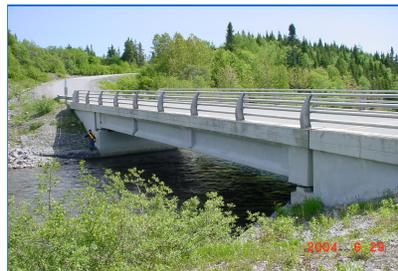
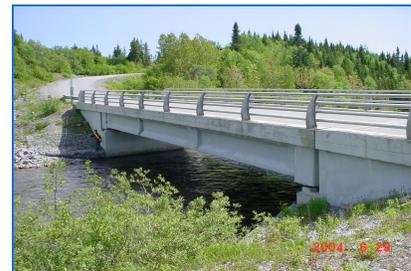
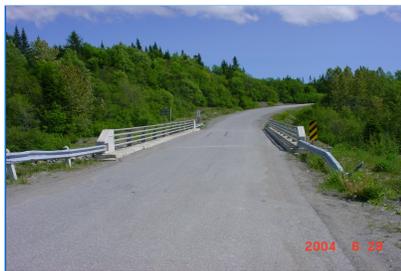
BRIDGE PHOTOS

SUPERSTRUCTURE			
Condition:	G - Good	Expansion Joints:	G - Good
Comments:	Minor spalling on the upstream outer girder.		
DECK			
Condition:	G - Good	Curbs:	G - Good
Hand Rail:	G - Good	Roadway Condition:	G - Good
Approach Rail:	G - Good		
Comments:	Cracking in asphalt at edge of approach and potholes forming near expansion joints.		
HYDROLOGY			
Water Velocity:	0 m/s	Ice Problem:	K - Known Problem
Water Depth:	0 m	Scour Problem:	P - Possible Problem
Waterway:	01 - Adequate	Debris Problem:	P - Possible Problem
Comments:			
REPLACEMENT/REHABILITATION			
Next Rehab. Date:		Replacement Year:	
Antic. Rehab. Cost:	\$0	Replacement Cost:	\$0
Recommendations:	Remove winter sand. Replace approach rail and install hazard markers.		
OBSERVATIONS			
Overall Condition:	G - Good	Requires Further Inspection:	No
Additional Observations:	Pictures on file		
LEGEND:			
Condition Definitions:		Problem Definitions:	
1 - *Good - [discontinued code].	F2 - Fair.	C - Unsafe (Closed to Public).	N - No Problem.
