GOVERNMENT OF NEWFOUNDLAND AND LABRADOR Department of Transportation and Infrastructure	BRIDGE INSPECTION REPORT B06012022-3	
Date: 4/26/2022	Inspected By: Colby Spencer	Category: Eng. - Engineering	
BRIDGE INFORMATION			
Site:	TCH-069 - PINCHGUT BROOK BRIDGE		
Route:		Overall Length:	41.9 m
Year Built:	2003	Est: No	Overall Width: 13.8 m
Year Last Rehab.:		Est: No	Roadway Width: 13.1 m
Region:	WEST COAST/NORTHERN	Sidewalk Width:	0 m
Jurisdiction:	Provincial	Clearance to R.D. or N.W.L.:	3 m
Type of Structure:	01 - AASH to Girder	Max Depth of N.W.L.:	0.7 m
Purpose of Structure:	03 - Over Navigable Waters	Spans:	
Type of Handrail:	05 - Concrete Barrier	<u>Span No.:</u>	<u>Length</u>
Roadway Surface:	01 - Concrete	1	25.8
Alignment Vertical:	01 - Good	2	0
Alignment Horizontal:	01 - Good	3	0
Restrictions:	No	<u>Span No.:</u>	<u>Length</u>
		4	0
		5	0
		6	0
BRIDGE PHOTOS

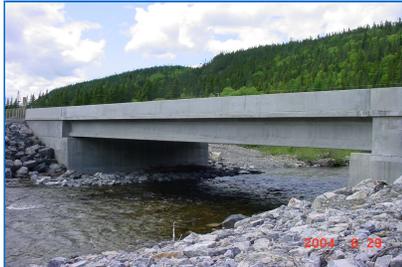
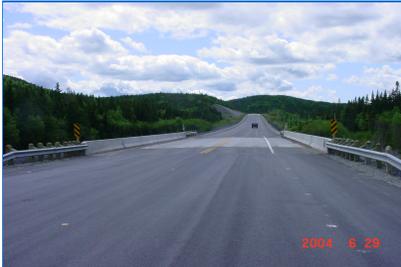
Approach Rail:	F2 - Fair		
Comments:	Approach rail detached from 3 posts and rail missing some posts. Cracking in asphalt at edge of approach slab. Downstream gutter undermining.		
HYDROLOGY			
Water Velocity:	0 m/s	Ice Problem:	P - Possible Problem
Water Depth:	0 m	Scour Problem:	P - Possible Problem
Waterway:	01 - Adequate	Debris Problem:	P - Possible Problem
Comments:			
REPLACEMENT/REHABILITATION			
Next Rehab. Date:		Replacement Year:	
Antic. Rehab. Cost:	\$0	Replacement Cost:	\$0
Recommendations:	Repair approach rail and gutter. Remove winter sand build-up along jersey barriers. Install bridge signage and four hazard markers.		
OBSERVATIONS			
Overall Condition:	G - Good	Requires Further Inspection:	No
Additional Observations:			
LEGEND:			
Condition Definitions:		Problem Definitions:	
1 - *Good - [discontinued code].	F2 - Fair.	C - Unsafe (Closed to Public).	N - No Problem.
2 - *Fair - [discontinued code].	F1 - Fair.	U - Uninspectable.	P - Possible Problem.
