GOVERNMENT OF NEWFOUNDLAND AND LABRADOR Department of Transportation and Infrastructure	BRIDGE INSPECTION REPORT B07302018-3	
Date: 7/23/2018	Inspected By: Parsons R	Category: Maint. - Maintenance	
BRIDGE INFORMATION			
Site:	1-086 - OCHRE PIT BROOK BRIDGE		
Route:		Overall Length:	17.3 m
Year Built:	1970	Est: No	Overall Width: 9.8 m
Year Last Rehab.:		Est: No	Roadway Width: 6.3 m
Region:	AVALON PENINSULA	Sidewalk Width:	0 m
Jurisdiction:	Provincial	Clearance to R.D. or N.W.L.:	3.2 m
Type of Structure:	02 - Double Tee	Max Depth of N.W.L.:	0.5 m
Purpose of Structure:	04 - Over Non-Navigable Waters	Spans:	
Type of Handrail:	04 - Steel Rail	<u>Span No.:</u>	<u>Length</u>
Roadway Surface:	02 - Asphalt	<u>Span No.:</u>	<u>Length</u>
Alignment Vertical:	02 - Adequate	1	8
Alignment Horizontal:	02 - Adequate	2	0
Restrictions:	No	3	0
		4	0
		5	0
		6	0
BRIDGE PHOTOS

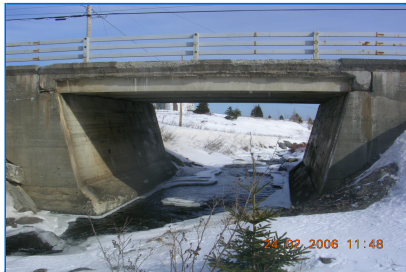
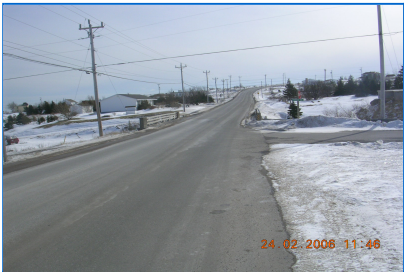
Bearing Seat:	F2 - Fair
Comments:	- Scouring and some deterioration of footings and south abutment and exposed rebar. - Undermining inlet and outlet beams crumbling with exposed rebar.		
SUPERSTRUCTURE			
Condition:	F1 - Fair	Expansion Joints:	U - Uninspectable
Comments:	- Expansion joints paved over. - Expansion joints cracked.		
DECK			
Condition:	P - Poor	Curbs:	P - Poor
Hand Rail:	P - Poor	Roadway Condition:	P - Poor

Approach Rail:	F2 - Fair		
Comments:	- Railing is in very poor condition needs replacing. - Curb and rail footings deteriorating and crumbling.		
HYDROLOGY			
Water Velocity:	0 m/s	Ice Problem:	P - Possible Problem
Water Depth:	1.0 m	Scour Problem:	K - Known Problem
Waterway:	01 - Adequate	Debris Problem:	P - Possible Problem
Comments:			
REPLACEMENT/REHABILITATION			
Next Rehab. Date:	2018	Replacement Year:	2018
Antic. Rehab. Cost:	\$0	Replacement Cost:	\$0
Recommendations:			
OBSERVATIONS			
Overall Condition:	P1 - Poor	Requires Further Inspection:	Yes
Additional Observations:	- Substructure fair curbs rails and footings in very bad shape needs visit from bridge office.		
LEGEND:			
Condition Definitions:			
1 - *Good - [discontinued code].	F2 - Fair.	C - Unsafe (Closed to Public).	Problem Definitions:
2 - *Fair - [discontinued code].	F1 - Fair.	U - Uninspectable.	N - No Problem.
3 - *Poor - [discontinued code].	P3 - Poor.	I - Inapplicable.	P - Possible Problem.
