GOVERNMENT OF NEWFOUNDLAND AND LABRADOR Department of Transportation and Infrastructure	BRIDGE INSPECTION REPORT B01102020-11	
Date: 11/14/2019	Inspected By: Lynch R / Martin L	Category: Eng. - Engineering	
BRIDGE INFORMATION			
Site:	TCH-140 - RATTLING BROOK PENSTOCK BRIDGE		
Route:		Overall Length:	51.4 m
Year Built:	2004	Est: No	Overall Width: 15.546 m
Year Last Rehab.:		Est: No	Roadway Width: 14.636 m
Region:	CENTRAL WEST	Sidewalk Width:	0 m
Jurisdiction:	Provincial	Clearance to R.D. or N.W.L.:	5 m
Type of Structure:	13 - Other	Max Depth of N.W.L.:	0 m
Purpose of Structure:	05 - Combination of Above		
Type of Handrail:	05 - Concrete Barrier		
Roadway Surface:	01 - Concrete	Span No.:	Length
Alignment Vertical:	02 - Adequate	1	38.6
Alignment Horizontal:	01 - Good	2	0
Restrictions:	No	3	0
		Span No.:	Length
		4	0
		5	0
		6	0
BRIDGE PHOTOS			
<div style="display: flex; justify-content: space-around;">

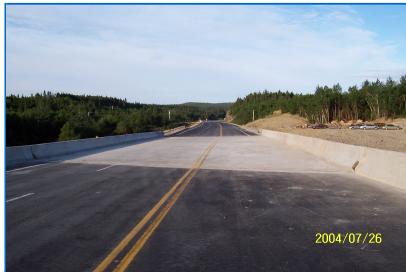
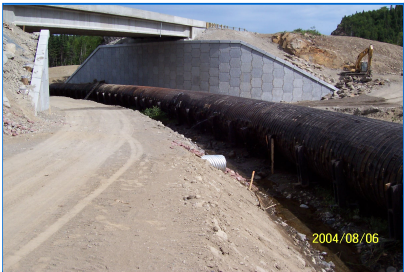
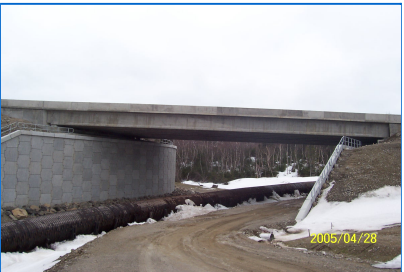
SUBSTRUCTURE			
Condition:	F2 - Fair	Bearings:	F2 - Fair
		Bearing Seat:	F2 - Fair
Comments:	All bearings in shear in different directions.		
SUPERSTRUCTURE			
Condition:	F2 - Fair	Expansion Joints:	F2 - Fair
Comments:	Expansion joint armour in jersey barrier LHS missing; large spalls with concrete exposed		
DECK			
Condition:	F2 - Fair	Curbs:	I - Inapplicable
Hand Rail:	I - Inapplicable	Roadway Condition:	I - Inapplicable

Approach Rail:	F2 - Fair		
Comments:	Minor plow damage to approach rails. Transitions on and off deck not level. Approaches settled and patched.		
HYDROLOGY			
Water Velocity:	0 m/s	Ice Problem:	NA - Not Applicable
Water Depth:	0 m	Scour Problem:	NA - Not Applicable
Waterway:	03 - Not Applicable	Debris Problem:	NA - Not Applicable
Comments:	Penstock and small brook crossing beneath structure.		
REPLACEMENT/REHABILITATION			
Next Rehab. Date:		Replacement Year:	
Antic. Rehab. Cost:	\$0	Replacement Cost:	\$0
Recommendations:	Repair jersey barrier and regrade approaches.		
OBSERVATIONS			
Overall Condition:	F2 - Fair	Requires Further Inspection:	No
Additional Observations:			
LEGEND:			
Condition Definitions:			
1 - *Good - [discontinued code].	F2 - Fair.	C - Unsafe (Closed to Public).	Problem Definitions:
2 - *Fair - [discontinued code].	F1 - Fair.	U - Uninspectable.	N - No Problem.
3 - *Poor - [discontinued code].	P3 - Poor.	I - Inapplicable.	P - Possible Problem.
