GOVERNMENT OF NEWFOUNDLAND AND LABRADOR Department of Transportation and Infrastructure	BRIDGE INSPECTION REPORT B08022021-10	
Date: 5/6/2021	Inspected By: Butler	Category: Eng. - Engineering	
BRIDGE INFORMATION			
Site: 2-195 - GARDEN COVE BRIDGE (OLD) - R210			
BRIDGE PHOTOS			
<div style="display: flex; justify-content: space-around;">

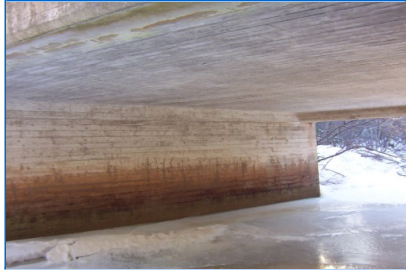
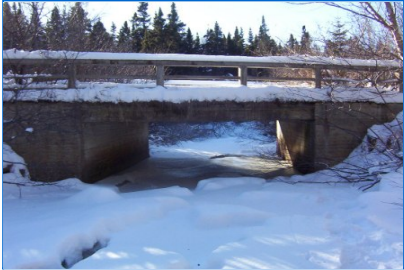
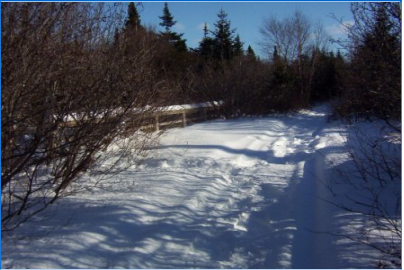
</div>			
SUBSTRUCTURE			
Condition:	F2 - Fair	Bearings:	I - Inapplicable
		Bearing Seat:	F2 - Fair
Comments:	Concrete abutments and wingwalls. Some cracking and erosion of the concrete.		
SUPERSTRUCTURE			
Condition:	F2 - Fair	Expansion Joints:	I - Inapplicable
Comments:	Reinforced concrete deck slab. Top weathered, some light cracks, noticed during 2017 inspection.		
DECK			
Condition:	P3 - Poor	Curbs:	P3 - Poor
Hand Rail:	P3 - Poor	Roadway Condition:	P3 - Poor
Approach Rail:	I - Inapplicable		
Comments:	Exposed concrete deck. Some vegetation growing on deck. Concrete hand rail, some light cracks. Roadway partly grown in. Appears to be a settlement adjacent to approach 2. Left side curb is spalling and losing concrete.

HYDROLOGY			
Water Velocity:	0.5 m/s	Ice Problem:	N - No Problem
Water Depth:	0.5 m	Scour Problem:	K - Known Problem
Waterway:	01 - Adequate	Debris Problem:	N - No Problem
Comments:	Minor scour at abutment two, could be causing settlement on approach surface.		
REPLACEMENT/REHABILITATION			
Next Rehab. Date:		Replacement Year:	
Antic. Rehab. Cost:	\$0	Replacement Cost:	\$0
Recommendations:	Repair scour and settlement.
