GOVERNMENT OF NEWFOUNDLAND AND LABRADOR Department of Transportation and Infrastructure	BRIDGE INSPECTION REPORT B01182021-16	
Date: 5/25/2020	Inspected By: Mike Fleming	Category: Eng. - Engineering	
BRIDGE INFORMATION			
Site:	4-011 - CLARKES BROOK BRIDGE		
Route:	450	Overall Length:	35.3 m
Year Built:	1962	Est: No	Overall Width: 10.4 m
Year Last Rehab.:	1995	Est: Yes	Roadway Width: 8 m
Region:	WEST COAST/NORTHERN		Sidewalk Width: 1.4 m
Jurisdiction:	Provincial		Clearance to R.D. or N.W.L.: 2.6 m
Type of Structure:	01 - AASH to Girder		Max Depth of N.W.L.: 0.5 m
Purpose of Structure:	03 - Over Navigable Waters		Spans:
Type of Handrail:	01 - Aluminum Rail		<u>Span No.:</u> <u>Length</u> <u>Span No.:</u> <u>Length</u>
Roadway Surface:	02 - Asphalt	1	23.6 4 0
Alignment Vertical:	02 - Adequate	2	0 5 0
Alignment Horizontal:	01 - Good	3	0 6 0
Restrictions:	No		
BRIDGE PHOTOS

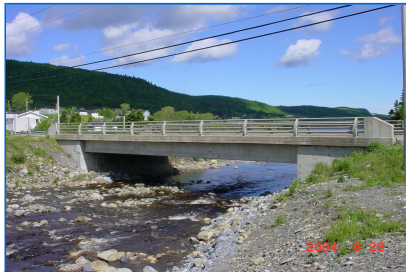
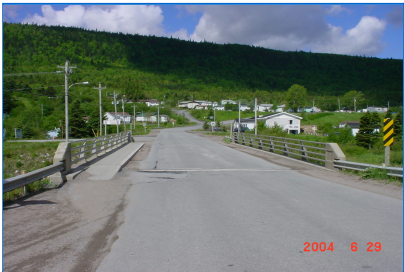
Bearing Seat:	G - Good
Comments:	Minor scaling damage and scaling along both abutment walls.		
SUPERSTRUCTURE			
Condition:	F2 - Fair	Expansion Joints:	P3 - Poor
Comments:	Expansion joints damaged and leaking. Moderate cracking throughout bottom portion of fascia girders and heavy efflorescence deposits on fascia girders.		
DECK			
Condition:	F2 - Fair	Curbs:	G - Good
Hand Rail:	F2 - Fair	Roadway Condition:	G - Good

Approach Rail:	F2 - Fair		
Comments:			
HYDROLOGY			
Water Velocity:	0 m/s	Ice Problem:	K - Known Problem
Water Depth:	0 m	Scour Problem:	P - Possible Problem
Waterway:	01 - Adequate	Debris Problem:	P - Possible Problem
Comments:			
REPLACEMENT/REHABILITATION			
Next Rehab. Date:	2021	Replacement Year:	2021
Antic. Rehab. Cost:	\$0	Replacement Cost:	\$0
Recommendations:			
OBSERVATIONS			
Overall Condition:	F2 - Fair	Requires Further Inspection:	No
Additional Observations:	Inspection pictures on file.		
LEGEND:			
Condition Definitions:			
1 - *Good - [discontinued code].	F2 - Fair.	C - Unsafe (Closed to Public).	Problem Definitions:
2 - *Fair - [discontinued code].	F1 - Fair.	U - Uninspectable.	N - No Problem.
3 - *Poor - [discontinued code].	P3 - Poor.	I - Inapplicable.	P - Possible Problem.
4 - *Unsafe - [discontinued code].	P1 - Poor.		K - Known Problem.
G - Good.	P - Poor.		NA - Not Applicable.
Category Definitions:
