GOVERNMENT OF NEWFOUNDLAND AND LABRADOR Department of Transportation and Infrastructure	BRIDGE INSPECTION REPORT B01192021-10	
Date: 5/22/2020	Inspected By: Mike Fleming	Category: Eng. - Engineering	
BRIDGE INFORMATION			
Site:	TCH-101 - CORNER BROOK STREAM BRIDE (ON CB INTERCHANGE)		
Route:		Overall Length:	30.1 m
Year Built:	1981	Est: No	Overall Width: 10.7 m
Year Last Rehab.:	1987	Est: No	Roadway Width: 8.9 m
Region:	WEST COAST/NORTHERN		Sidewalk Width: 0 m
Jurisdiction:	Provincial	Clearance to R.D. or N.W.L.:	3.4 m
Type of Structure:	02 - Double Tee	Max Depth of N.W.L.:	1.5 m
Purpose of Structure:	03 - Over Navigable Waters		
Type of Handrail:	01 - Aluminum Rail		
Roadway Surface:	02 - Asphalt	Spans:	
Alignment Vertical:	01 - Good	<u>Span No.:</u>	<u>Length</u>
Alignment Horizontal:	02 - Adequate	1	12.2
Restrictions:	No	2	0
		3	0
		<u>Span No.:</u>	<u>Length</u>
		4	0
		5	0
		6	0
BRIDGE PHOTOS

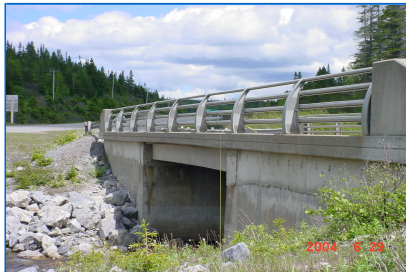
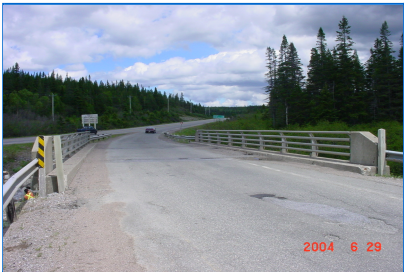
SUBSTRUCTURE			
Condition:	F2 - Fair	Bearings:	G - Good
		Bearing Seat:	G - Good
Comments:			
SUPERSTRUCTURE			
Condition:	F2 - Fair	Expansion Joints:	P3 - Poor
Comments:	Expansion joints paved over and leaking		
DECK			
Condition:	F2 - Fair	Curbs:	F2 - Fair
Hand Rail:	G - Good	Roadway Condition:	F2 - Fair

Approach Rail:	F2 - Fair		
Comments:	minor damage noted on curb; approach rail is damaged.		
HYDROLOGY			
Water Velocity:	0 m/s	Ice Problem:	P - Possible Problem
Water Depth:	0 m	Scour Problem:	P - Possible Problem
Waterway:	01 - Adequate	Debris Problem:	P - Possible Problem
Comments:			
REPLACEMENT/REHABILITATION			
Next Rehab. Date:	2021	Replacement Year:	2021
Antic. Rehab. Cost:	\$0	Replacement Cost:	\$0
Recommendations:			
OBSERVATIONS			
Overall Condition:	F2 - Fair	Requires Further Inspection:	No
Additional Observations:	Inspection pictures on file.		
LEGEND:			
Condition Definitions:			
1 - *Good - [discontinued code].	F2 - Fair.	C - Unsafe (Closed to Public).	Problem Definitions:
2 - *Fair - [discontinued code].	F1 - Fair.	U - Uninspectable.	N - No Problem.
3 - *Poor - [discontinued code].	P3 - Poor.	I - Inapplicable.	P - Possible Problem.
4 - *Unsafe - [discontinued code].	P1 - Poor.		K - Known Problem.
