Wastewater Collection Pipe Rehabilitation (CIPP)

Circular Road Project

Grand Falls · Windsor

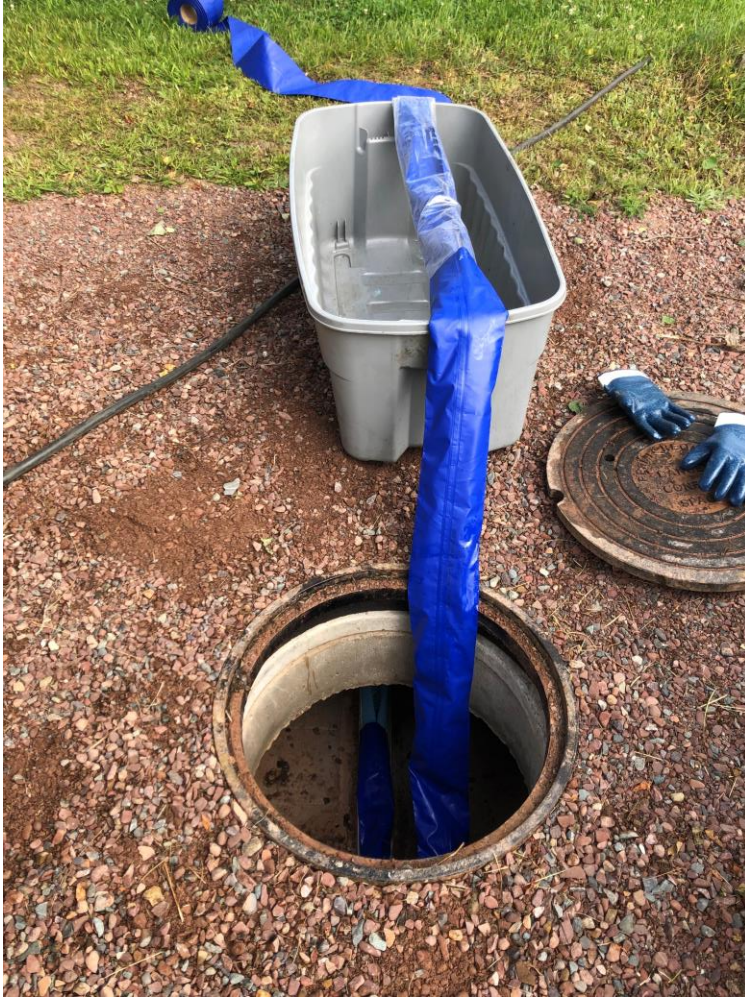
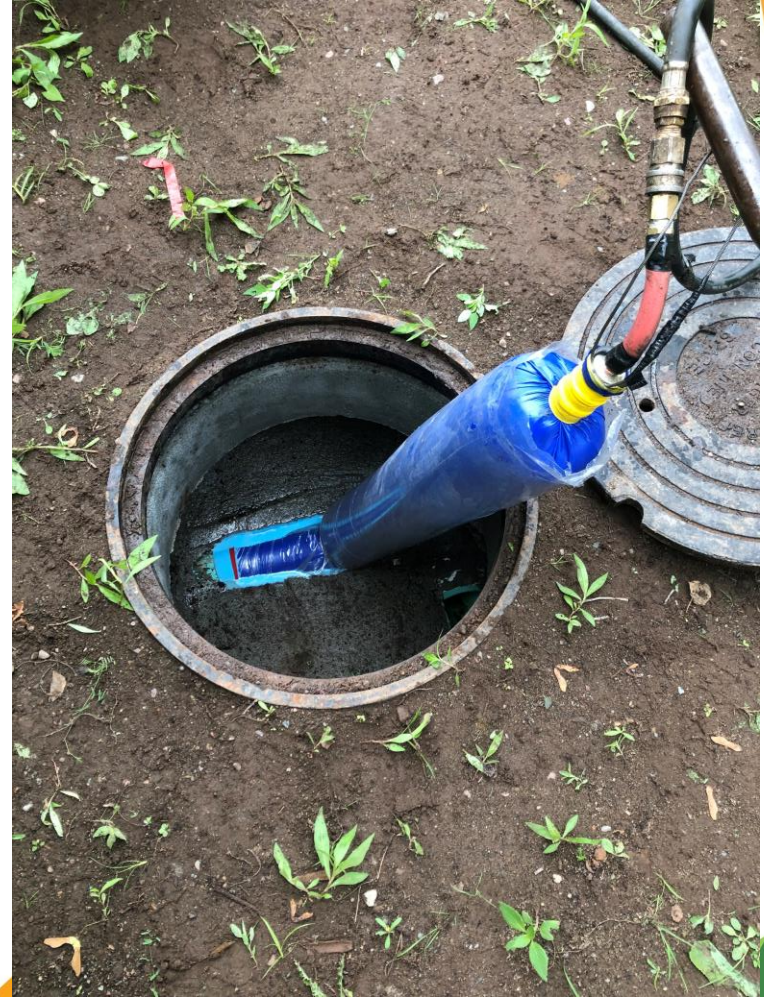
Hot Water Curing

- All 100 mm pipes were wetted with epoxy on-site and cured with hot water.
- Epoxy lining designed for shorter runs (~50m)
- 1-3 hour curing time
- Disadvantage is they must be used installed and cured quickly.

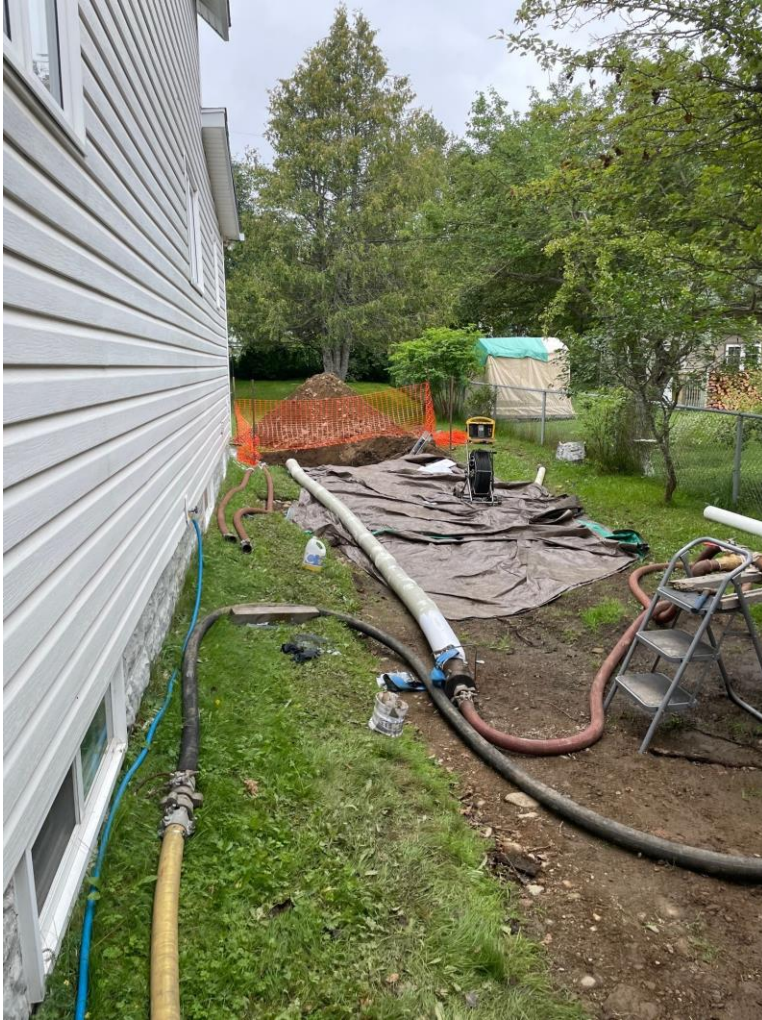
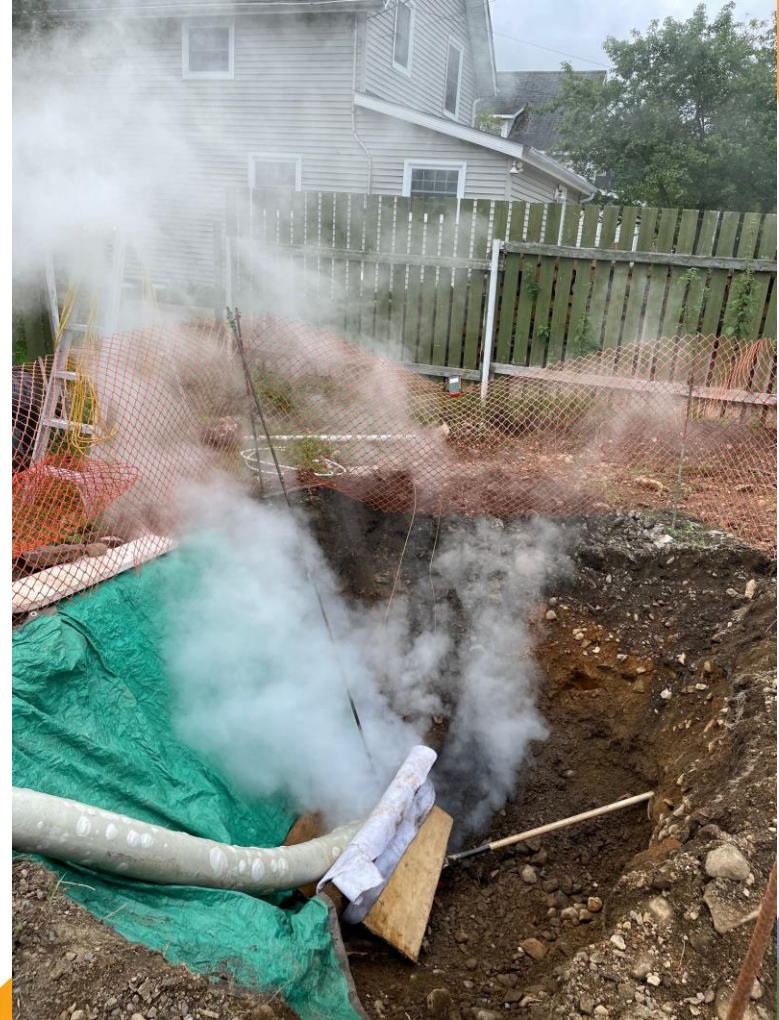
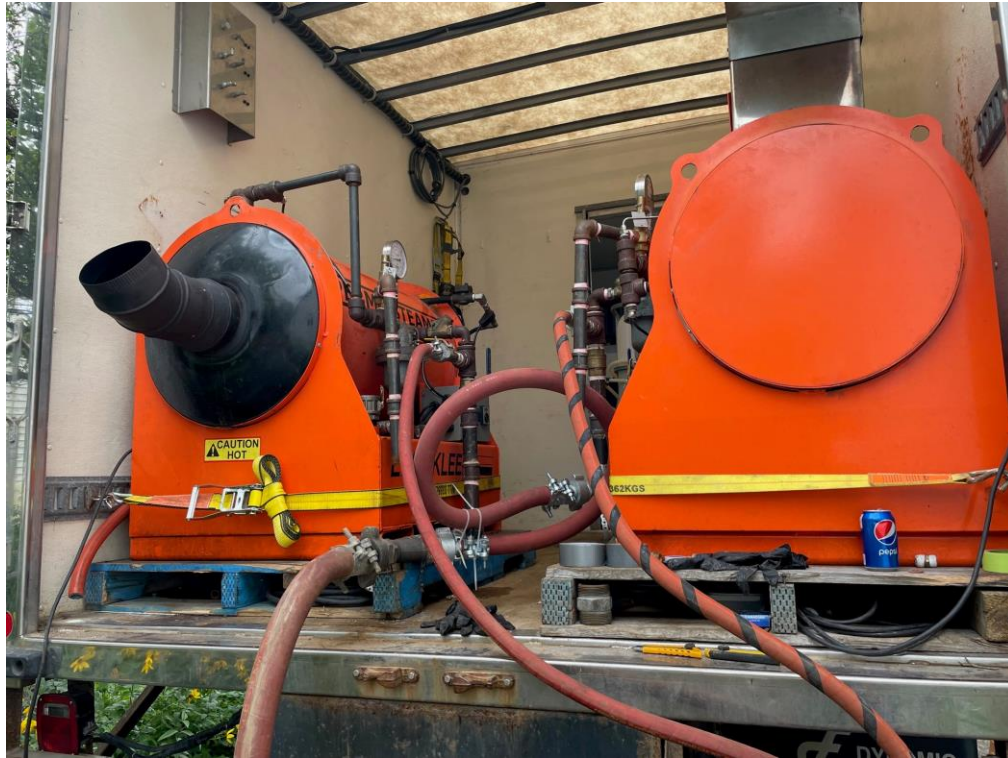
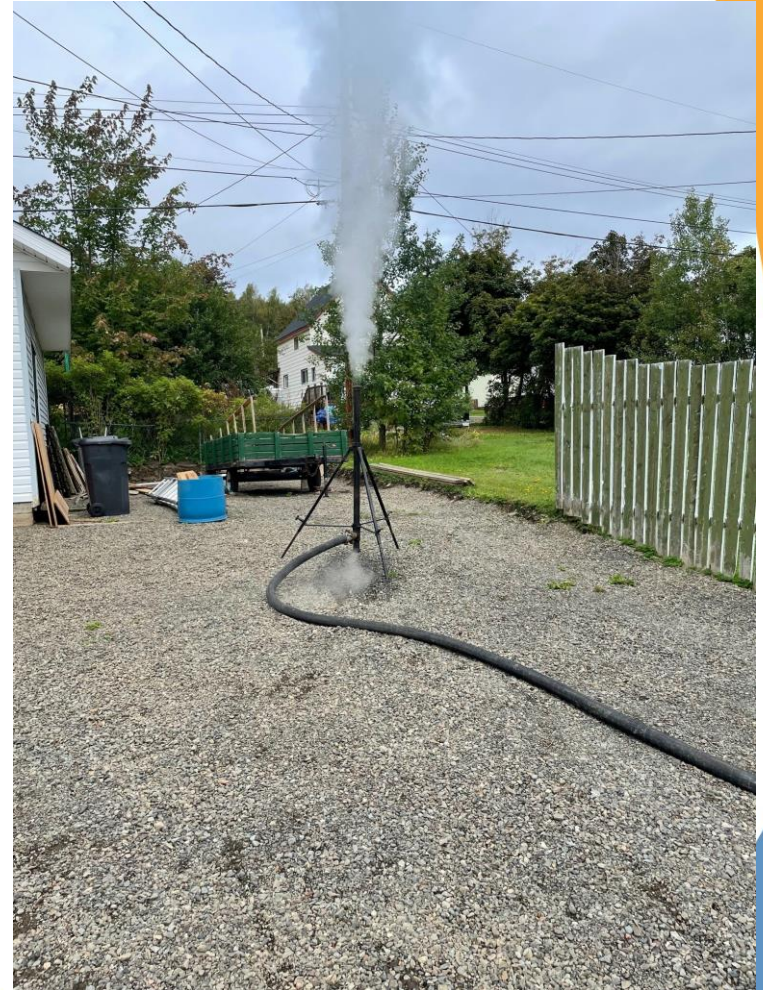
Steam Curing

- Liners were ordered from New Jersey already pre-wetted with resin and kept on ice.
- Kept in refrigeration truck out of sunlight.
- Curing is 90 minutes at 130 degrees Fahrenheit with 30-minute cool down.
- Pressure varies 8 – 12 psi.
- 3 thermocouples in place measuring temps.
