Site Inspection Summary

Abandoned Oil Wells - Shoal Point

Purpose of Inspection Ongoing Monitoring of Abandoned Oil Wells at Shoal Point

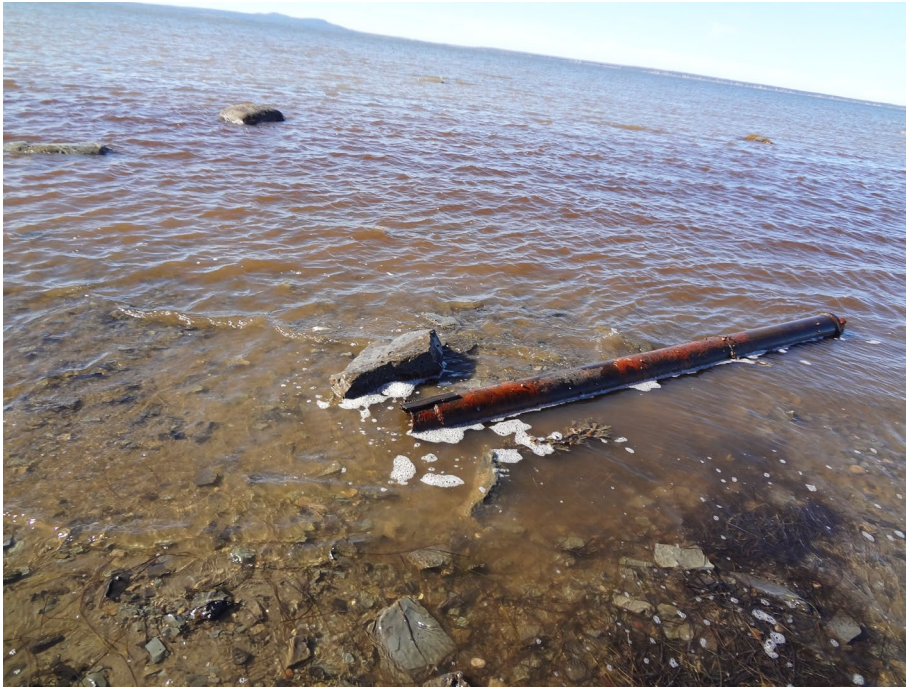
Photo 2 – Location of Well Repair #2

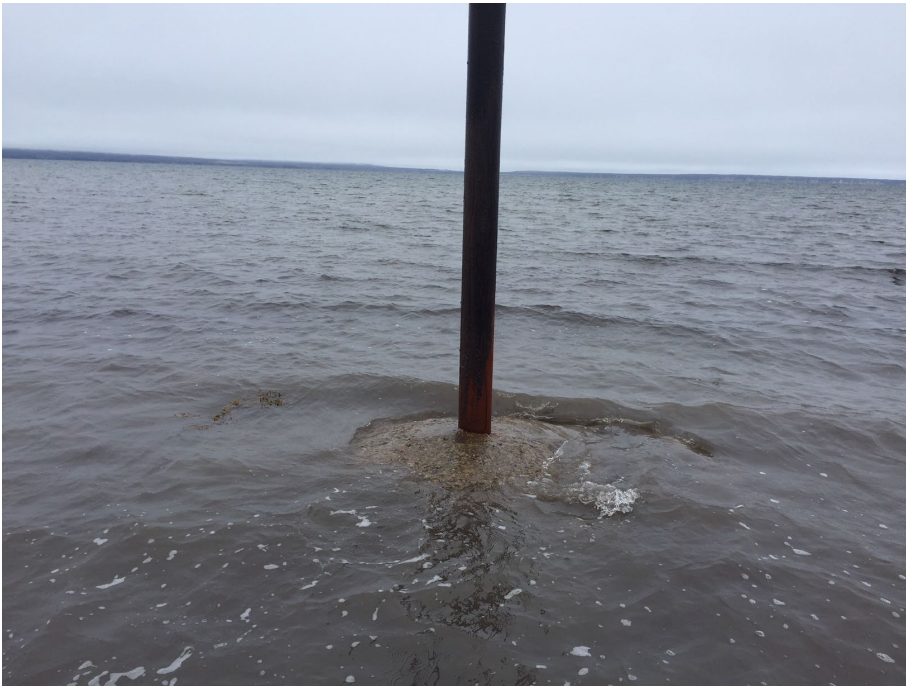
Photo 3 – Well Repair #1 Casing and Concrete Base

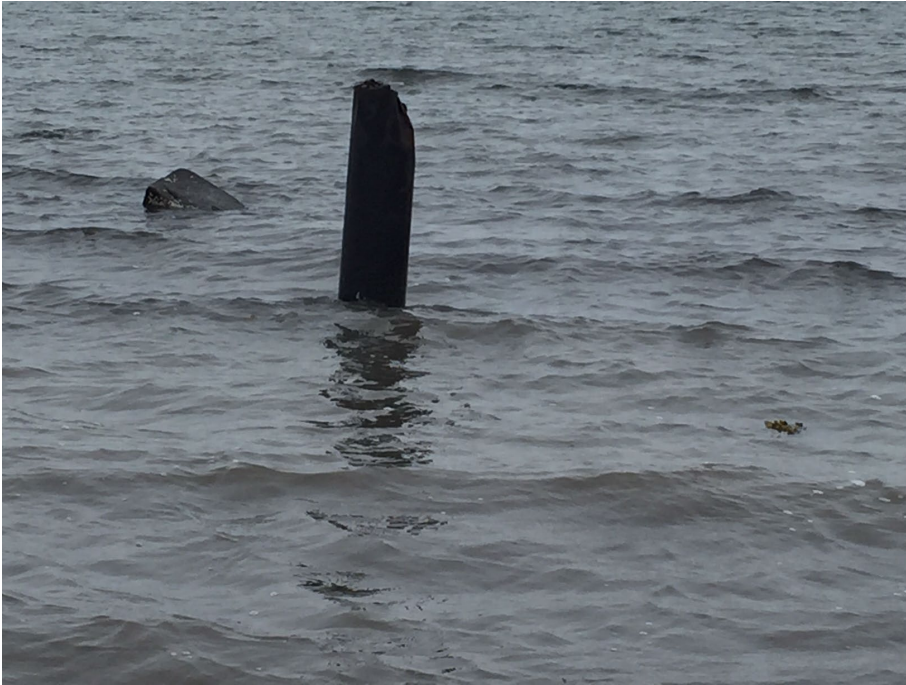
Photo 4 – Abandoned Well Casing

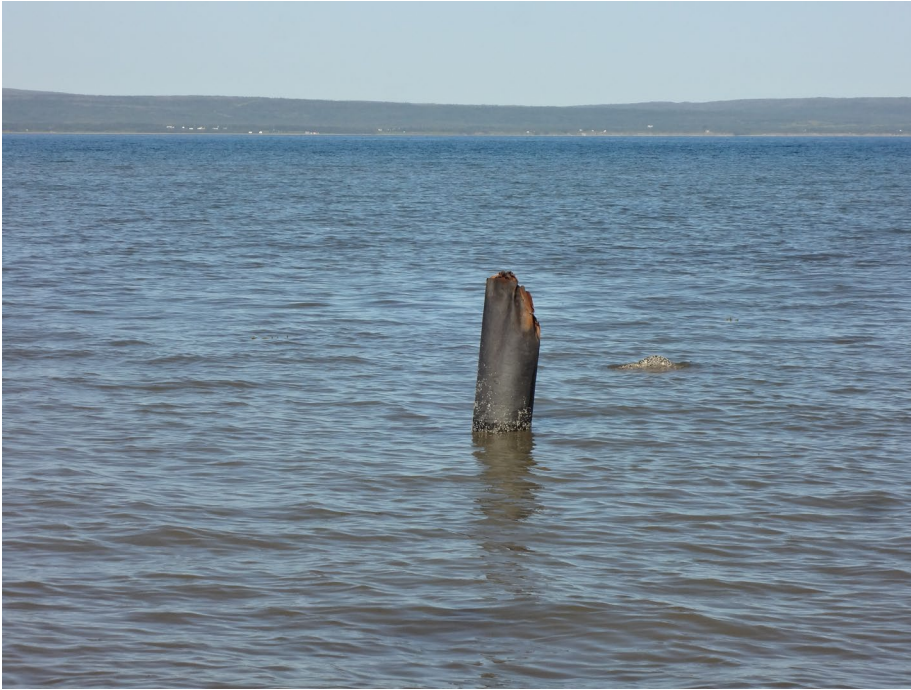
Photo 4 – Abandoned Well Casing

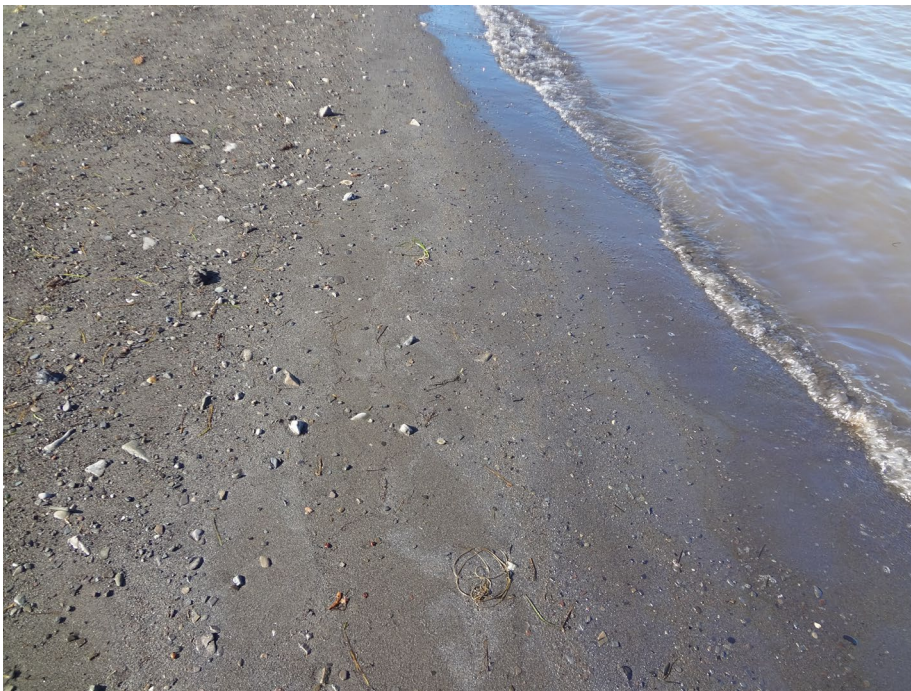
Photo 5 – Slight Oil Sheening along Beach

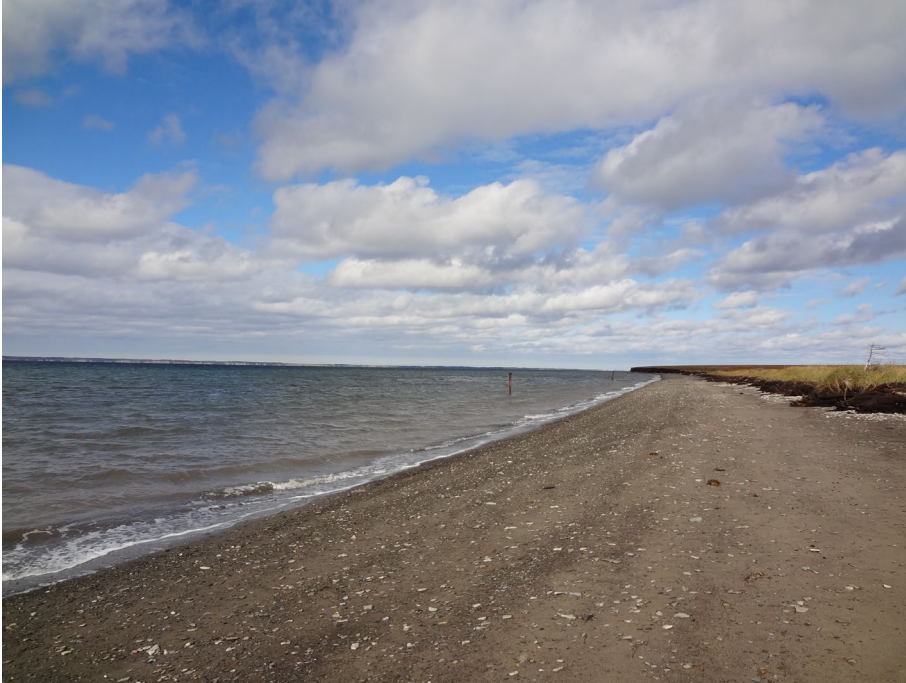
Photo 1 – General Area of Wells

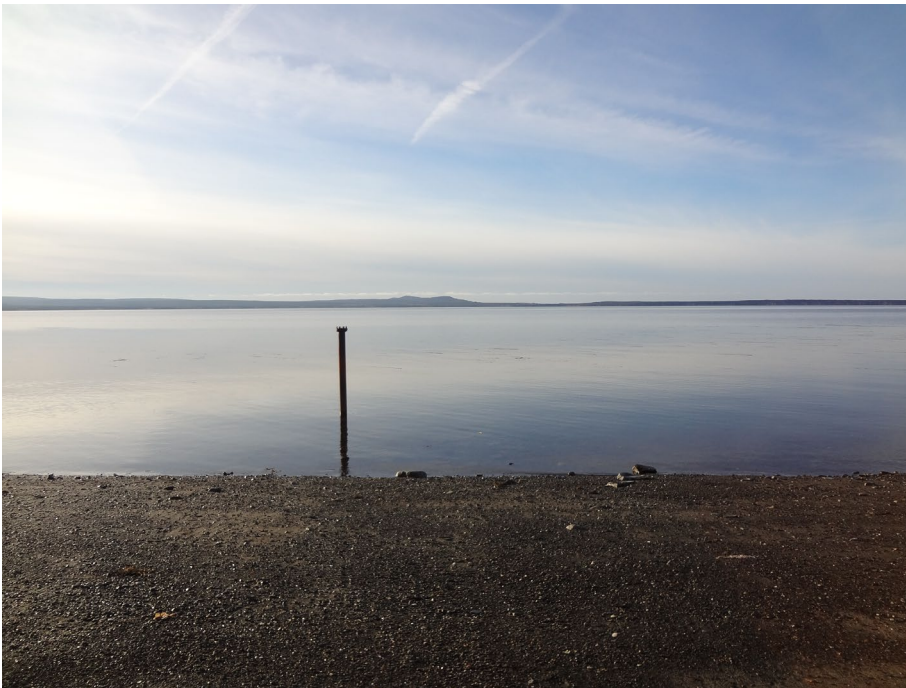
Photo 5 – General Site Area

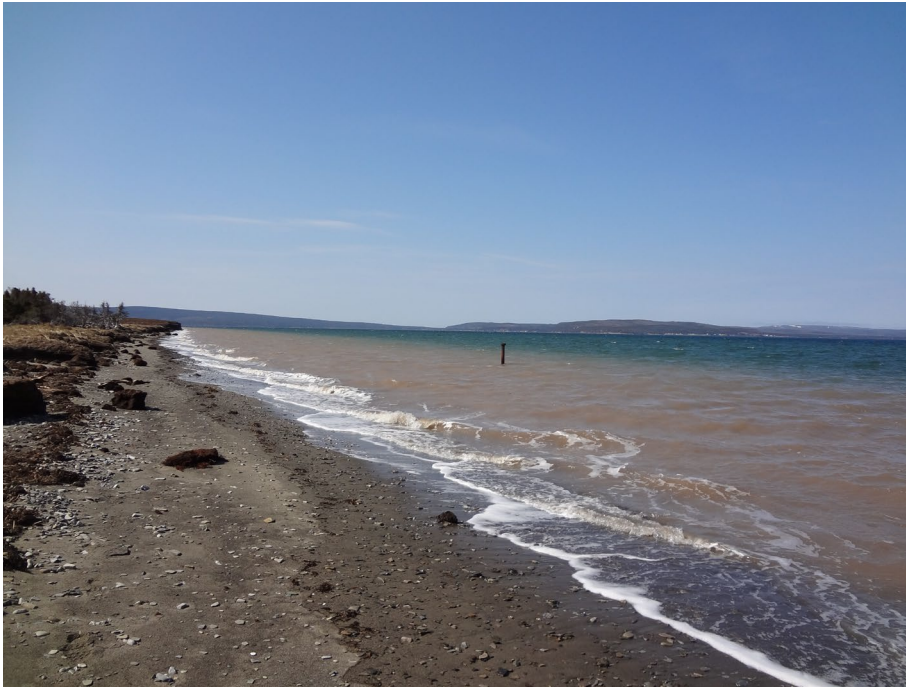
Photo 2 – General Site Area

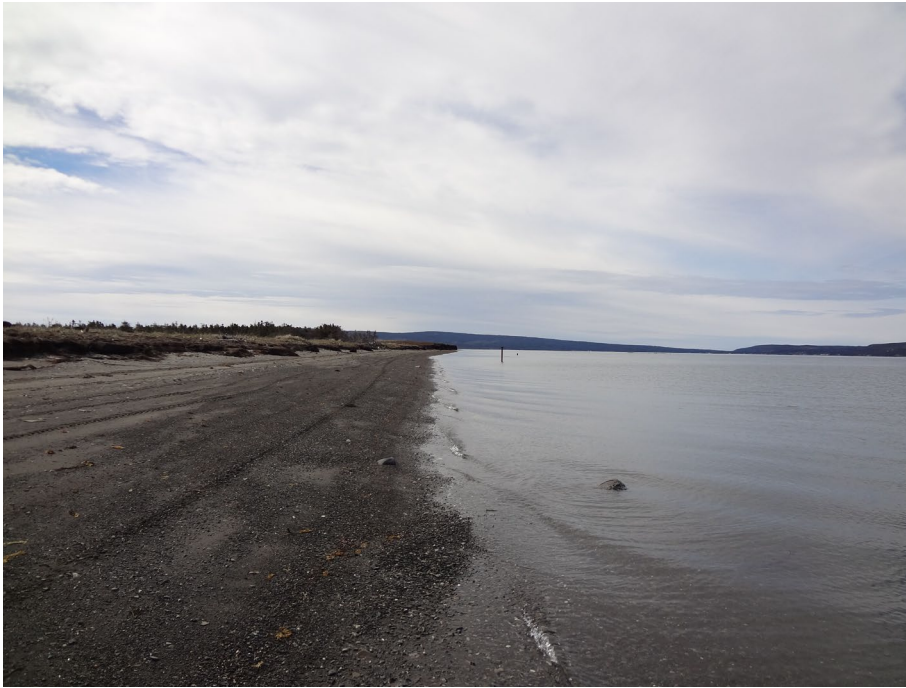
Photo 2 – General Site Area

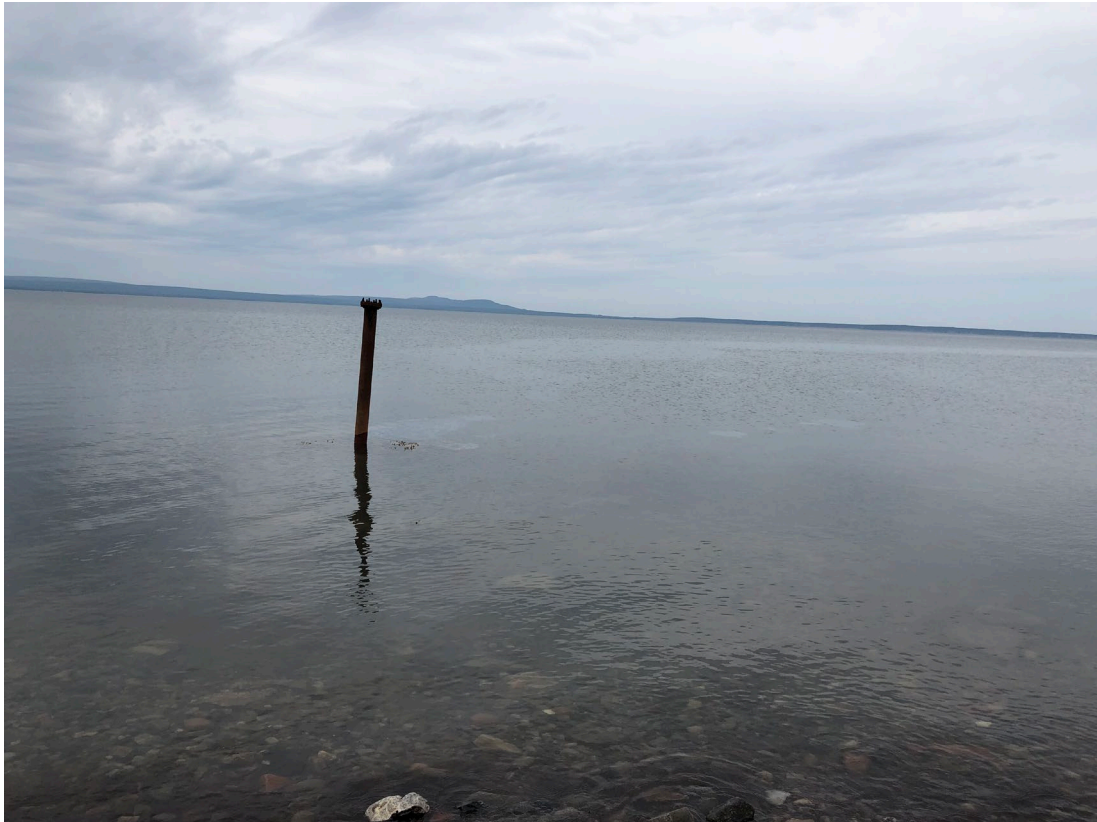
- The water level was relatively low with the wells situated in the water only a short distance from the shore.
- Oil sheening was observed in the vicinity of Well Repair #1. Sheening was predominant in the area around the well base. However, oil sheens were observed originating at random locations within the general well area.
- Tidal and wave action were minimal.
- Sheens formed as oil drops rose to the surface and expanded. Oil remained on the water surface for considerable time creating large sheen areas.
- Oil seepage was not observed from any of the other well locations.
- Monitoring of the area for oil seepage will continue.

Photo 1 – Abandoned Well Repair #1

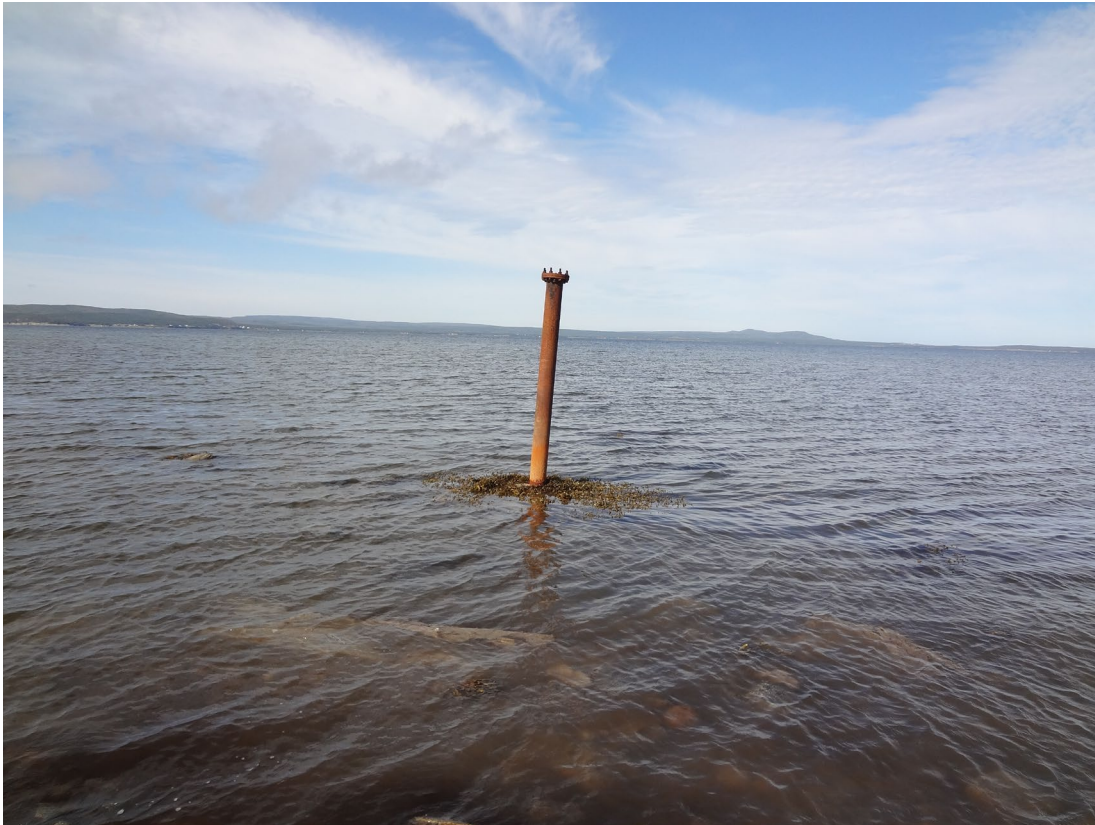
- The tide was low with the wells situated in the water only a short distance from the shore.
- The formation of intermittent oil sheens was observed at random locations in the vicinity of Well Repair #1. The sheens were dispersed by wave action over a relatively short distance from the well.
- The concrete base of Well Repair #1 was covered with seaweed.
- Oil seepage was not observed from any of the other well locations.
- Monitoring of the area for oil seepage will continue.

Photo 1 – Abandoned Well Repair #1

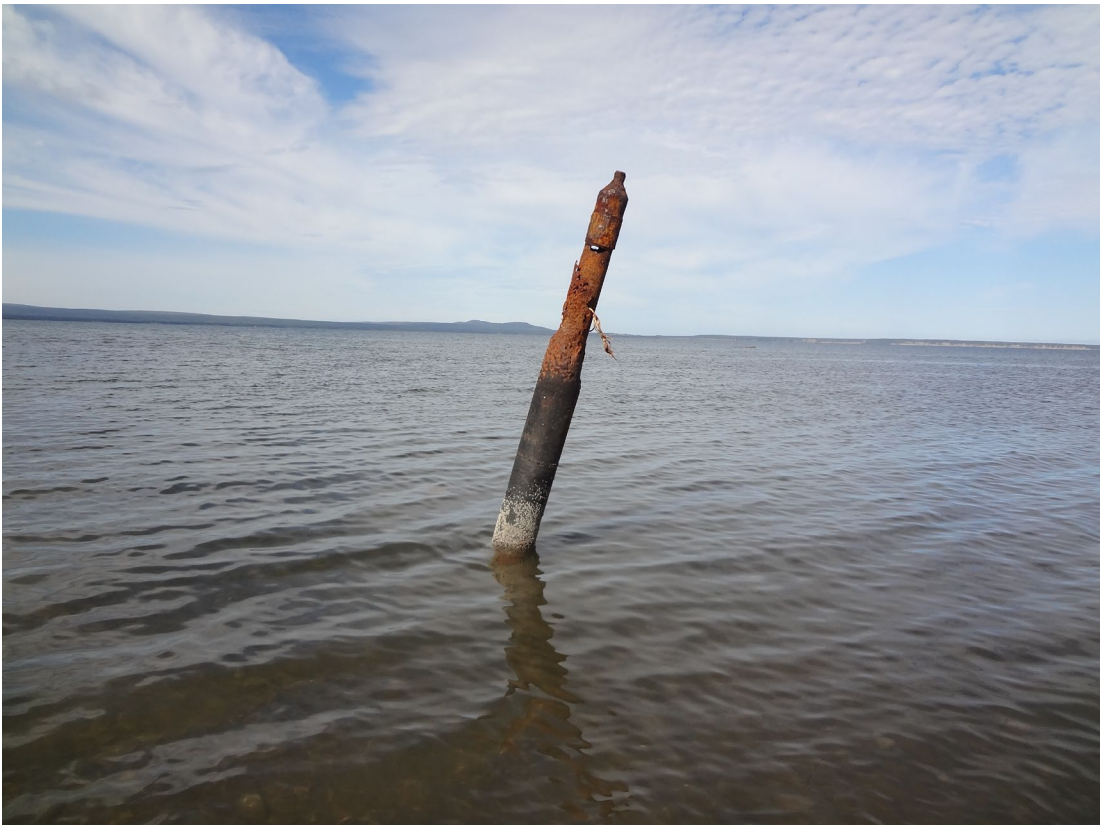
Photo 3 – Abandoned Oil Well Casing (Closest to the Shoal Point Tip)

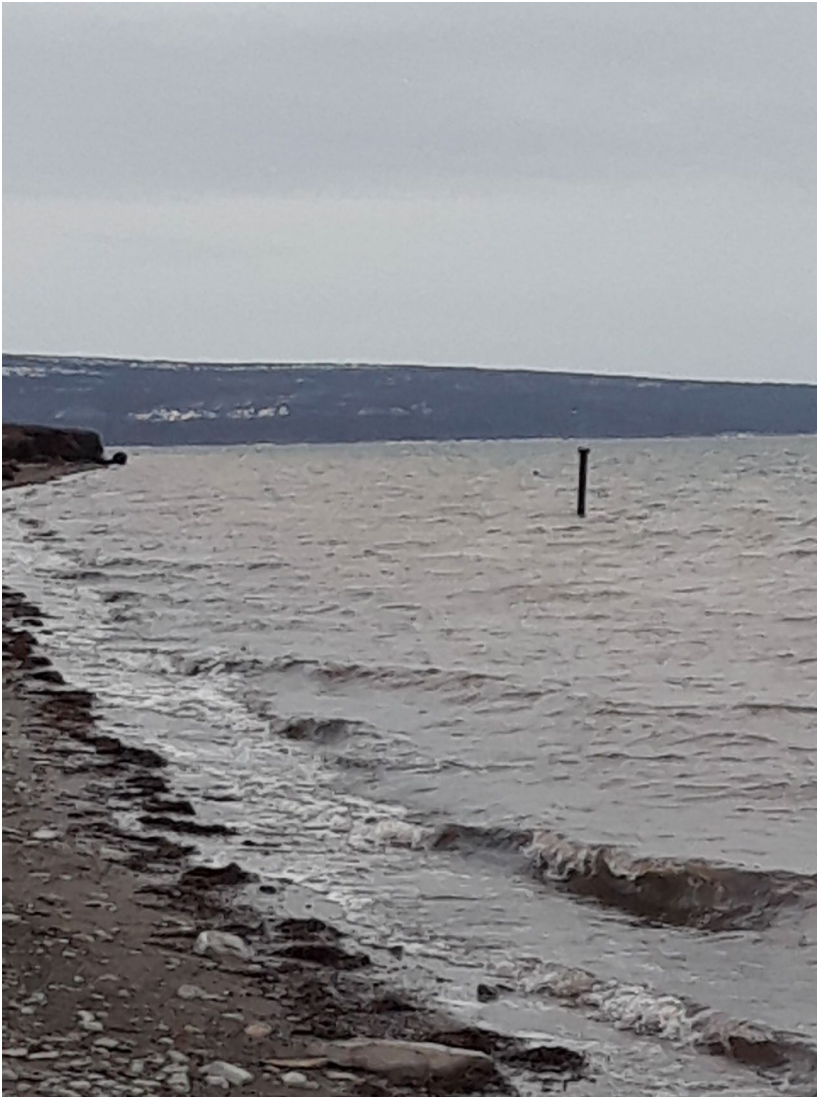
Photo 1 – Shoal Point Abandoned Well Area

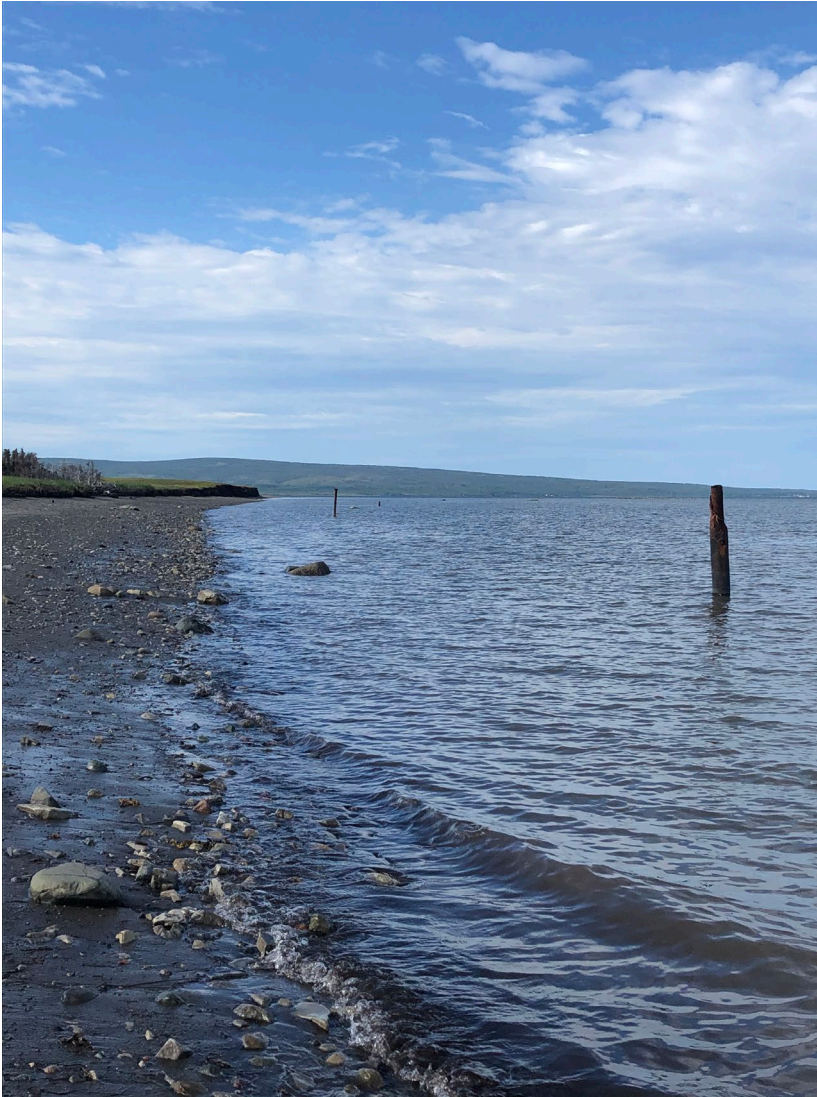
Photo 2 – Shoal Point Abandoned Well Area

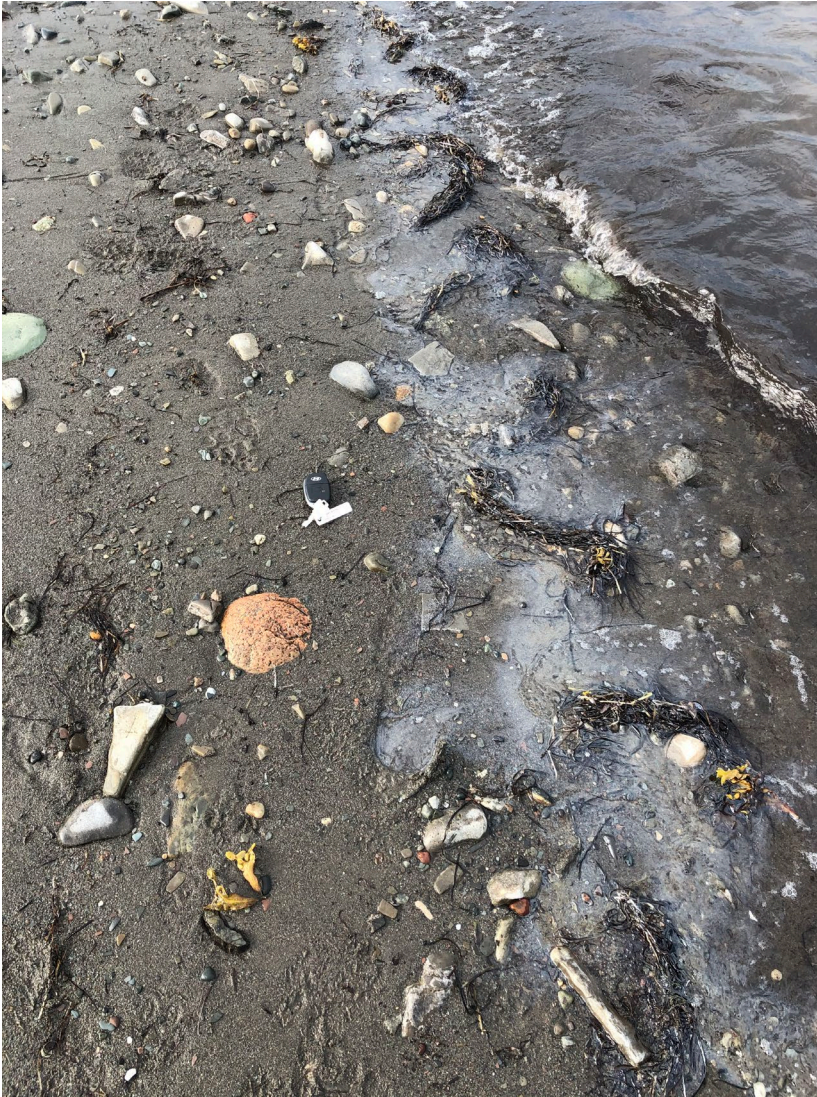
- Oil sheening was observed in the vicinity of Well Repair #1.
- Oil seepage was not observed at any of the other well locations.
- An oil odour was detected downwind from Well Repair #1.
- Oil sheening was visible along a section of beach at the water mark.
- Monitoring of the area will continue.

Photo 3 – Oil Sheening along Shore at Water Mark

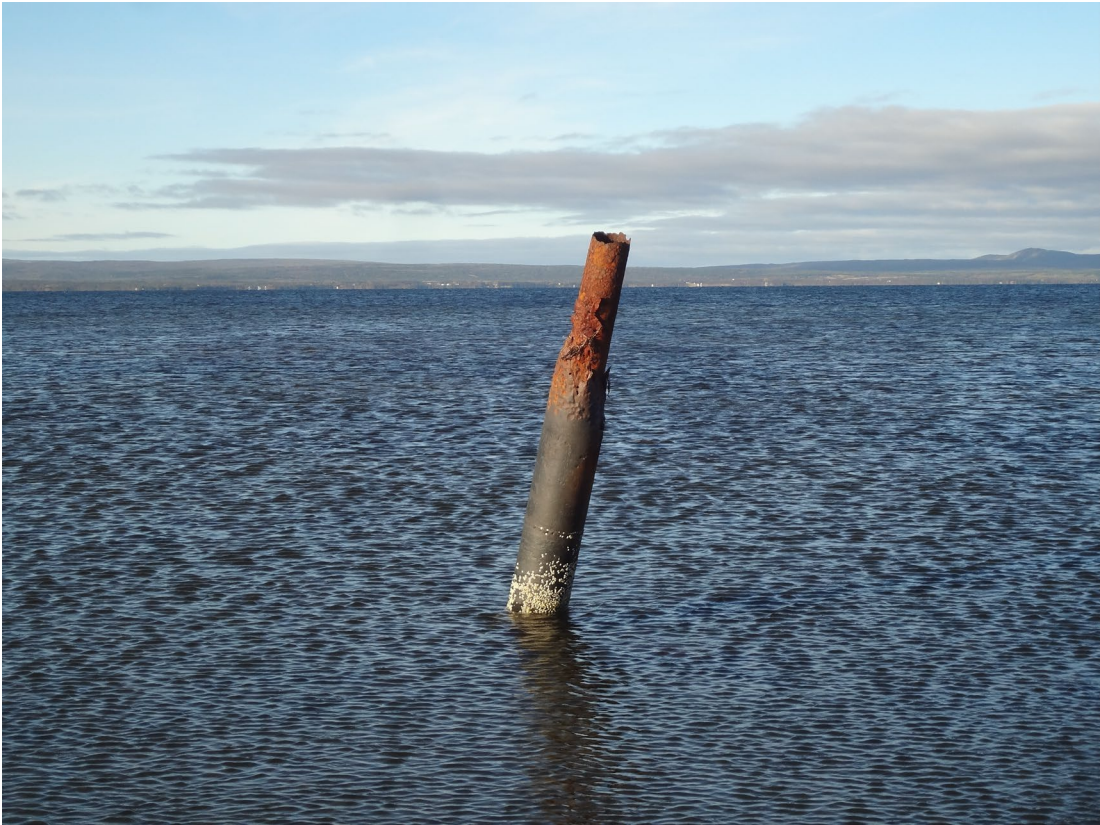
- Wave action was mild to moderate.
- Oil seepage/sheening was not observed at any of the well locations or elsewhere in the bay.
- There was no oil odor detected during the site visit. Wind direction was away from the shore.
- The top section of the abandoned oil well casing located closest to Shoal Point Tip is no longer intact.
- Monitoring of the area will continue.

Photo 2 – Abandoned Oil Well Casing (Closest to Shoal Point Tip)

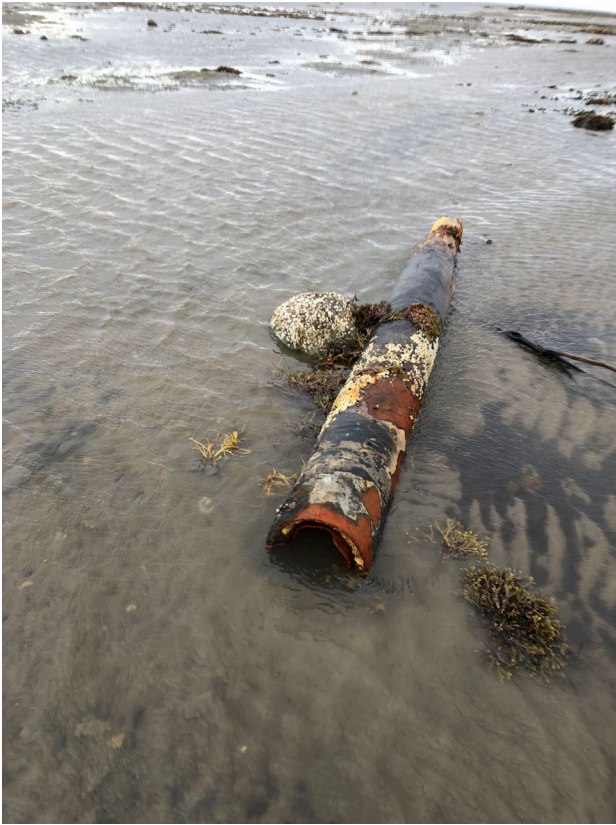
- There was no oil seepage/sheening observed in general vicinity of well repair #2 (Well #2).
- The casing for abandoned Well #3 (well located closest to the tip of Shoal Point) has been sheared off at ground level. There was no oil seepage/sheening observed in general vicinity of this well.

Photo 4 – Abandoned Oil Well #3 (Closest to Shoal Point Tip)

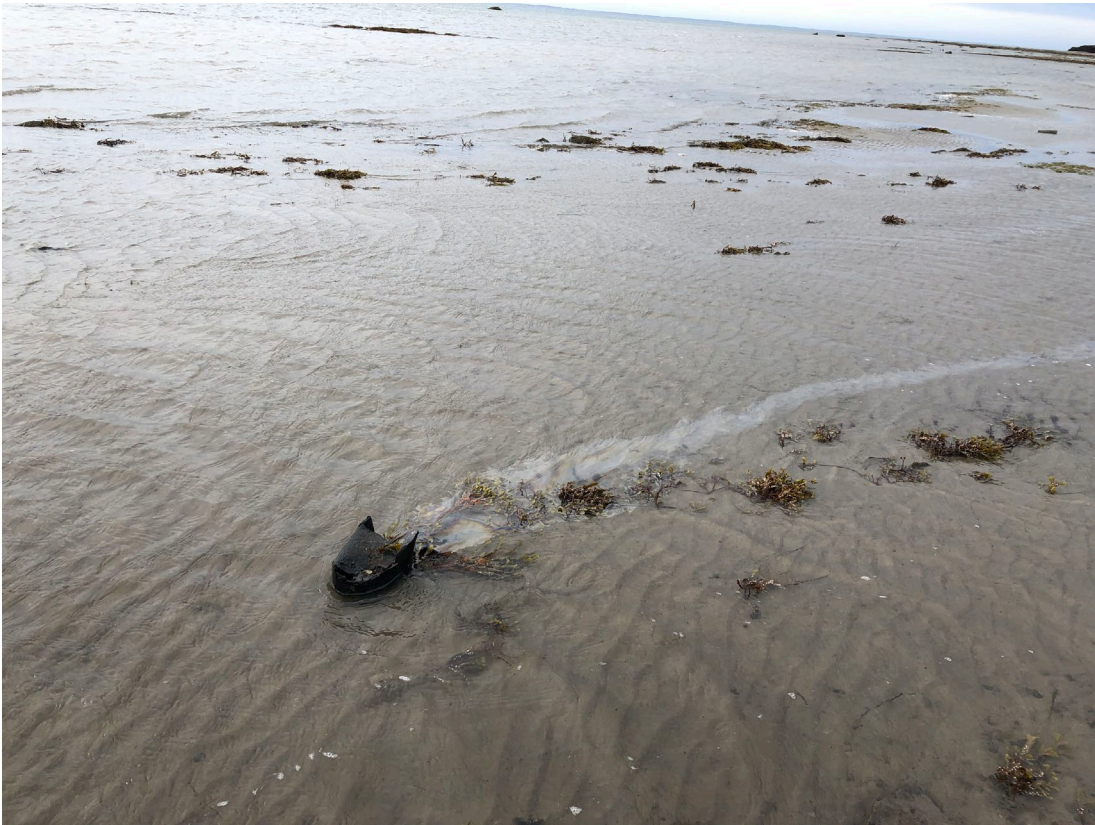
- A previously undetected abandoned oil well casing was discovered (labelled Well #5). The well is located 10-15 m to the right of Well #4 and a further 20-30 m offshore. An oil/water mixture was observed in the casing resulting in sheening in the bay.

Photo 6 – Oil Sheening at Abandoned Oil Well #5

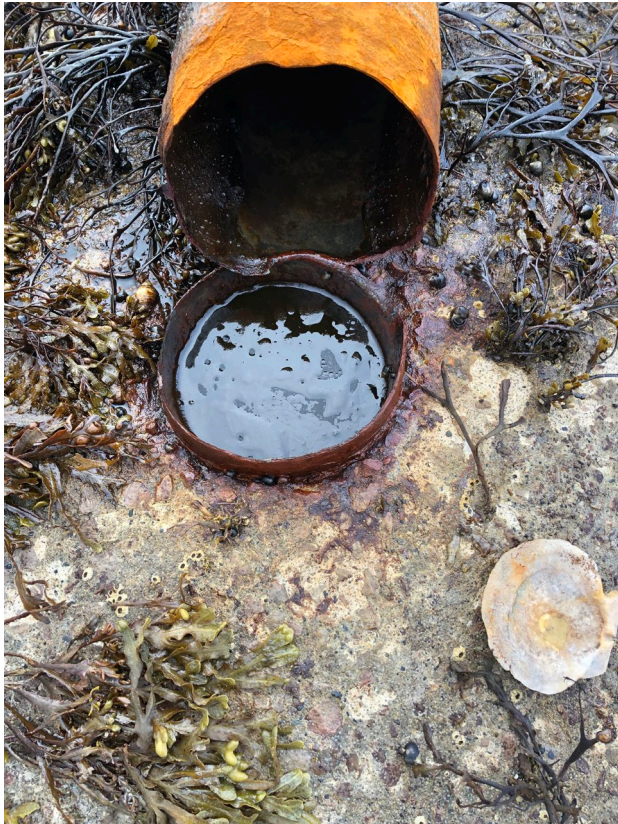
- Bubbling was observed on the surface of the pooled oil/water mixture which had accumulated within the pipe of Well Repair #1.
- Slight and intermittent oil sheening was observed in the vicinity of Oil Well #5. The sheening appeared to originate from within the well casing. The well casing extends about 0.5 m from the sea floor and was level with the water surface.
- A previously undetected abandoned oil well casing was discovered (labelled Well #6). The well is located to the north of Well #5. Slight and intermittent oil sheening was observed in the vicinity of Oil Well #6. The well casing extends about 0.5 m from the sea floor and was just beneath the water surface.
- The locations of the wells are provided on the attached map.
- Monitoring of the area will continue.

Photo 1 – Pooled Oil/Water Mixture Well Repair #1

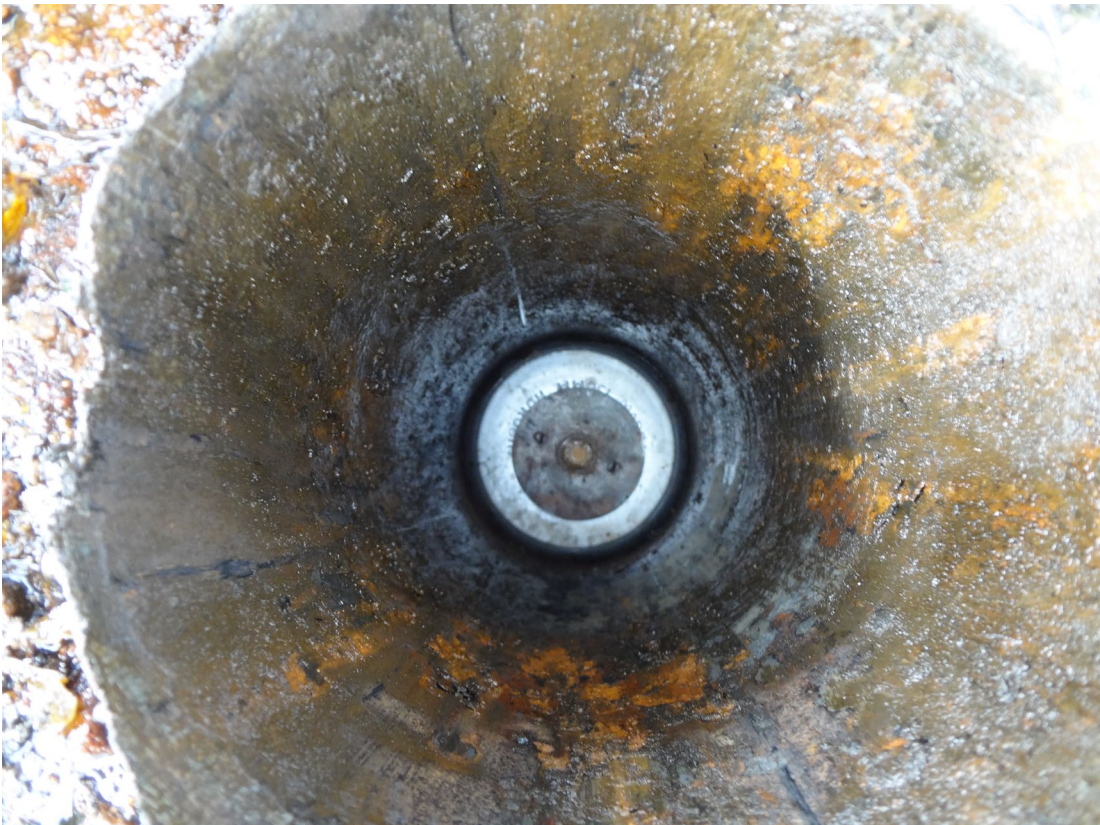
Photo 3 – Installed Plug Well #1

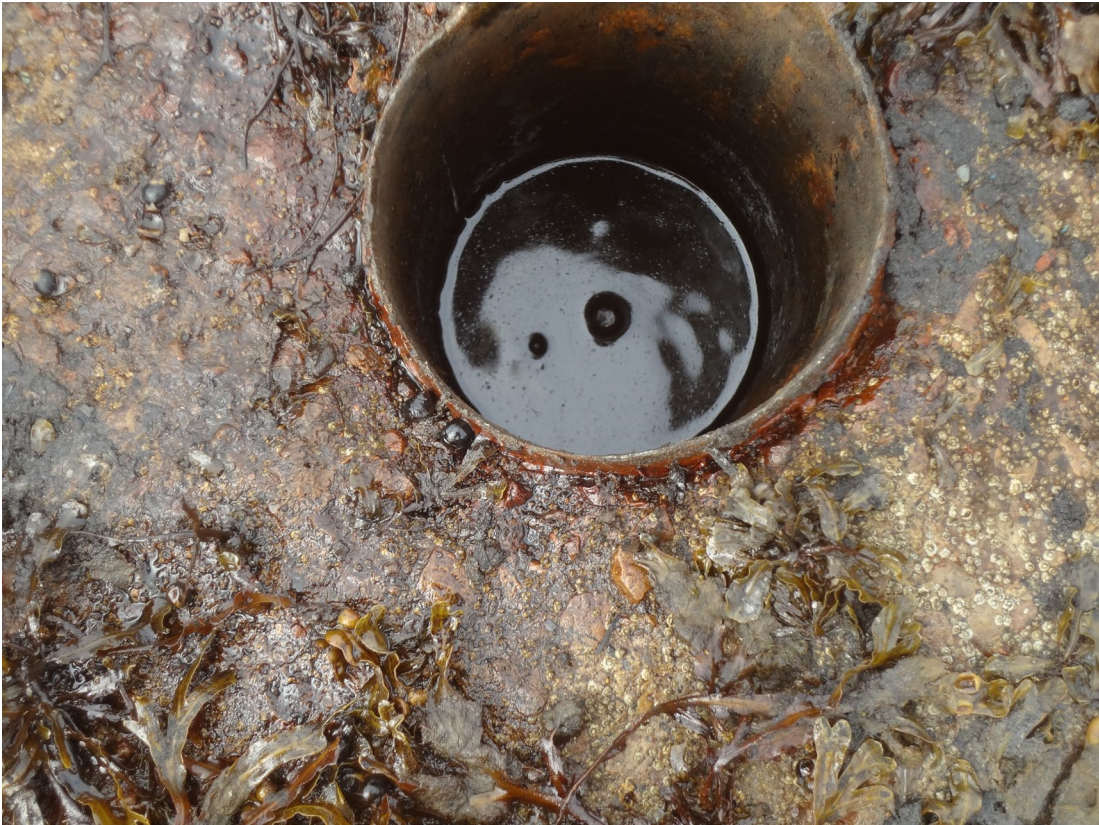
- Oil/water mixture continued to accumulate in the well casing after the installation of the plug. Active gas bubbles were observed on the surface within the well casing.

Photo 4 – Oil/Water Accumulation and Gas Bubbles after Plug Installation

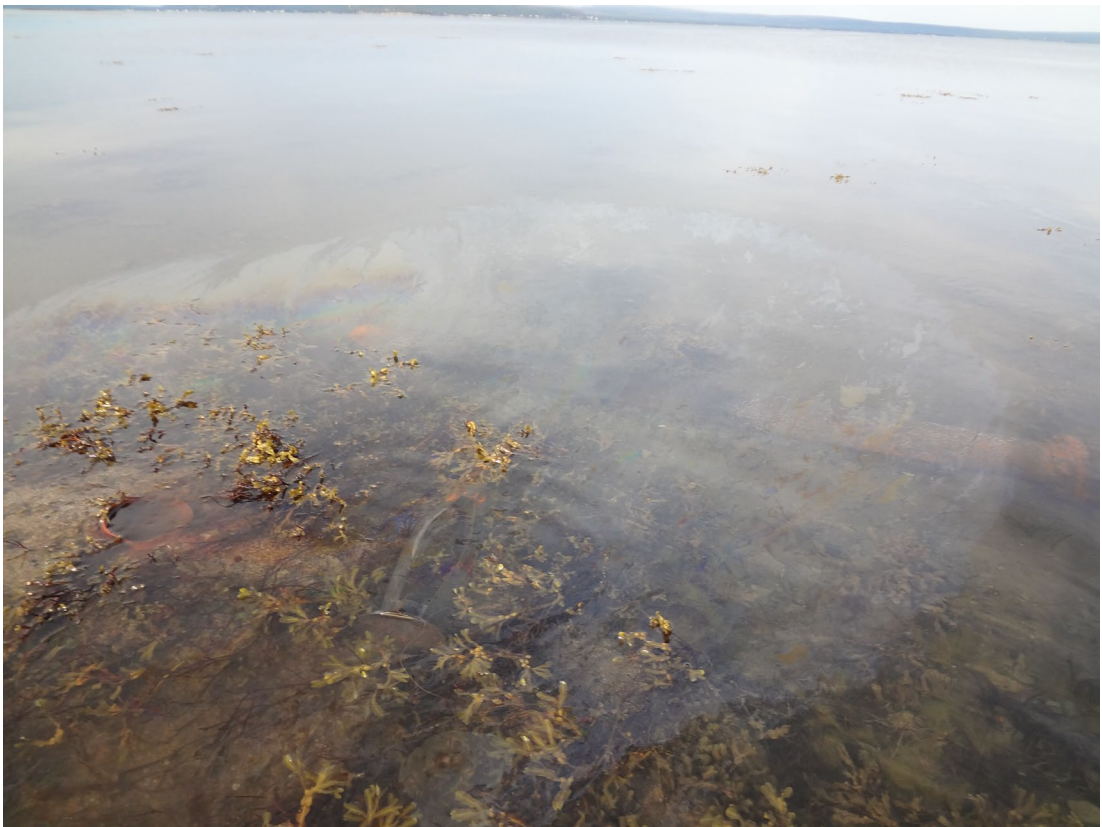
Photo 3 – Oil sheening at Well #1 (Cap Removed)

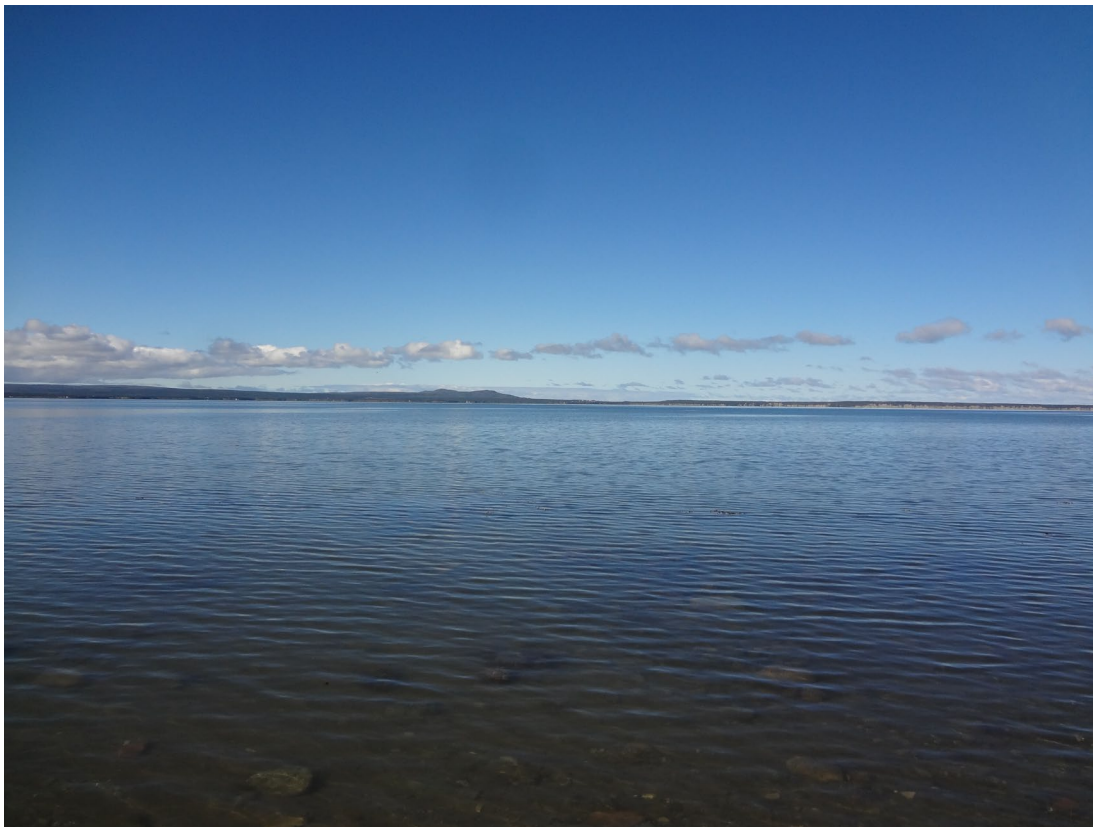
Photo 1 – Abandoned Well(s) Area View from Shore

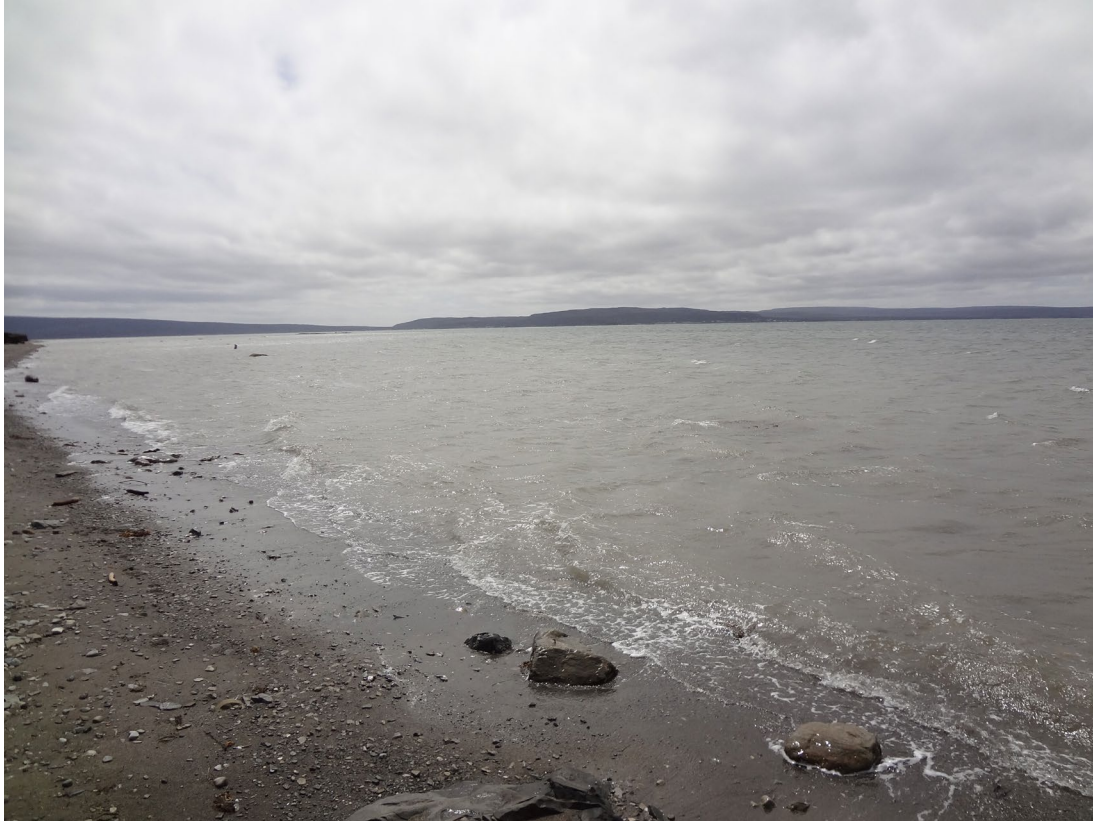
Photo 1 – Abandoned Well(s) Area View from Shore
