Inspection Report- Buchans Penstock Bridge

**Department of Environment and Conservation
Inspection Report – Buchans Penstock Bridge
DOEC Project #734.302.5
Buchans, NL
Jan 25, 2013**

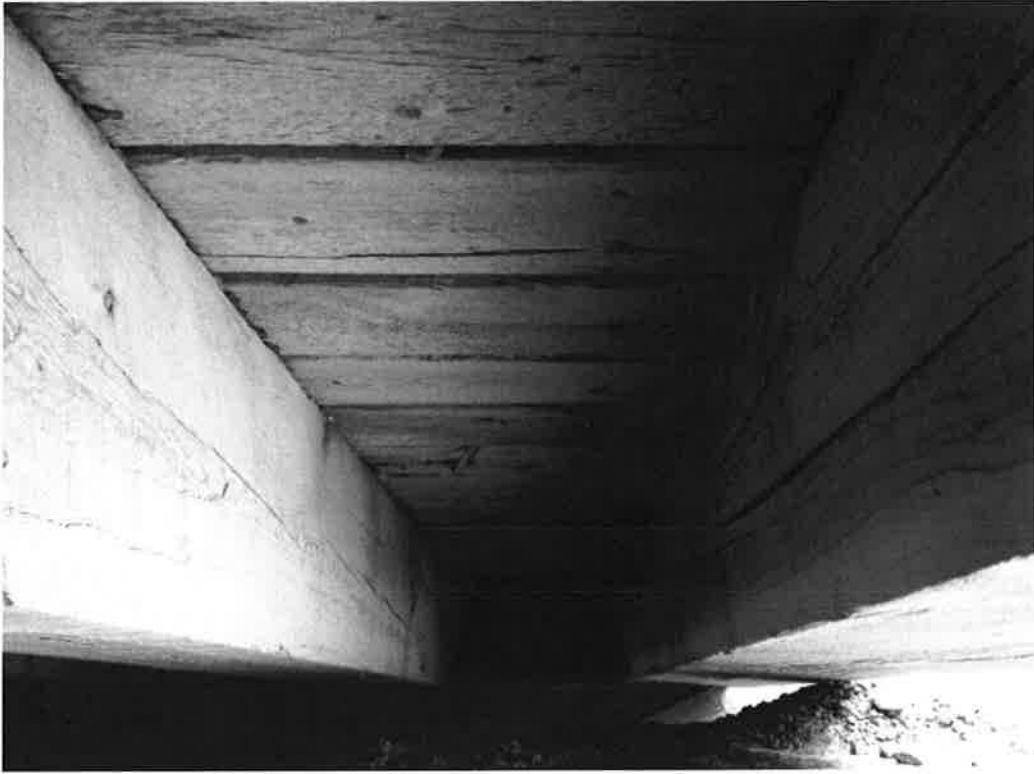
Gap between Beams 1 & 2 Looking South

The 10x10 timber beams showed visible signs of overloading at some point as there are longitudinal splits in Beams #1, 4, 6, and 8. Beam #4 in particular was badly deteriorated and had failed in bearing and/or shear at both ends. Beam #6 was split near the centre of the span from apparent flexural failure.
