**Desktop Environmental
Review, Former U.S. Military
Facility, Northwest Point, NL**

Prepared for:
Newfoundland and Labrador
Department of Municipal Affairs and
Environment, 4th Floor
Confederation Building
West Block, St. John's, NL A1B 4J6

Prepared by:
Stassinu Stantec Limited
Partnership
141 Kelsey Drive
St. John's, NL A1B 0L2
Tel: (709) 576-1458
Fax: (709) 576-2126

Final Report

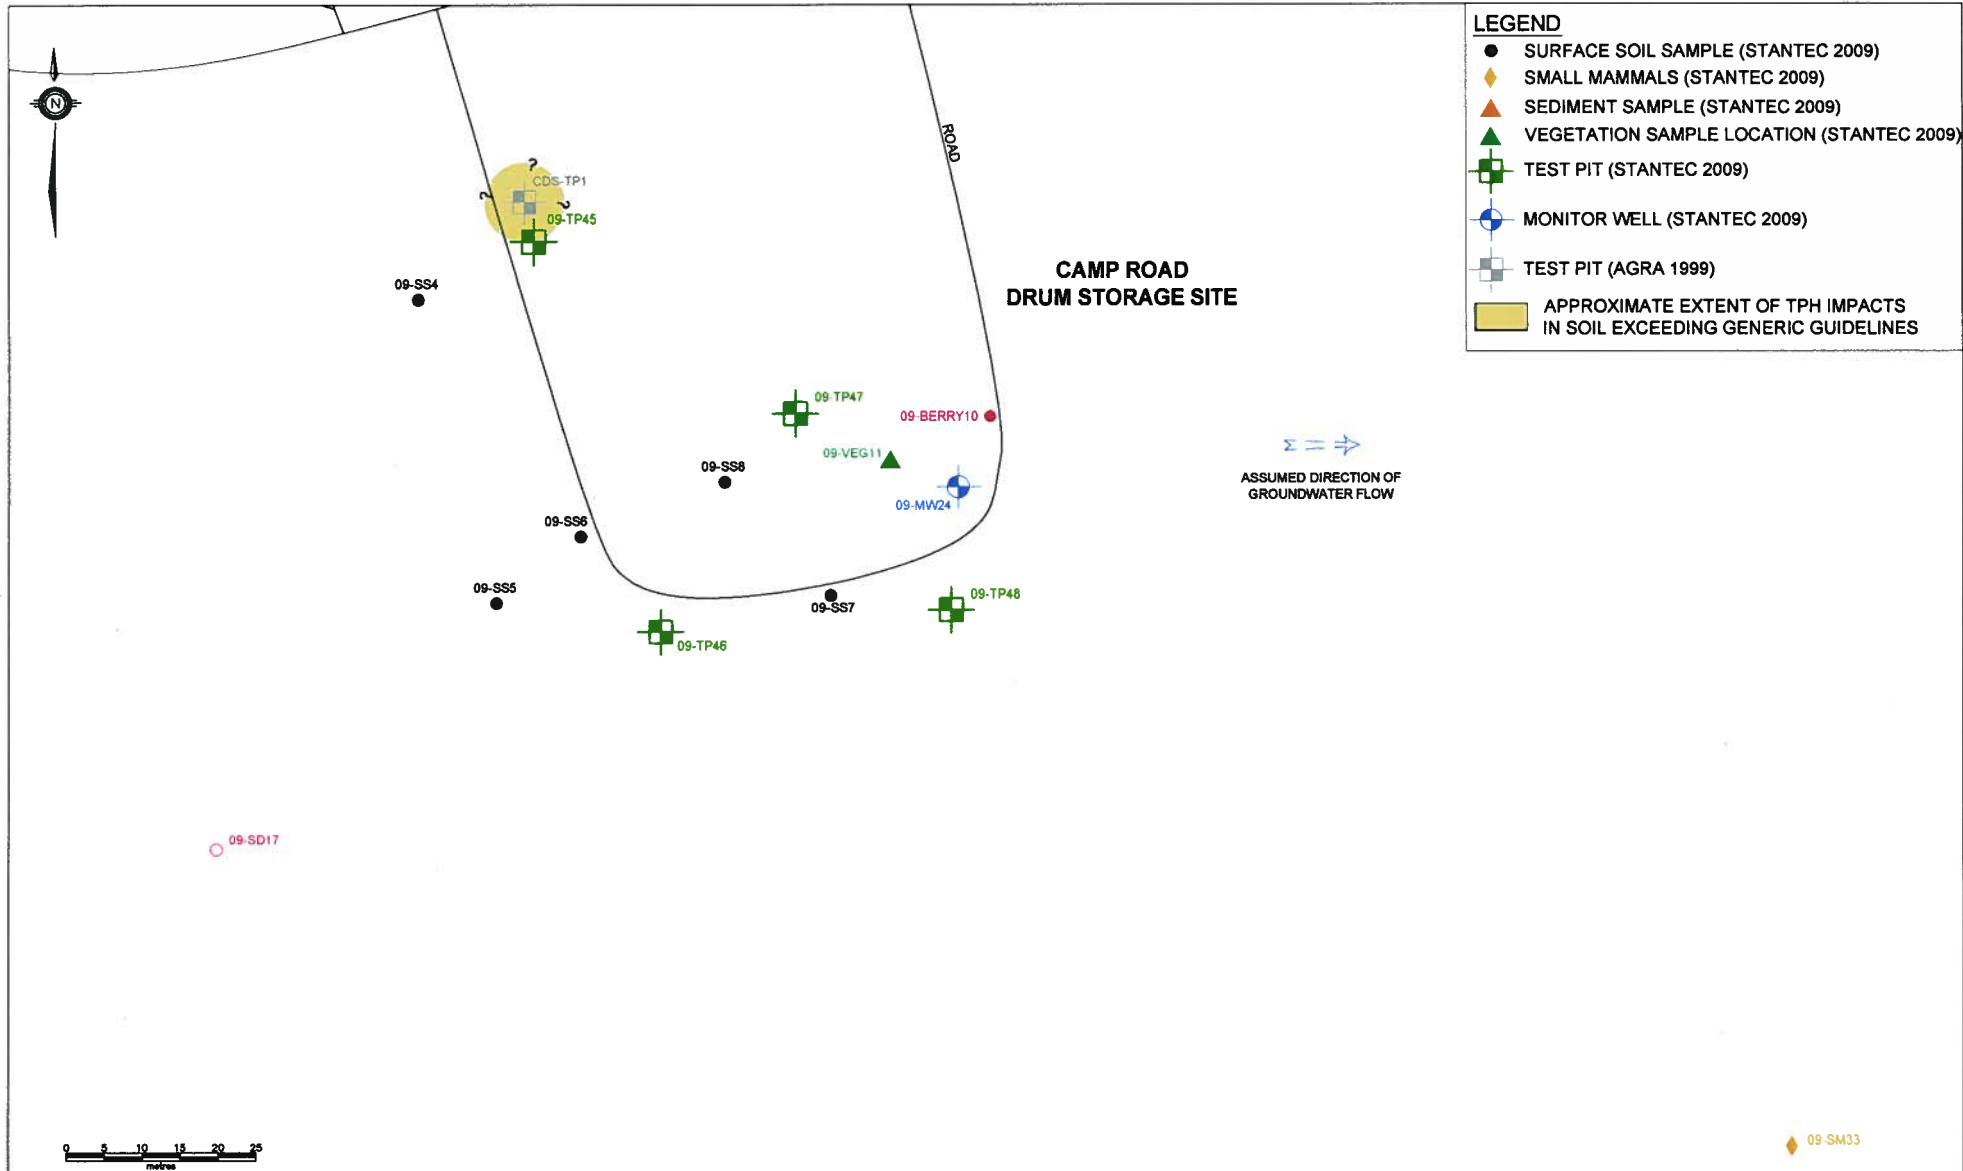
SCALE:	1:800	DATE:	JUNE 17, 2010
DRAWN BY:	N.M.	CHECKED BY:	A.R.
EDITED BY:	-	REV. No.	0
DRAWING No.:	121410105-EE-09A		
CAD FILE:	1044857-EE-07.DWG

CLIENT:	NEWFOUNDLAND AND LABRADOR DEPARTMENT OF ENVIRONMENT AND CONSERVATION
PROJECT TITLE:	PHASE III ENVIRONMENTAL SITE ASSESSMENT, HUMAN HEALTH AND ECOLOGICAL RISK ASSESSMENTS, REMEDIAL ACTION PLAN FOR THE FORMER U.S. MILITARY FACILITY OF NORTHWEST POINT, NL
DRAWING TITLE:	APPROXIMATE EXTENT OF TPH IMPACTS EXCEEDING GENERIC GUIDELINES - CAMP ROAD DRUM STORAGE SITE

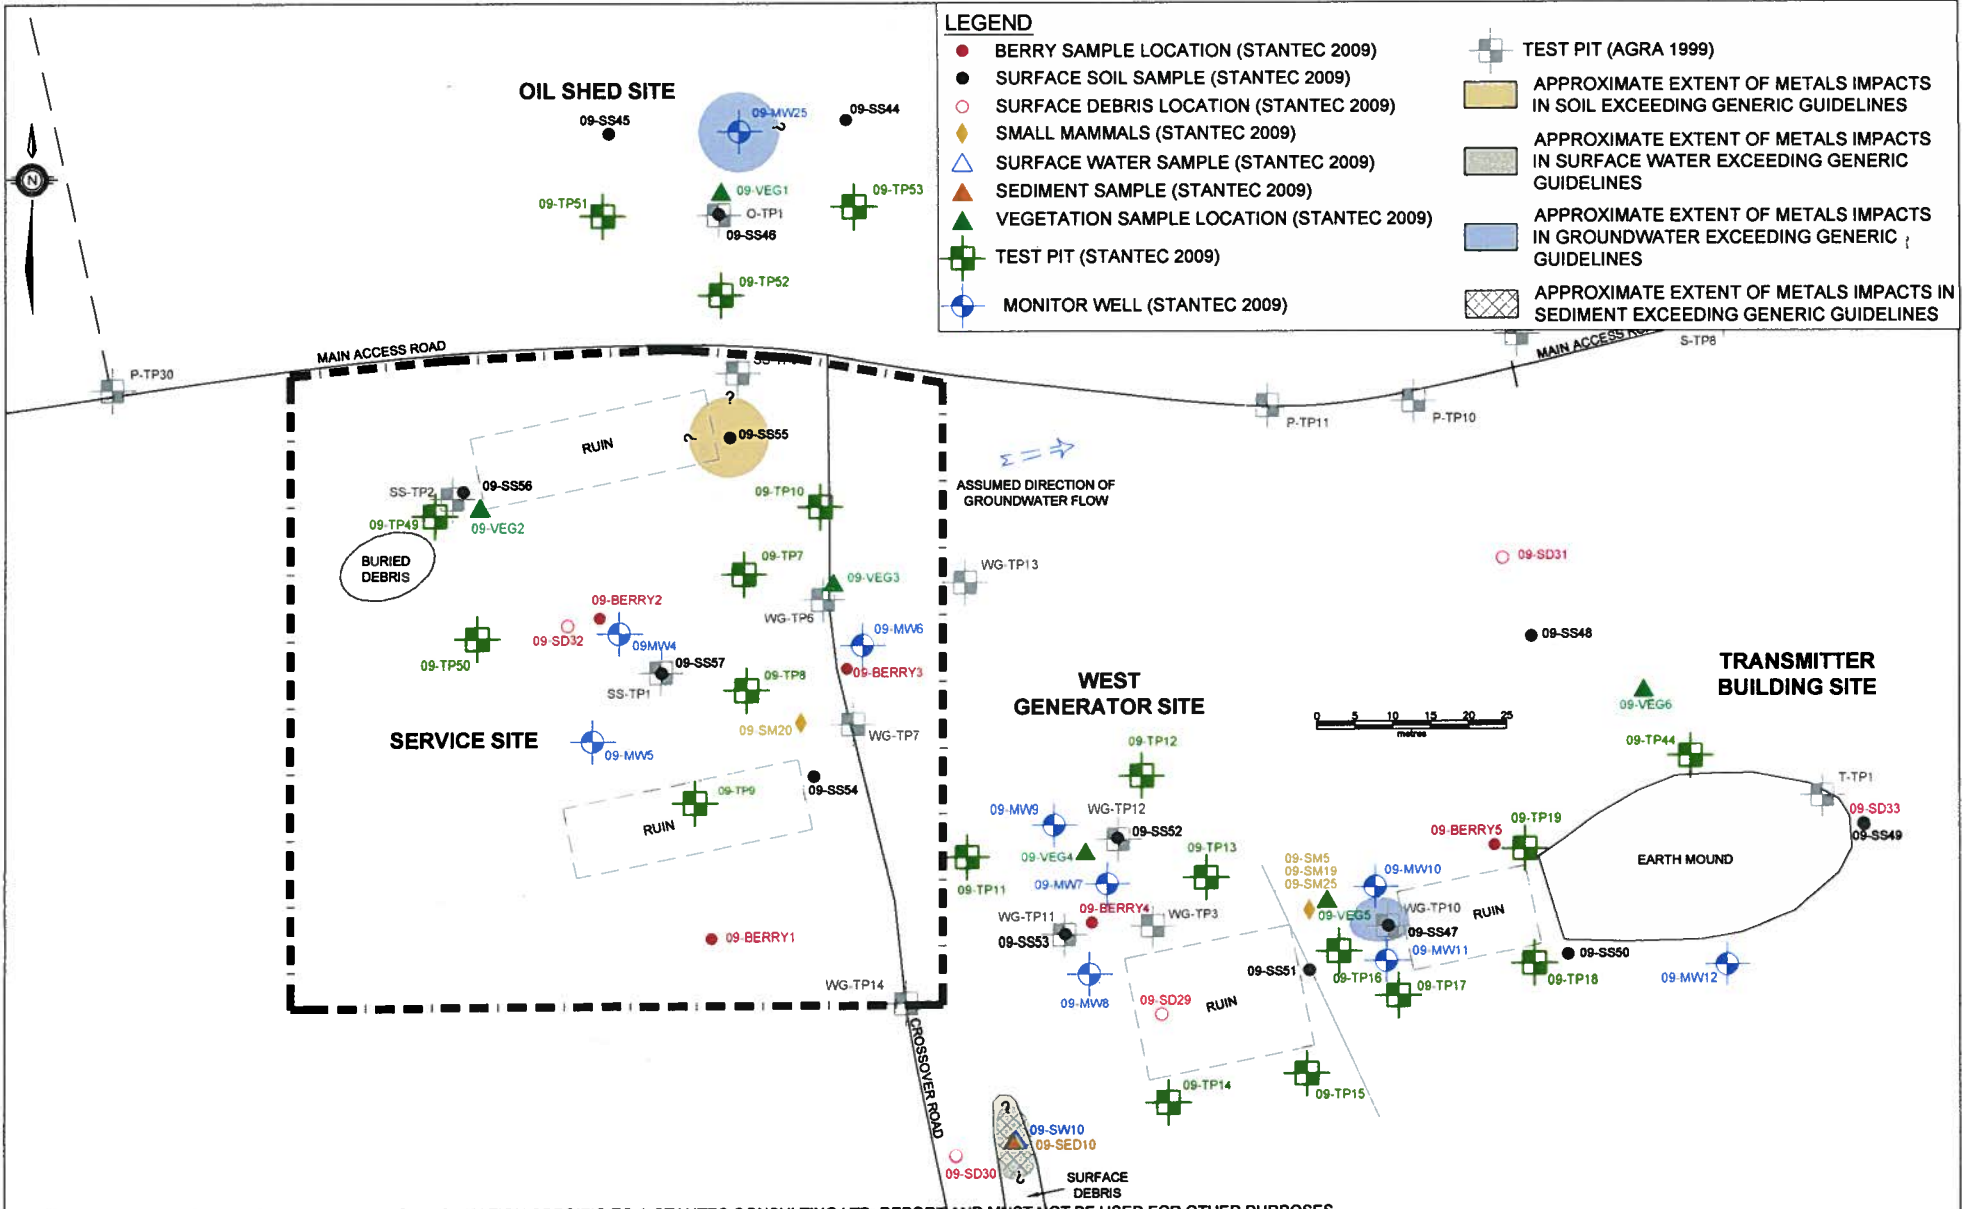
SCALE:	1:800	DATE:	JUNE 21, 2010
DRAWN BY:	N.M.	CHECKED BY:	A.R.
EDITED BY:	R.L.	REV. No.	0
DRAWING No.:	121410105-EE-10C		
CAD FILE:	1044857-EE-11.DWG

CLIENT:	NEWFOUNDLAND AND LABRADOR DEPARTMENT OF ENVIRONMENT AND CONSERVATION
PROJECT TITLE:	PHASE III ENVIRONMENTAL SITE ASSESSMENT, HUMAN HEALTH AND ECOLOGICAL RISK ASSESSMENTS, REMEDIAL ACTION PLAN FOR THE FORMER U.S. MILITARY FACILITY OF NORTHWEST POINT, NL
DRAWING TITLE:	APPROXIMATE EXTENT OF METALS IMPACTS EXCEEDING GENERIC GUIDELINES - SERVICE SITE

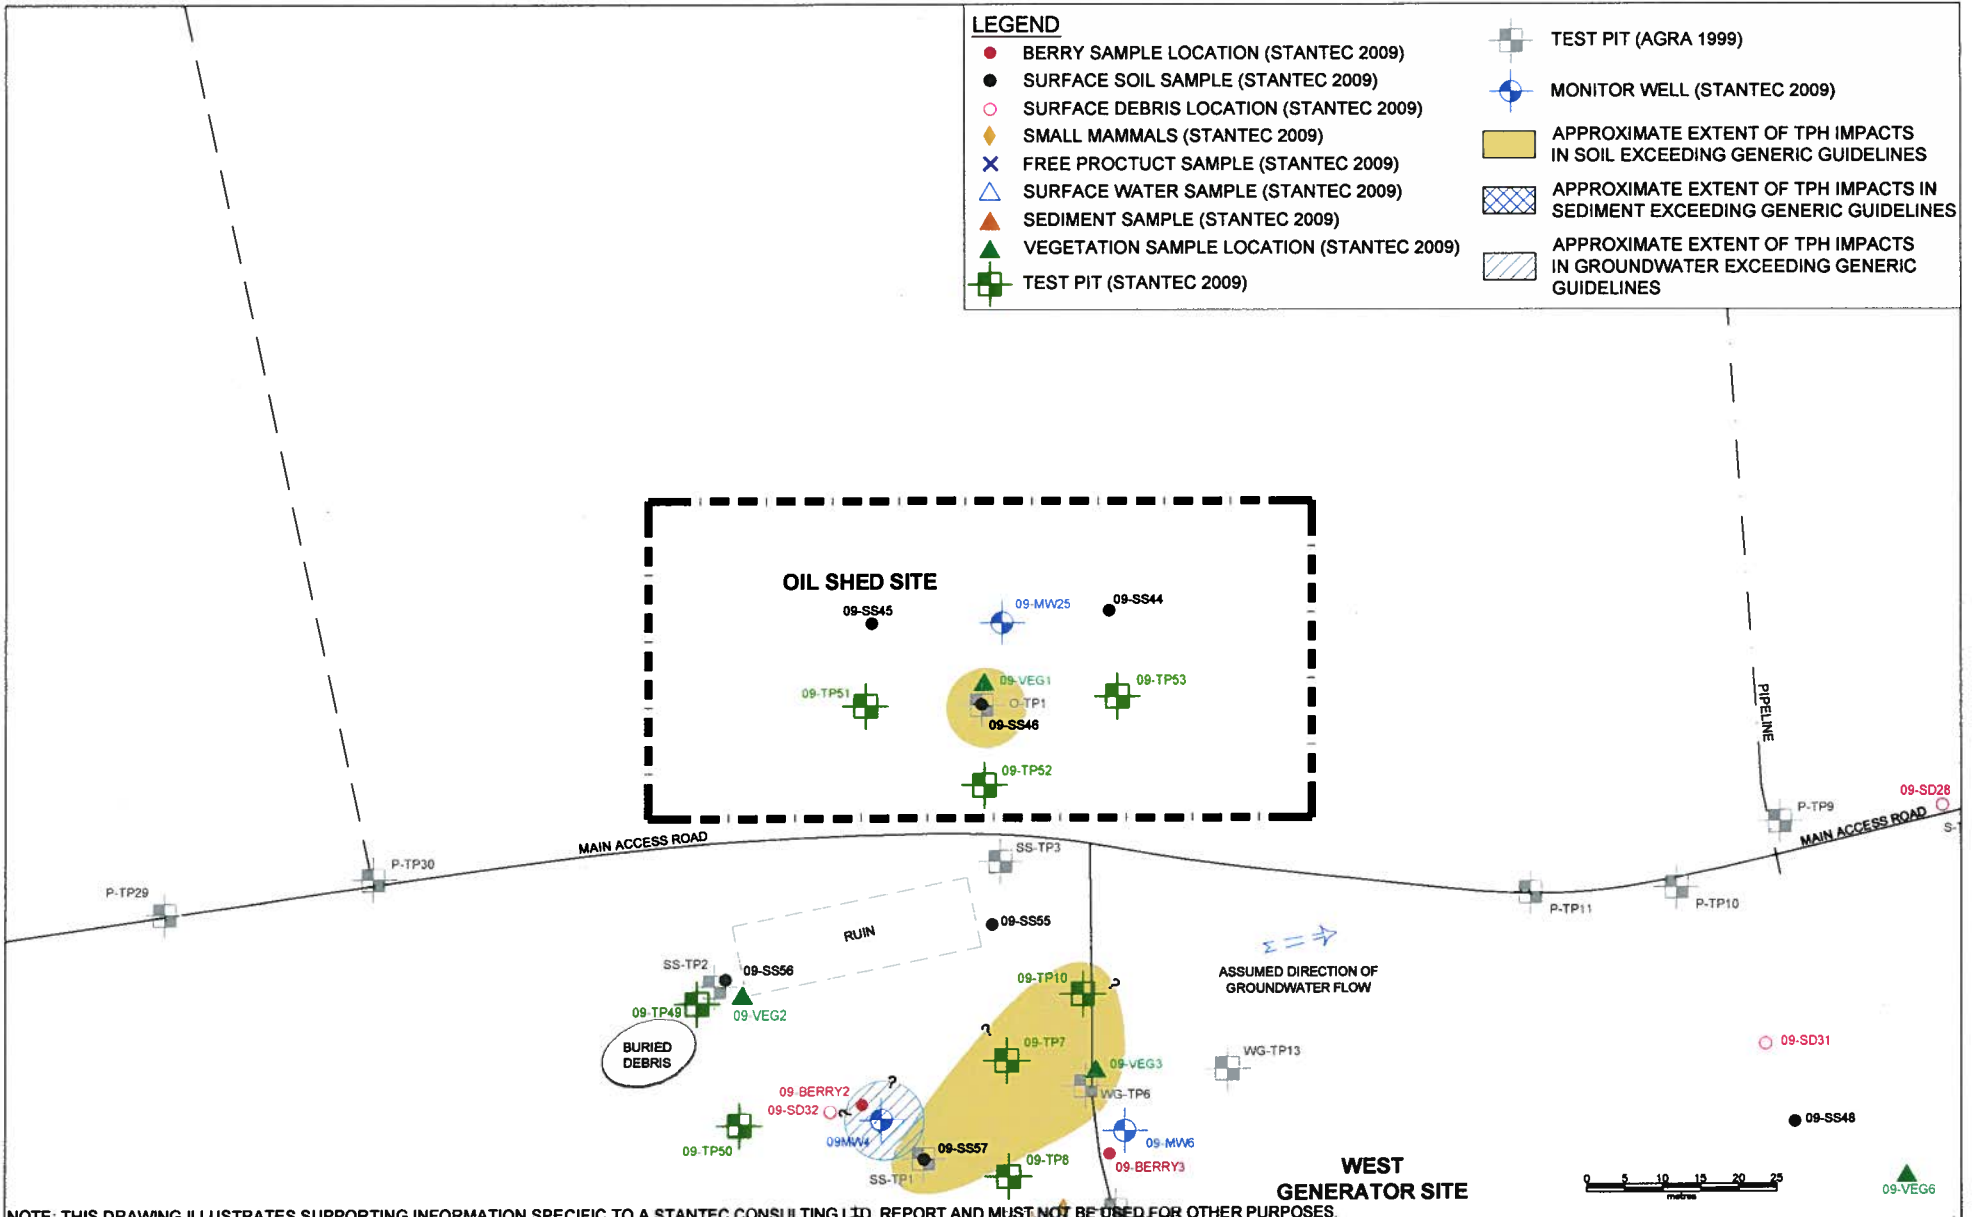
SCALE:	1:800	DATE:	JUNE 18, 2010
DRAWN BY:	N.M.	CHECKED BY:	A.R.
EDITED BY:	R.L.	REV. No.	0
DRAWING No.:	121410105-EE-11B		
CAD FILE:	1044857-EE-10.DWG

CLIENT:	NEWFOUNDLAND AND LABRADOR DEPARTMENT OF ENVIRONMENT AND CONSERVATION
PROJECT TITLE:	PHASE III ENVIRONMENTAL SITE ASSESSMENT, HUMAN HEALTH AND ECOLOGICAL RISK ASSESSMENTS, REMEDIAL ACTION PLAN FOR THE FORMER U.S. MILITARY FACILITY OF NORTHWEST POINT, NL
DRAWING TITLE:	APPROXIMATE EXTENT OF TPH IMPACTS EXCEEDING GENERIC GUIDELINES - OIL SHED SITE

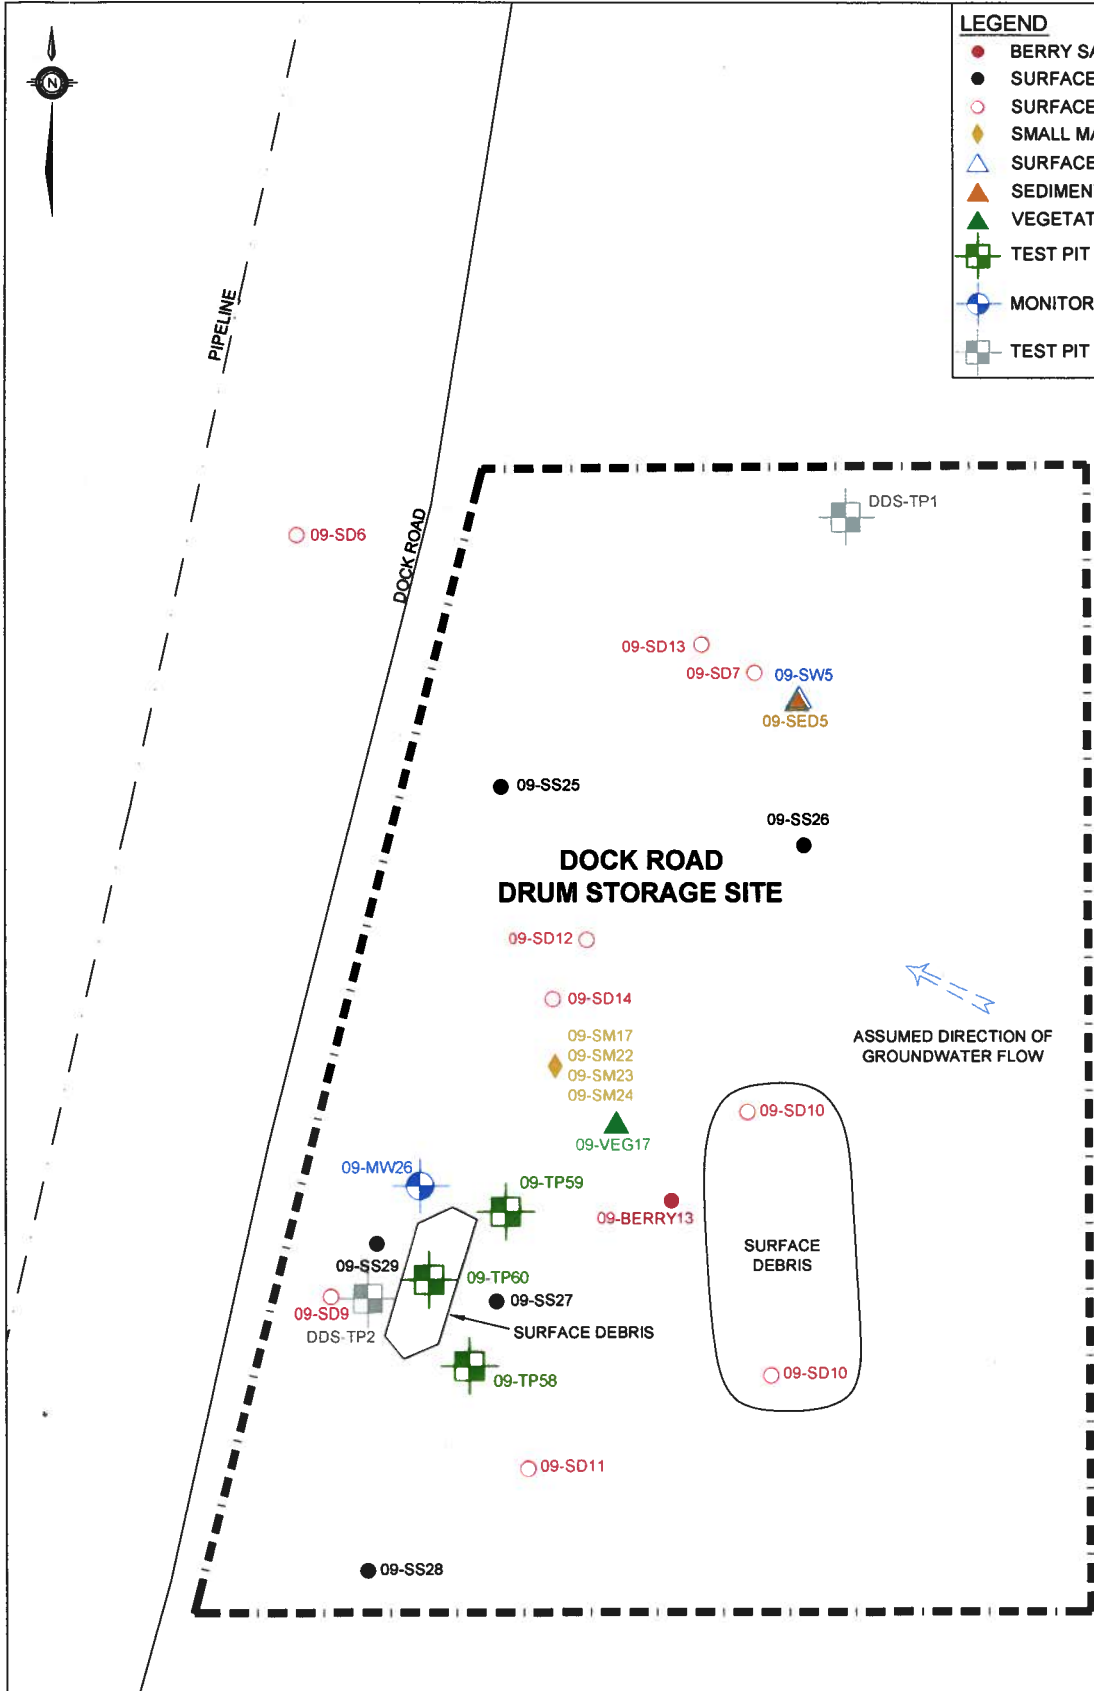
Buried debris was not encountered in the test pits at the site completed in 2009 as part of the Phase III ESA. Surface debris and physical hazards at the Dock Road Drum Storage Site were found throughout the site. Drawing No. 121410105-EE-12A in Appendix A shows the locations of the surface debris encountered. Items encountered on the site consisted of the following:

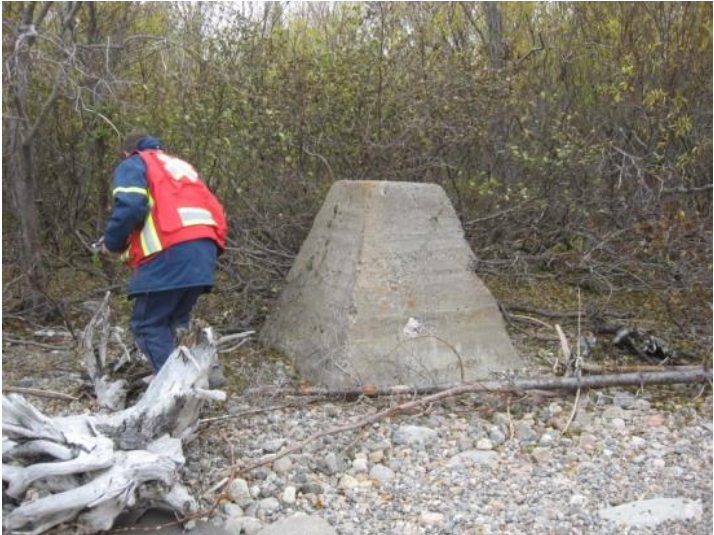
<p><u>09-SD2</u></p> <p>Coordinates (NAD27) Easting: 694715 Northing: 5932308</p> <p>Description: 1.5 m³ concrete anchor block</p> <p>Location: Lake Melville shoreline, Underground Pipeline Site</p>

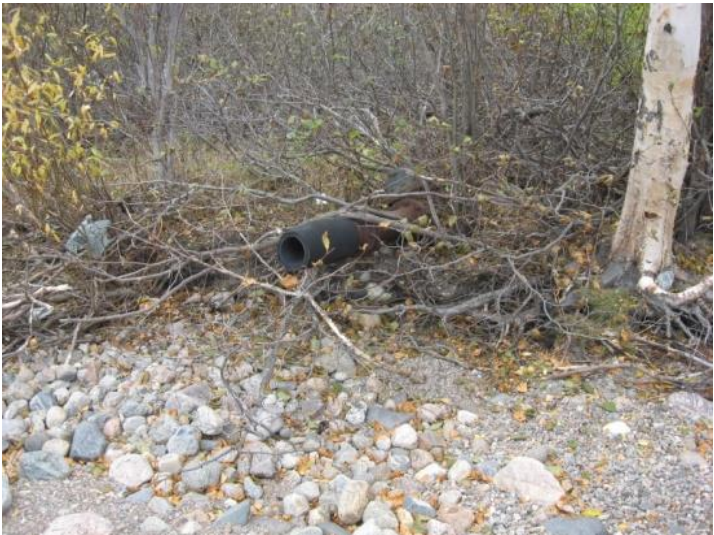
<p><u>09-SD3</u></p> <p>Coordinates (NAD27) Easting: 694728 Northing: 5932315</p> <p>Description: 6 m long 200 mm diameter steel pipe, valve</p> <p>Location: Lake Melville shoreline, Underground Pipeline Site</p>

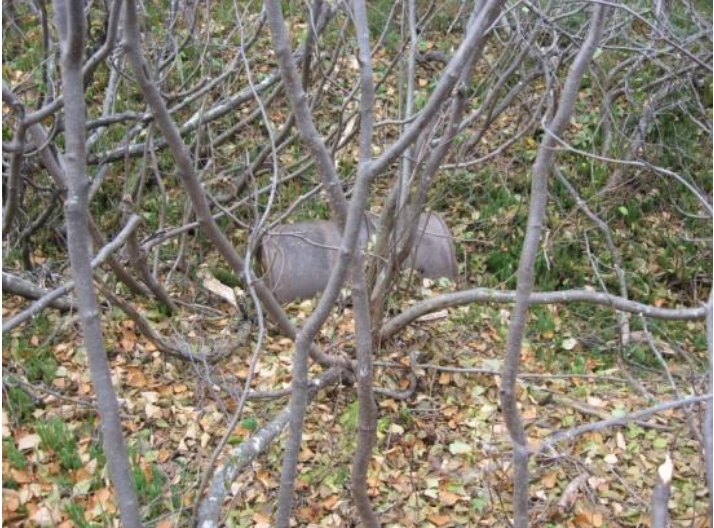
<p><u>09-SD5</u></p> <p>Coordinates (NAD27) Easting: 694737 Northing: 5932318</p> <p>Description: 10 m of steel cable</p> <p>Location: Lake Melville shoreline, Underground Pipeline Site</p>	<p>No photo taken</p>
<p><u>09-SD6</u></p> <p>Coordinates (NAD27) Easting: 694736 Northing: 5932176</p> <p>Description: 1 empty 200 L steel drum</p> <p>Location: Between Dock Road and Pipeline, east of Helicopter Pad Site</p>

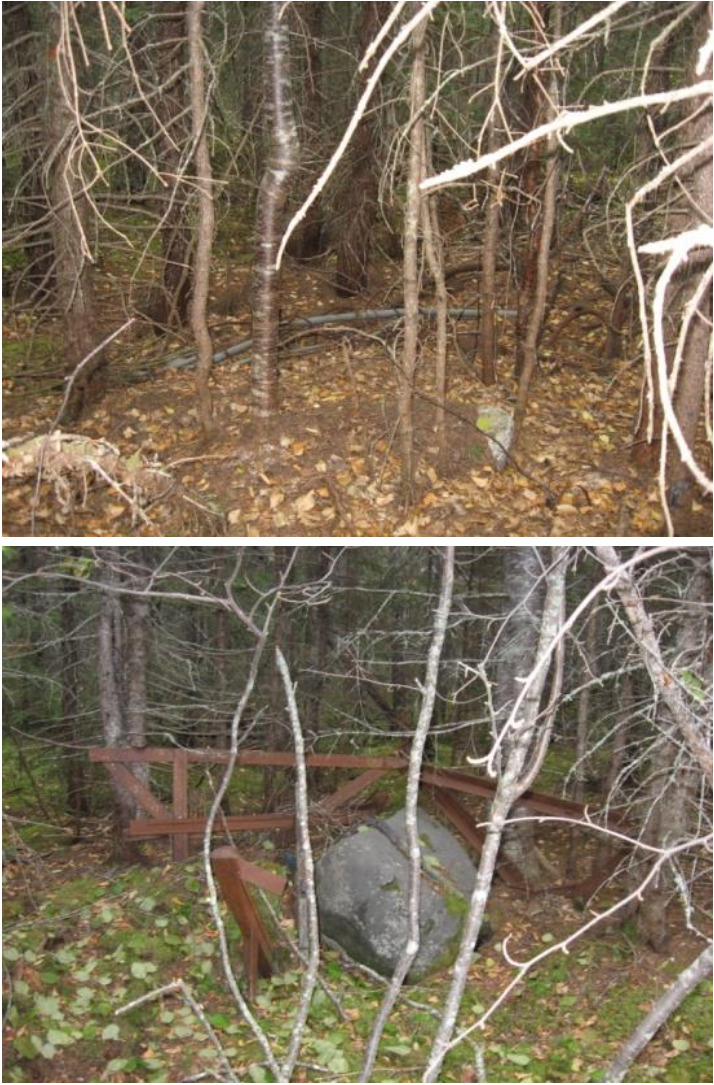
<p><u>09-SD10</u></p> <p>Coordinates (NAD27) Easting: 694787 to 694784 Northing: 5932088 to 5932116</p> <p>Description: 100 m x 30 m scattered surface and partially buried debris (plate steel, pipe, steel cable, drums, etc.)</p> <p>Location: Dock Road Drum Storage Site</p>

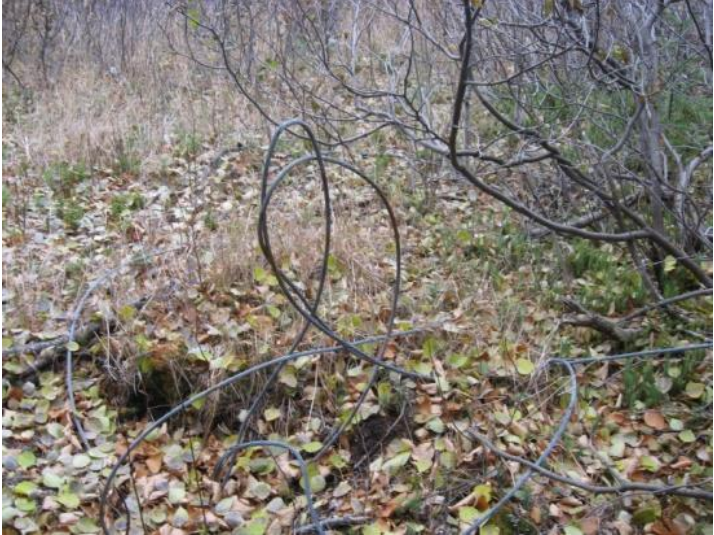
<p><u>09-SD11</u></p> <p>Coordinates (NAD27) Easting: 694762 Northing: 5932078</p> <p>Description: 20 m steel cable, 5 m long 50 mm diameter galvanized steel pipe</p> <p>Location: Dock Road Drum Storage Site</p>

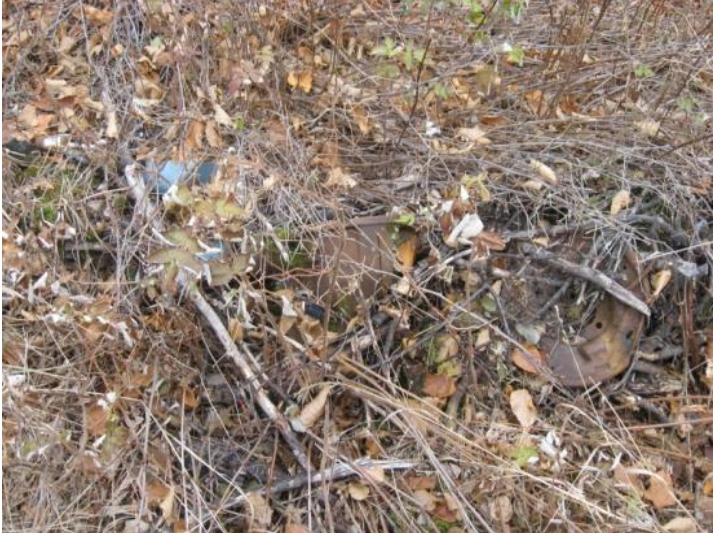
<p><u>09-SD12</u></p> <p>Coordinates (NAD27) Easting: 694767 Northing: 5932134</p> <p>Description: Partially buried rear end of car</p> <p>Location: Dock Road Drum Storage Site</p>

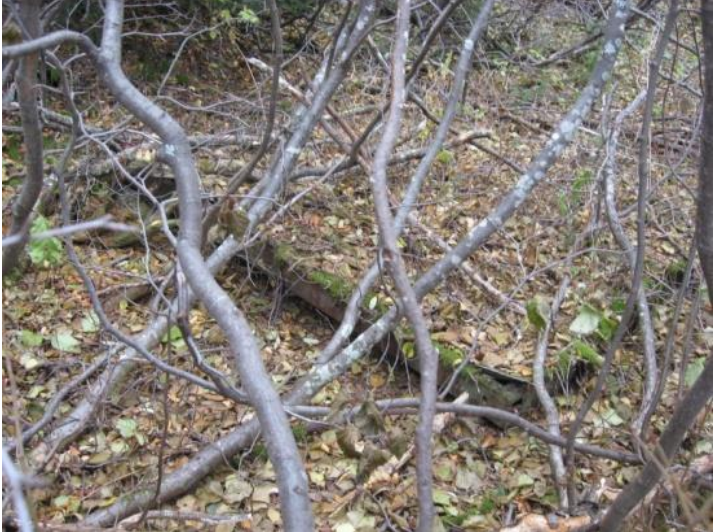
<p><u>09-SD14</u></p> <p>Coordinates (NAD27) Easting: 694763 Northing: 5932127</p> <p>Description: 2 m x 3 m tail gate</p> <p>Location: Dock Road Drum Storage Site</p>

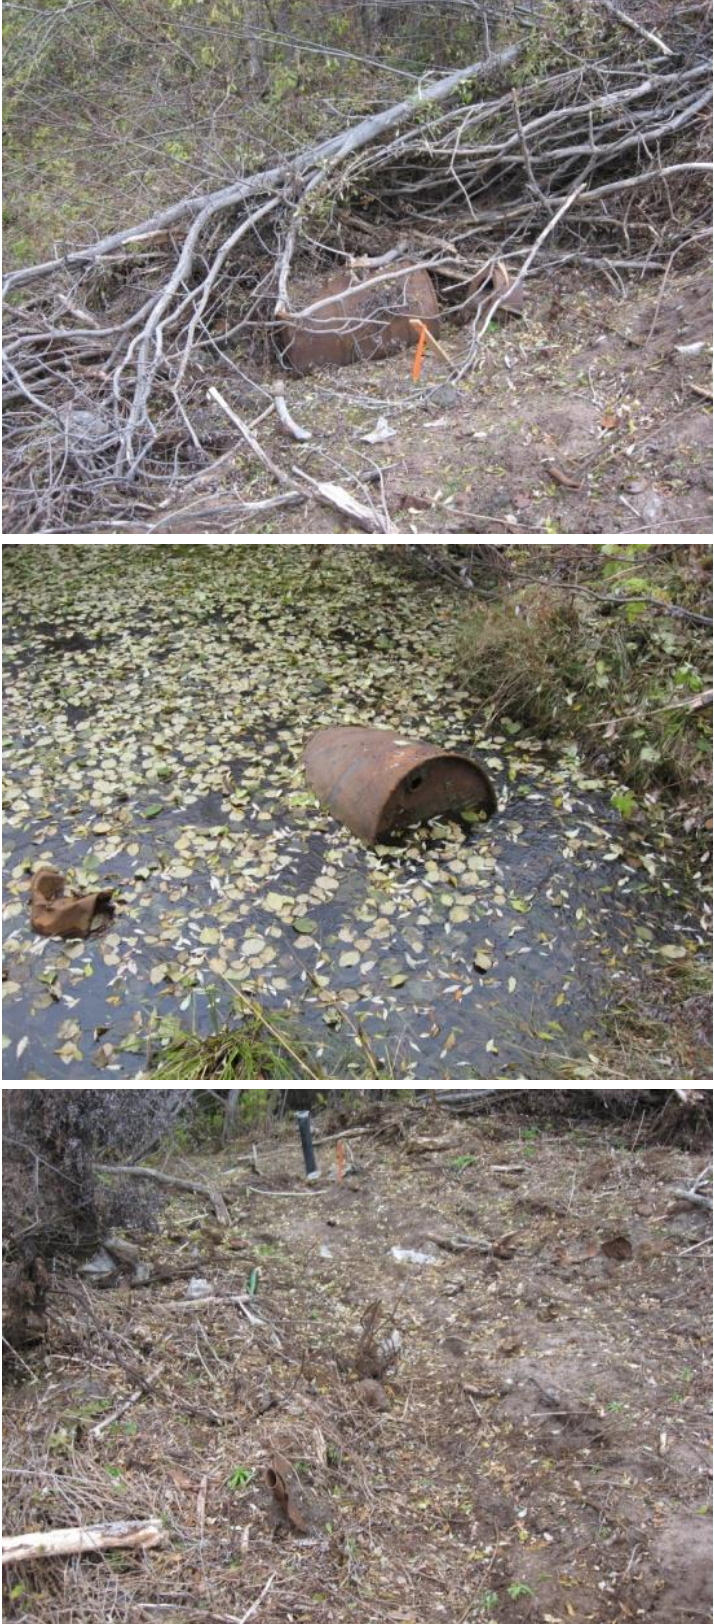
Location ID / Description	Photo(s)
<p><u>09-SD15</u></p> <p>Coordinates (NAD27) Easting: 694636 Northing: 5932032</p> <p>Description: 5 200 L drums, small amounts of surface and partially buried debris (metal, batteries, etc.)</p> <p>Location: Lake Melville Dump Site</p>

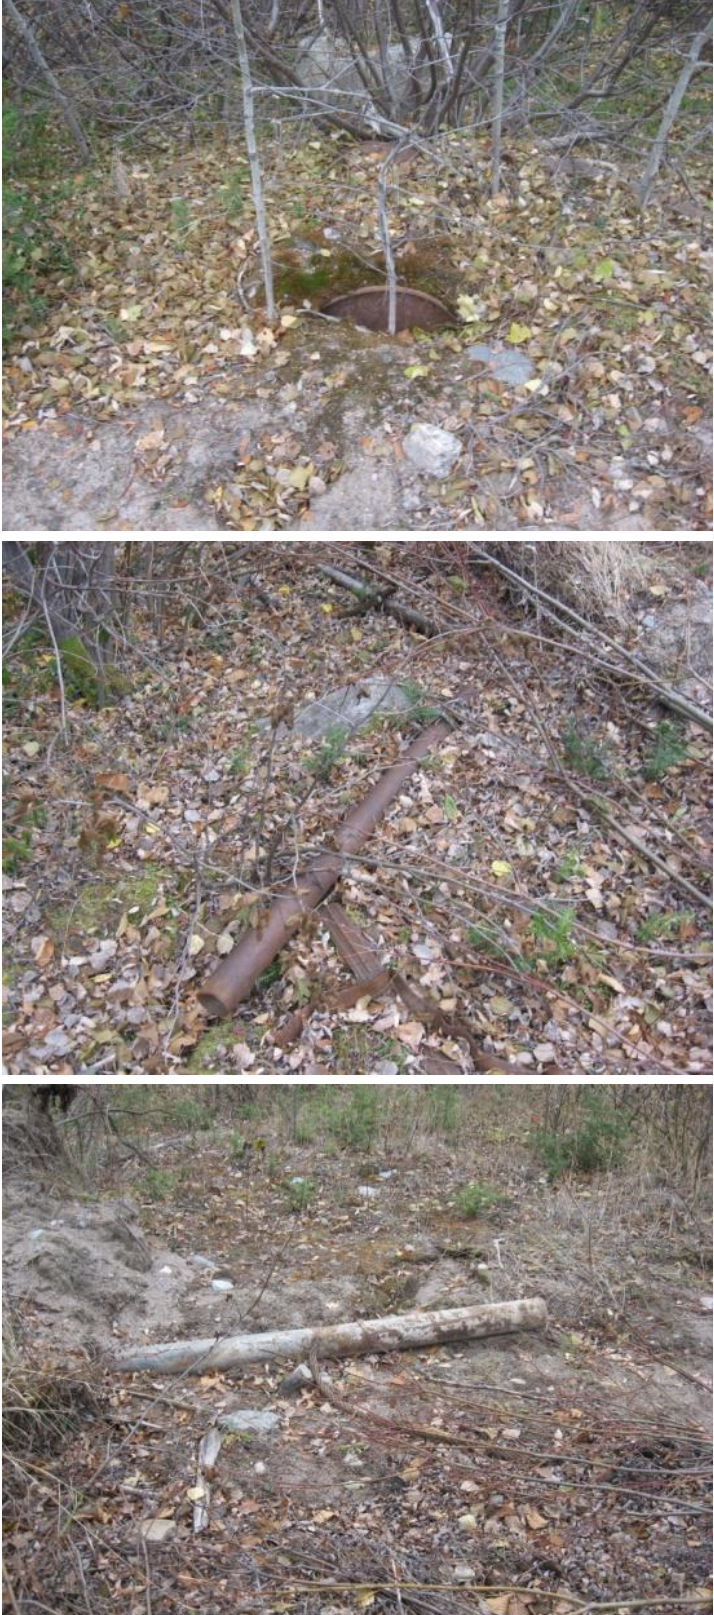
Location ID / Description	Photo(s)
<p>09-SD16</p> <p>Coordinates (NAD27) Easting: 694799 Northing: 5931074</p> <p>Description: Partially buried and surface metal debris (drums, pipe, cans)</p> <p>Location: Camp Road Dump Site</p>

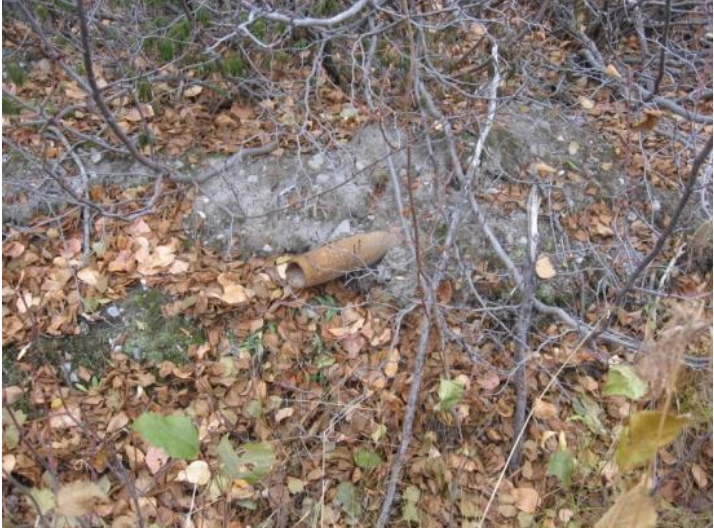
<p><u>09-SD18</u></p> <p>Coordinates (NAD27) Easting: 694317 Northing: 5931085</p> <p>Description: 0.4 m of 75 mm diameter steel pipe protruding from ground</p> <p>Location: North of VOR road, north of South Bulk Fuel Storage Site</p>

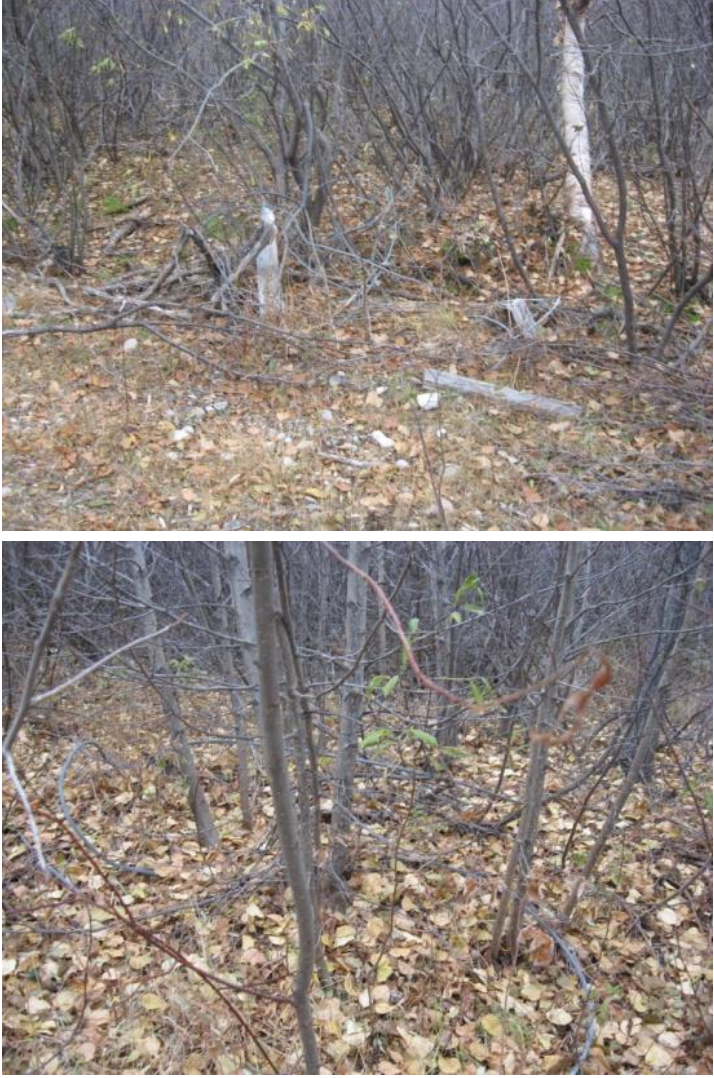
Location ID / Description	Photo(s)
<p><u>09-SD19</u></p> <p>Coordinates (NAD27) Easting: 694306 Northing: 5931223</p> <p>Description: 20 m of steel cable</p> <p>Location: North of Main Access Road, along sewer line</p>

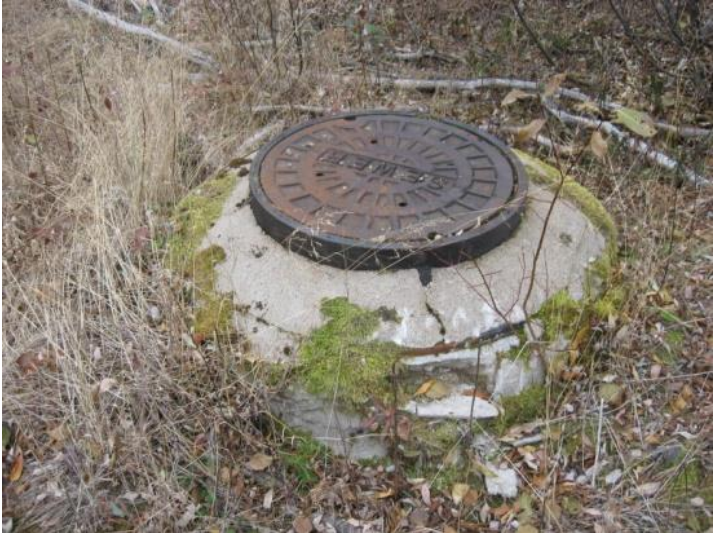
<p><u>09-SD22</u></p> <p>Coordinates (NAD27) Easting: 694294 Northing: 5931245</p> <p>Description: Sewer manhole</p> <p>Location: North of Main Access Road, along sewer line</p>

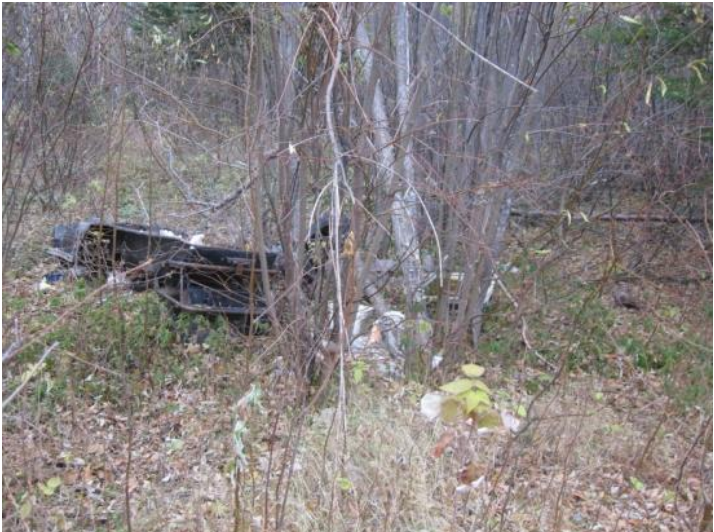
<p><u>09-SD23</u></p> <p>Coordinates (NAD27) Easting: 694296 Northing: 5931291</p> <p>Description: Domestic debris, old skidoo, outboard motor, tire</p> <p>Location: North Bulk Fuel Storage Site, near the former tower rubble location</p>

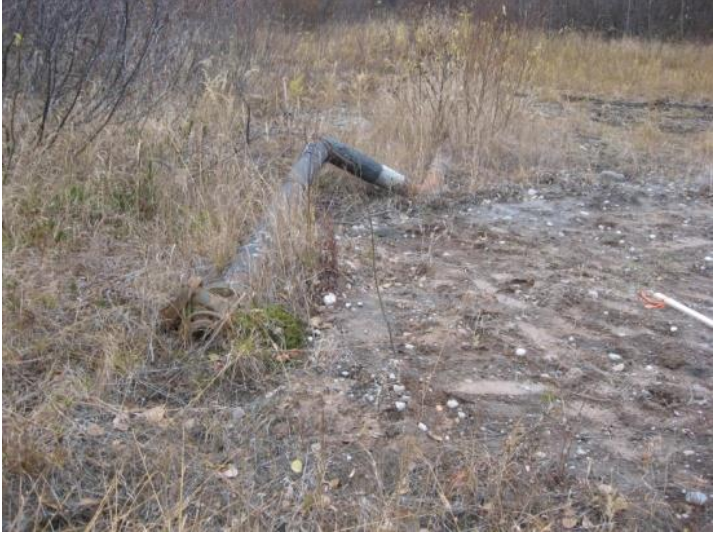
<p><u>09-SD25</u></p> <p>Coordinates (NAD27) Easting: 694254 Northing: 5931379</p> <p>Description: 12 m long 200 mm diameter steel pipe, valve</p> <p>Location: North Bulk Fuel Storage Site</p>

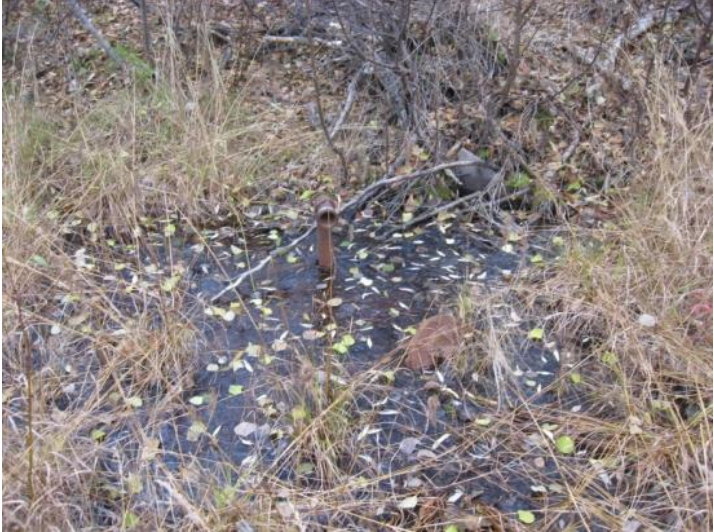
<p><u>09-SD26</u></p> <p>Coordinates (NAD27) Easting: 694255 Northing: 5931357</p> <p>Description: 0.3 m of 50 mm diameter steel pipe protruding from ground, valve</p> <p>Location: North Bulk Fuel Storage Site</p>

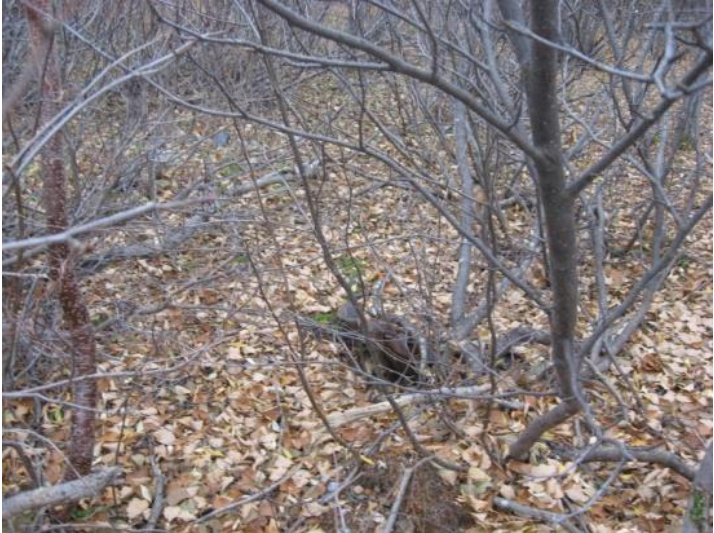
<p><u>09-SD28</u></p> <p>Coordinates (NAD27) Easting: 694288 Northing: 5931210</p> <p>Description: Steel drum, partially buried concrete debris</p> <p>Location: Sewer Site, north of Main Access Road</p>

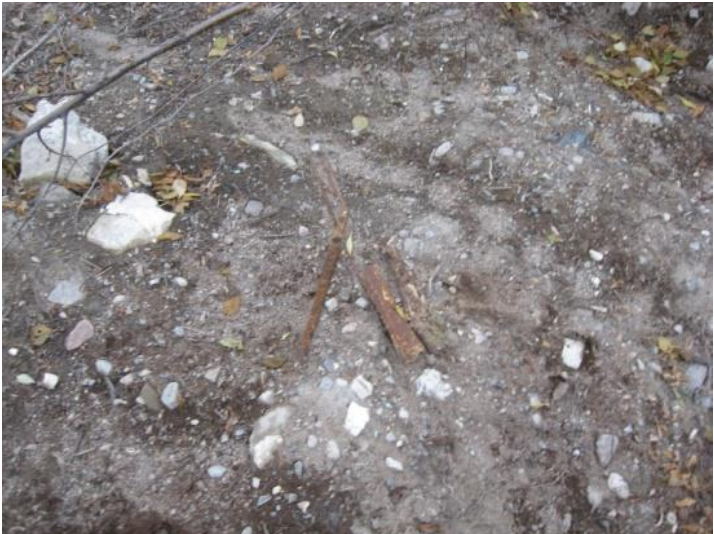
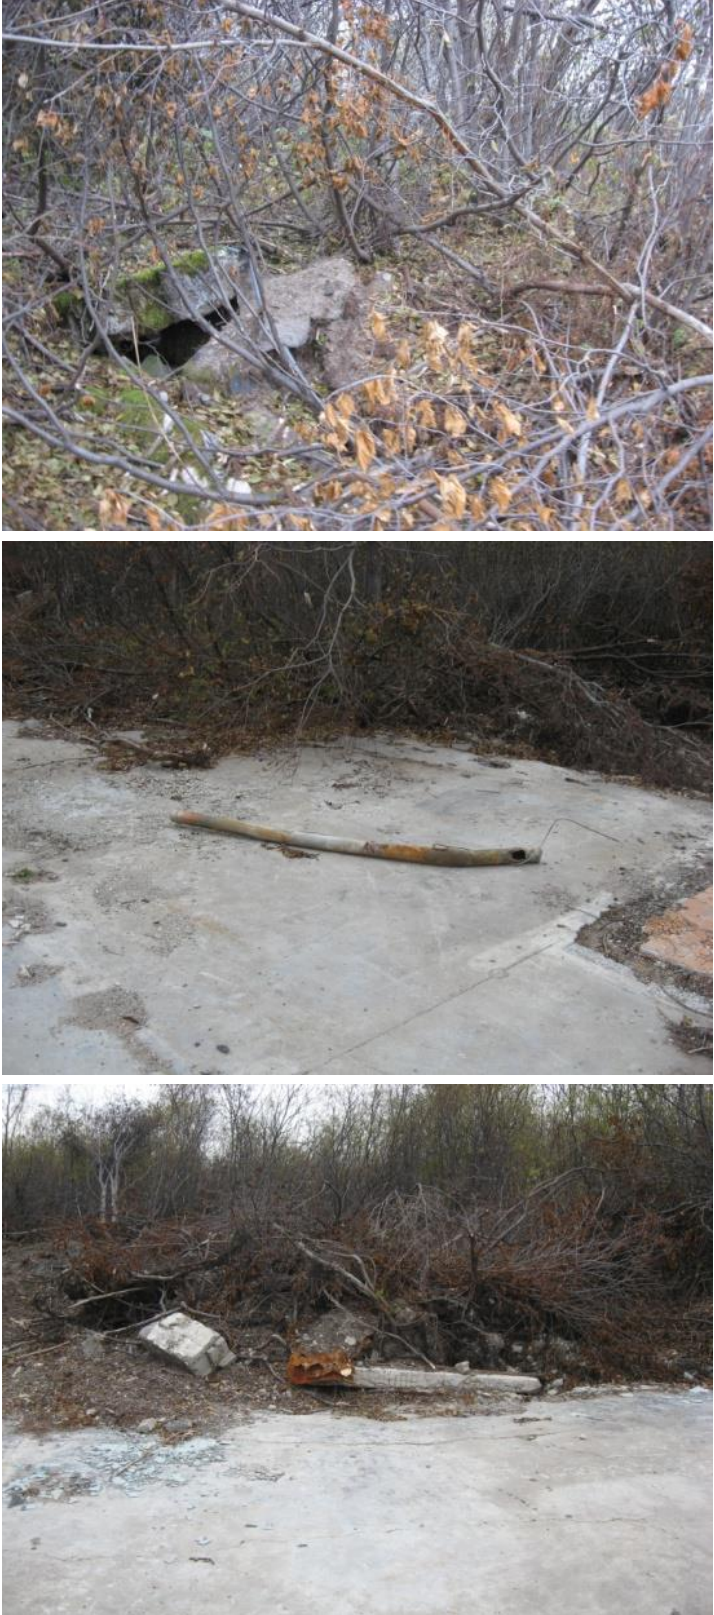
Surface debris and physical hazards at the West Generator Site were generally found along the southern portion of the site. Drawing No. 121410105-EE-06A in Appendix A shows the locations of the surface debris encountered. Items encountered on the West Generator Site consisted of the following:

<p><u>09-SD29</u></p> <p>Coordinates (NAD27) Not recorded</p> <p>Description: 10 m² of partially buried pipe, metal and concrete debris</p> <p>Location: West Generator Site</p>

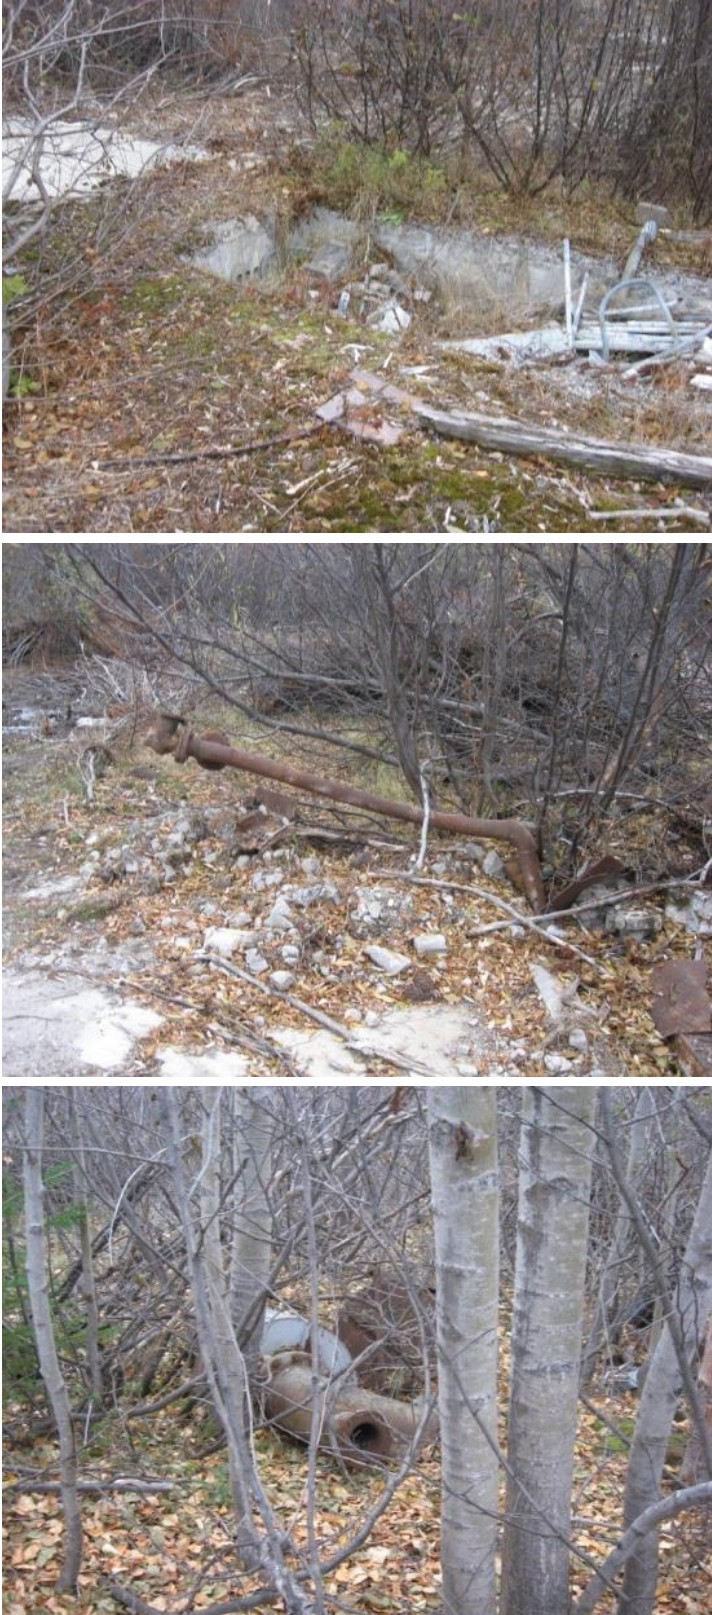
Location ID / Description	Photo(s)
<p data-bbox="186 877 289 909"><u>09-SD30</u></p> <p data-bbox="186 934 430 966">Coordinates (NAD27)</p> <p data-bbox="186 961 373 993">Easting: 694195</p> <p data-bbox="186 989 397 1020">Northing: 5931098</p> <p data-bbox="186 1045 560 1182">Description: 100 m stretch of partially buried metal and concrete (50 mm, 200 mm and 300 mm diameter pipes, metal sheeting, drums, valves, cable, etc.)</p> <p data-bbox="186 1207 527 1239">Location: West Generator Site</p>

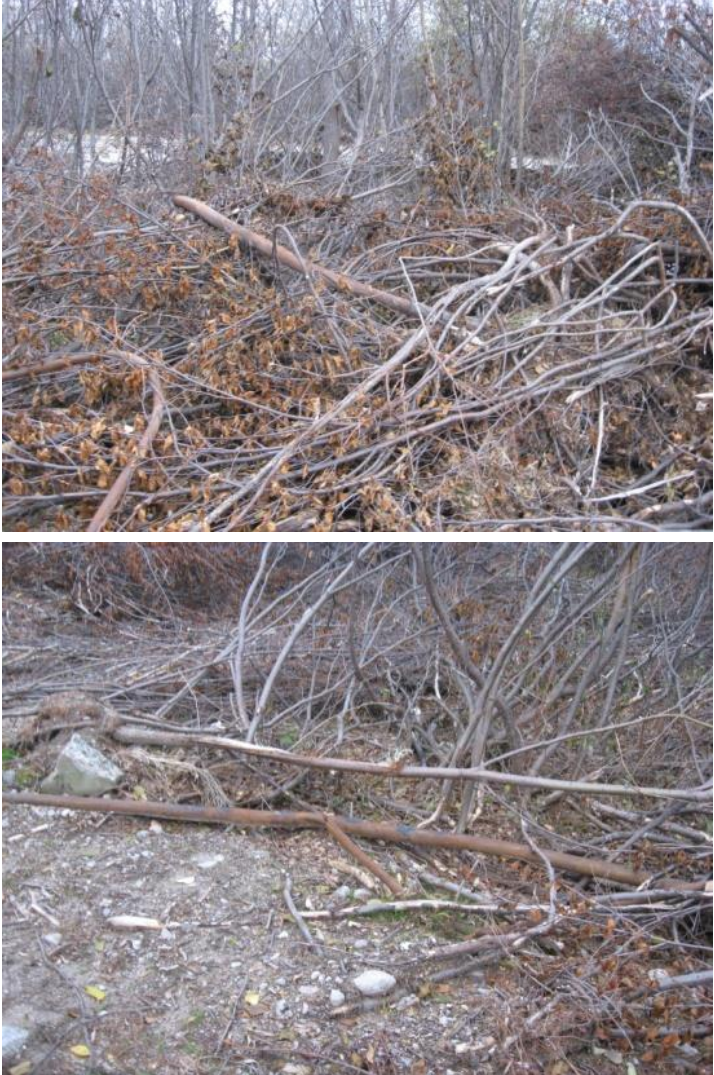
<p><u>09-SD32</u></p> <p>Coordinates (NAD27) Easting: 694142 Northing: 5931167</p> <p>Description: 10 m long 50 mm diameter steel pipe, 10 m long 25 mm conduit (partially buried)</p> <p>Location: Service Site</p>
