Technical Memo: Deer Lake Seepage Issue

Prepared for: Haseen Khan, P.Eng.

Prepared by: Paula Dawe, P.Eng.
Water Resources Management Division
Department of Environment and Conservation
Copies: Department of Municipal Affairs, Town of Deer Lake
Date: June 30, 2014
File Number: 533-06

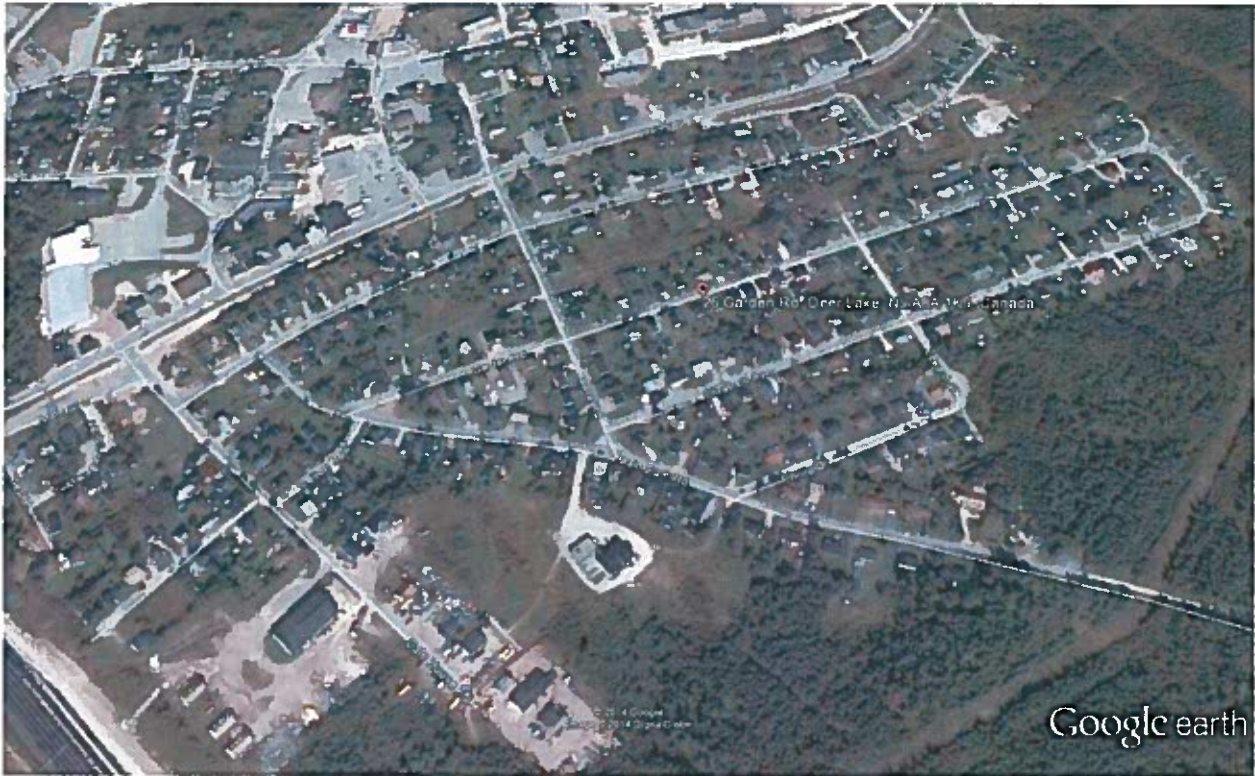
Figure 2: Deer Lake residential area downstream of Humber Canal and affected by high groundwater levels including street names

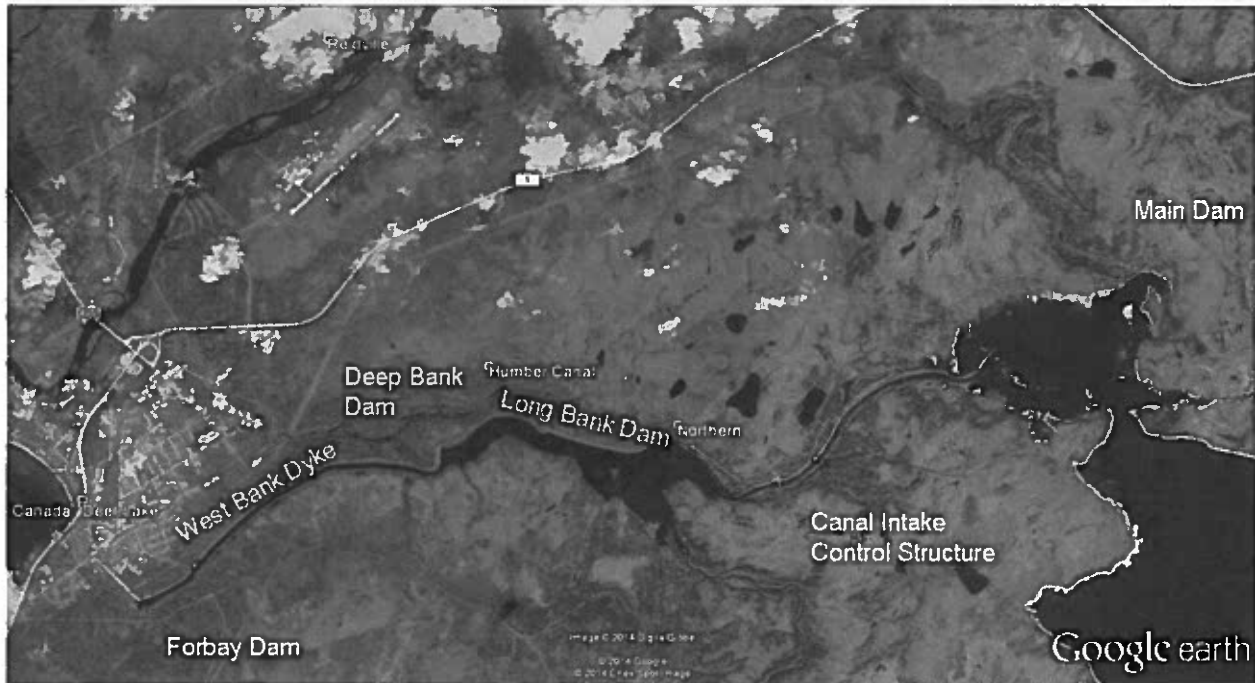
As shown in Figure 5, the DLP system of water control structures was originally built in 1923-24 and uses runoff from Grand Lake to generate hydroelectricity at the generating station in the Town of Deer Lake. The DLP system is comprised of:

Figure 5: Deer Lake Power System

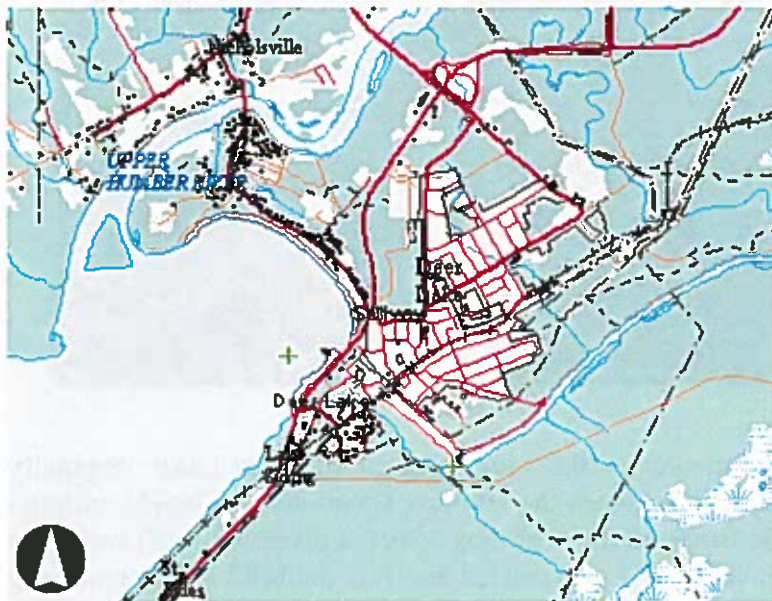
There are no groundwater monitoring wells anywhere in the area to monitor groundwater levels. There are a handful of hydrometric stations in the area as shown in Figure 10 including:

Figure 10: Location of hydrometric stations

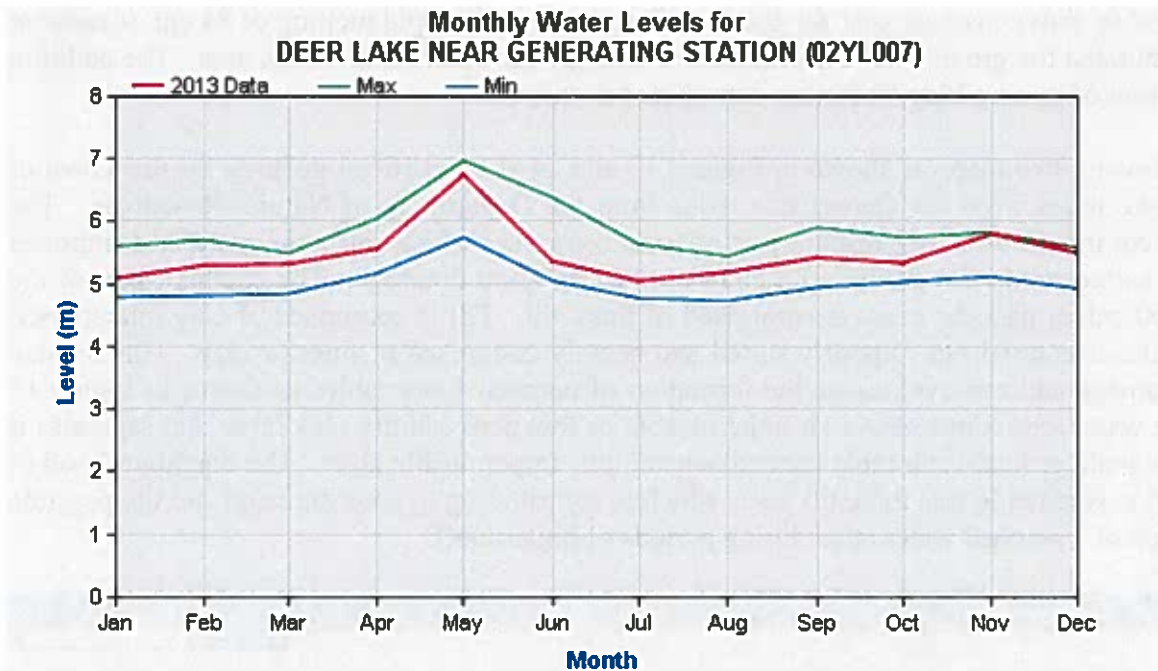
As can be seen in the following graphs in Figures 11 and 12, water levels in Deer Lake tend to peak in May, but are otherwise relatively steady throughout the year. Flow from the Humber Canal also displays maximum levels in May with typically little variation throughout the year. The Humber Canal is a highly regulated system controlled by the Intake Control Dam and Forebay Dam. According to town staff, who visit the Humber Canal at least once per week (once per day in summer), the canal water level is steady only varying by approximately a foot. This uniform water level maintained in the Humber Canal would likely be mirrored by relatively uniform amounts of seepage from the dam as monitored by weirs 1-18. This will be confirmed once weir flow data is supplied by DLP.

Figure 11: Monthly water levels in Deer Lake, statistics for 86 years of data

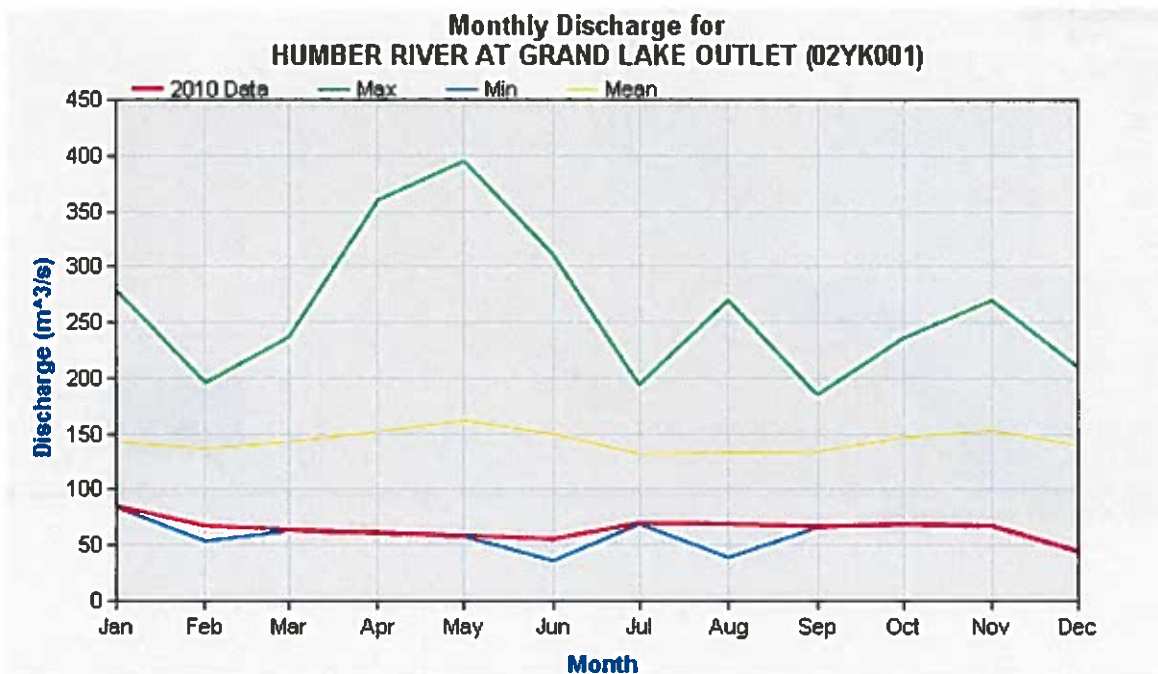
Figure 12: Monthly Discharge at the Humber Canal, statistics for 86 years of data

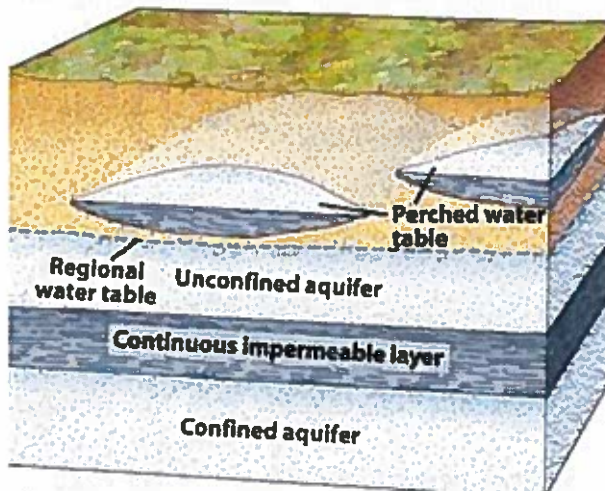
The following two maps as shown in Figures 13 and 14 show surficial geology for the Town of Deer Lake taken from the Geoscience Atlas from the Department of Natural Resources. The town is cut in half with the northern part of town comprised of glacialfluvial material comprised of well sorted sands and gravels and characterized by good drainage. The southern part of the town, extending past the canal is comprised of thick till. Till is comprised of clay interspersed with courser material that is poorly sorted and heavily comprised of fines or clay. Tills display poor drainage and can even cause the formation of perched water tables as shown in Figure 15 where a water lens forms above an impermeable or low permeability clay layer that separates it from the main groundwater table located beneath this impermeable layer. The neighbourhood in question is situated in this thick till layer which is contributing to poor drainage and the possible formation of a perched water table during periods of high runoff.

Figure 15: Perched water table
