Weird Stuff in Water!

Department of Municipal Affairs and Environment

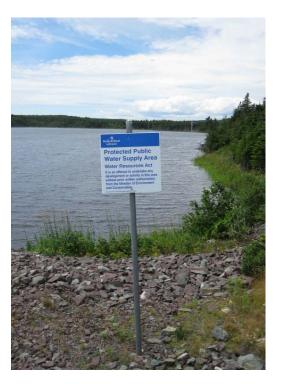
Unauthorized Activity Within the Watershed

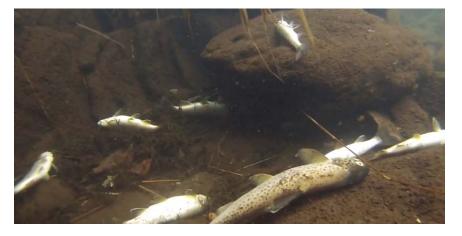
Dead Fish

- September 10, 2016 City of St. John's Parks and Open Spaces Division notified of a large number of dead fish in the Waterford River and the Bowring Park Duck Pond.
- City staff investigated and found the likely cause was a water main which expelled significant quantities of drinking water into a river that feeds into the Waterford River.
- Chorine levels in the drinking water were within the Guidelines for Canadian Drinking Water Quality

- Chlorine levels were safe for human consumption but not safe for fish.
- City staff consulted with the Federal Department of Natural Resources and Water Resources Management Division and both agreed this was the likely cause.
- September 12, 2016 No traces of chlorine residual were found in the Waterford River and the fish have returned to the affected areas.
