MEETINGS IN ST. JOHN'S AND VISITS TO LOWER CHURCHILL PROJECT SITES, JULY 23 TO 28, 2017

Prepared for: Natural Resources Canada and Nalcor Energy
IE Point of Contact: Nik Argirov
Date: October 06, 2017

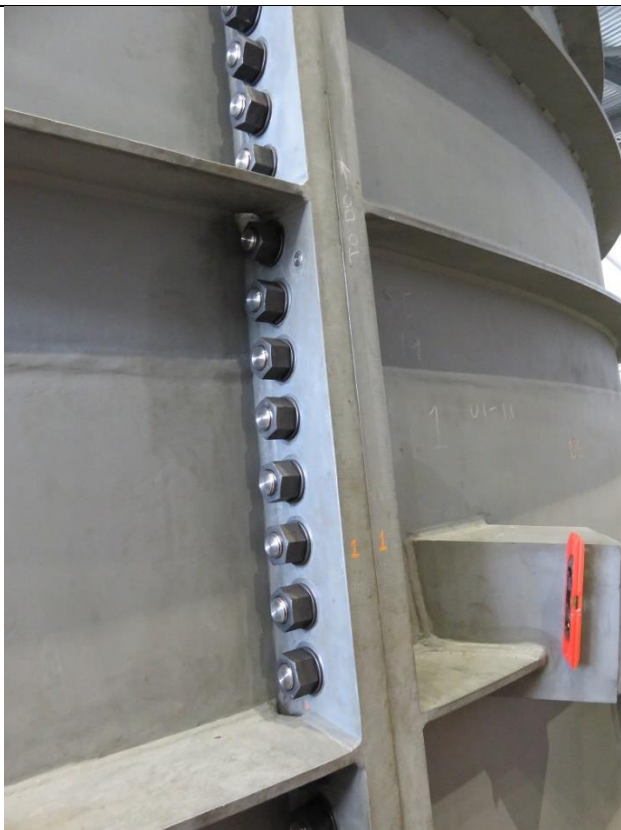
Photo A.12: Bolting details for draft tube liner segments.

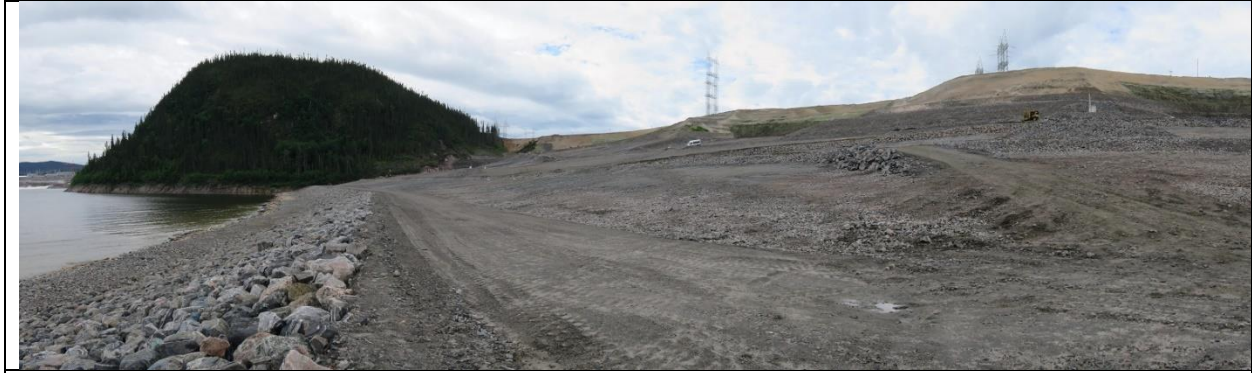
- Fine-grained soil slopes were hydroseeded earlier in the summer and grass was starting to grow (Photos E.1 to E.8). Local erosion from surface runoff was observed in several locations of the upper slopes where vegetation cover was not fully established; local maintenance and repair of these areas may be required in future.

Photo E.5: Southerly panorama view along downstream side of North Spur slope stabilization works.

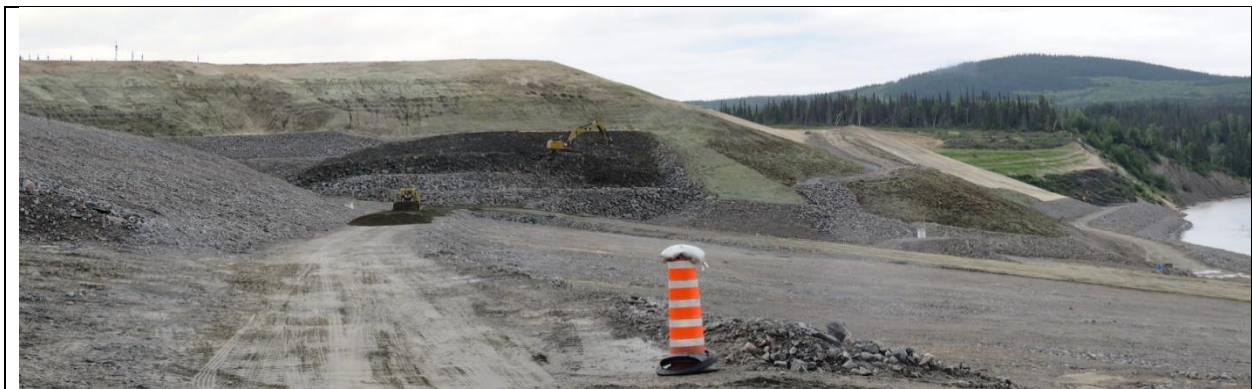
Photo E.6: Northerly panorama view along downstream side of North Spur slope stabilization works. Kettle Lakes discharge channel is at far right. Note local surface erosion (rolling) of upper slope.

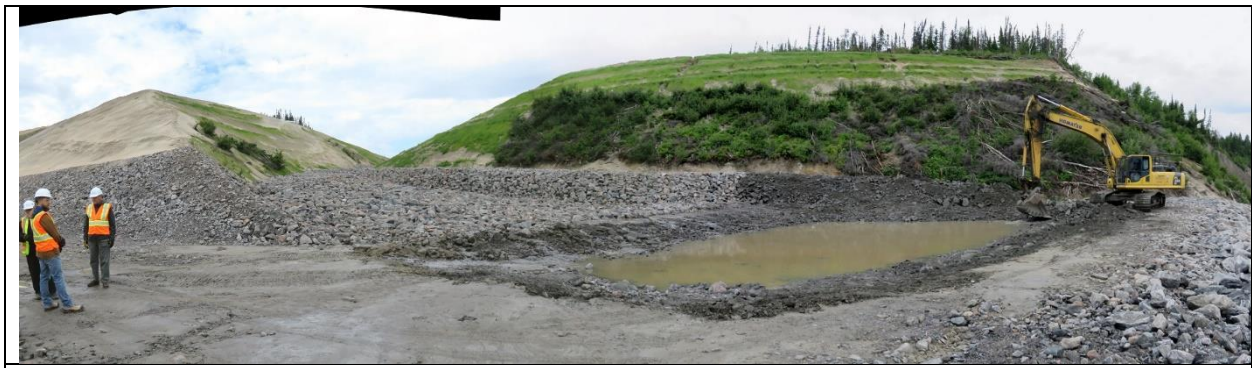
Photo E.7: Northwesterly panorama view looking upstream along Kettle Lake discharge channel.
