**PHASE I ENVIRONMENTAL SITE ASSESSMENT
FORMER RAMBLER MINE PROPERTY
BAIE VERTE, NEWFOUNDLAND**

SUMMARY

Davis Engineering & Associates Ltd. (DEAL) was commissioned by the Provincial Department of Natural Resources (DNR) to conduct a Phase I Environmental Site Assessment of the Former Rambler Mines Property in Baie Verte, Newfoundland and Labrador. Based on a review of information supplied by the Client as well as observations made during the site investigation, the property assessment has revealed the following:

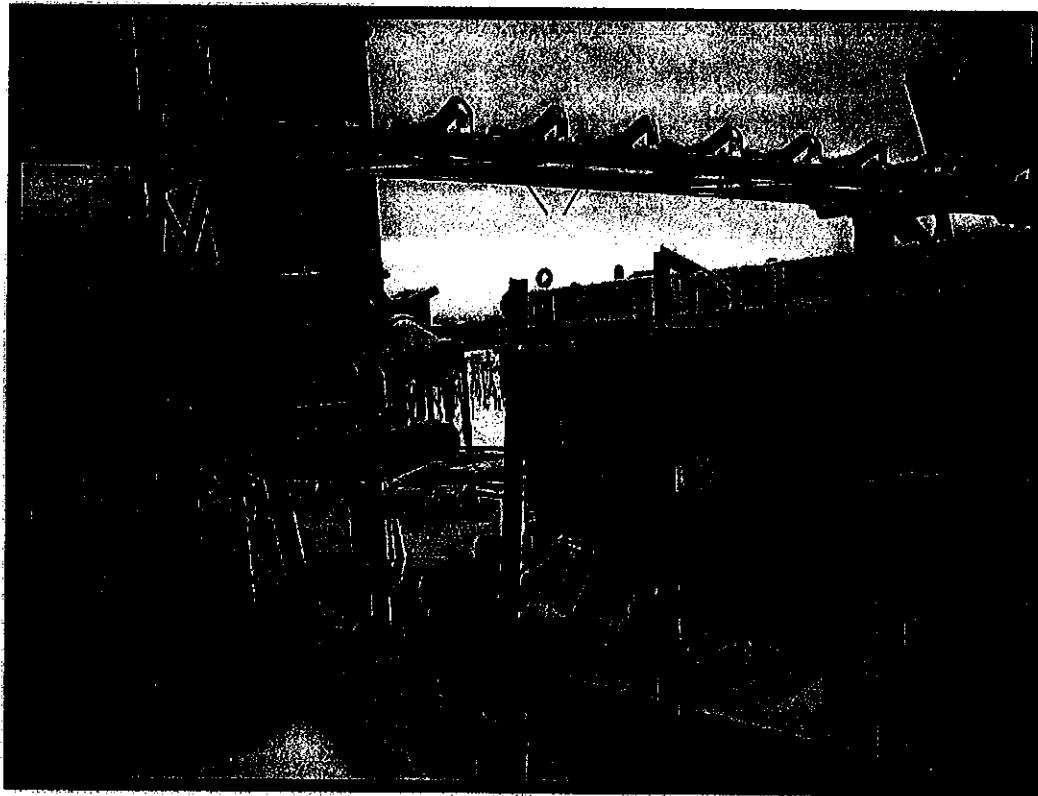
Photograph 6: Raymo Processing Facility adjacent to Tailings Pond

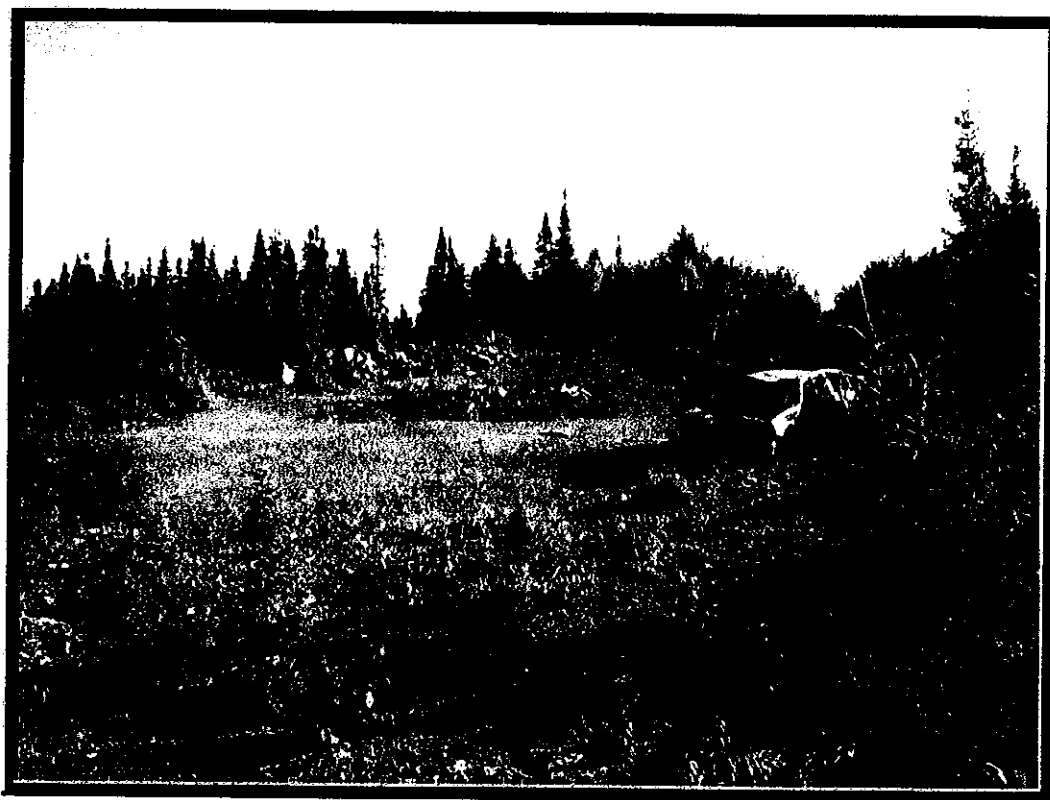
Photograph 2A: Big Rambler Pond Mine Portal Area

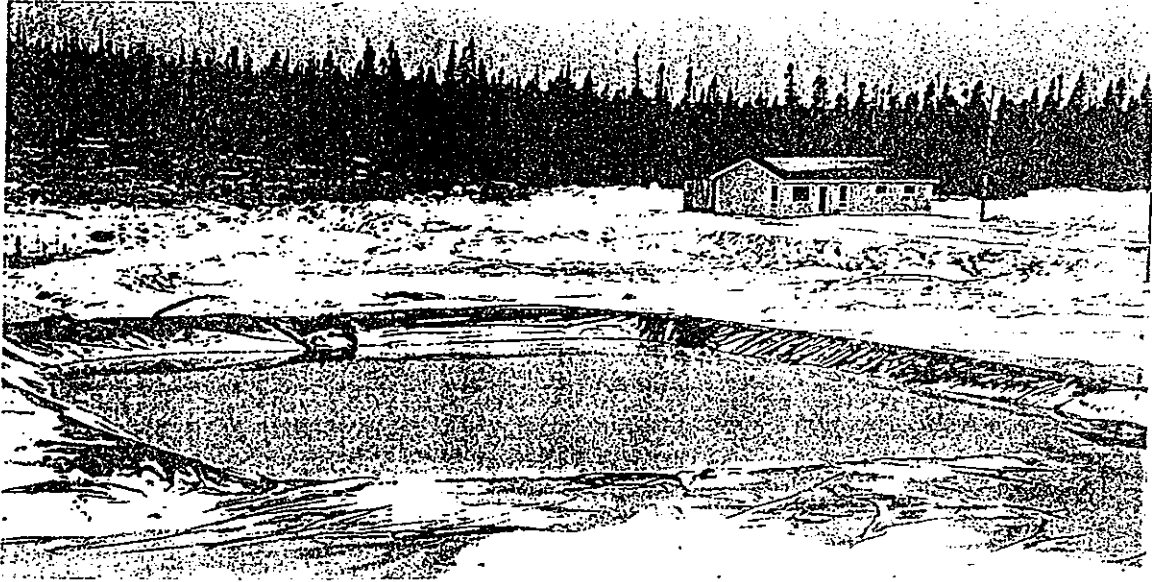
6(a) Reagent Containment Pond

After treating all the solutions contained within the reagent containment pond, the magnitude of the potential hazard associated with the highly acidic nature of the material left was a great concern to public safety and the generation of more acid mine water. The reagent pond was filled immediately.

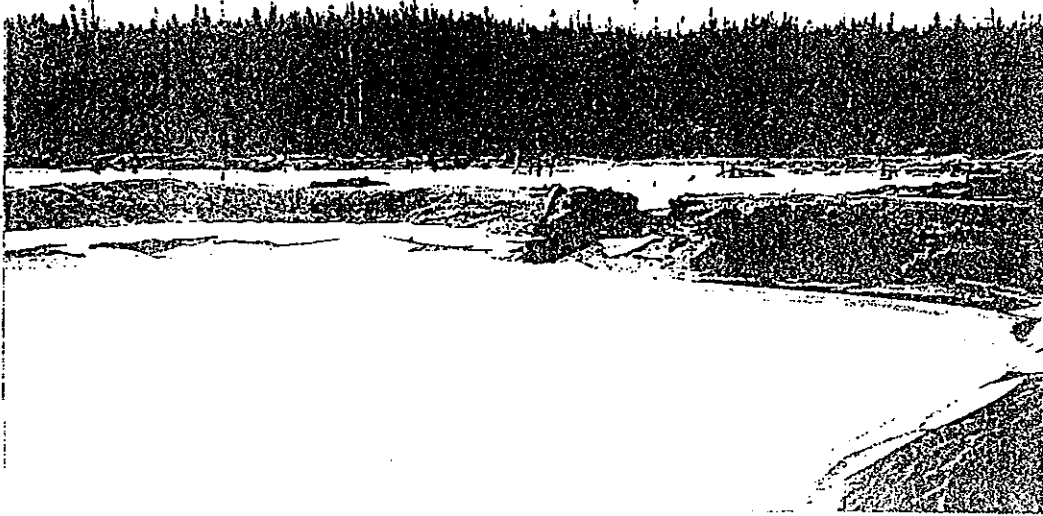
6(b) Trench in Reagent Pond Dam

The reagent pond dam and liner were pushed in and buried. The area was backfilled and leveled and the remaining heaped pile sloped off.
