GOVERNMENT OF NEWFOUNDLAND AND LABRADOR Department of Transportation and Infrastructure	BRIDGE INSPECTION REPORT B08232019-1	
Date: 7/10/2019	Inspected By: Terrance Coates	Category: Eng. - Engineering	
BRIDGE INFORMATION			
Site:	4-165 - HARRYMAN'S BROOK BRIDGE		
Route:	422	Overall Length:	6.1 m
Year Built:	1956	Est: No	Overall Width: 9.5 m
Year Last Rehab.:		Est: No	Roadway Width: 9 m
Region:	WEST COAST/NORTHERN		Sidewalk Width: 0 m
Jurisdiction:	Provincial	Clearance to R.D. or N.W.L.:	1.1 m
Type of Structure:	03 - Reinforced Concrete Beam/Slab		Max Depth of N.W.L.: 1 m
Purpose of Structure:	03 - Over Navigable Waters		Spans:
Type of Handrail:	02 - Concrete Rail		<u>Span No.:</u> <u>Length</u> <u>Span No.:</u> <u>Length</u>
Roadway Surface:	01 - Concrete	1	5.5 4 0
Alignment Vertical:	01 - Good	2	0 5 0
Alignment Horizontal:	01 - Good	3	0 6 0
Restrictions:	No		
BRIDGE PHOTOS

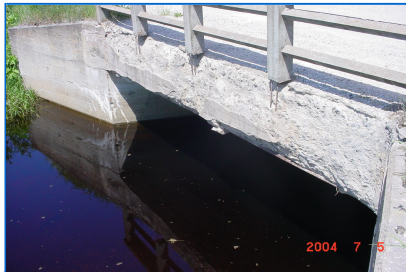
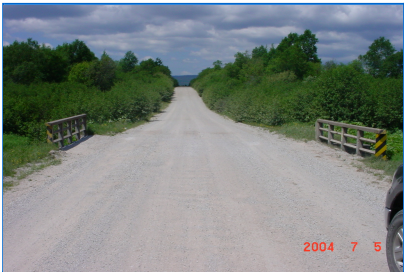
Bearing Seat:	I - Inapplicable
Comments:	Exposed reinforcement underside of deck		
SUPERSTRUCTURE			
Condition:	F1 - Fair	Expansion Joints:	I - Inapplicable
Comments:	Efflorescence deposits on side of slab		
DECK			
Condition:	F1 - Fair	Curbs:	I - Inapplicable
Hand Rail:	P1 - Poor	Roadway Condition:	I - Inapplicable

Approach Rail:	I - Inapplicable		
Comments:	Rails in poor condition, no approach rail, deteriorated concrete below rail - rebar exposed		
HYDROLOGY			
Water Velocity:	0 m/s	Ice Problem:	N - No Problem
Water Depth:	0 m	Scour Problem:	N - No Problem
Waterway:	01 - Adequate	Debris Problem:	N - No Problem
Comments:			
REPLACEMENT/REHABILITATION			
Next Rehab. Date:	2019	Replacement Year:	2019
Antic. Rehab. Cost:	\$0	Replacement Cost:	\$0
Recommendations:	Consider replacement with 40 foot steel panel bridge		
OBSERVATIONS			
Overall Condition:	F1 - Fair	Requires Further Inspection:	No
Additional Observations:	Bridge requires annual inspection		
LEGEND:			
Condition Definitions:			
1 - *Good - [discontinued code].	F2 - Fair.	C - Unsafe (Closed to Public).	Problem Definitions:
2 - *Fair - [discontinued code].	F1 - Fair.	U - Uninspectable.	N - No Problem.
3 - *Poor - [discontinued code].	P3 - Poor.	I - Inapplicable.	P - Possible Problem.
