# **Building Condition Assessment - Breakwater Books Building and Former Roebothan-McKay-Marshall Law Building**

96-100 Water Street and 205-211 Duckworth Street, St. John's NL

**Government of Newfoundland and  
Labrador, Department of  
Transportation and Infrastructure  
Building Condition Report  
Client Reference no. 102405008**

June 2026  
02501045.000-0100-BS-R-0001-01

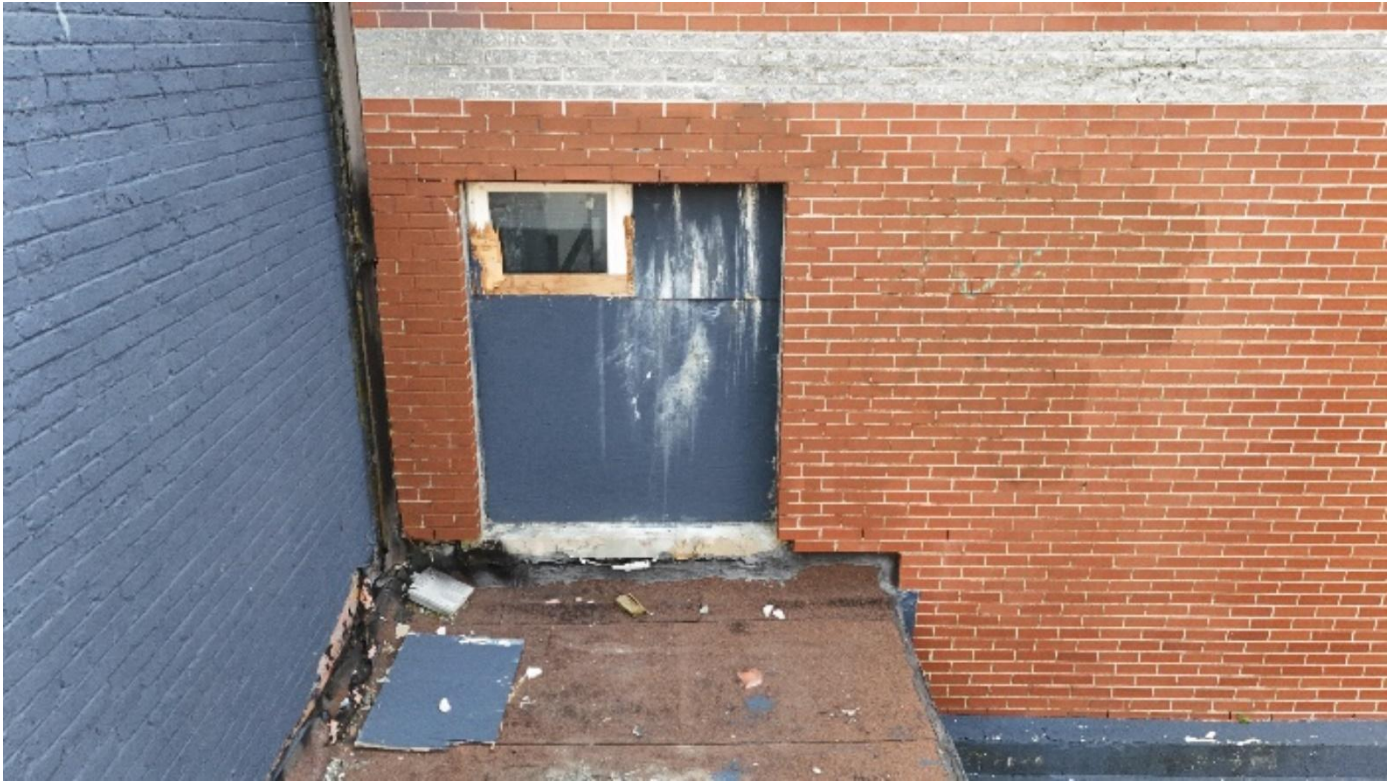
**Photo 8: Partial west elevation above tunnel at level 2**

previously a freight elevator with the north stairwell. This section of the elevation is in fair condition, as there are signs of settlement issues on its north end from lack of proper support, which likely arose from the fire of the adjacent law building.

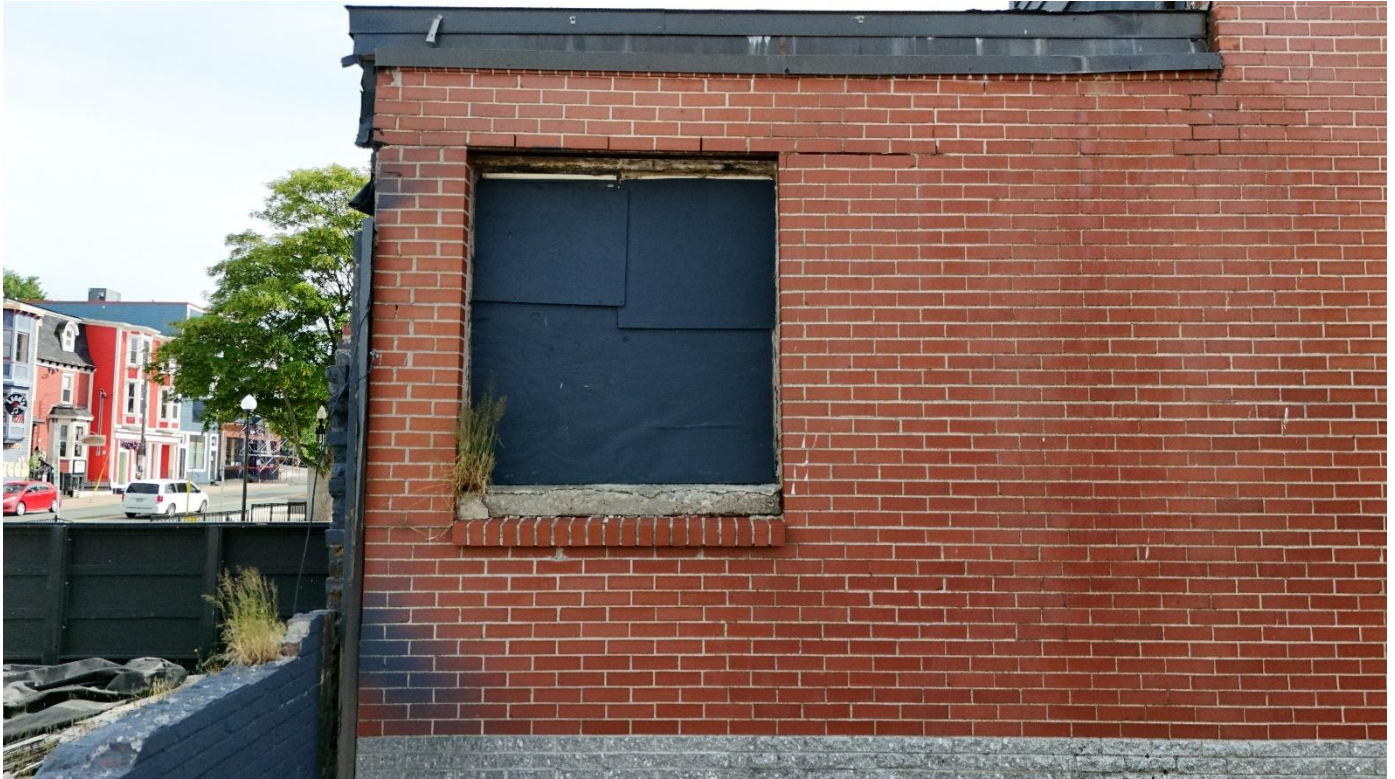
Photo 9: Partial west elevation above tunnel at level 3

This elevation mimics the stone belt separating the second and third storey of the front in two different ways: first in the newer section with what appears to be four layers of concrete split face brick; and second in the older front section with two layers of larger stone blocks. To the south end of the wall there is a brick pilaster that is capped at just over third storey height that is capped by a decorative pilaster capital. It is unclear whether this is purely decorative or aides in concealment of electrical of some nature, as there is evidence of electrical of in this region on the interior. This would have been added in the 1960s when the adjacent building was demolished. All these features are in **good** condition.

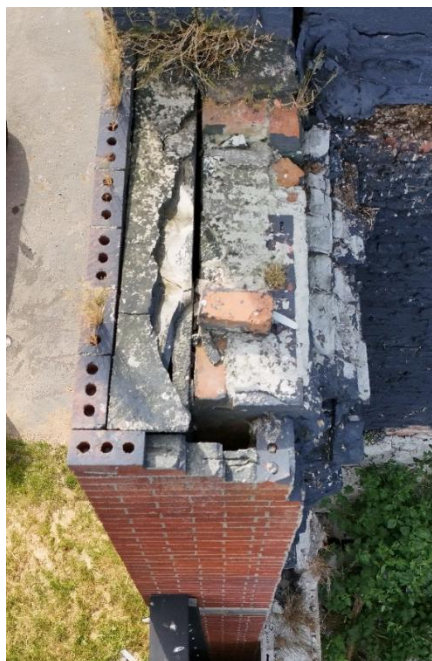
The east elevation is thickly layered and is essentially a double wall, as it is made up of the party wall from the adjacent Mechanics Society Hall that was demolished in the early 1980's. Photos indicate that its exterior brick wall was left supported against 100 Water Street and hosted brick buttresses, which were later evened out to better tie this wall into the Breakwater Books building. Drone photos indicate that the portion of this wall bordering the 1935 addition is composed of 2 internal layers of concrete block clad with brick. While the portion of the original structure would likely completely be layered brick reaching the same thickness due to the construction date. This elevation is in **good** condition.

Photo 11: Double wall

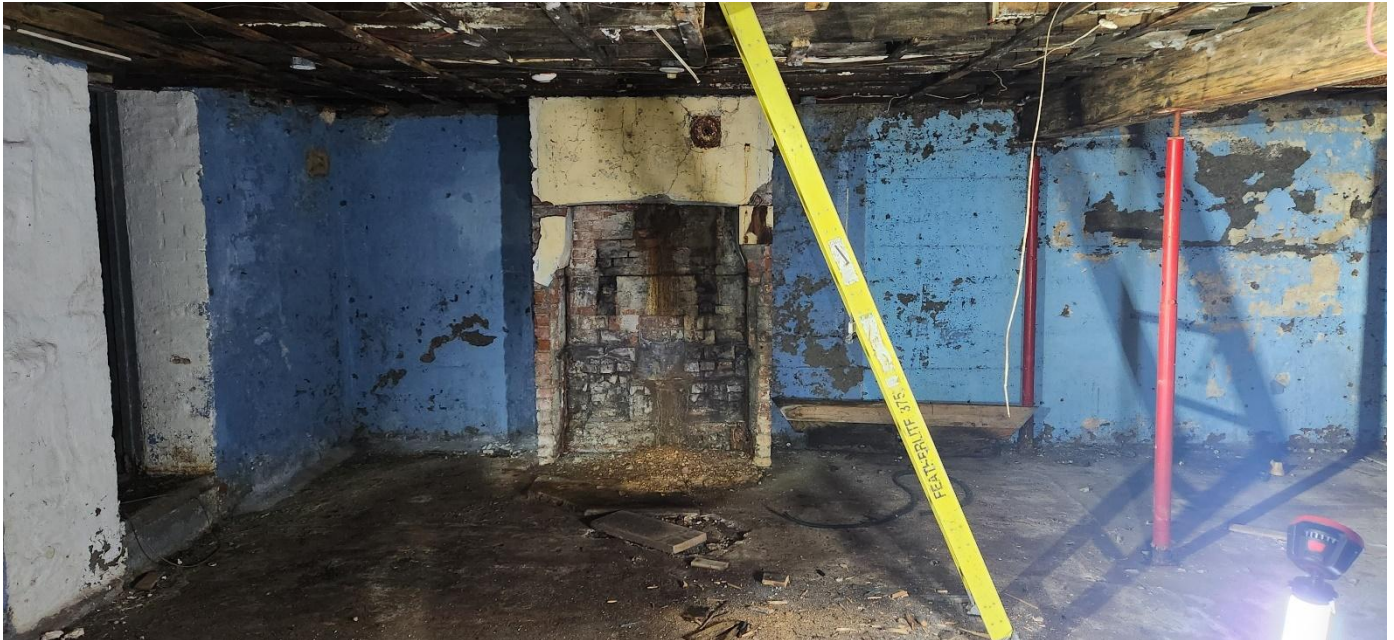
Photo 14: Room B01 looking east

The basement flooring is unfinished concrete. Under the front of house, the concrete is in **poor** condition and would need to be re-poured, as there is some damage in front of the chimney breast that reveals the concrete in this area is roughly just an inch thick. This may be original or have been poured onto a compact dirt floor shortly after.

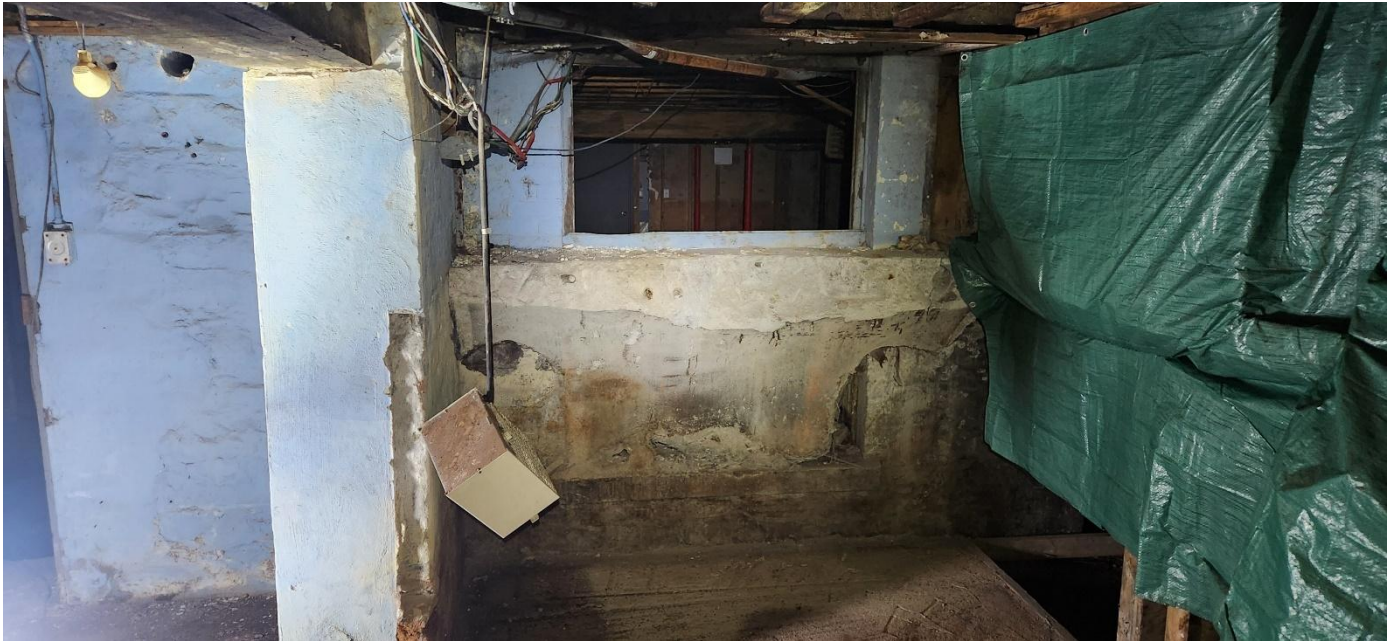
Photo 16: Basement B04 looking south

All masonry appears structurally sound in **fair** condition and is all layered with, white, yellow, and light blue paint in varying degrees of deterioration. The old exterior wall at some point had additional concrete poured to transform the entry point into a smaller window. It is unclear when this was done.

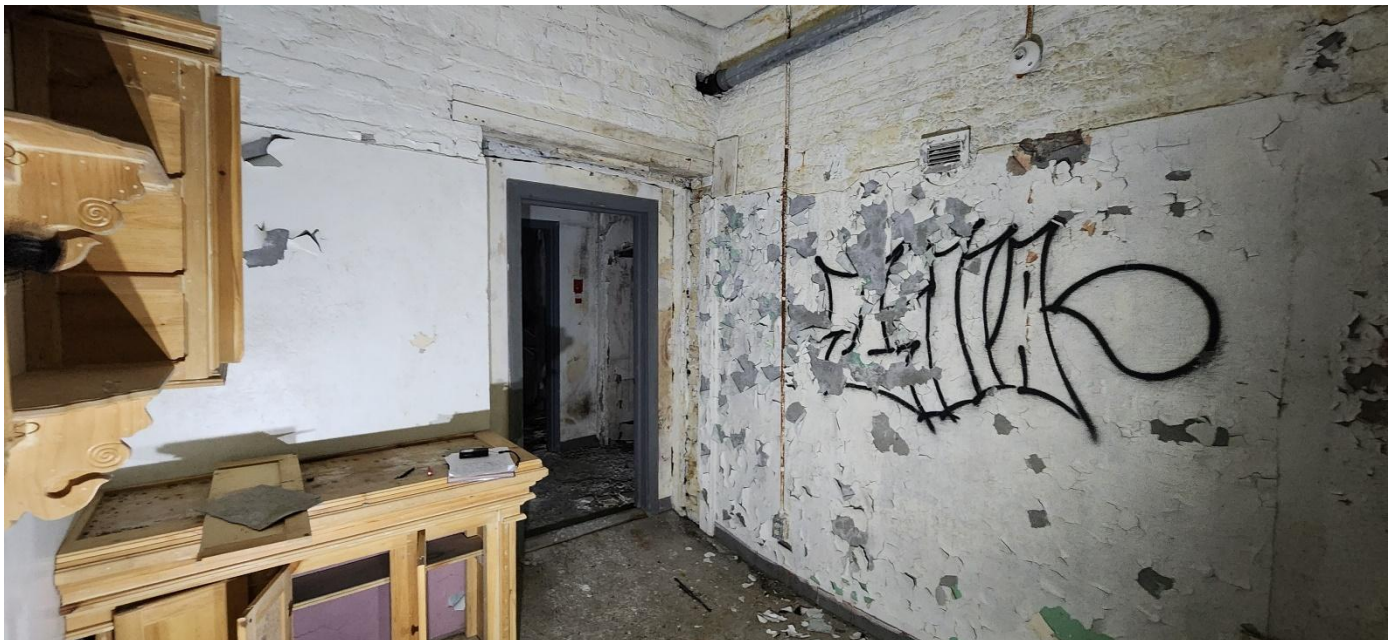
Photo 17: Kitchen 106 looking west towards tunnel

In the rear the flooring has been stripped away and just the subfloor of layered plywood sheets remains. The floor steps up as you approach the tunnel and storage room and slopes up with a plywood ramp to meet this in the kitchen. The plywood is in poor condition, as it is dirty and stained in places, and would need to be replaced. In the tunnel and storage room the floors are concrete and appear to be in **fair** condition, however they are rarely visible beneath fallen debris and dirt.

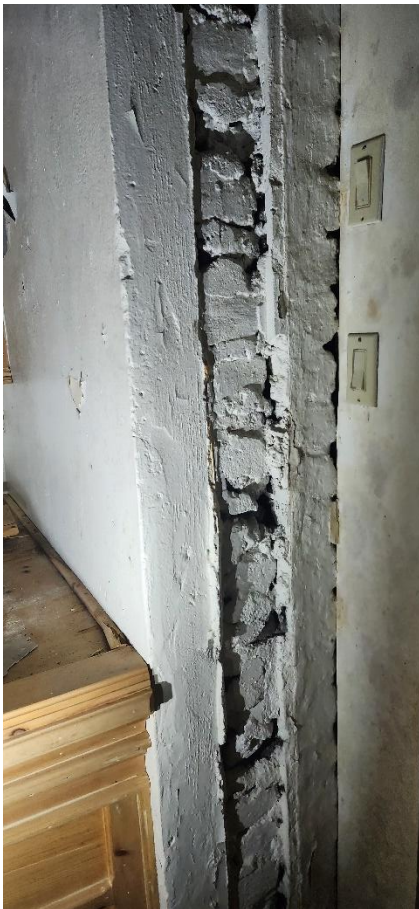
The rear of the building has mostly a white painted gypsum board finish in **poor** condition, as it is stained from mould growth and vandalism and is peeling in places. In the kitchen there are a variety of walls that are also all painted white and in **poor** condition: the south is stained plaster similar to the rest of the rear; the east is concrete block coated with a peeling layer of paint; and the east and west are parged over up to top of door height, where they then transition to being painted brick. Fire plans from the 1900s indicate this east wall was originally an exterior wall, which is corroborated by it being thicker than other interior walls.

**Photo 18: Wall assembly at Kitchen 106**

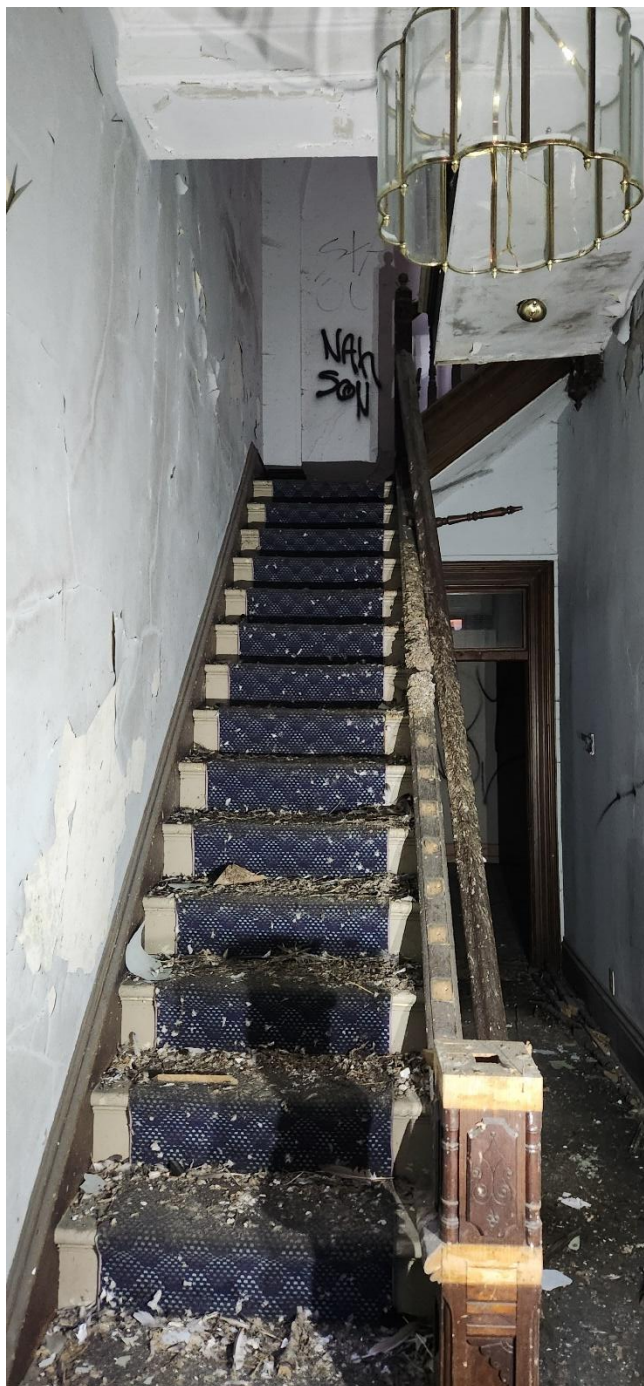
Photo 20: Stair 1 from level 1 looking north

The original wooden railings of the stairs are in **very poor** condition as they have been vandalized beyond repair. This is unfortunately the case throughout the building, so these elements would have to be replaced. The trim around the staircases is intact apart from this and could be restored.

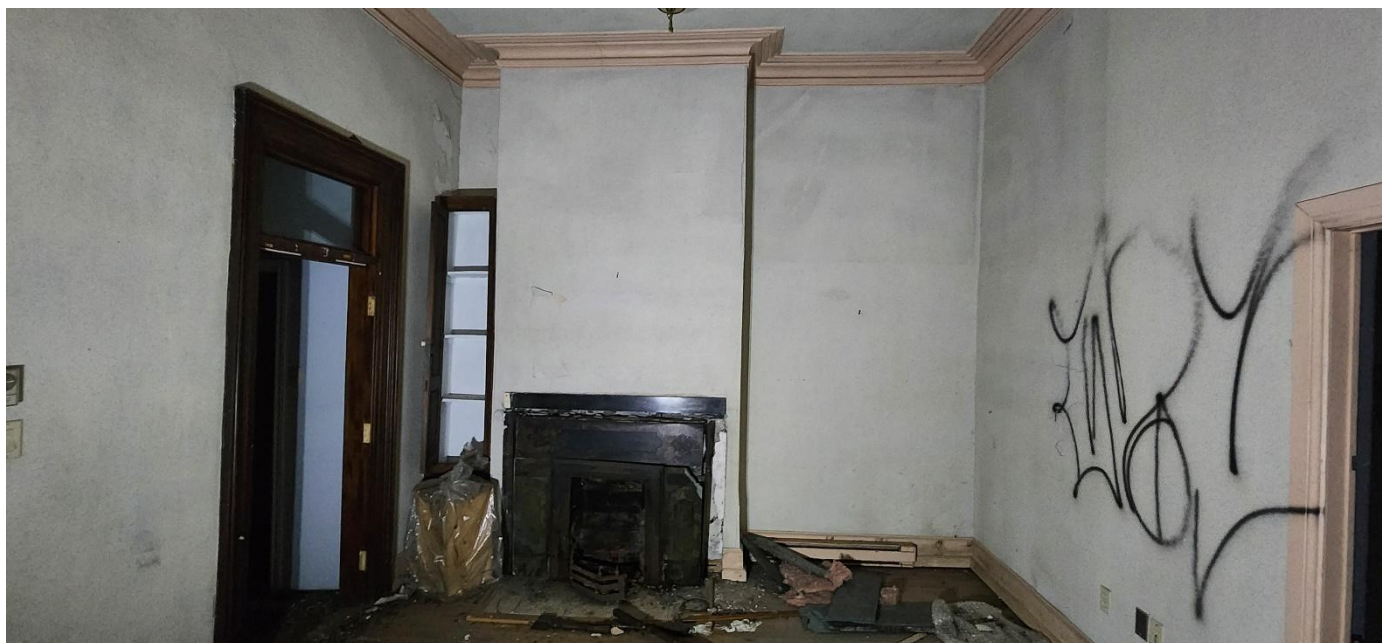
Photo 22: Room 103 looking west

Room 103 contains pink-painted plaster crown moulding, and wooden door casings and baseboards that exhibit moderate wear and are likely all original. The crown moulding appears similar to that found in the stairwell but finished in pink, while the baseboards and most door casings are of simpler design except at the doorway to the stairwell, which uses the same brown casing found in the front entryway. This trim is all in **fair** condition and could be restored.

This room also features an ornate plaster ceiling medallion above the former chandelier, which remains in **good** condition but its fireplace and surrounding wooden frame are in **poor** condition, showing visible damage.

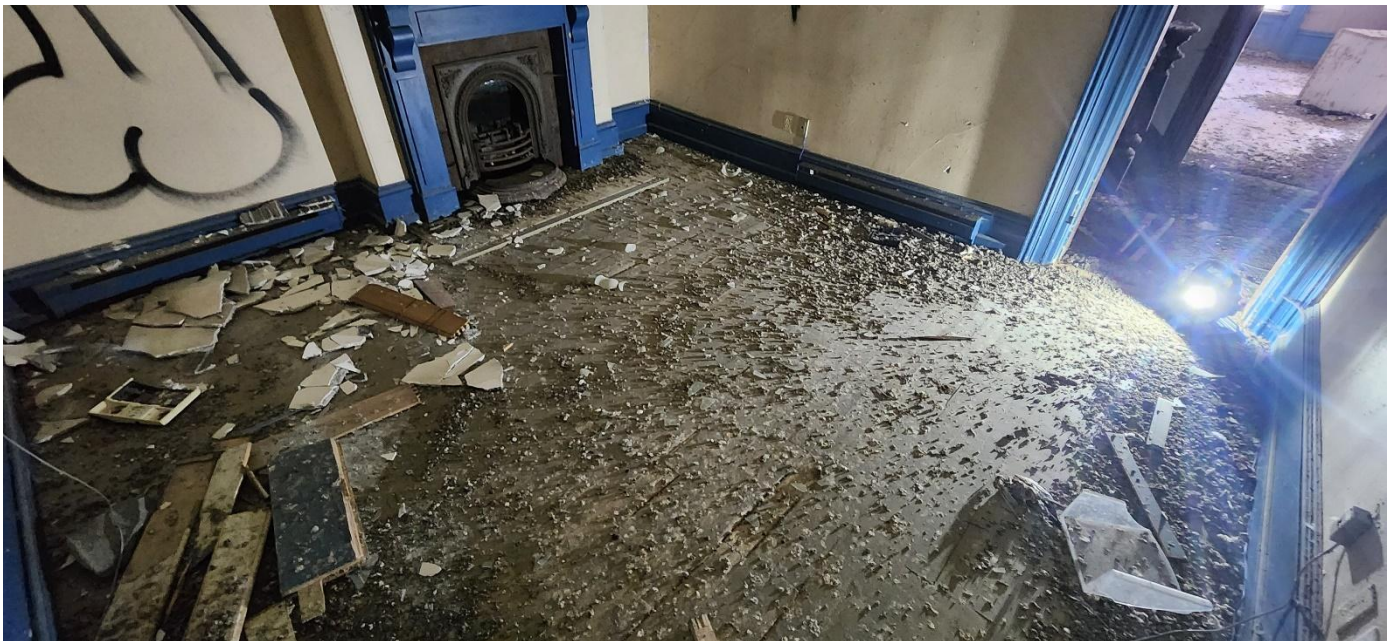
Photo 23: Room 204 looking southeast

Across the remainder of the second floor, hardwood flooring is present and is generally in **fair** condition where visible beneath accumulated debris, except in room 204 where there are some separation and irregularities visible between boards. The steps in the south stairwell also appear to be in **fair** condition with no issues observable and could have significant useful life remaining.

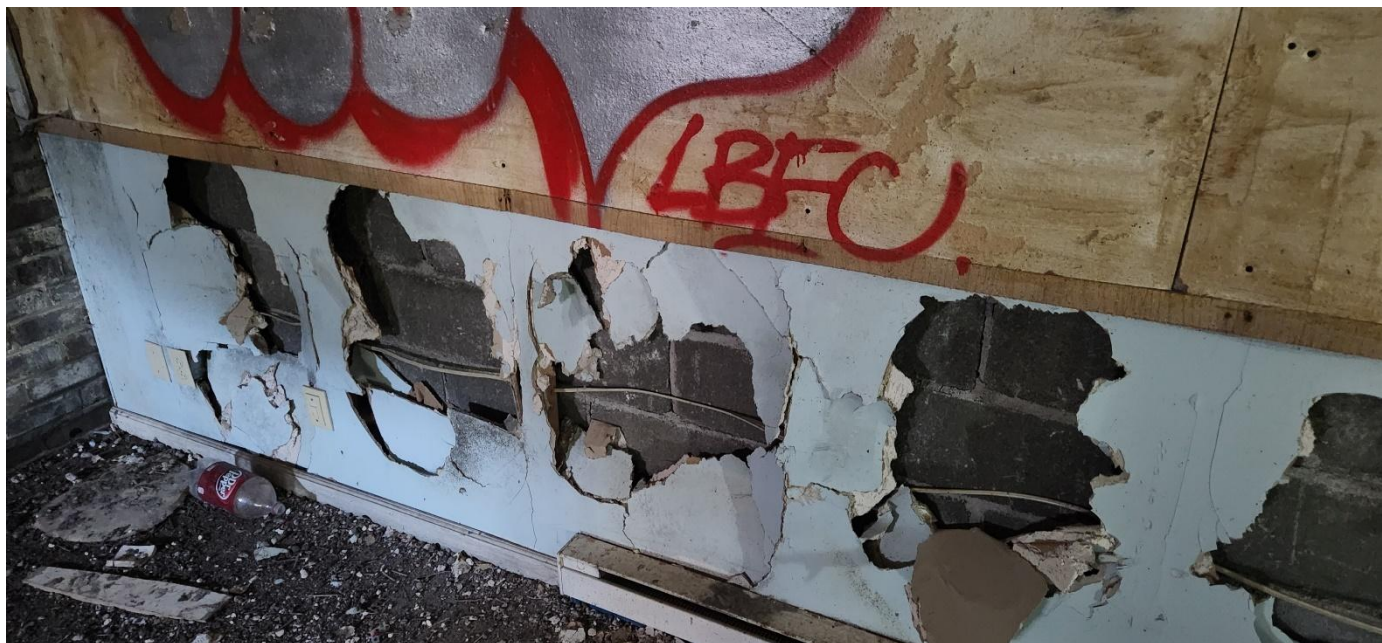
Photo 24: Room 205 looking east

The walls in the rear of the second floor are not original and are in **poor** condition from water damage and vandalism. In room 205, the north and south walls consist of exposed brick, while the east and west walls are concrete block visible beneath the heavily damaged gypsum board of a wood framed wall. The north stairwell is enclosed with wood framed walls finished with gypsum board that are all water damaged. Their interior surfaces show significant dampness and mould growth and would need replacement.

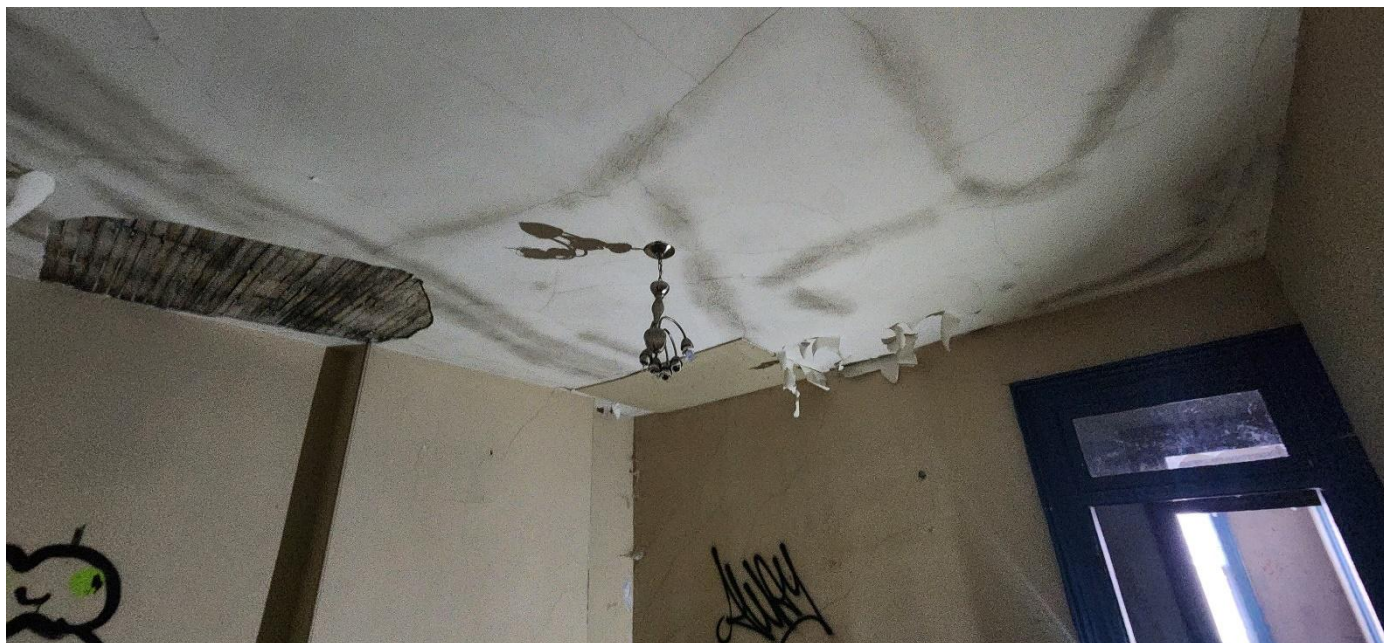
However, the plaster ceiling of Room 204 has a large missing section that exposes the lath above, which could still be restored. The ceiling in Room 205 is finished with gypsum board sheets that are in **very poor** condition and would have to be replaced, with large sections having collapsed to the floor exposing above structure.

Photo 25: Room 204 ceiling

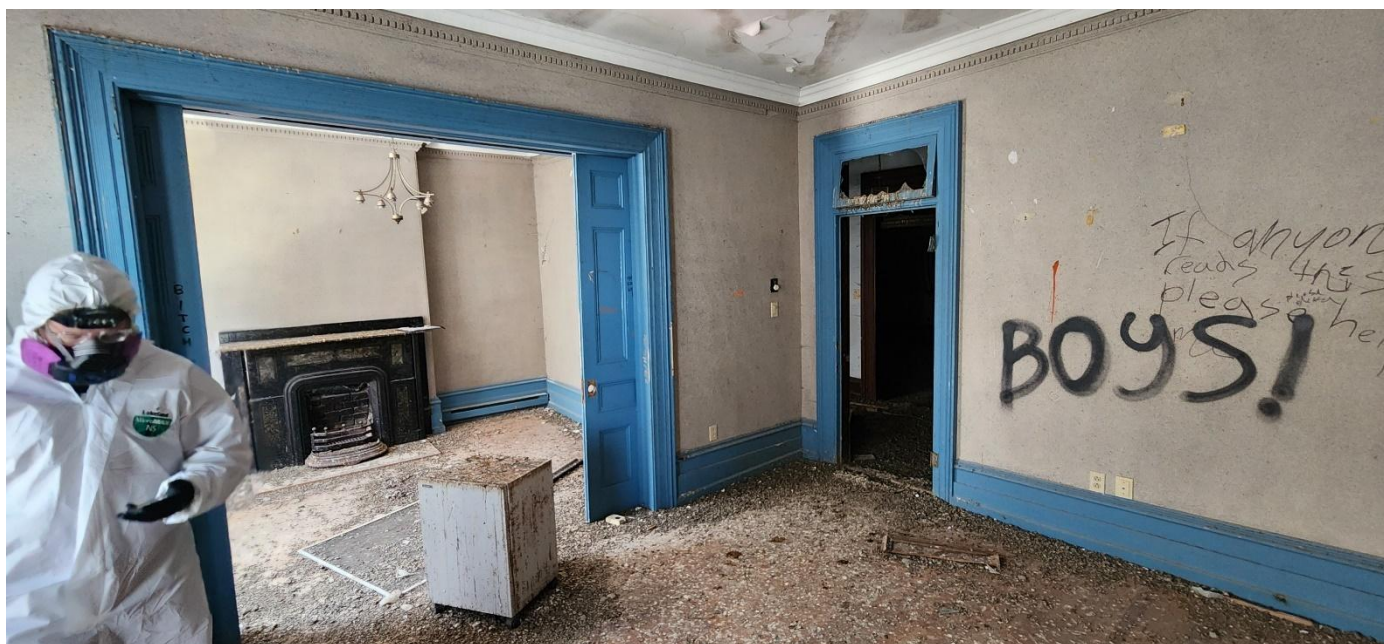
Photo 26: View from Room 202 looking west to Room 201

Most doors on this level are missing, apart from the door to room 201. This wooden door is damaged and in **poor** condition, having had its handle torn off. A sliding door between rooms 201 and 202 also remains in place and is functional, though it is also in **poor** condition due to missing handles and deep scratches from vandalism. Overall, door replacement and restoration will be necessary throughout this floor.

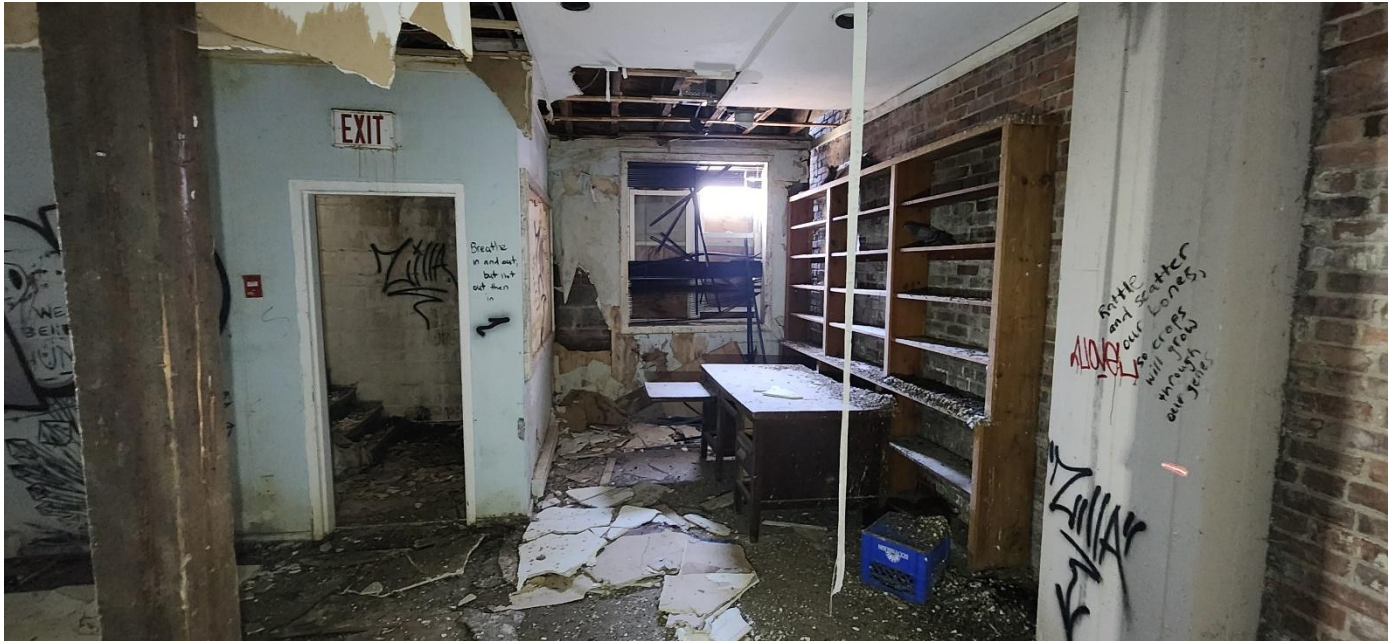
Photo 27: Room 205 looking west

The rear addition has simpler, white-painted crown moulding, baseboards, and trim, in **poor** condition, some of which are missing or show moisture damage. These are from a more recent renovation and would need to be replaced. The window here on the west face is also in disrepair.

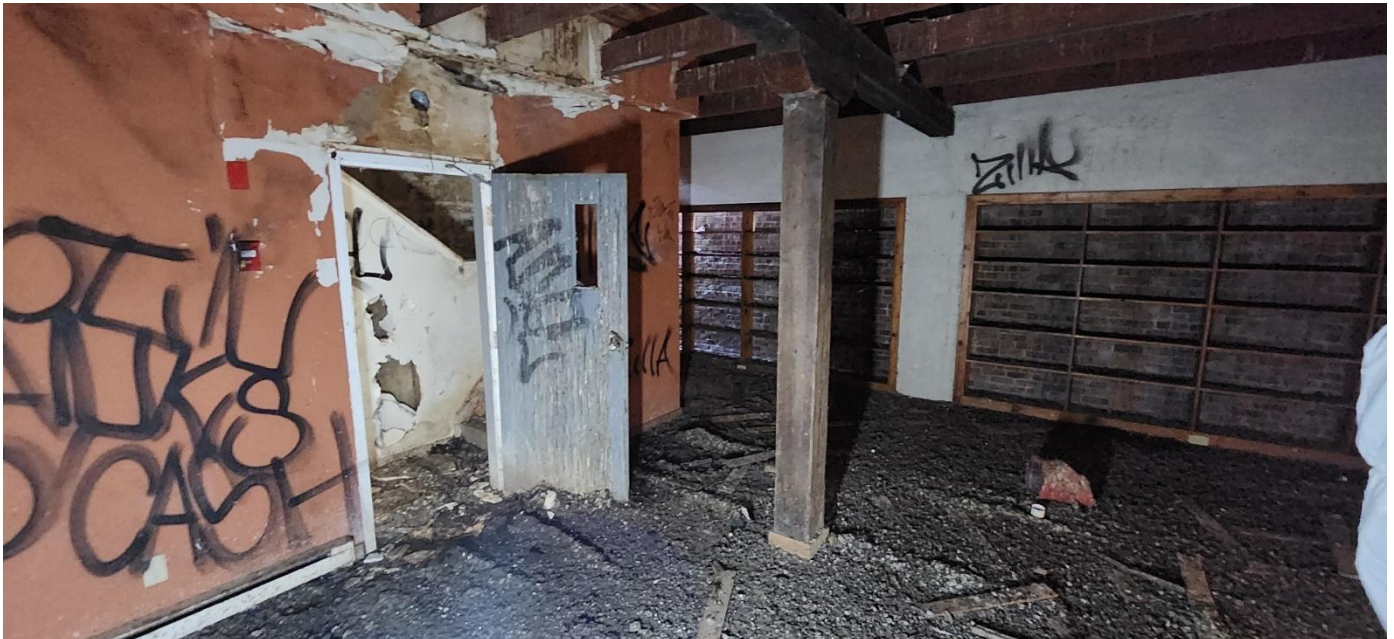
Photo 28: Room 305 looking northwest

The walls in the rear of the third floor are generally in **poor** condition. Room 305 in this end has a mix of wall types with exposed brick to the north behind a wood-framed gypsum finished wall with built-in wooden shelving, concrete block revealed to the east by removed wooden paneling, a brick wall with an original exterior window and door to the south, and red painted gypsum board to the west. While the masonry appears structurally sound, other surfaces are water damaged and torn and should be removed. The room also seems to be exposed to the elements through a gap between the north wood framed wall and the old brick exterior wall of the law building. The east concrete block wall contains indents where missing floor joists were previously seated. The south stairwell off this room is enclosed with wood framed gypsum board finished walls, which exhibit dampness, mould, and holes, and should be redone as they have little remaining life.

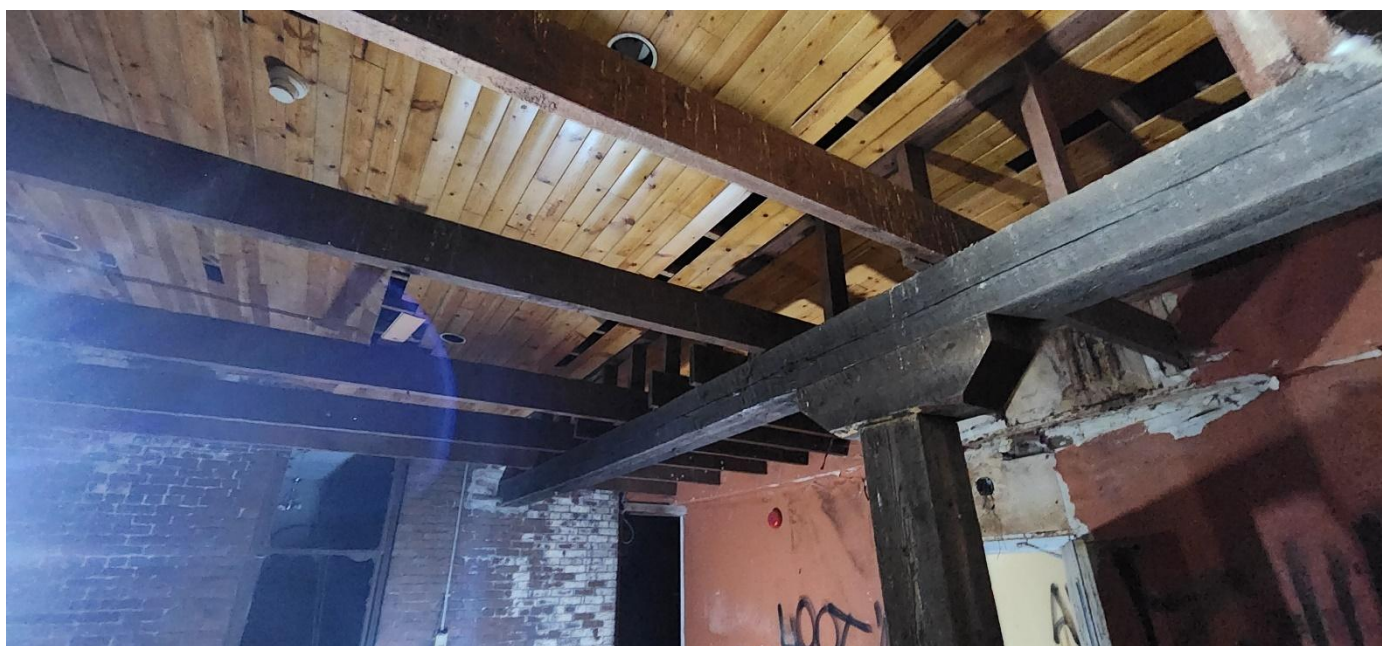
Photo 30: Room 305 looking south

Ceiling conditions of this level vary by room. In room 305, the ceiling consists of relatively recent wood boards set above the older structure. This ceiling is in **poor** condition, having partially collapsed in some areas which exposes a second higher layer of floor joists set a couple feet above older joists below. Aerial site photos suggest that the ceiling was elevated during the Breakwater Books renovation around 1989 to accommodate a rooftop patio, as aerial photos show that the 1960s addition that added storage space was slightly lower in height.

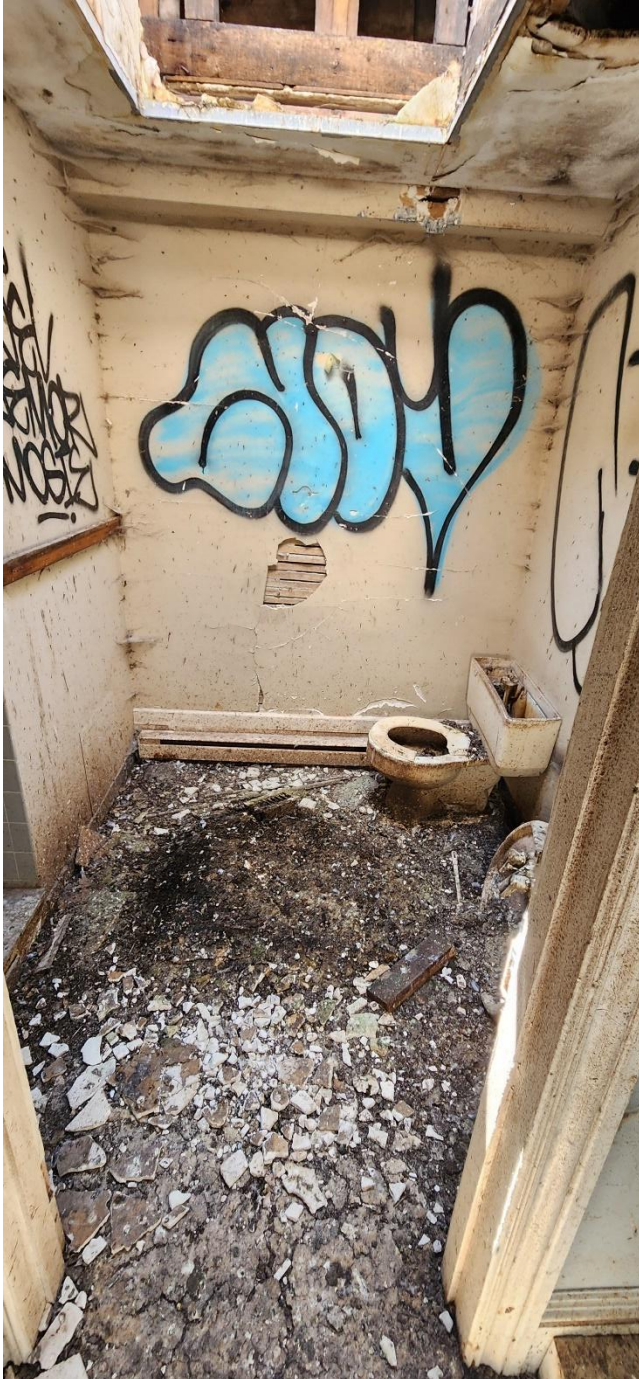
Photo 32: Room 407 looking west

Level 4 has experienced significant moisture damage that is much more evident than in the floors below and is in overall **poor** condition. The bathroom skylight has no pane and is uncovered, which has exposed the whole building to excessive moisture and deteriorated the below room. At the north end of the building, an outdoor rooftop patio was accessible from room 403; however, access is obstructed by an existing step, suggesting structural deformation within this wall. Overall, water intrusion and exposure to the elements are an issue on this level and are unfortunately contributing to the accelerated decline of finishes and structural elements that will need to be addressed promptly.

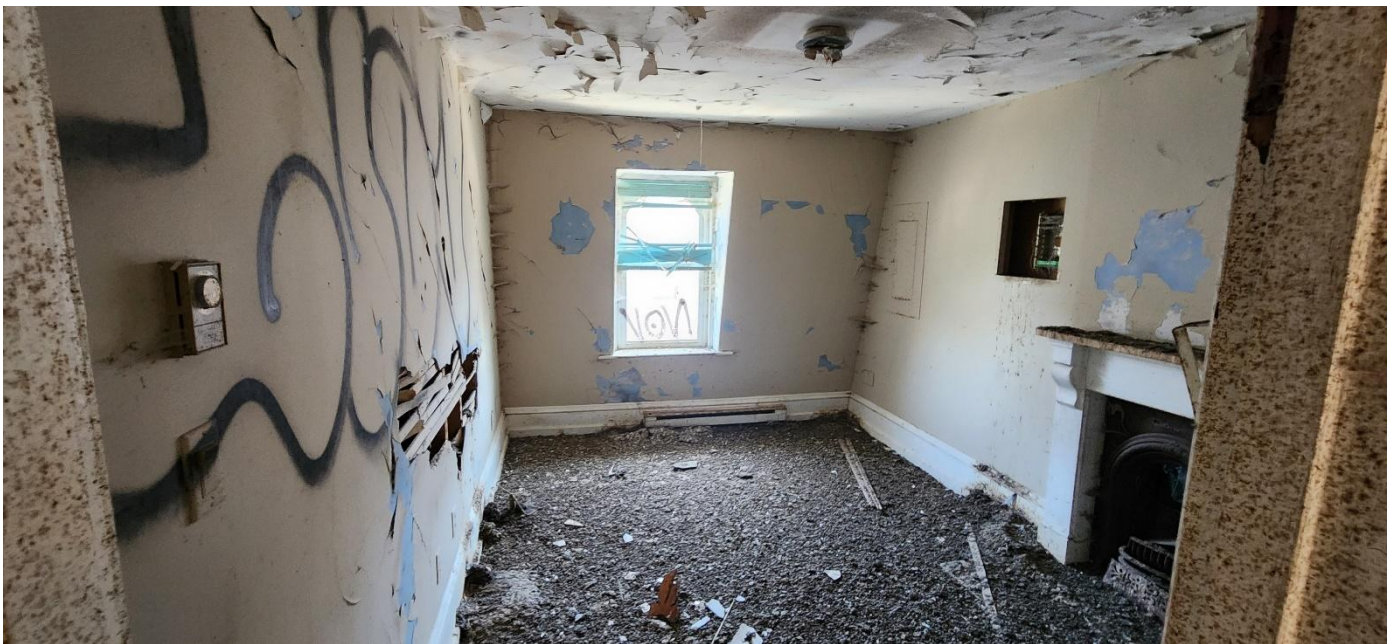
Photo 33: Room 401 looking south

All of the walls on the fourth floor are in **poor** condition, being heavily vandalized and showing extensive signs of moisture damage. Rooms 401, 402, and 404 feature beige painted lath and plaster finished walls, which are cracked, mouldy, cobwebbed, and peeling, revealing a light blue undercoat in places. Room 403 and the bathroom have similar walls that are white painted and, along with room 401, have holes that expose damaged underlying lath. The corridor walls are finished in a light blue painted plaster and are in a similar condition, there is also a large hole along these walls near room 401. The plaster itself appears intact so restoration may be possible but should be addressed as swiftly as possible.

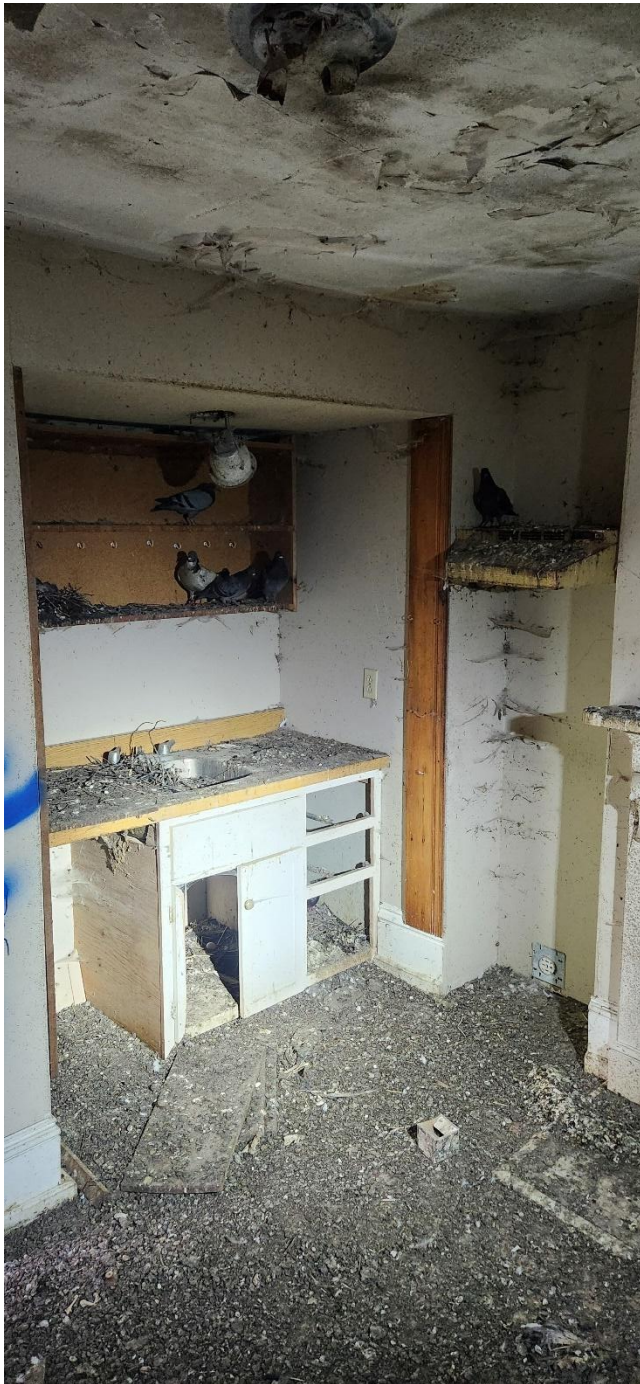
Photo 35: Room 403 looking southwest

All of the ceilings of this floor are lath and plaster that exhibit extensive peeling and deterioration due to prolonged moisture exposure. In the bathroom, sections of ceiling have collapsed, revealing the roof structure above. Additionally, the ceiling in room 403 above the kitchenette shows noticeable sagging, indicating potential water damage to the above roof structure. Overall, the plaster ceilings on this level are in **very poor** condition and will require significant repair or replacement.

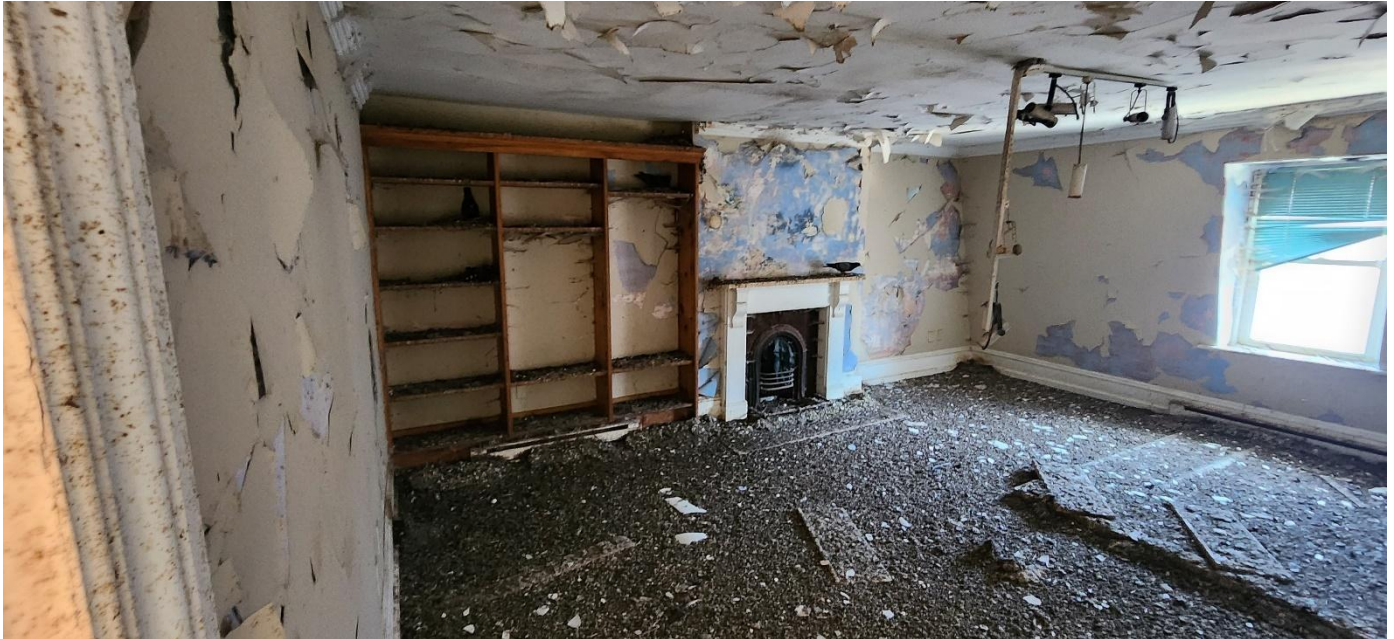
**Photo 36: Room 402 looking southeast**

All trim is painted white but stained by mould and feces throughout. The baseboard corners often have significant waste accumulation and staining. Rooms 401, 403, and 404 feature the typical ornate baseboards and casings, but there are sections of baseboard missing in room 403. Room 402 and the corridor have crown moulding, baseboards, and casings that appear undamaged, besides some missing crown moulding in the northeast corner of room 402. The brown-painted casing around the south stairwell door is a large and unique feature that remains intact, though the glass is broken. All trim and ornamentation is in **fair** condition and should be restored to add significant useful life.

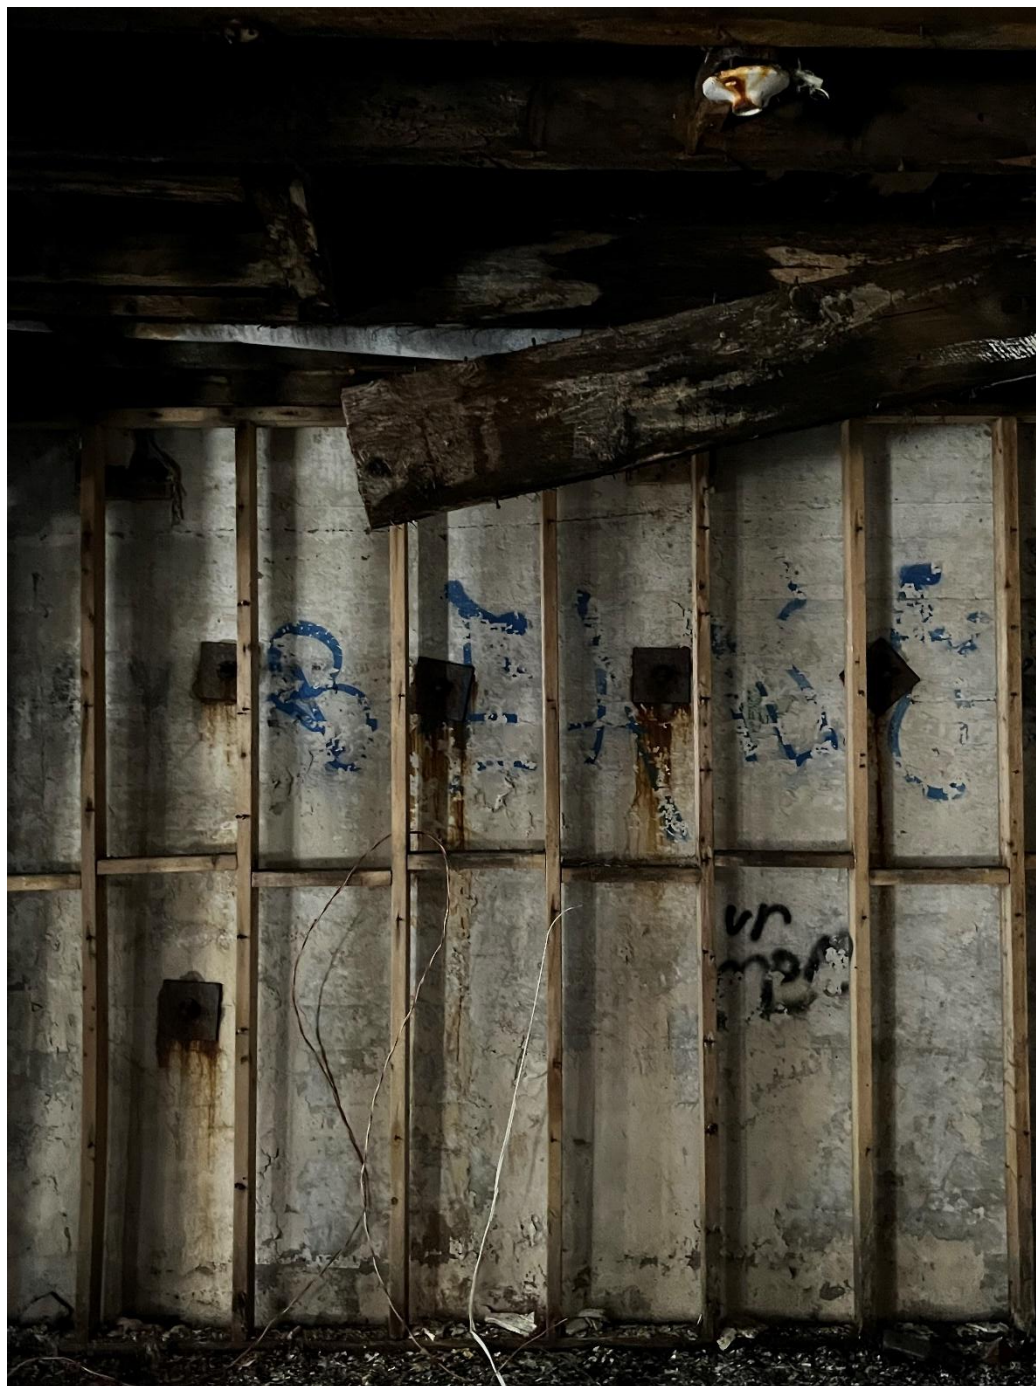
Photo 37: Concrete wall with anchors along Holloway Street

remains and appears to be both a retaining wall and a basement foundation wall of the former law firm. The wall appears to be a cast-in-place concrete wall with anchors constructed in front of a rubble retaining wall supporting the road surface of Duckworth Street. Whether or not the concrete wall was constructed as a back-up support to the rubble wall is unknown; however, its construction is suggestive of this purpose.

The construction of the former law building was built into the site and comprised of more than one building combined during its lifespan. A similar anchor-reinforced retaining wall was visible in Room 108 on Level 1; however, this wall is further south on the site than the shoulder of Duckworth Street. Each building appeared to have a basement, although the Duckworth Street and Water Street structures shared different basement floor elevations as the grade difference between both streets is significant and multiple underground levels not common for structures in St. John's of this vintage and purpose. Detailed photographs can be found in Appendix C.

Given the limited access, interdependency with the road structure of Duckworth Street, and complexity associated with the amalgamation of several buildings, the condition of the areas adjacent to Breakwater Books is largely **inconclusive**. A large amount of rubble is still present from the structural demolition and from a pure remaining useful life perspective, some elements could range from **fair** to **good**; however, further investigation is required.

Given the volume of debris, questionable overall integrity, and remaining structure that would need to be removed to gain access to the remaining foundations, it may not be a useful allocation of public funds to undergo such demolition and explorative work. Apart from the retaining structures along Duckworth Street and likely Holloway Street, and any demising or shared walls, the elements of these foundations do not rely on or provide support to Breakwater Books. As such, it may prove more beneficial to plan new site developments around Breakwater Books, should the Department decide to recapitalize this asset.
