# **Building Condition Assessment - Breakwater Books Building and Former Roebothan-McKay-Marshall Law Building**

96-100 Water Street and 205-211 Duckworth Street, St. John's NL

**Government of Newfoundland and  
Labrador, Department of  
Transportation and Infrastructure  
Building Condition Report  
Client Reference no. 102405008**

June 2026  
02501045.000-0100-BS-R-0001-01

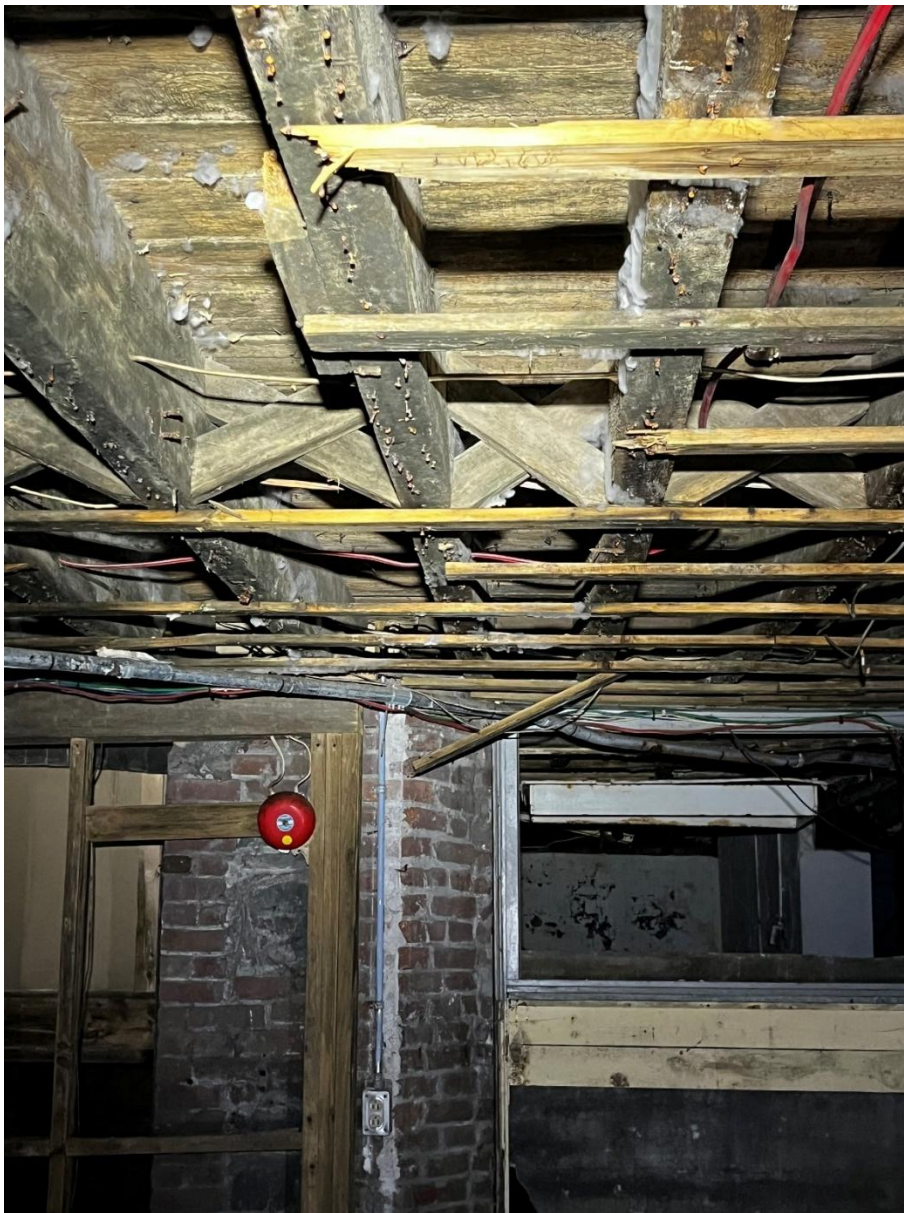
Photo 39: Level 1 floor framing Area 1

inferred items summarized in Table 6 and is describe by level below. Overall, the condition presents in **good** condition, with potentially significant remaining useful life.

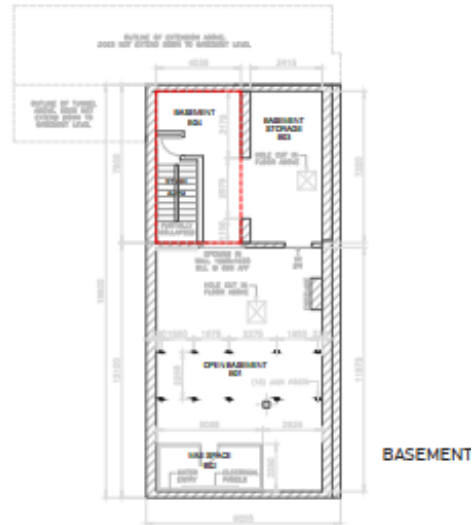
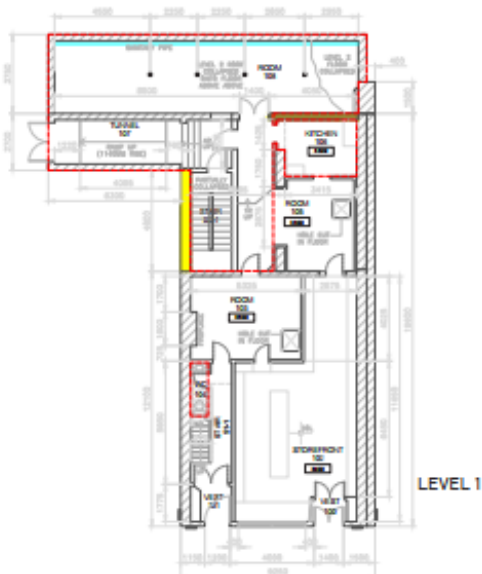
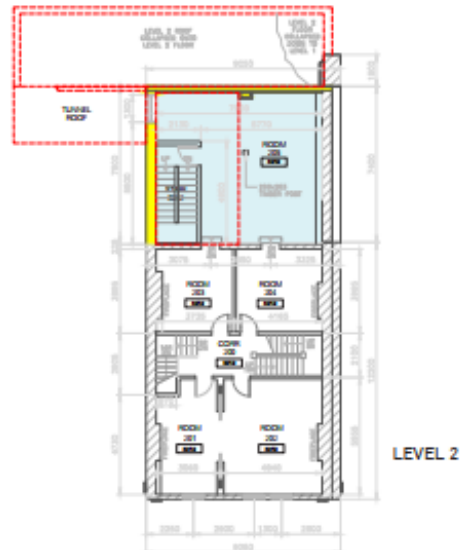
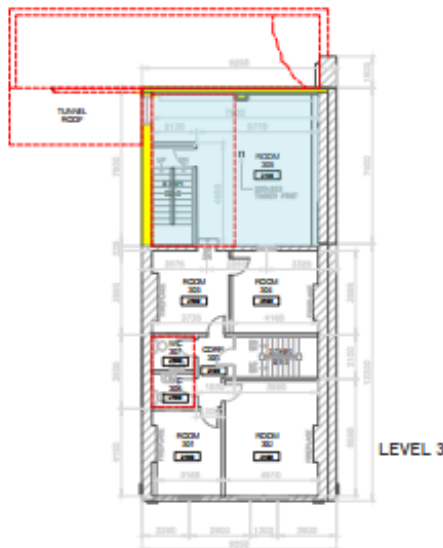
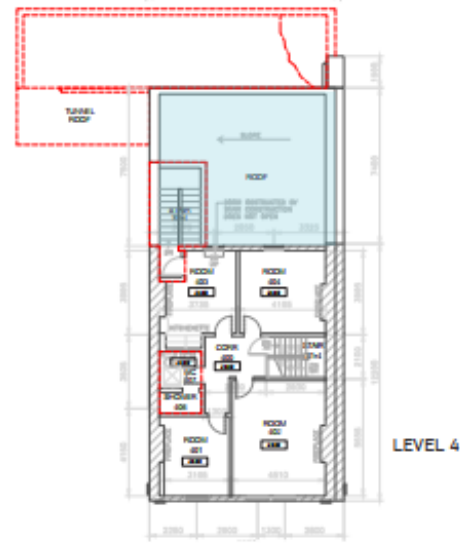
Figure 3: Recommended Areas of Remediation (Not to Scale)

It is for these reasons we believe a comprehensive and broad evaluation of the building should be performed prior to advancing any works on the site. The building's structure boasts considerable potential, making repurposing a reasonably plausible solution. In keeping with this report, more than one viable option for redevelopment seems apparent, and corresponding costs largely dictated by the chosen use and major occupancy. Regardless of target use, some baseline construction is recommended to remove the unstable and unusable remains of the adjacent areas built onto the building and restore the areas deemed suitable for remediation to a singular, enclosed structure. A needs assessment will help identify potential uses for the building, which will help guide the Department toward an architectural scope for redevelopment. This assessment should include participation from personnel with a broad range of diverse backgrounds to ensure intangible benefits are accurately captured and properly considered. Figure 3 below shows a graphical representation of what would remain after redevelopment and what areas require demolition or stabilization.

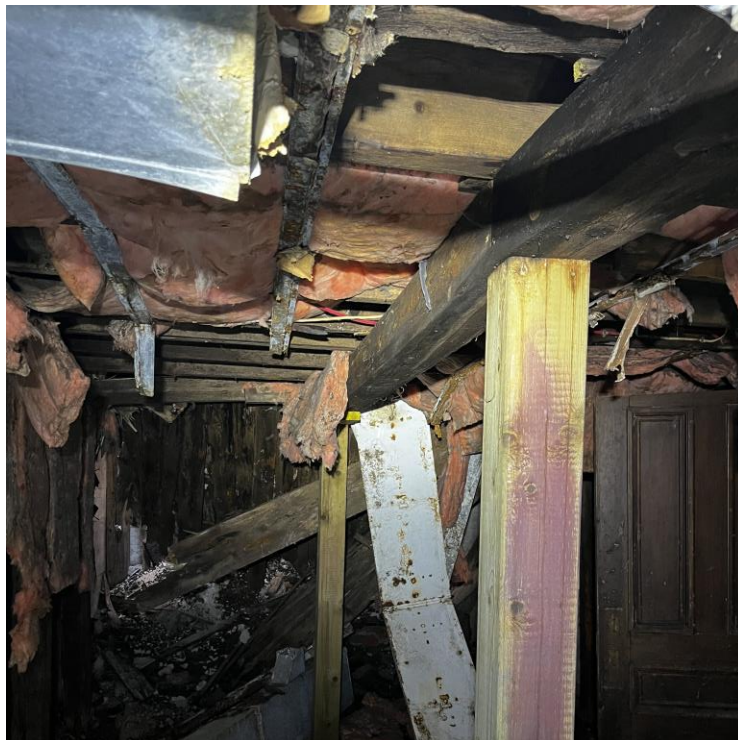
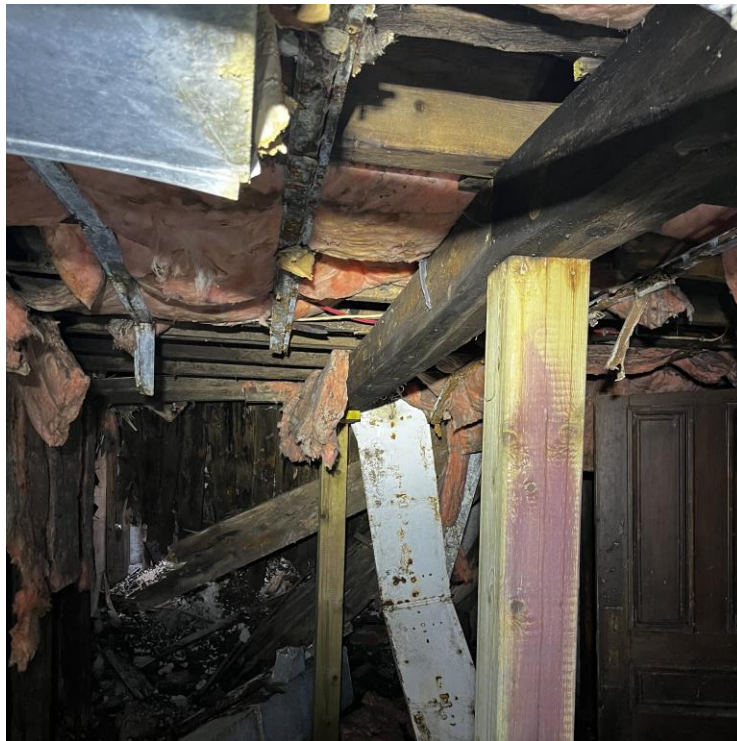
Photo 8: 108 Collapsed Room

Photo 9: 108 Collapsed Room

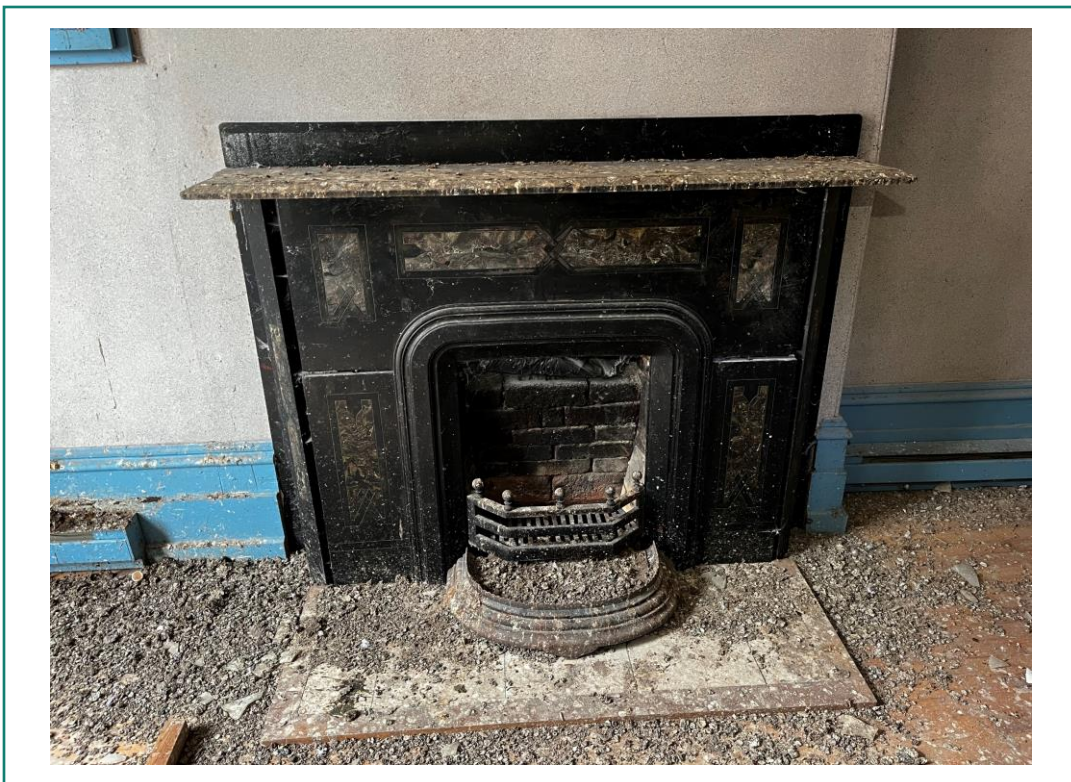
Photo 12: Fireplace and Fecal Matter 201 Room

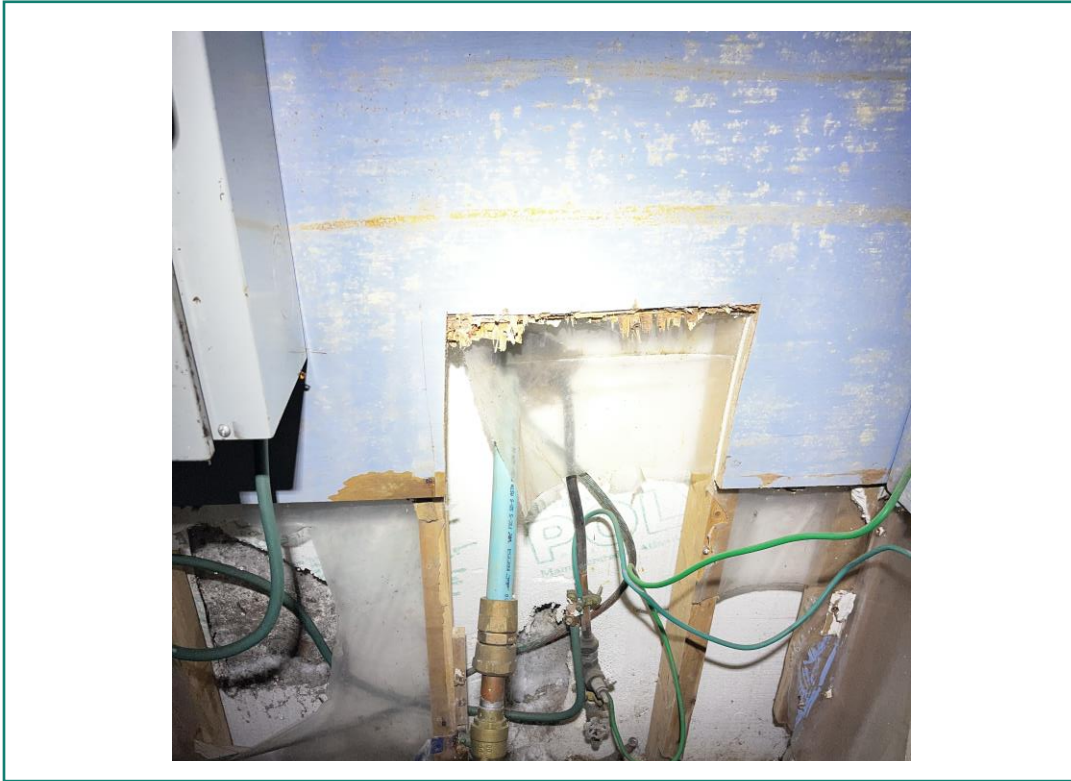
Photo 31: B02 M&E Space - Water Entry

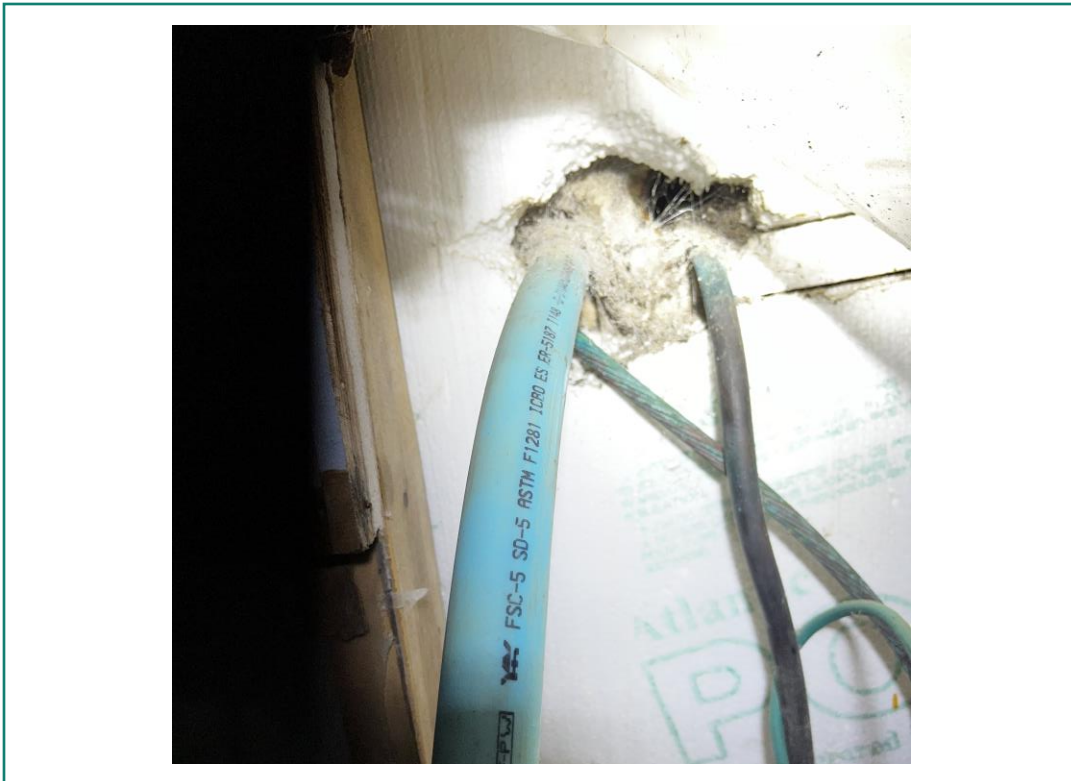
Photo 32: B02 M&E Space - Water Entry

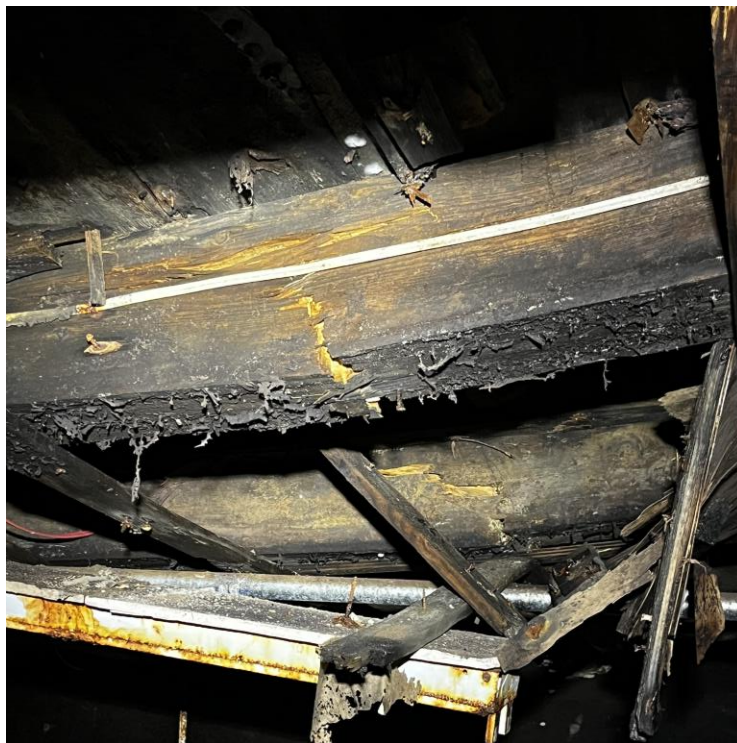
Photo 38: B04 Basement - Cracked Framing Below Tunnel and Corridor

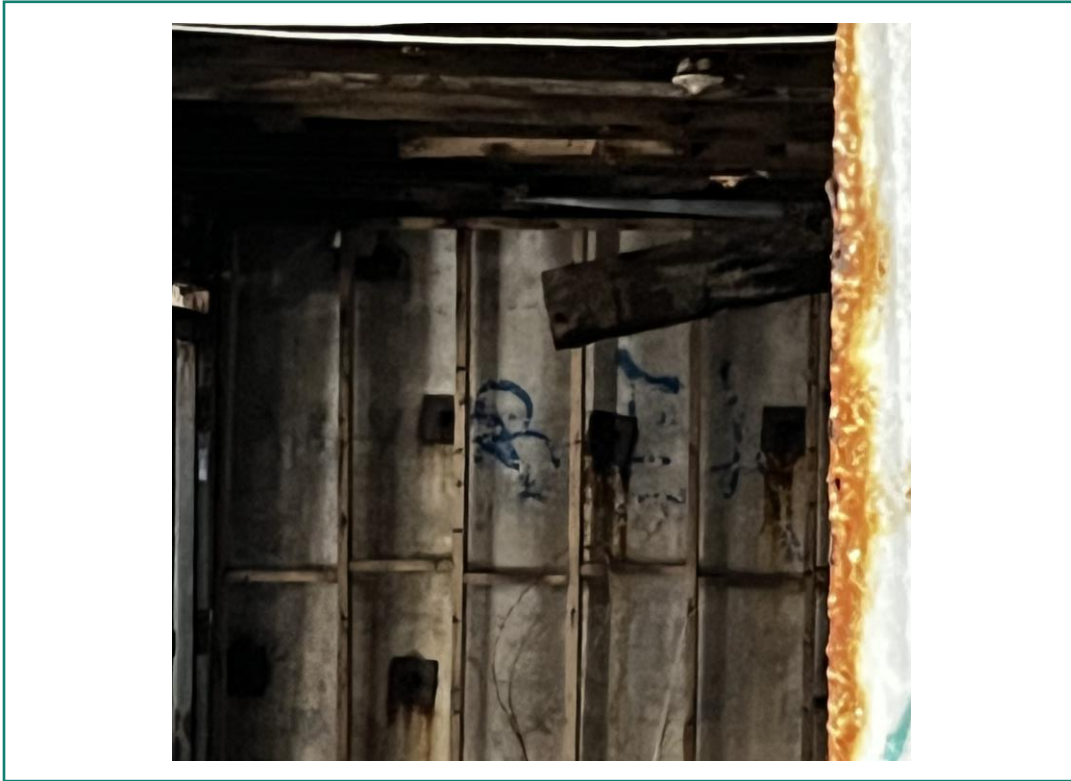
Photo 45: Collapsed Area Level 2 Facing West (Holloway Street)

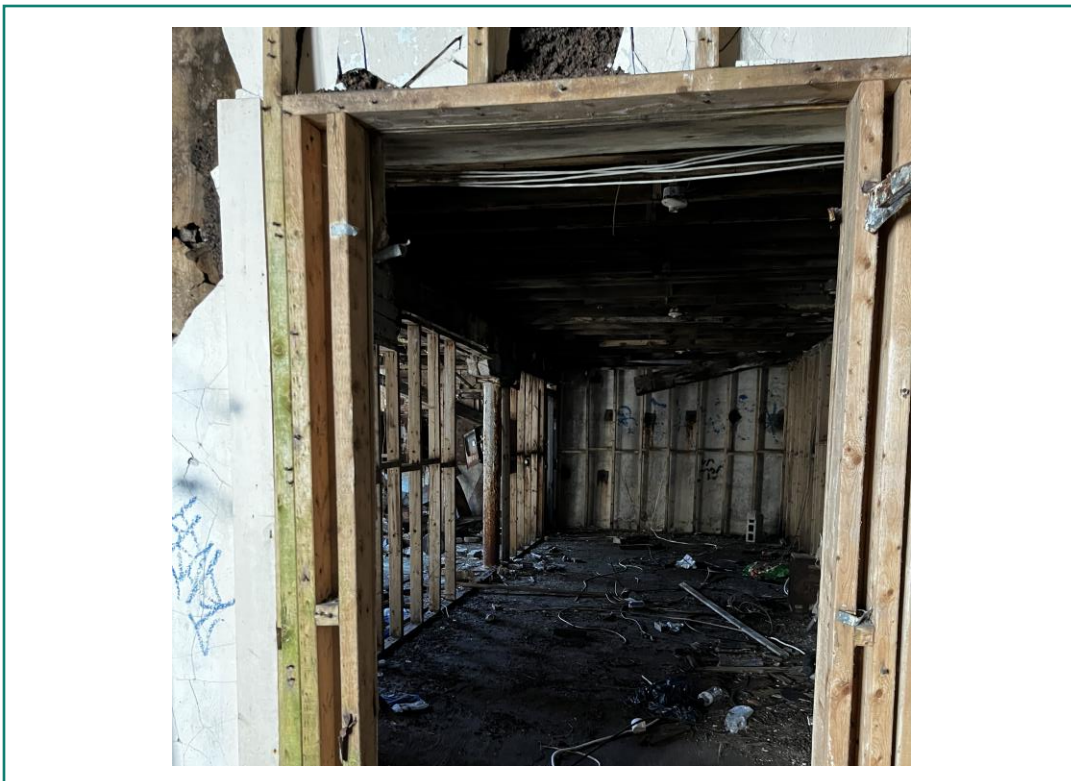
Photo 46: Collapsed Area Level 2 Facing West (Holloway Street)

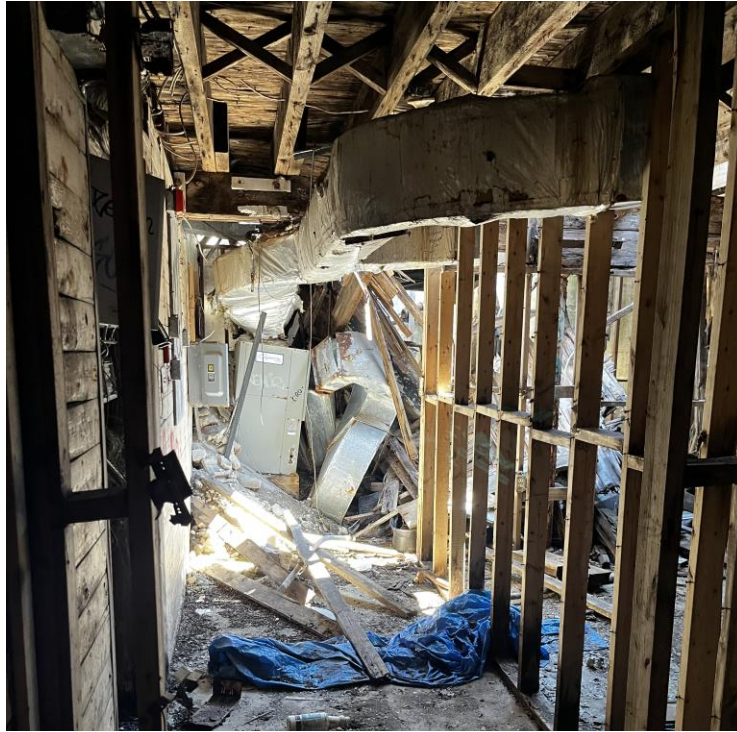
Photo 47: Collapsed Area Level 2 Facing South (Water Street)

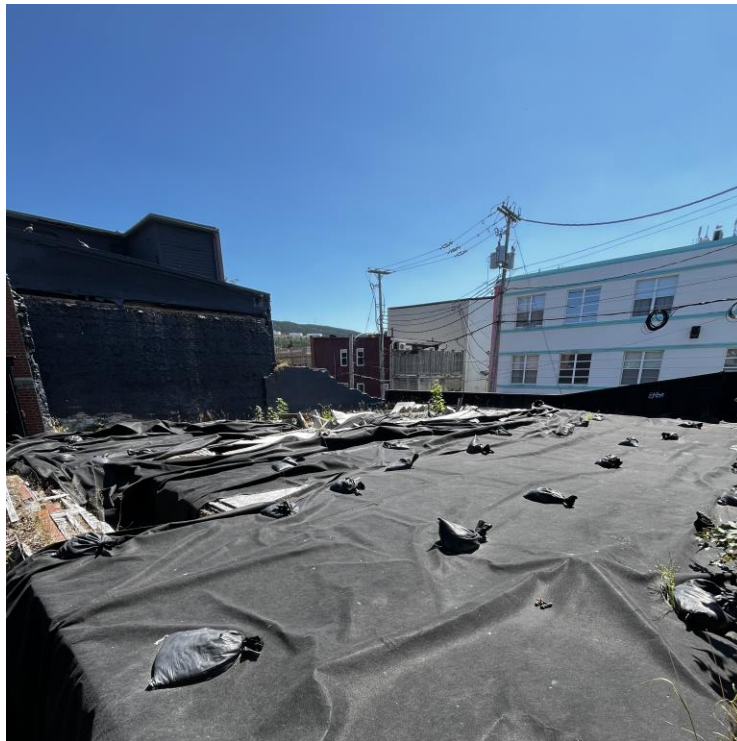
Photo 48: Collapsed Area Level 3 Facing South (Water Street)
