Marystown Harbour Bridge

Condition Assessment Report

223049.10 | April 2023

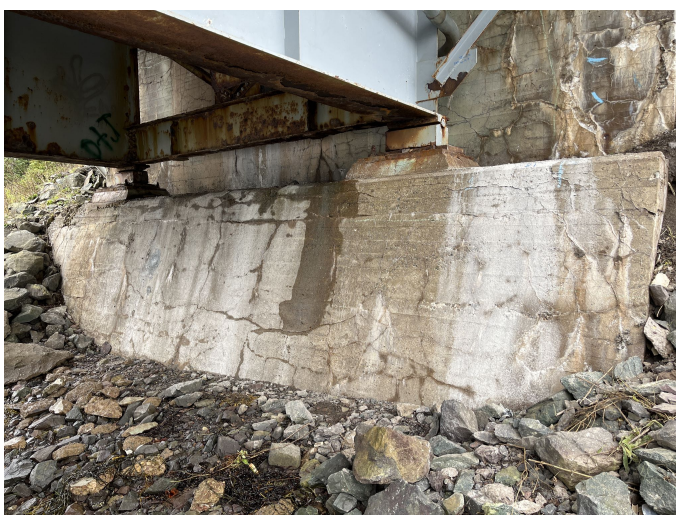
Photo ID 702 Location North
Element Group Abutments
Element Type Abutment Walls
2022-09-29 1:38:57 PM

North abutment wall, core 20 location.

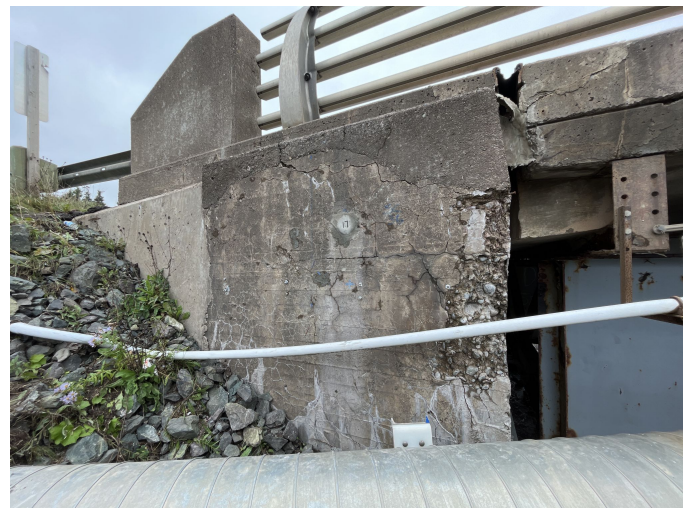
Photo ID 718 Location Northwest
Element Group Abutments
Element Type Wingwalls
2022-09-29 2:03:56 PM

Northwest wingwall and core 17 location

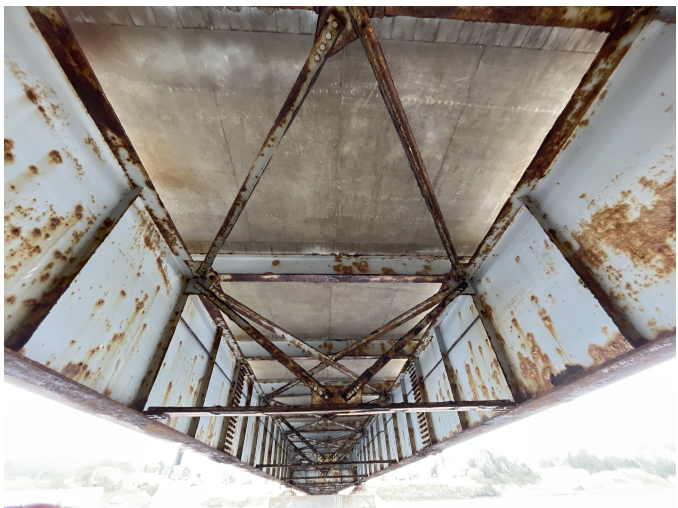
Photo ID 725 Location North
Element Group
Element Type
2022-09-29 2:12:39 PM

Deck soffit looking South at pier 1 in front of North abutment.

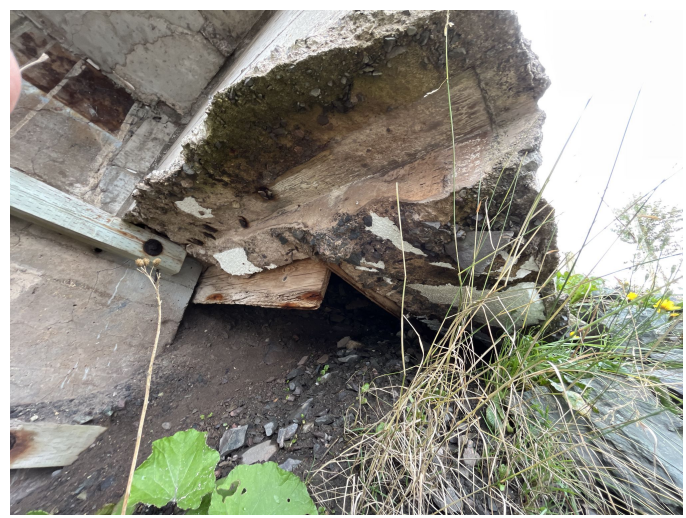
Photo ID 730 Location Northeast
 Element Group Approaches
 Element Type Barriers
 2022-09-29 2:18:20 PM

Undermining on Northeast corner extension for sidewalk and end block.

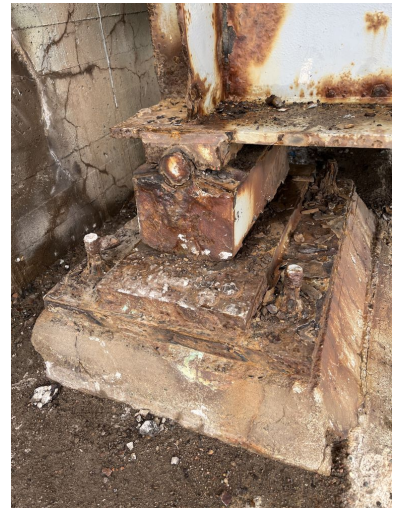
Photo ID 749 Location North Abutment
 Element Group Abutments
 Element Type Bearings
 2022-09-29 3:47:51 PM

Northwest bearing looking East.

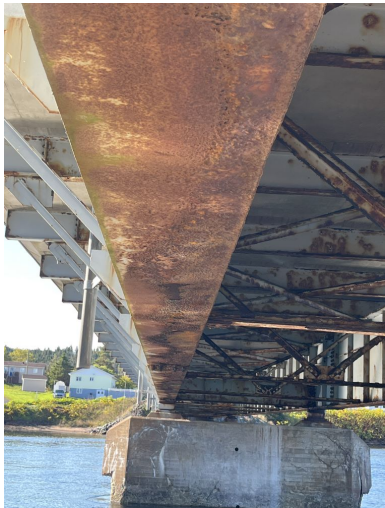
Photo ID 921 Location North
Element Group Beams
Element Type Girders
2022-09-30 10:05:31 AM

Bottom flange east girder looking south. Typical corrosion.

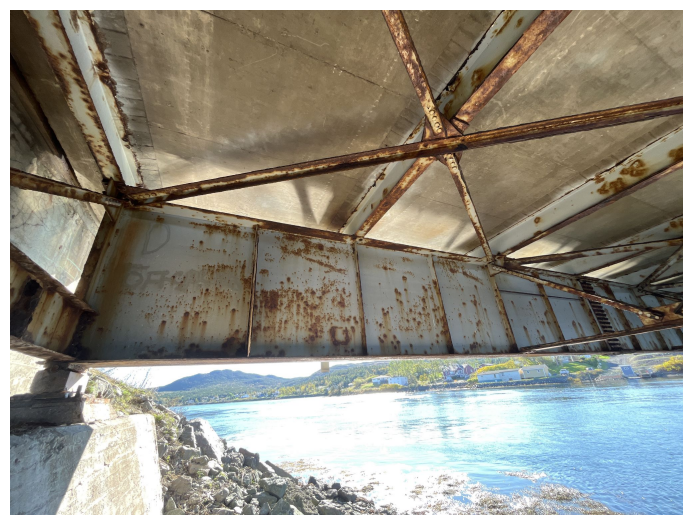
Photo ID 922 Location North
Element Group Beams
Element Type Girders
[2022-09-30 10:06:04 AM](#)

East girder looking east

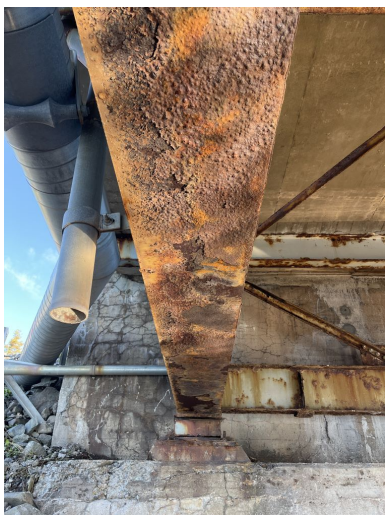
Photo ID 934 Location North
Element Group Beams
Element Type Girders
[2022-09-30 10:13:32 AM](#)

West girder bottom flange looking north. Typical Corrosion

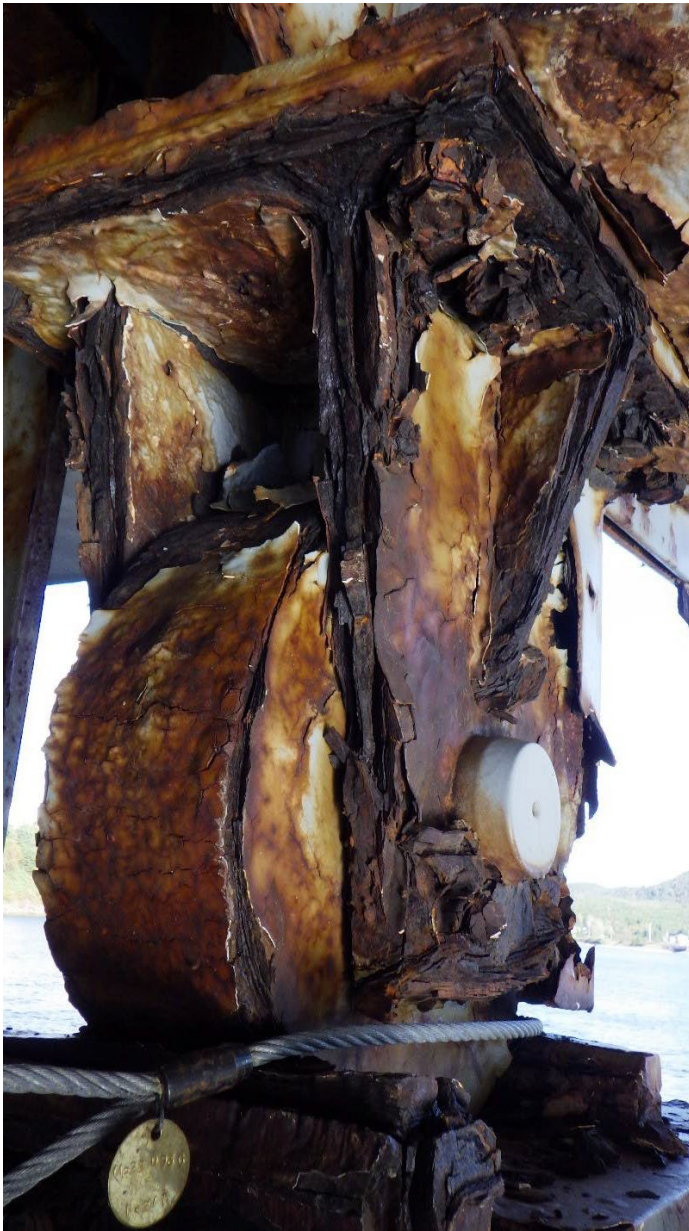
Figure 3. Bearing at swing pier

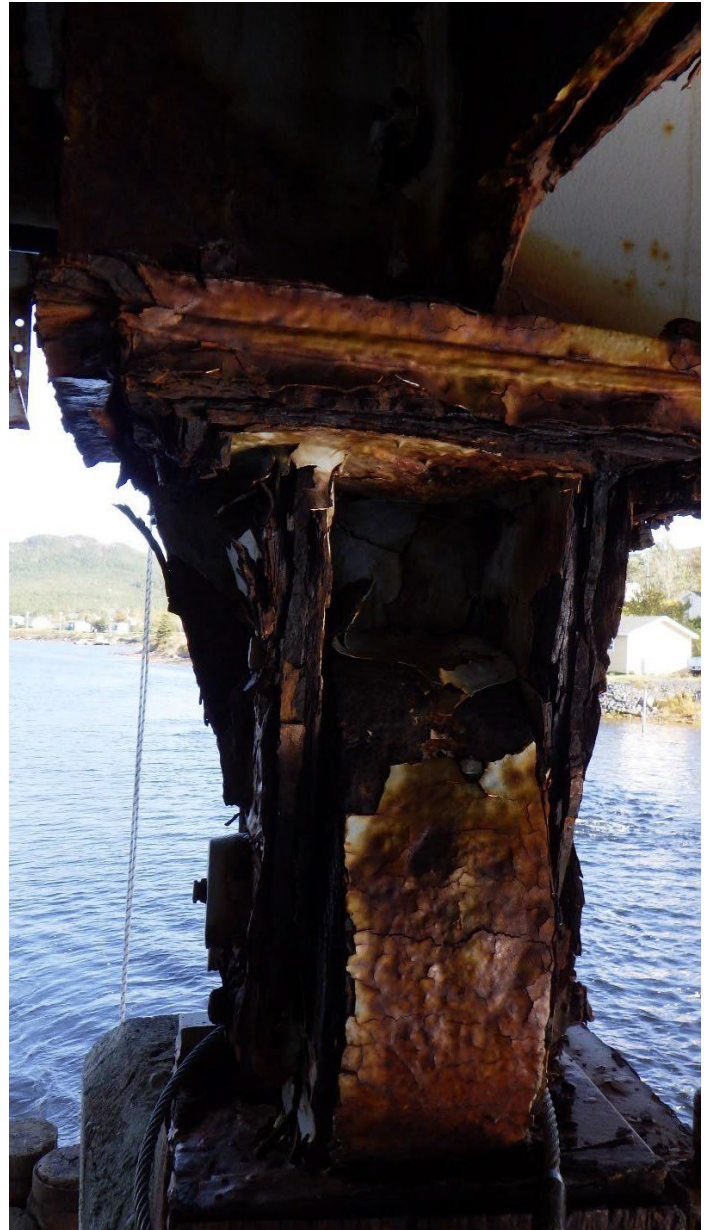
Figure 4. Bearing at swing pier

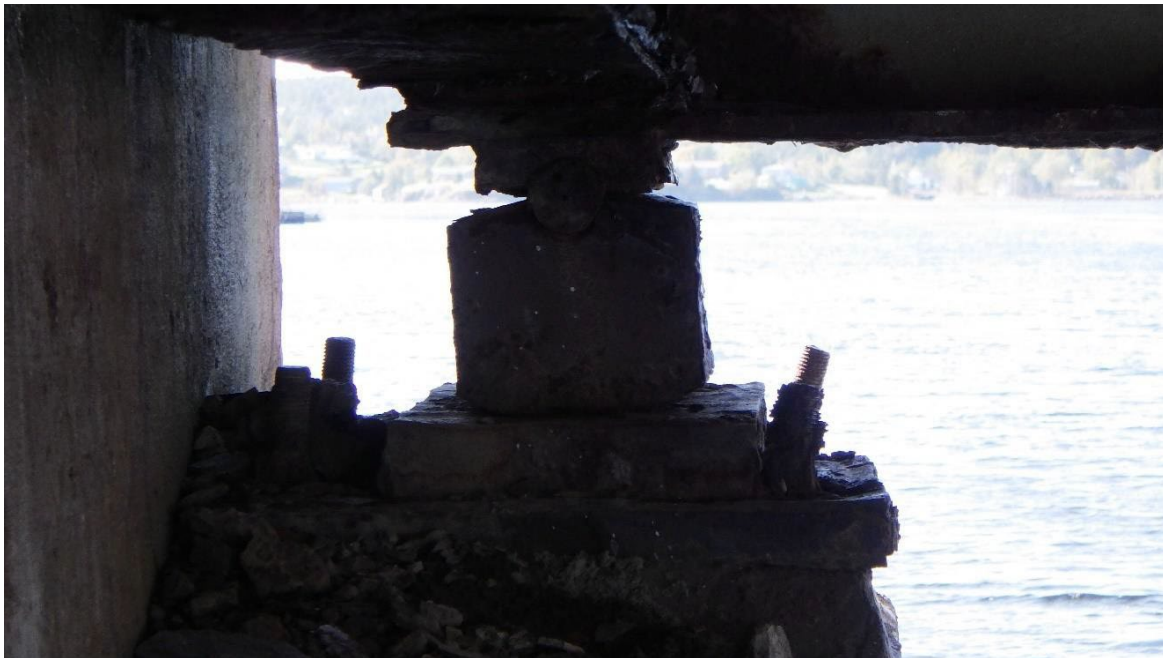
Figure 7. North side of pier three

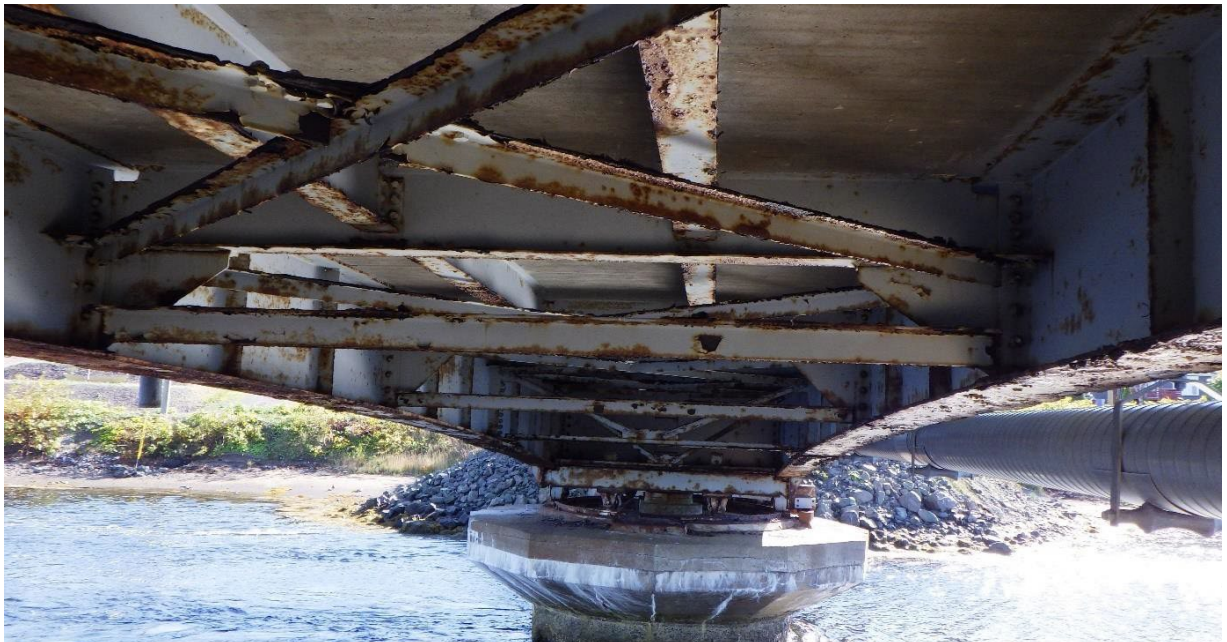
Figure 10. From Pier 3 looking at swing pier

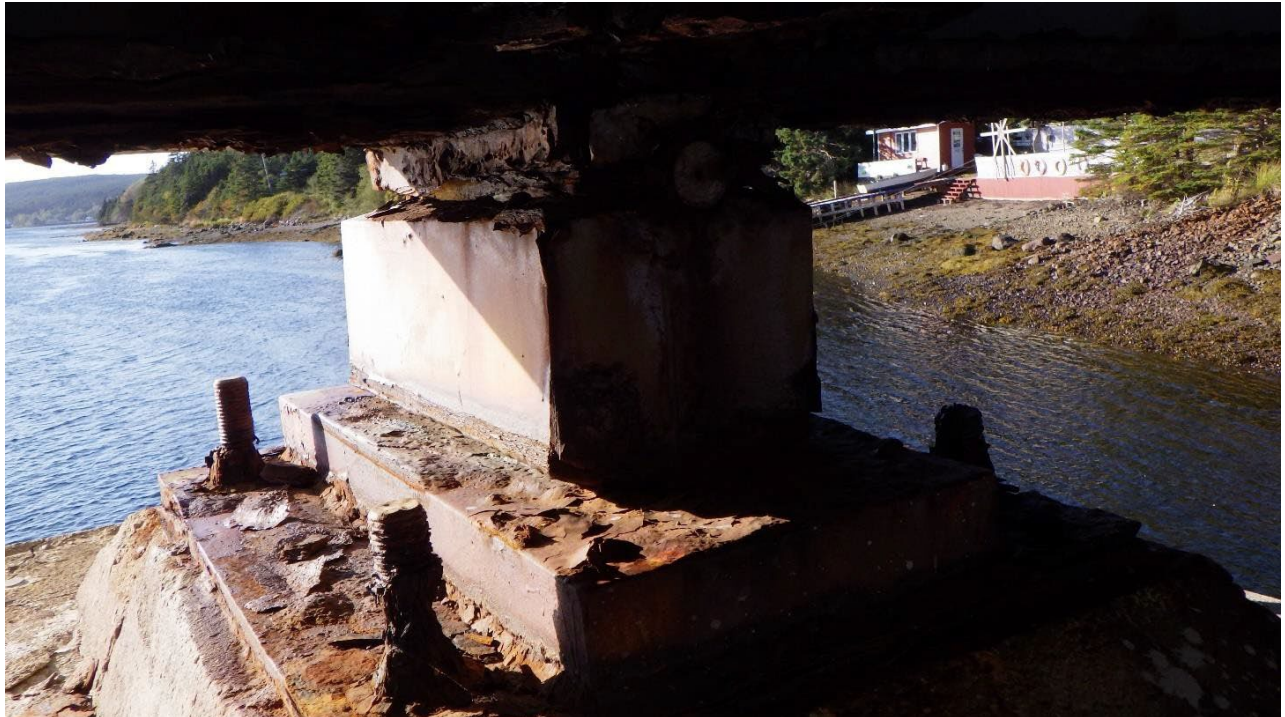
Figure 11. Substantial material loss on bearing components. Pier 1

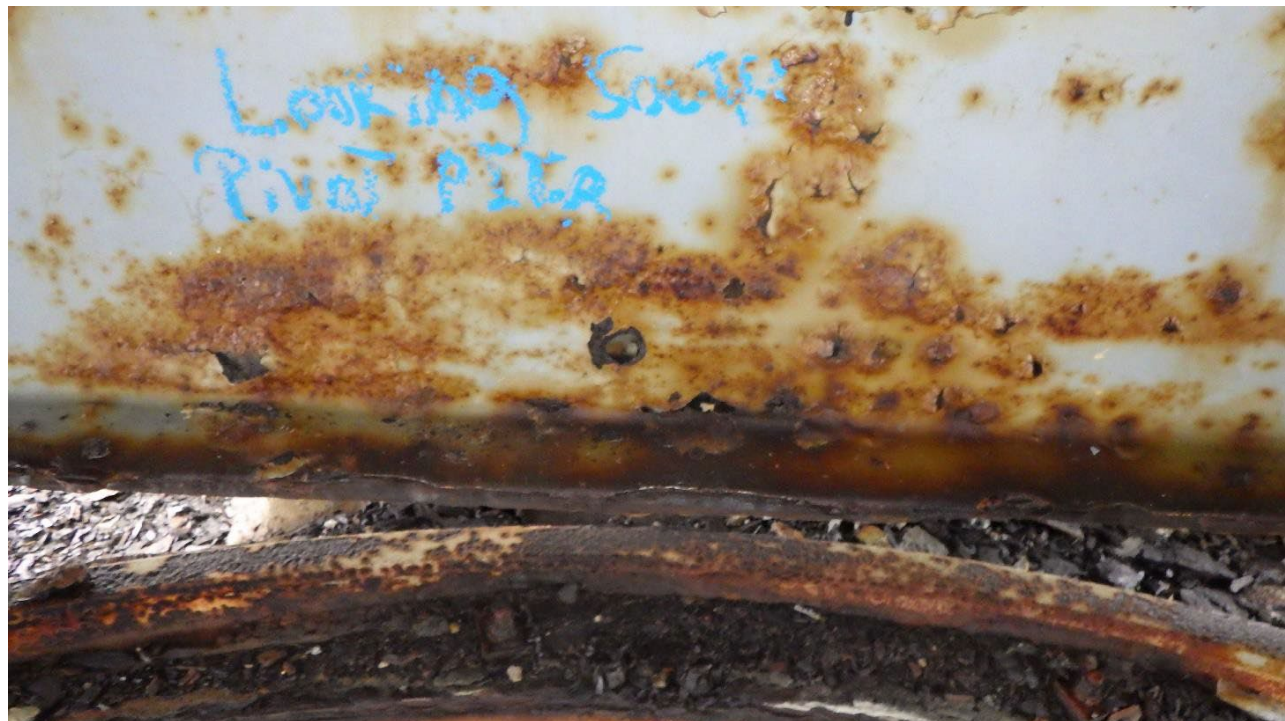
Figure 12. Holes in lateral beam on swing pier.

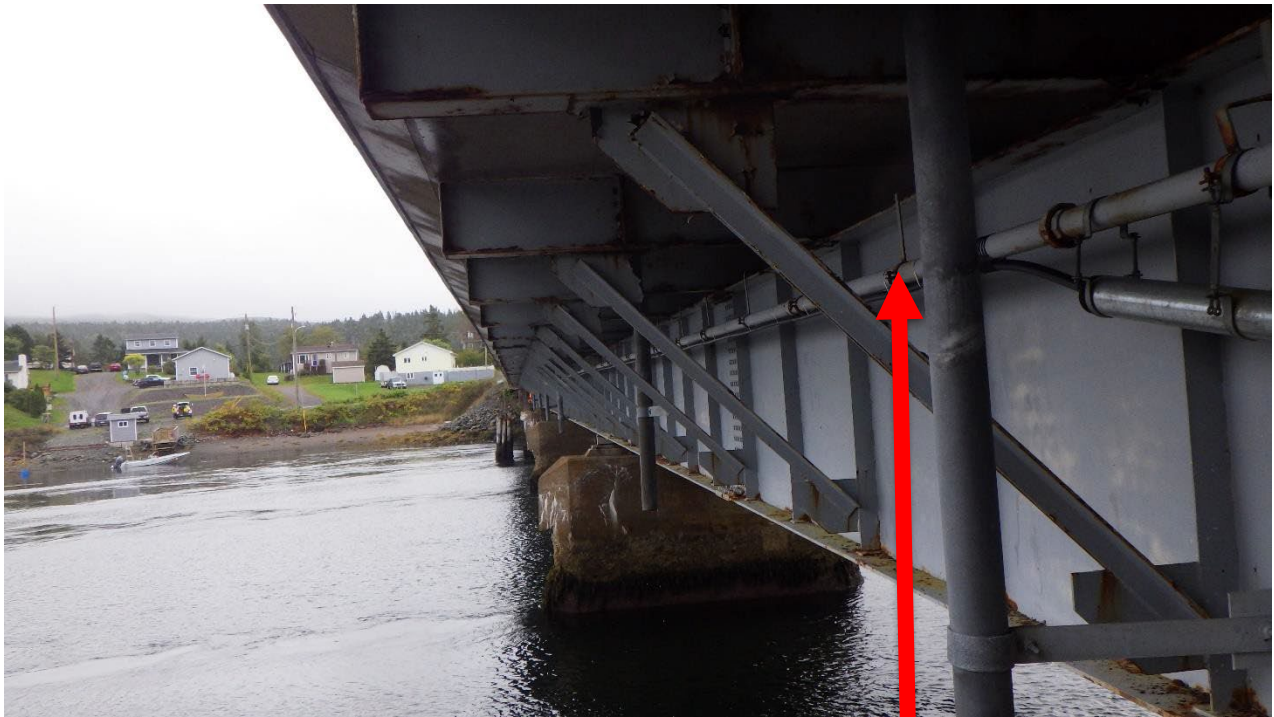
Figure 13. Majority of brackets holding up 4" line is completely detached from girder.

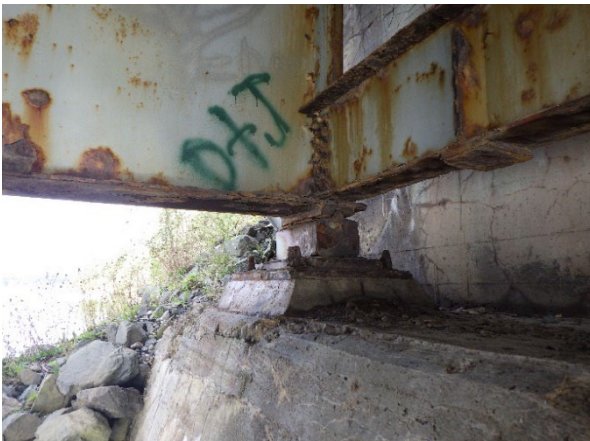
General condition of the coating between the North Abutment and Pier #1. Examples of coating failures are blistering, staining, and undercutting. A test was performed with a dull scraper and the gray topcoat layer came off and turned white (Fig#5). DFT were taken over six locations, the average DFT 447.04 micrometers.

Fig #1 - Example of Blistering, Staining, undercutting.

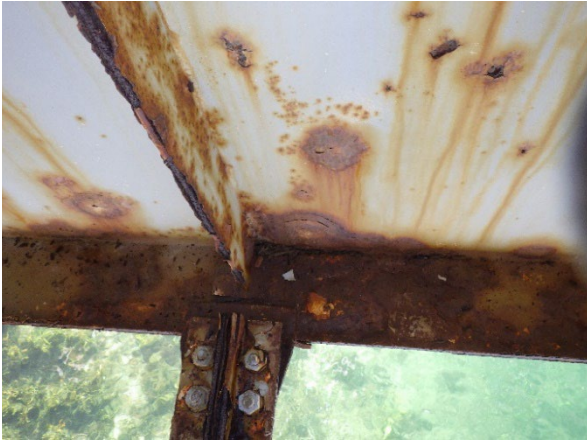
Fig #4 - Typical delamination of the coating from the substrate

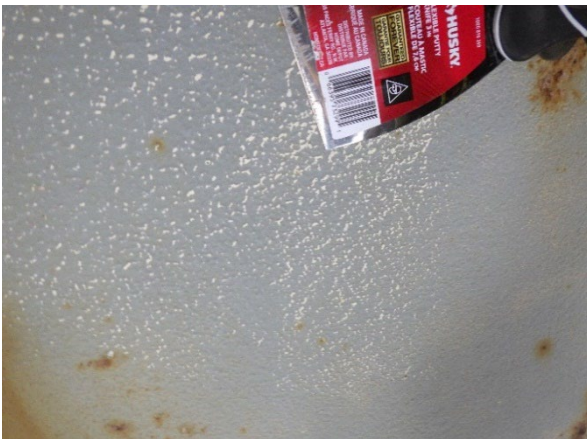
Fig #5 - Scrape test was preformed, showing white layer.

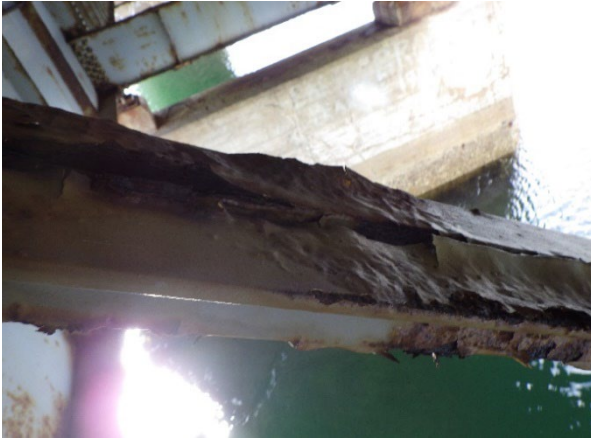
Fig #8 – Typical coating condition on cross bracing.

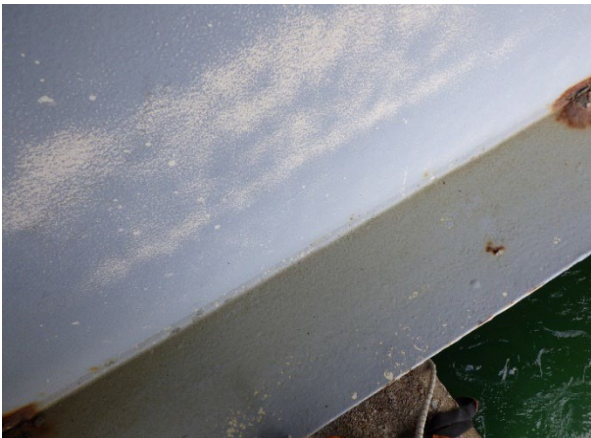
Fig #10 – White coating showing through the topcoat.

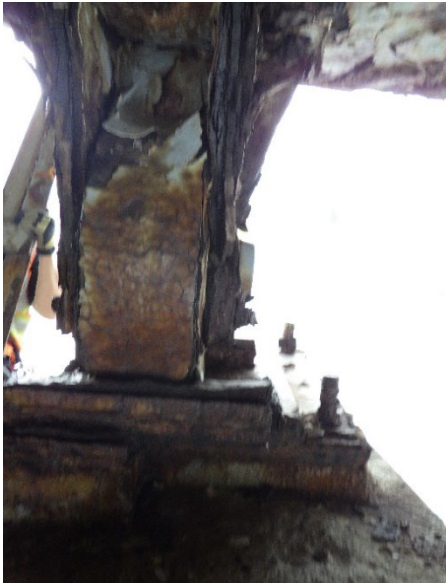
Fig #16 – Swing pier rollers.

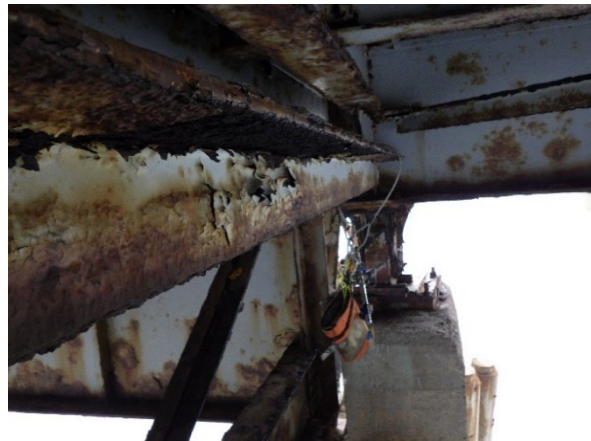
Fig #17 - Swing Pier angle steel, delamination of coating.

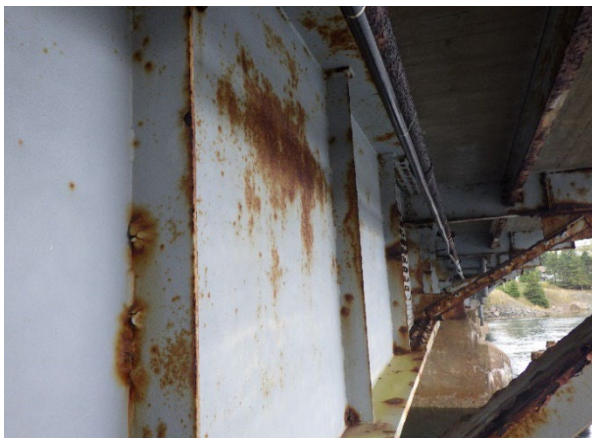
Fig #18 – Typical main beam coating condition.

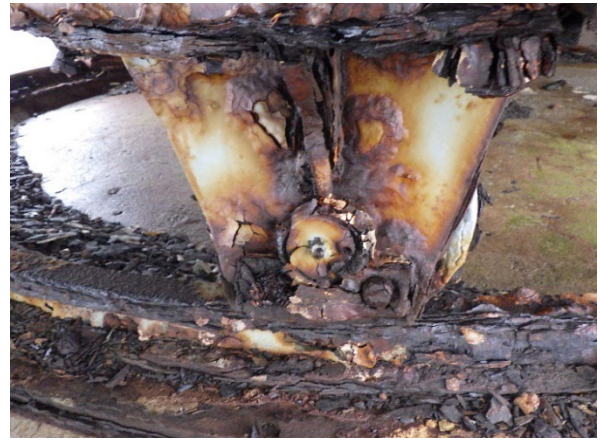
Fig #21 – Swing Pier pivot structure.

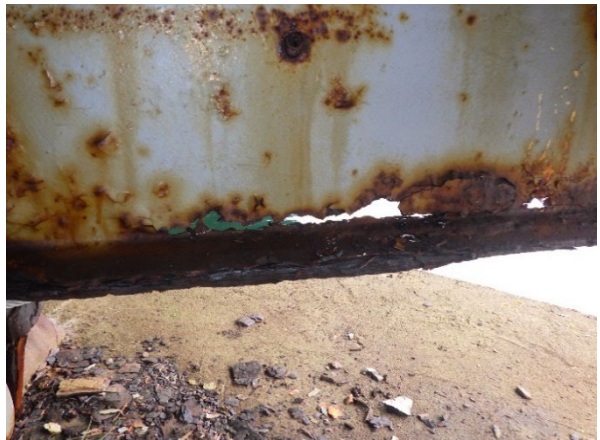
Fig #23 – Hole in swing pier structure.

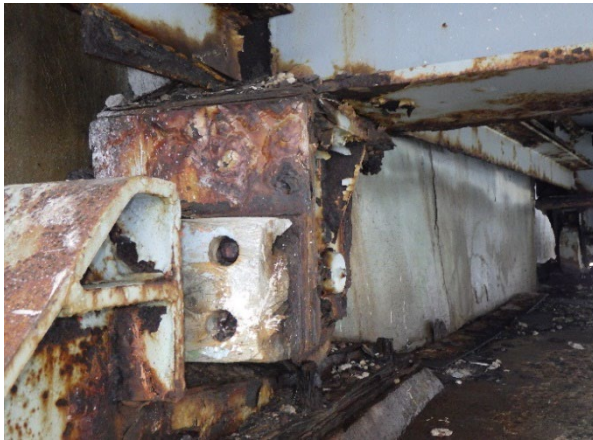
Fig #24 – Coating failure, blistering and delamination.

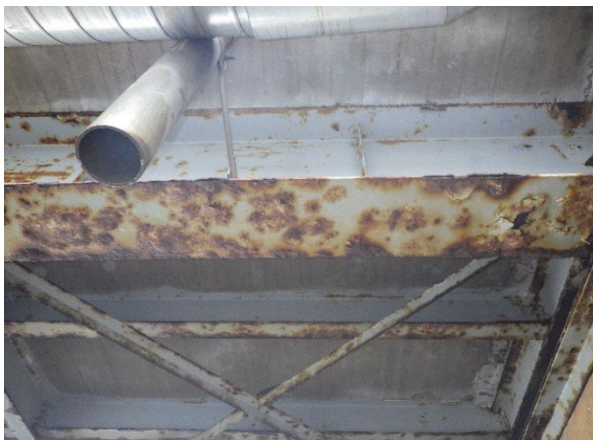
Fig #26 – Main beams, rust staining and blistering.
