| | GOVERNMENT OF NEWFOUNDLAND AND LABRADOR Department of Transportation and Infrastructure | BRIDGE INSPECTION REPORT B07062017-5 | |
| Date: 6/23/2017 | Inspected By: Kent Randell | Category: Eng. - Engineering | |
| Site: | 5-025 - WABUSH NARROWS BRIDGE | | |

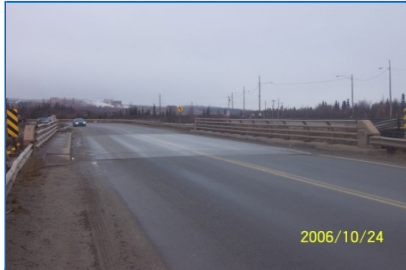
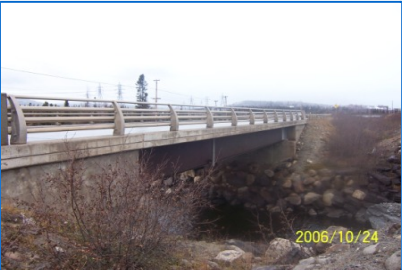
| Comments: | Minor deterioration in bearing. | | |
| Comments: | Expansion joints are leaking east and west. Surface rust flaking off the bottom flange of 2 beam from south side. | | |

| Recommendations: | Bridge office to determine replacement and cost. | | |
