Dam Break Inundation Mapping and Emergency Management for Water Supply Dams

Paula Dawe, P.Eng pauladawe@gov.nl.ca March 23, 2022

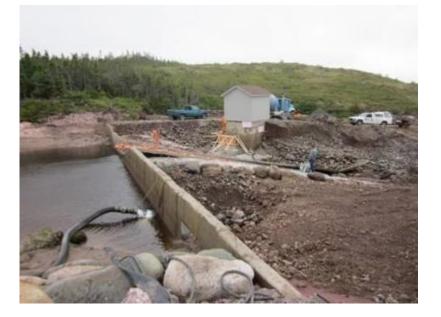
Sunnyside Water Supply Dam Failure

- Occurred in September 2010 (Igor)
- Breach washed away all earthen embankments, undermined the spillway and pump house
- Significant damages to municipal infrastructures

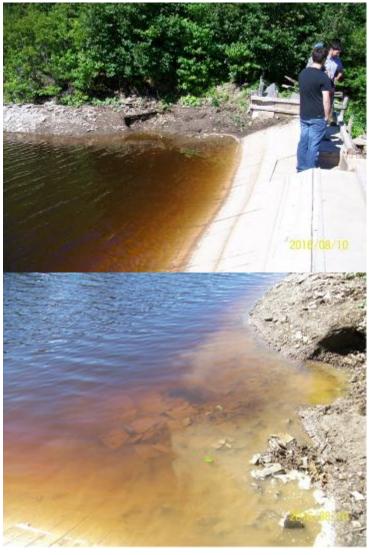
Piccadilly Head Water Supply Dam Failure

- LSD noticed dam was leaking in Aug 2016
- Internal erosion evident by a whirlpool in reservoir which was cutting into left embankment
- Downstream seepage ~50-75 GPM
- \$20,000 for emergency repairs
