TECHNICAL MEMO

Prepared By: Water Resources Management Division (WRMD)

Re: Controlled Breach of Earthen Dams

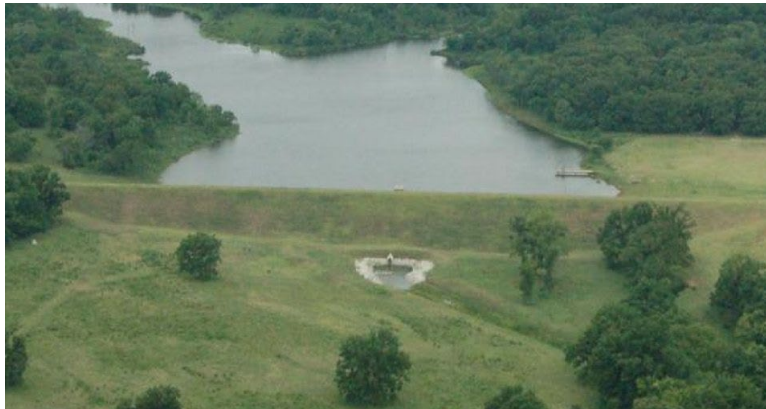
Figure 1: Earthen embankment dam at Double Creek Watershed, Washington County

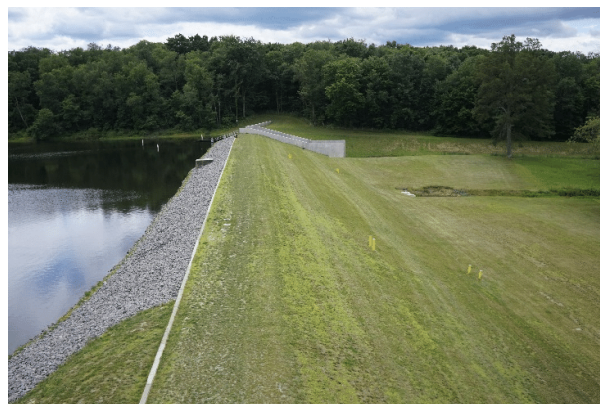
Figure 3: Earthen embankment dam at Glade Run Lake, Pennsylvania

Unlike concrete dams, which can usually withstand some overtopping, earthen dams are much more vulnerable to the erosional damage caused by overtopping. Compared to an erosion resistant and ridged structure like a concrete dam, earthen dams are especially vulnerable to erosional effects on their downstream faces. The upstream face of the embankment typically has erosion protection in the form of riprap or erosion resisting fabric, however, the downstream face will have little to no erosion protection [1]. If water begins to flow over the crest, the unprotected downstream face can suffer severe erosional damage [2]. Depending on the depth and speed of the water flowing over the crest the damage can lead to partial embankment failure or, in extreme situations, total failure. A few inches of depth does not prompt immediate action, however, a foot or more of depth should be very concerning, especially when moving at high speeds [3]. Another factor that can affect the level of erosional damage is the cohesiveness of the fill used to build the earthen dam. The more cohesive the soil is the more resistant it will be to erosion [2]. Light vegetation growth, such as grass, can also help to protect against erosion and stabilize the embankment (see Figure 3). Anything more significant like trees or bushes can negatively impact the integrity of the dam.

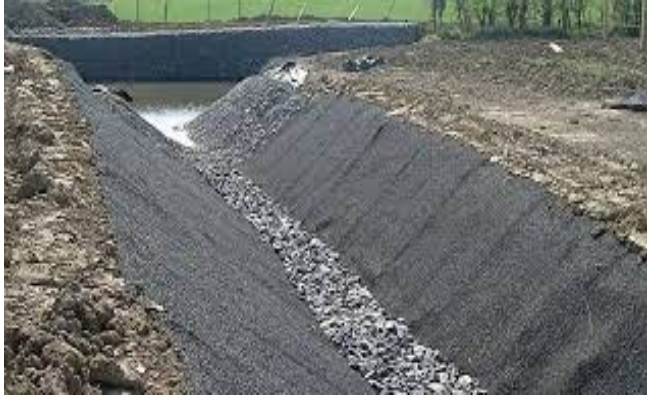
Figure 5: Geotextile lined spillway in Gridley, California

Once the breaching point has been determined, the flow path that the discharging water will follow must be reinforced against erosion. This path can be visually identified by the low points between the breach and the downstream flow path since the water will follow across the lowest path until it reaches the tail waters downstream. The downstream face of earthen dams typically don't have much erosion protection, which leaves these areas susceptible to the erosional forces of the discharging water. Therefore, the path along which the water will flow needs to be reinforced. With the lowest elevation path identified, reinforcement to protect against erosion can be implemented by laying riprap, erosion resistant blanket, geotextile fabric, or plastic sheets along the flow path [3]. See Figures 5 and 6 showing the use of geotextile and riprap for erosion protection. Sandbags can also be used to line the sides of the flow path and the area around the breach. This can help to further protect against erosion, provide additional depth for the flow channel, and direct the path of the flowing water to prevent it from spreading out and causing further erosional damage.

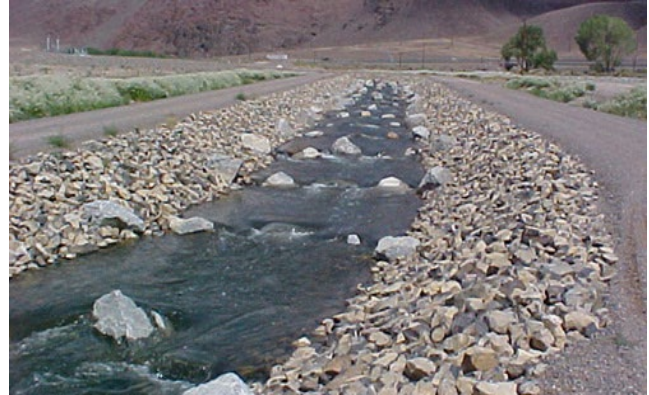
Figure 6: Riprap lined spillway in Truckee River, Nevada
