TECHNICAL MEMO

Prepared By: Water Resources Management Division (WRMD)

Re: Vegetation on Earthen Dams

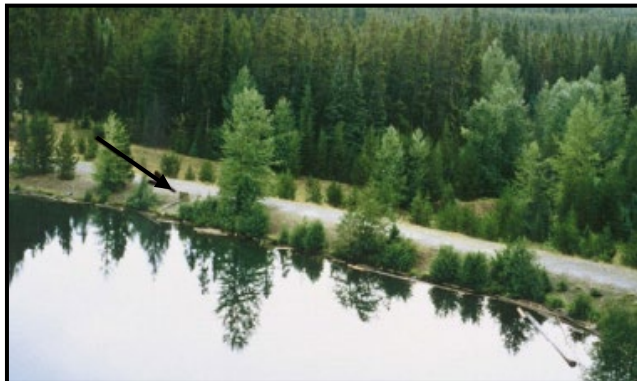
Figure 5: Before Remediation: excess growth, broken log boom. (FEMA, 2005, Pg. 34).

The impetus for rehabilitation begins “when effects of an improper vegetation maintenance and control program create conditions that are detrimental to the structural integrity of the earthen dam” (FEMA, Pg. 3-4). Young trees growing on a dam in British Columbia (Figure 5) were removed (Figure 6) before they could become established and threaten the structure.

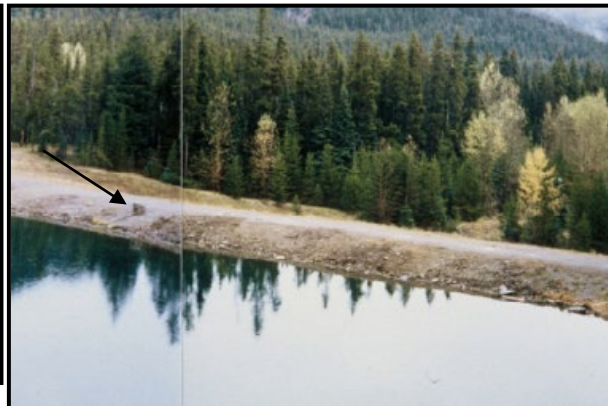
Figure 6: After Remediation: Properly maintained crest and embankment. (FEMA, 2005, Pg. 34).

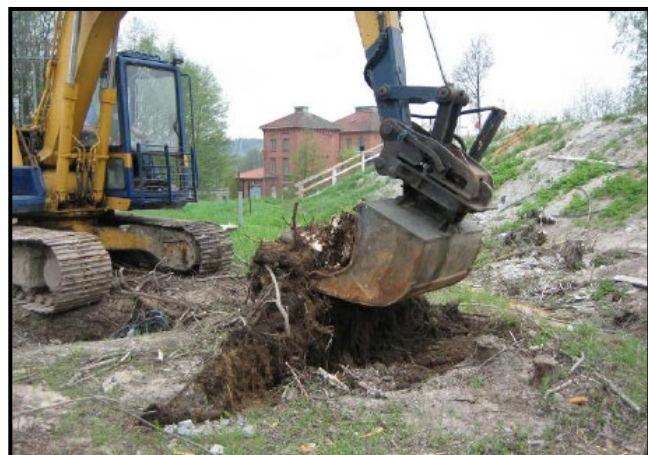
Figure 5 - Stump Pull Test: Removal of Alder stump at Peltokoski embankment dam, Finland. Image retrieved from (Laasonen, 2013, Pg. 2).

The removal of a rotten tree stump by pulling (Figure 7) causes breakage of roots at weak points. Careful extraction of an embankment slope (Figure 8) exposes a decaying eucalyptus tree, indicating the possible size and spread of a shallow root system. Where woody vegetation has been previously removed, there may be a need for additional remediation. In Illinois a downstream slope “failure initiated from decomposition of the roots of several grown trees previously cut-down” (Oskoorouchi & Lane, 2004, Pg. 2). Once a tree dies, the root system should be removed and the structure backfilled to “restore this dam to a safe condition and original design life” (FEMA, Pg. 4.11).

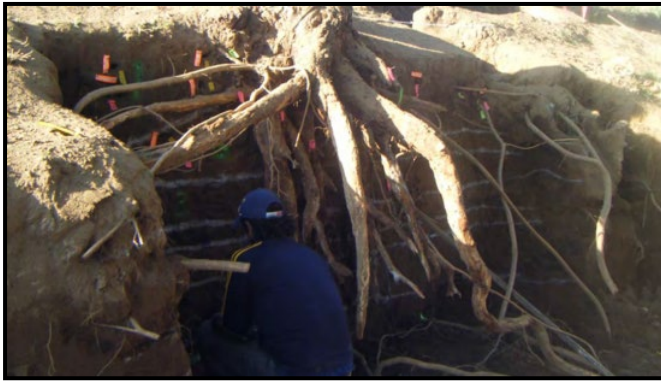
Figure 6 – Eucalyptus tree root system within embankment slope exposed Image retrieved from (Shriro, et al., 2013, Pg. 97)

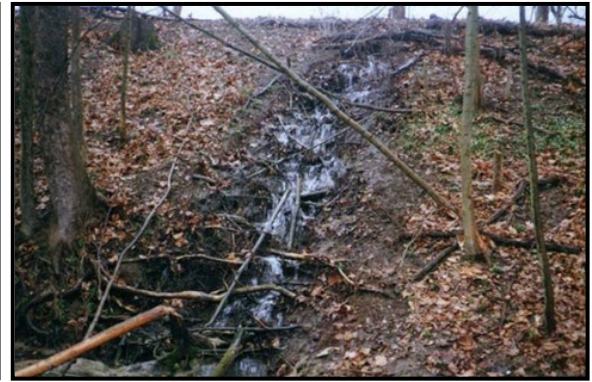
Figure 7 - Seepage caused by piping through a dam's embankment. (United States Department of Agriculture, Pg. 13).
