# Real-Time Water Quality Deployment Report

## Teck Duck Pond Operations

2019

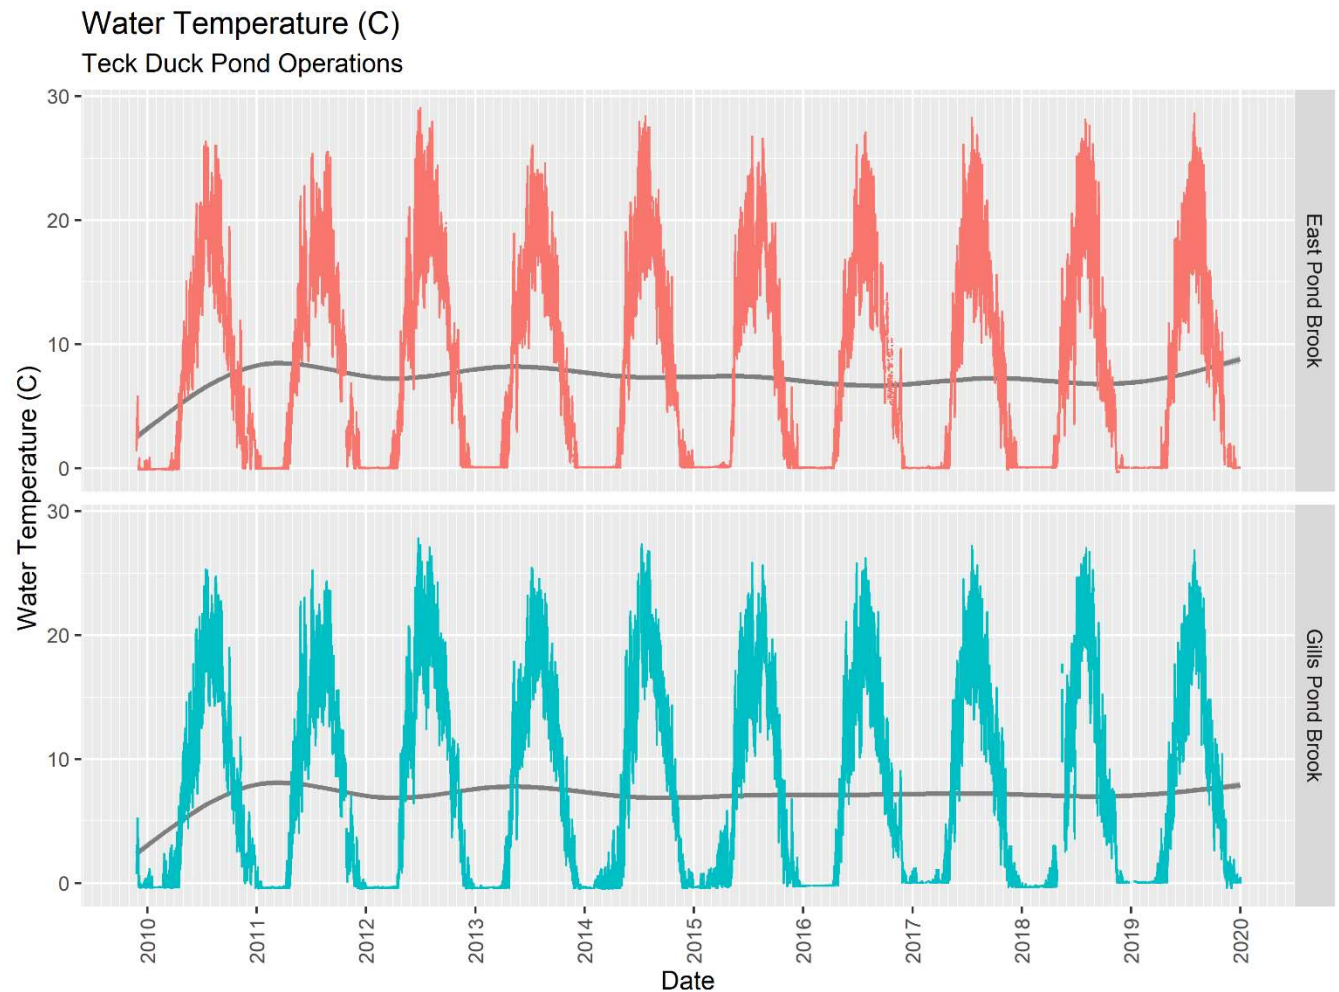
**Figure 1: Water Temperature at Teck DPO**

Water temperatures in 2019 were slightly lower than mean temperatures from the previous nine years (see Table 1). This is likely annual variation and of no immediate concern.

Some transmission issues resulted in a loss of data from EPB in December 2019. As a result, the median temperature value may be skewed. Mean water temperatures are reported in Table 1.

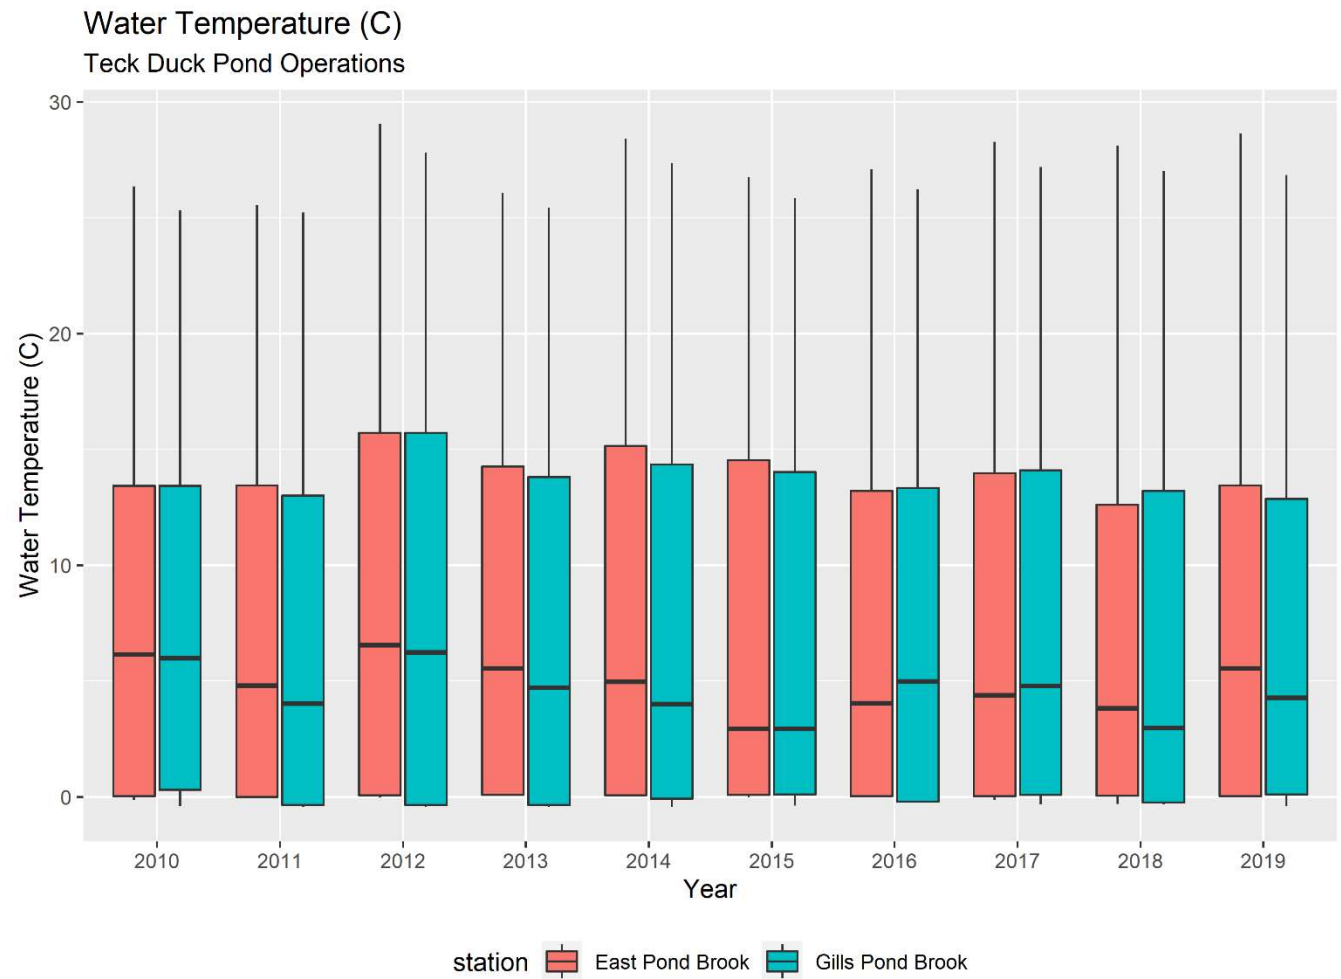
Figure 2 shows the range in water temperatures at EPB and TGPB stations since 2010. In that time span, 2019 was on par with other average years, and warmer than 2018 which was unusually cool.

Figure 2: Boxplots of water temperature at Teck DPO from 2010 to 2019

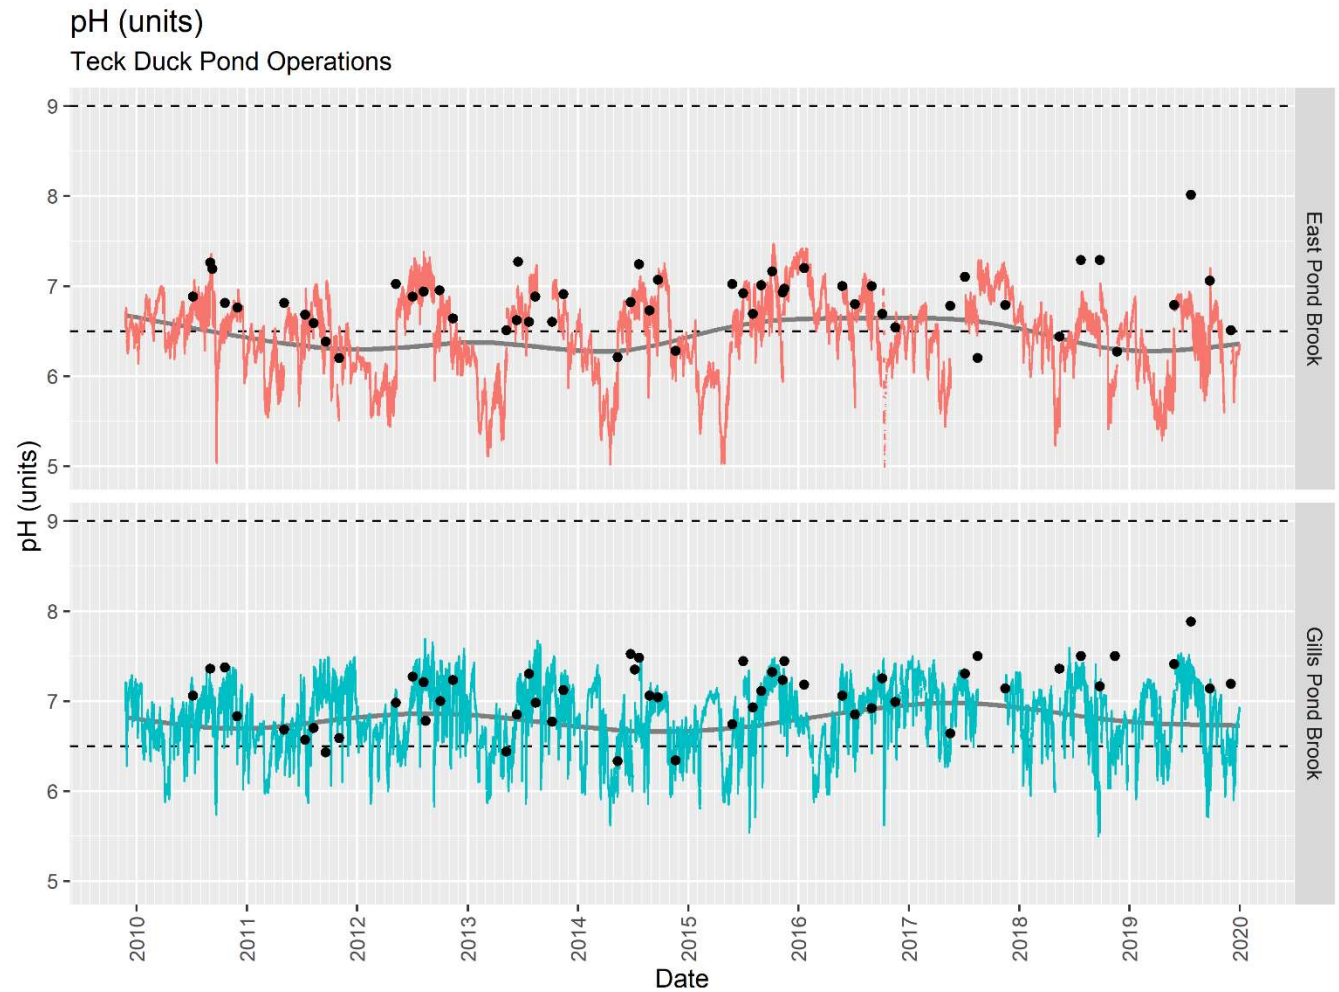
Figure 3 shows that pH levels at East Pond Brook typically fall at, or somewhat below, the CCME guidelines for the protection aquatic organisms (dashed lines). pH levels at Gill's Pond Brook typically fall at, or somewhat above, CCME guidelines. The 2019 data was consistent with this trend as TGPB recorded higher pH values than EPB.

Figure 3: pH at Teck DPO

Ambient waters on the island of Newfoundland tend to be acidic due to natural geological and ecological characteristics. As such, the ambient waters of East Pond Brook are slightly acidic. Gills Pond Brook waters, however, are highly influenced by treated effluent discharged from an upstream polishing pond. These waters are treated to maintain a near-basic pH of 7.0

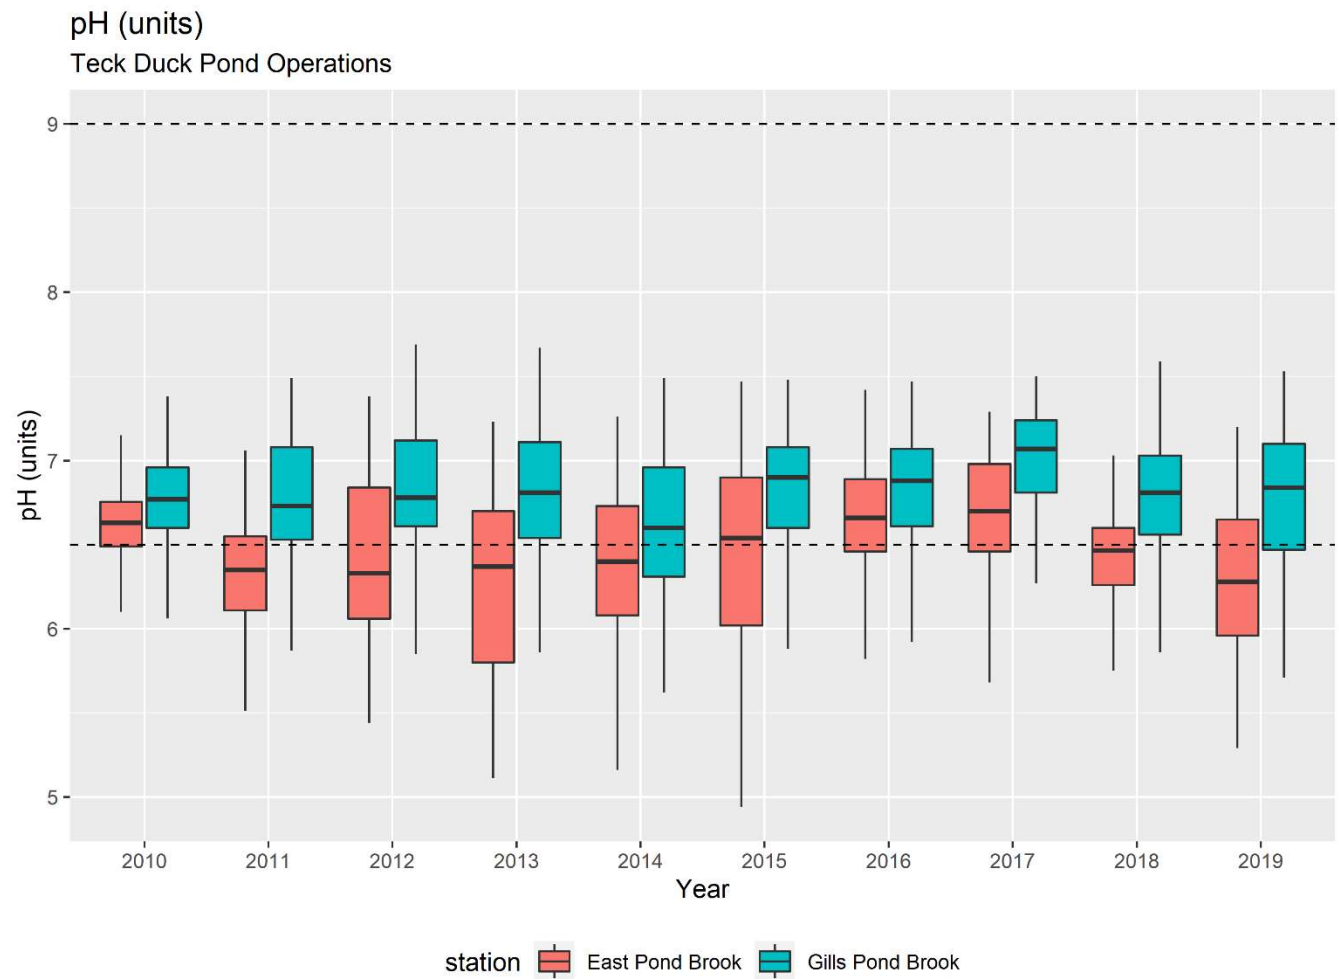
pH values in 2019 were somewhat lower than those observed at East Pond Brook in 2018, but 2019 Tributary to Gills Pond Brook data was on par with 2018 data, as seen in Figure 4. Median annual pH values at East Pond Brook reached a historical low in 2019.

Figure 4: Boxplots of pH at Teck DPO from 2010 to 2019

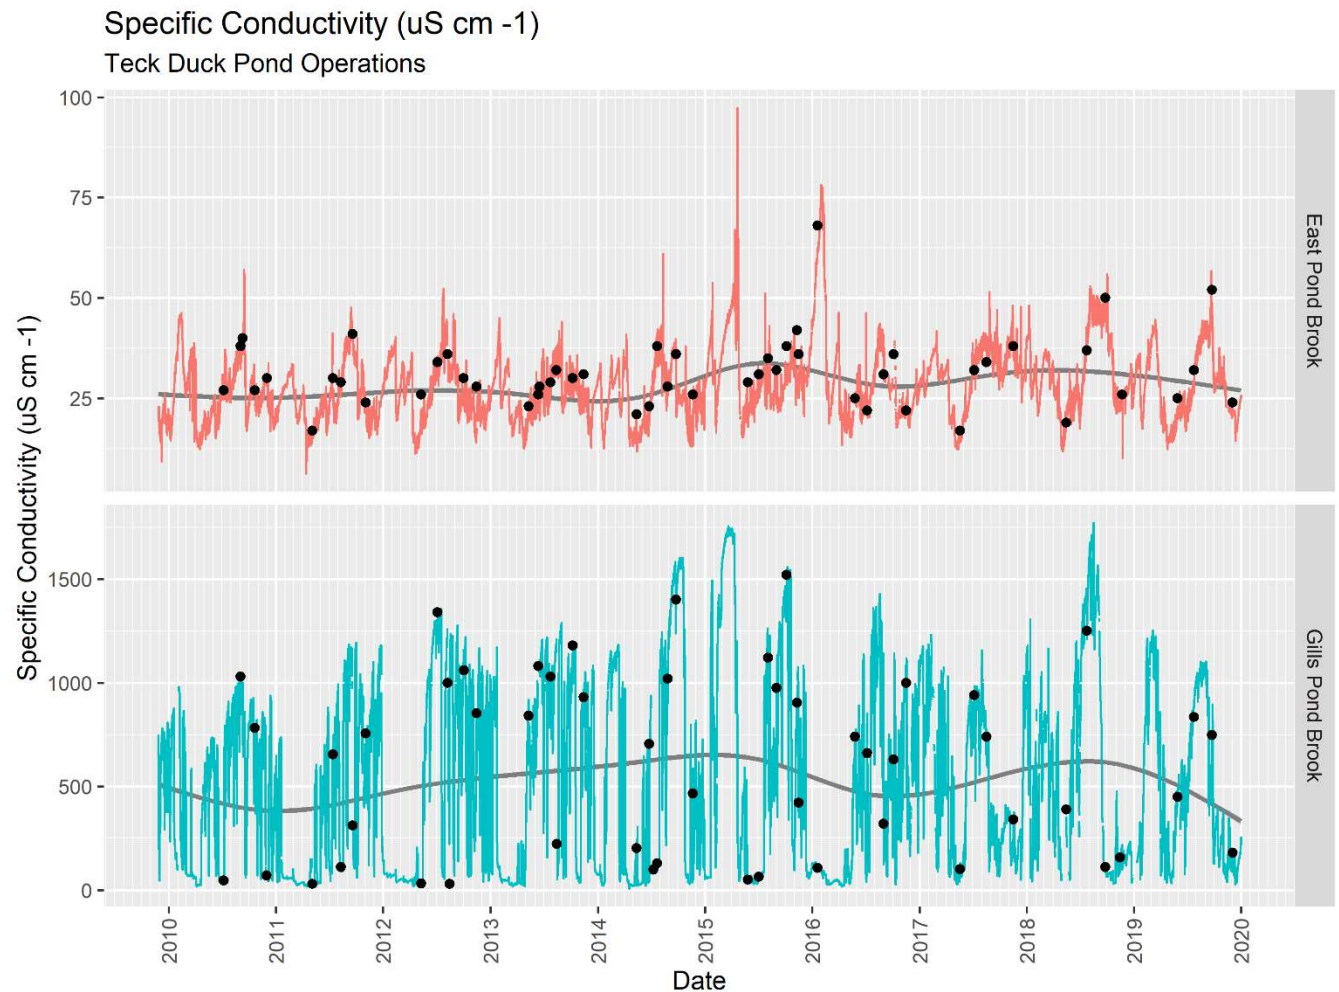
A slow and long term rising trend in conductivity previously observed in East Pond Brook data, is not as evident in 2019, as shown by the trend line in Figure 5. The driving force behind this increase may be related to a number of factors such as atmospheric deposition of dust from industrial activity in the area, soil disturbance from nearby logging activities, or movement of dissolved solid-laden groundwater from the tailings management area higher in the watershed.

Figure 5: Specific Conductivity at Teck DPO

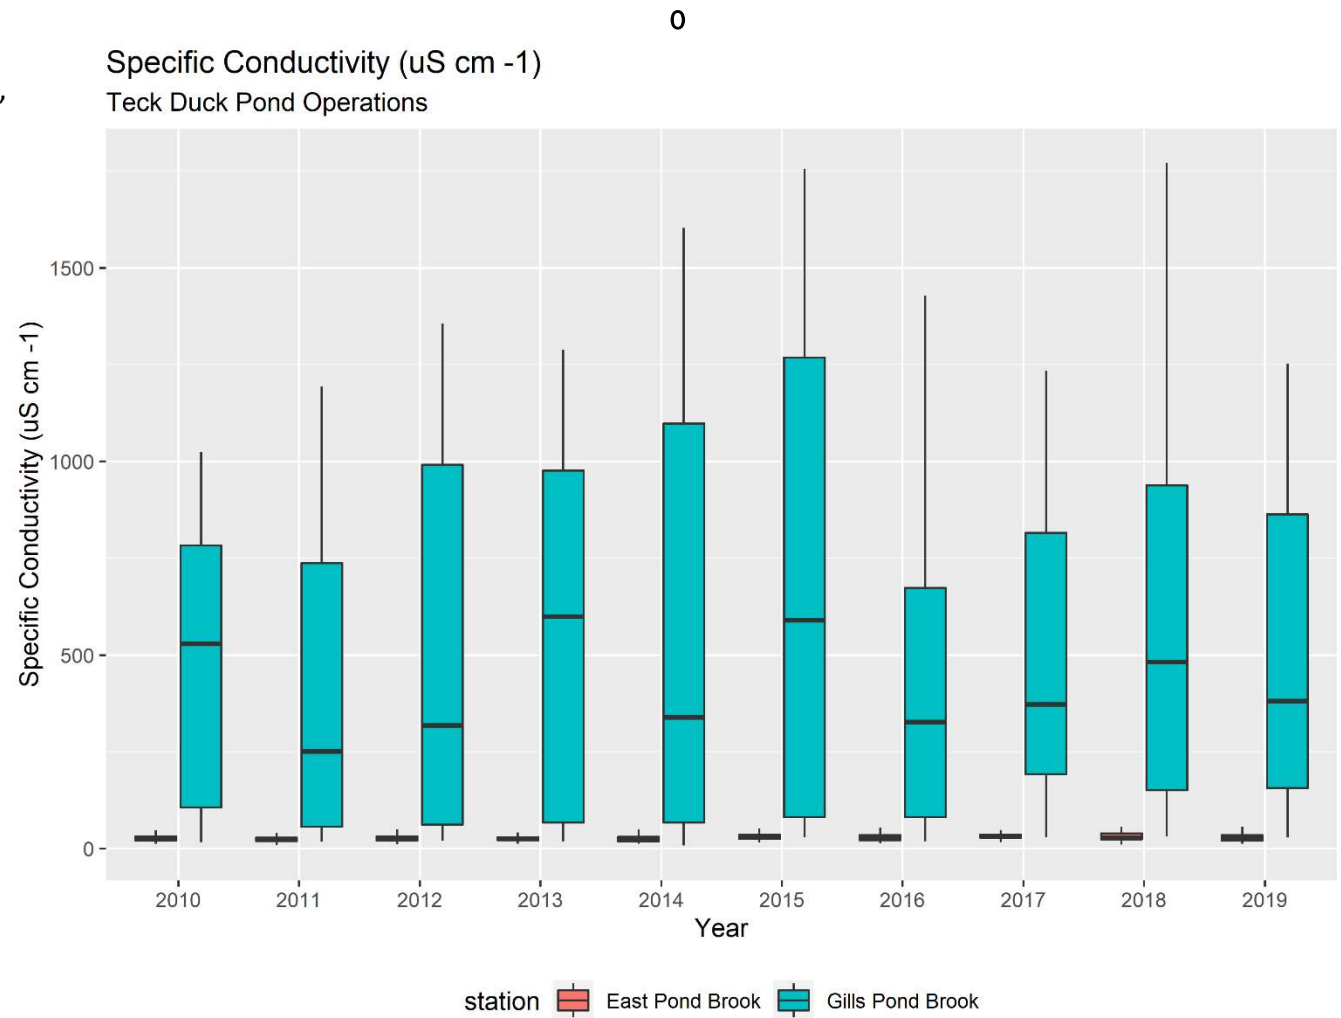
The influence of polishing pond effluent on water quality in Gill's Pond Brook is evident in Figure 6. Without polishing pond effluent, specific conductivity levels at EPB and TGPB stations would report values similar to one another. Specific conductivity at TGPB station, however, is substantially higher than EPB station which barely registers on the plot to the right.

Figure 6: Boxplots of specific conductivity at Teck DPO from 2010 to 2019

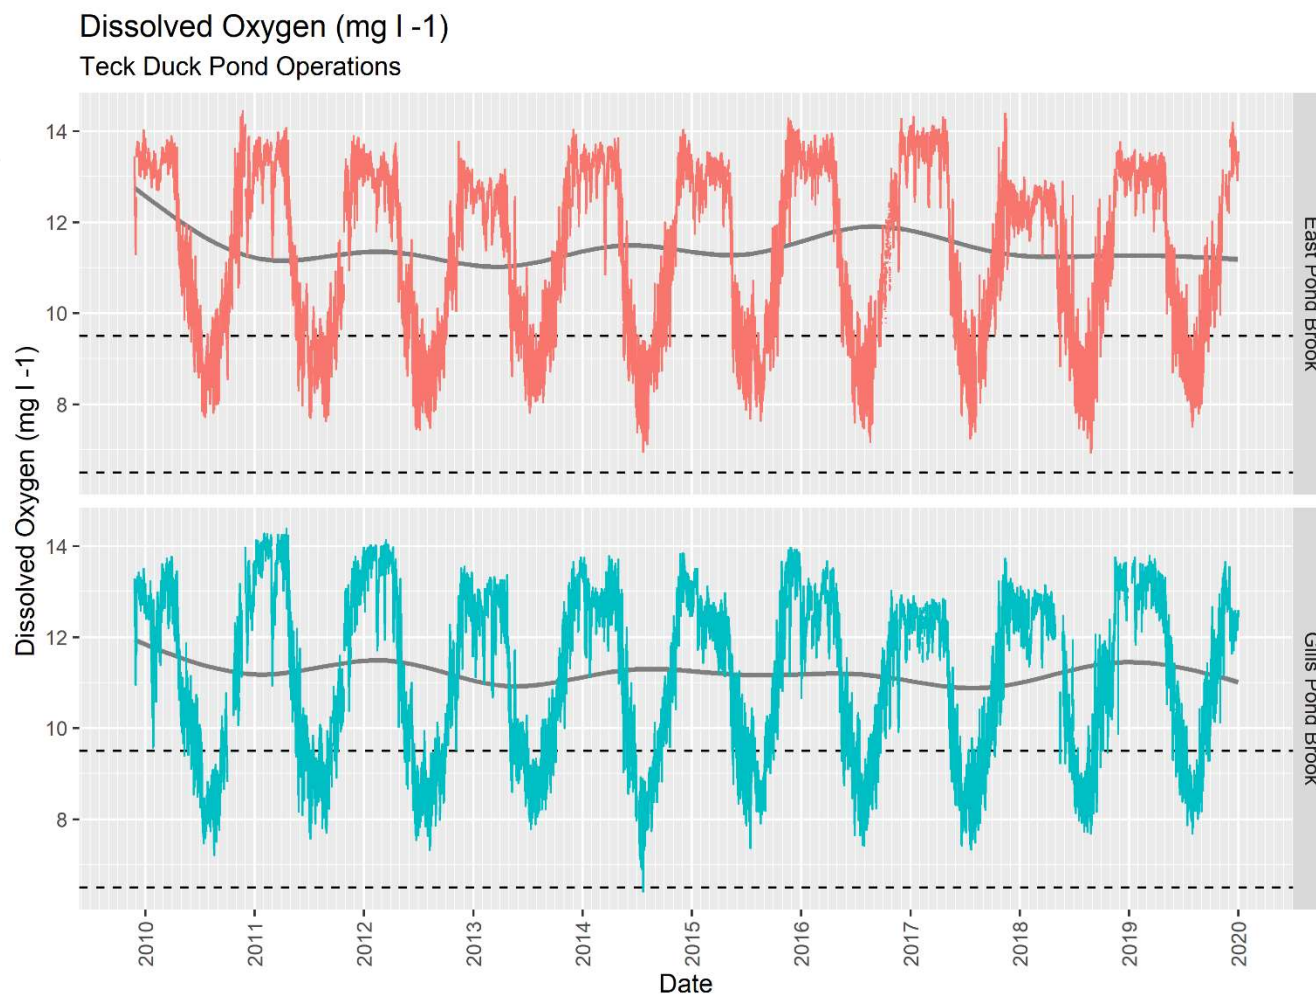
In 2019, all dissolved oxygen values were found to be above the CCME Aquatic Life Guideline for other life stages (6.5mg/L), but below the guideline for early stages (9.5 mg/L) during the warmer seasons when water can hold less oxygen (Figure 7). Guidelines are indicated on Figure 7 by dashed lines.

Figure 7: Dissolved oxygen at Teck DPO

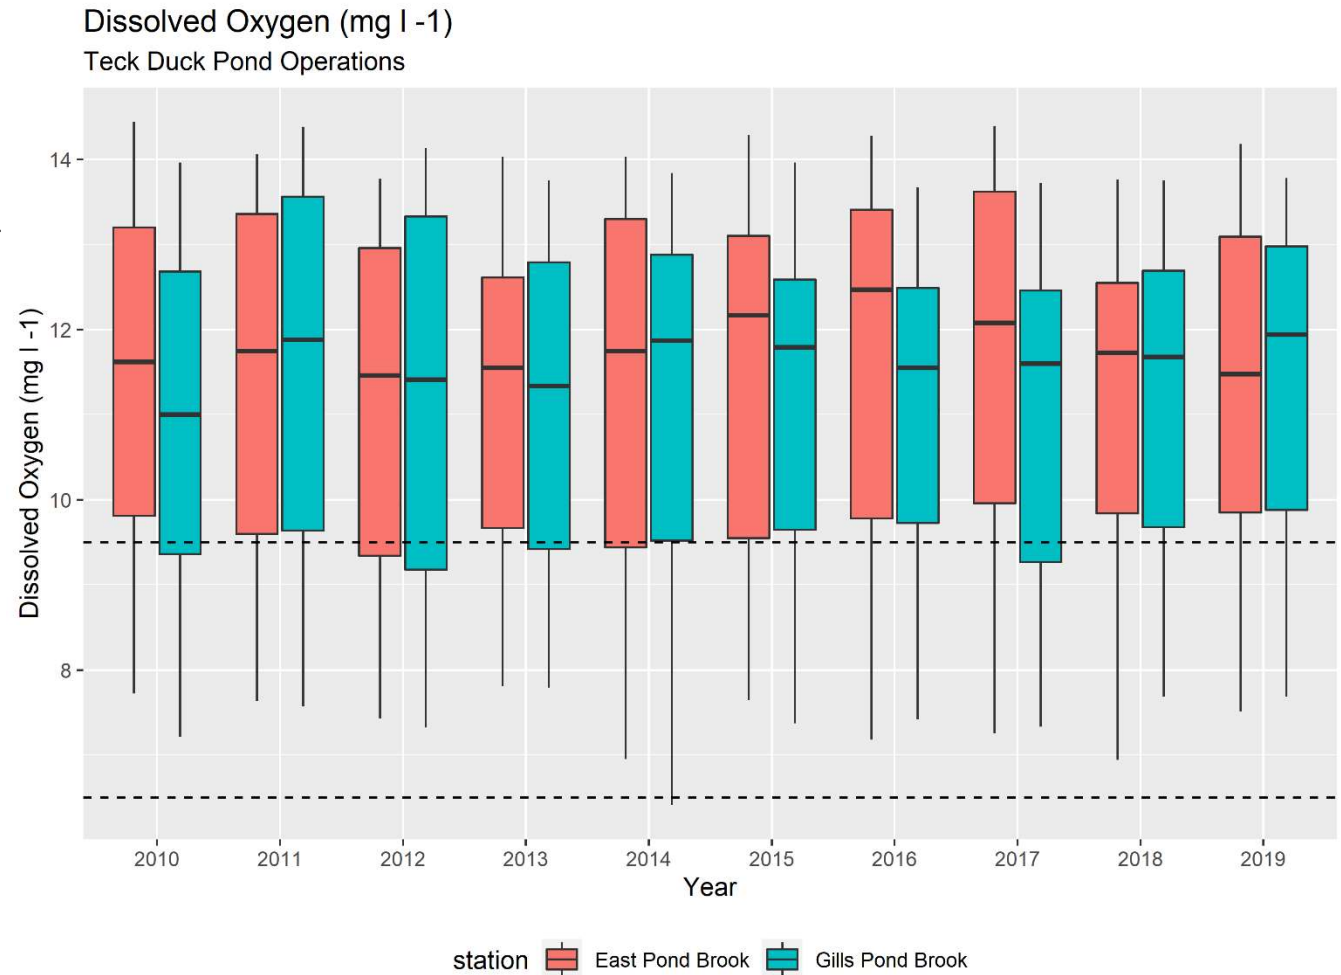
As seen in Figure 8, dissolved oxygen concentrations have not changed in any considerable up- or downward trend since monitoring began. Each box, which represents the central 75% of values, is generally greater than the least-conservative CCME guideline of 9.5 mg/l for the protection of aquatic biota in early life stages (black, dashed lines).

Figure 8: Boxplots of dissolved oxygen at Teck DPO from 2010 to 2019

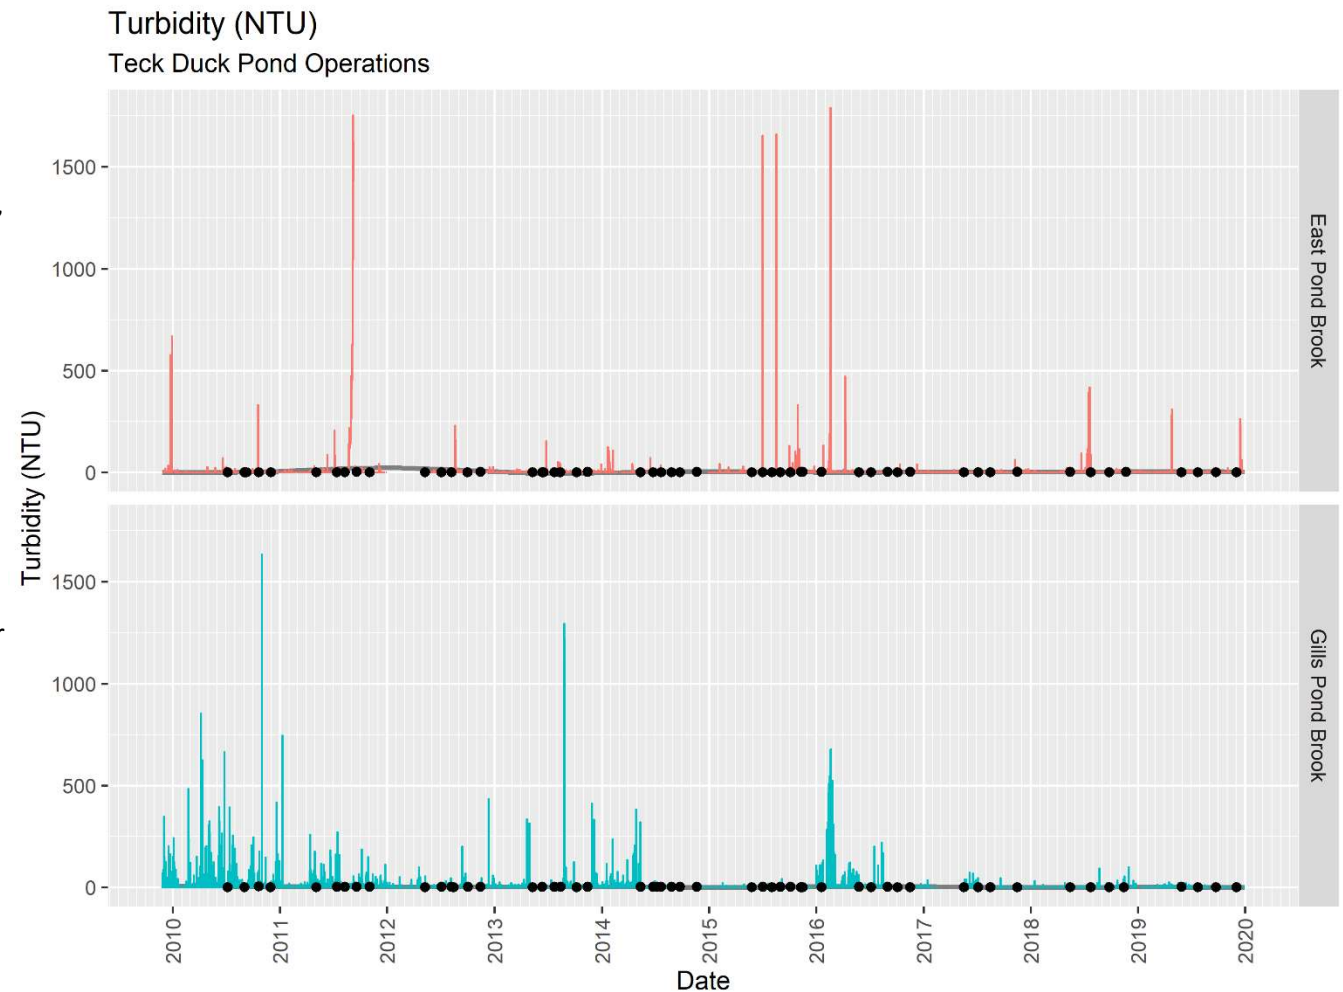
Despite median values of 0 NTU historically, Figure 9 shows that there are some notable periods of higher turbidity. At TGPB station, these periods are especially obvious from 2010 to mid-2014 and again in 2016. Following this period, turbidity events became fewer in number and lower in magnitude. In 2019, EPB reported a small level of background turbidity, with sporadic increases. GPB reported an abnormally low maximum value. Only a small number of turbidity events were encountered at either station and were short in duration.

**Figure 9: Turbidity at Teck DPO**

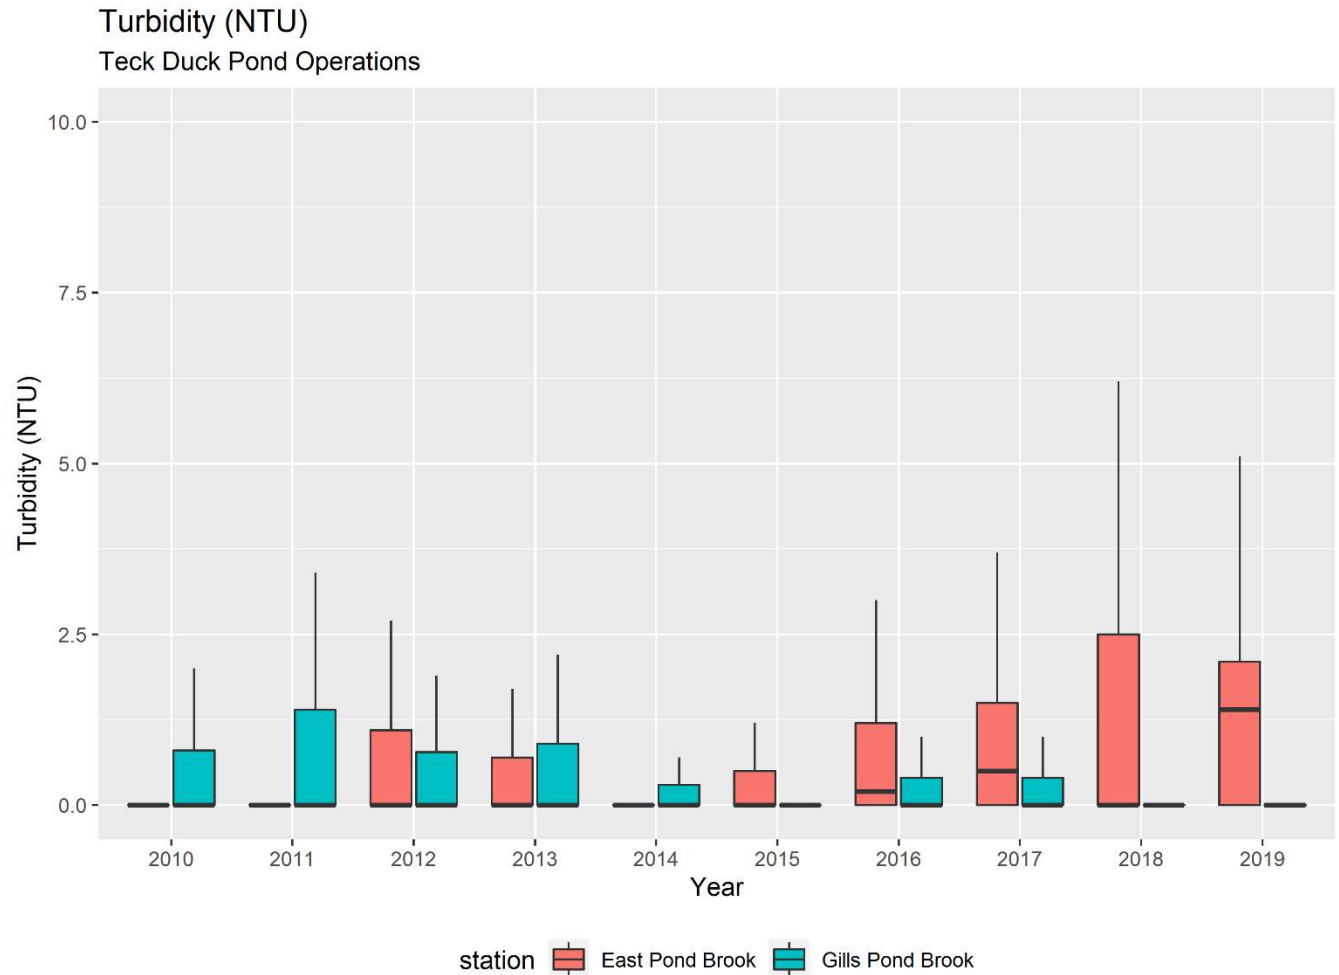
The long-term characteristics of turbidity at the Teck DPO sites are seen in Figure 10. Within each boxplot, a central, horizontal black bar indicates median turbidity. Median values are generally located at 0 NTU, except for East Pond Brook in 2016, 2017 and 2019. Those three years seemed to indicate a rising trend in turbidity. The upper range of turbidity values at East Pond Brook showed steady increases from 2015 to 2018. The 2019 values are just below those of 2018.

The mechanisms responsible for this increase are not known but possible explanations could be closure work at Teck DPO or logging work occurring in the area.

Figure 10: Boxplots of turbidity at Teck DPO from 2010 to 2019

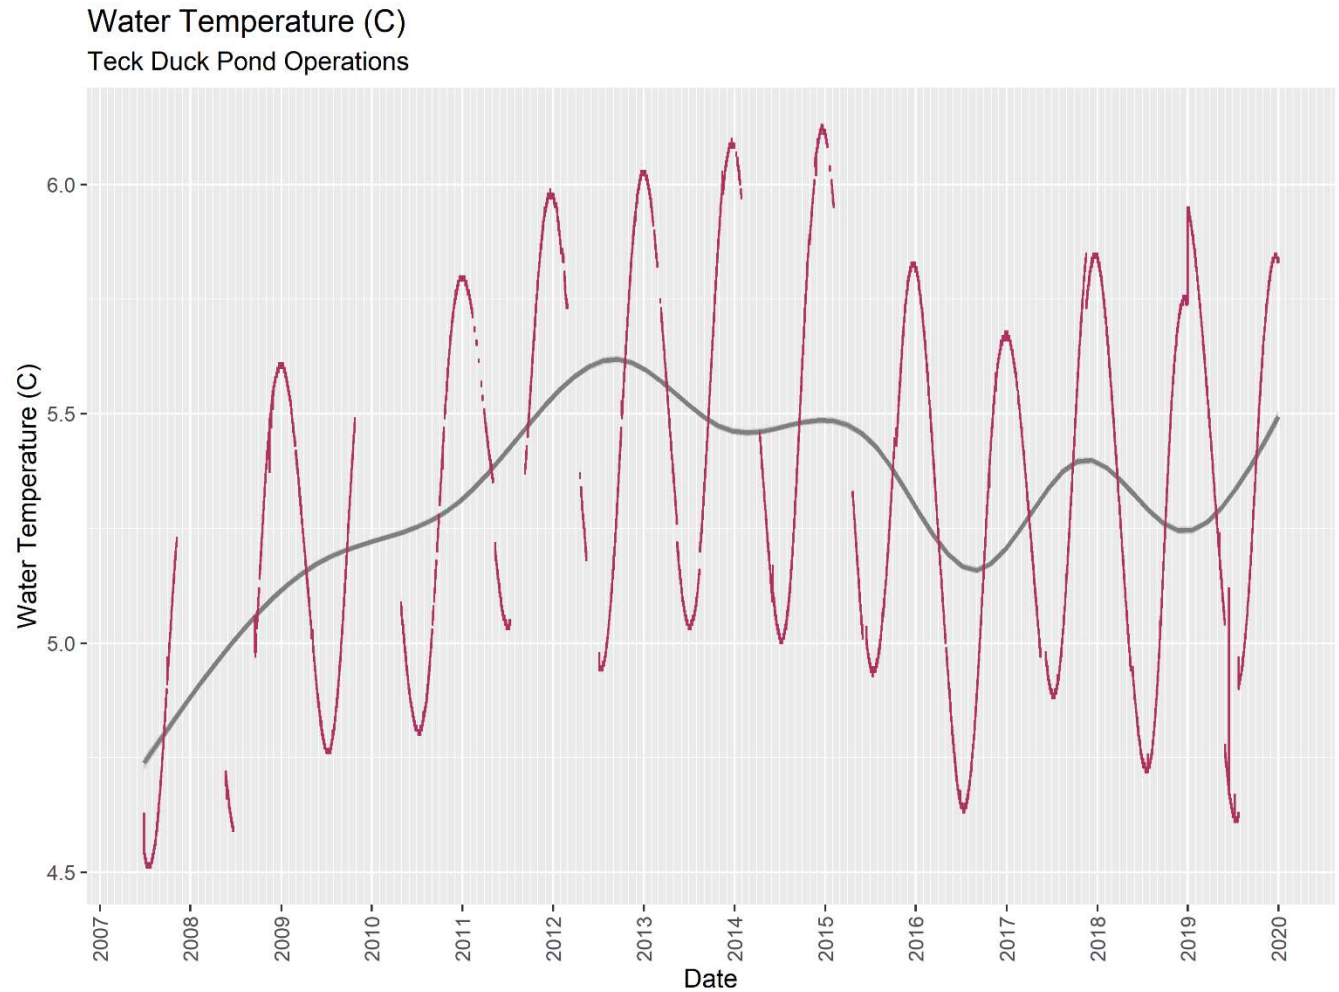
Figure 11 shows that annual low temperatures tend to occur in mid-July and annual high temperatures tend to occur in mid-December. The 2019 data followed this trend.

**Figure 11: Water temperature at Well after Tailings Dam, Teck DPO**

Interestingly, Figure 14 appears to mirror an opposite and inverse relationship with water temperature (Figure 11). In years where water temperature is cooler, pH levels tend to be more alkaline and when water is warmer, conditions appear to be more acidic. It is unclear if this is coincidental or if there is an actual relationship between the two parameters at this location.

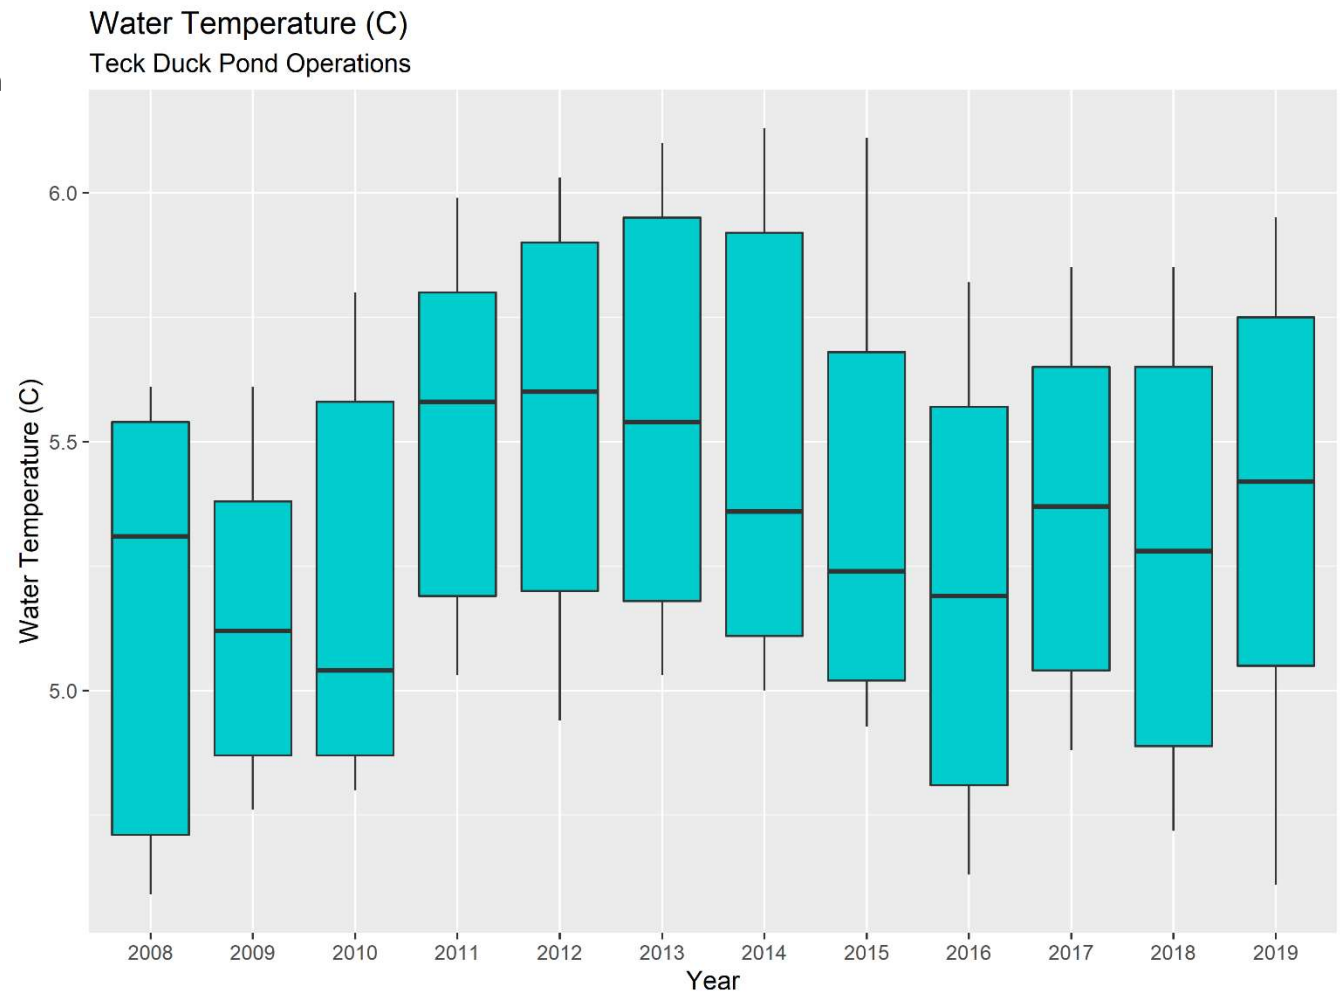
Figure 12 shows the consistency of water temperatures from 2008 to 2019 where there is considerable overlap in ranges from one year to the next. No notable trend is obvious at this time.

Figure 12: Boxplots of water temperature at Well after Tailings Dam, Teck DPO, from 2008 to 2019

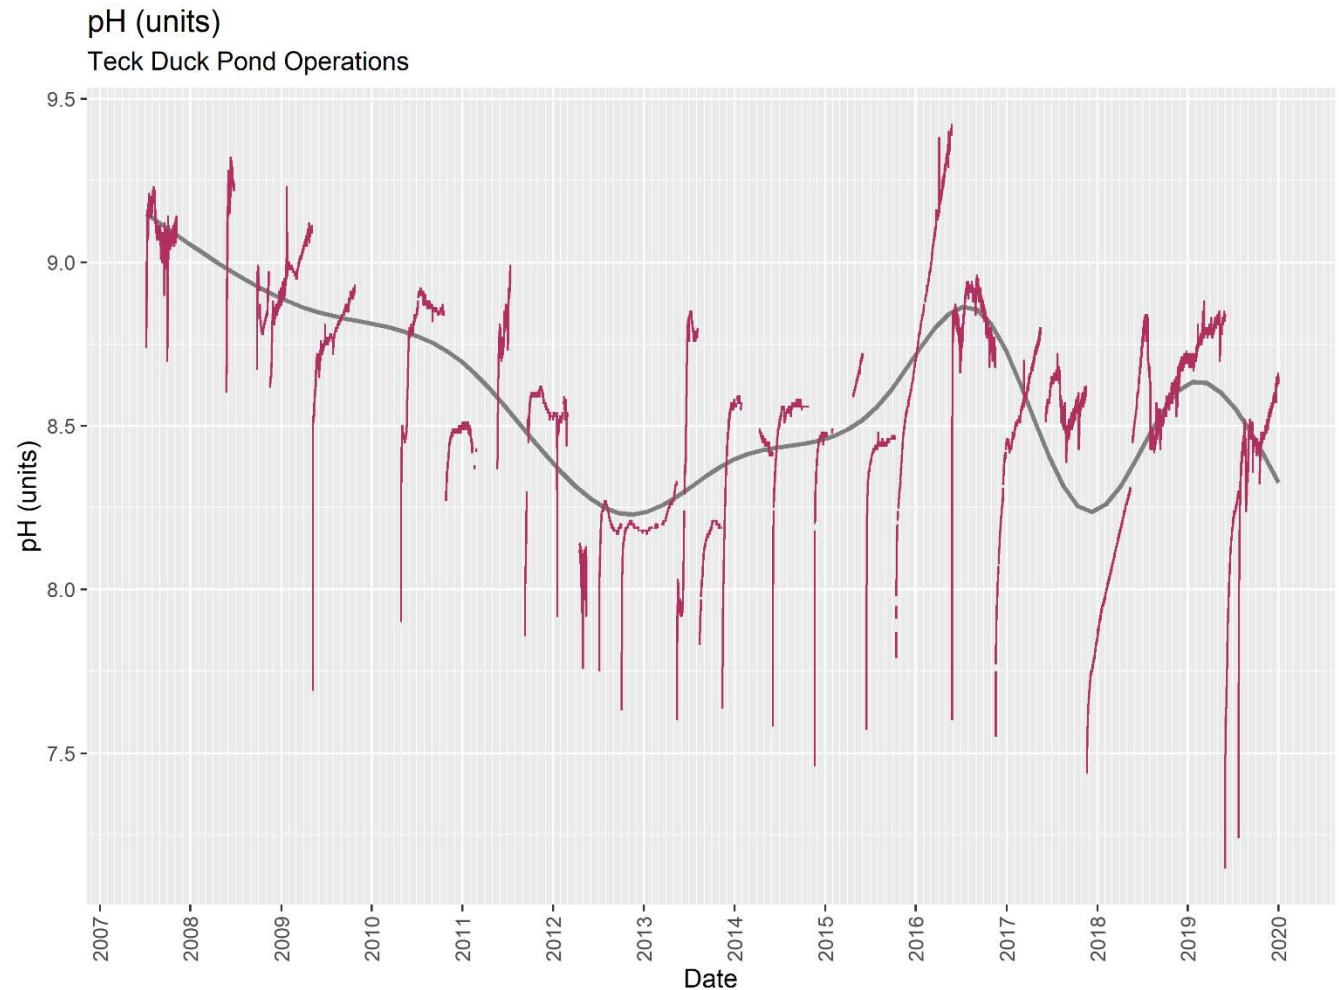
Readily apparent in Figure 13 is the long period of time it takes for pH to stabilize in the well following routine maintenance. This effect can be attributed to factors such as sensor stabilisation or chemical change resulting from aquifer water being pulled into the borehole. The rising trend can take upwards of a month to stabilize.

**Figure 13: pH at Well after Tailings Dam, Teck DPO**

The variance observed in Figure 13 makes it challenging to pick out trends or overall changes in pH. Figure 14 offers a clearer view of pH over time.

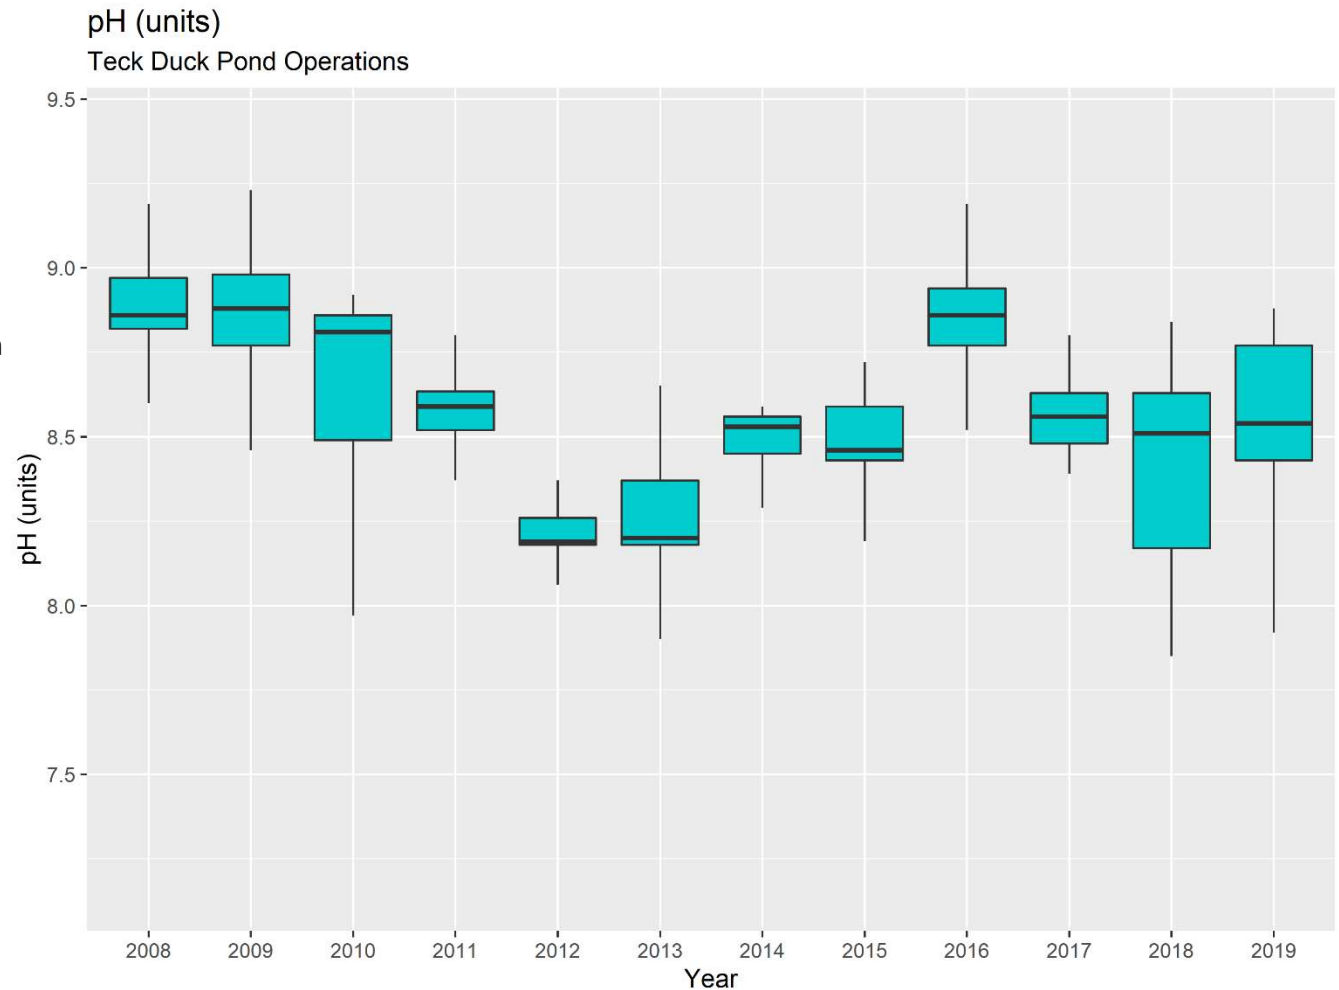
pH levels within the well tend to be alkaline in nature. Median levels over the past three years appear to be relatively stable, but have varying ranges.

Figure 14: Boxplots of pH at Well after Tailings Dam, Teck DPO, from 2008 to 2019

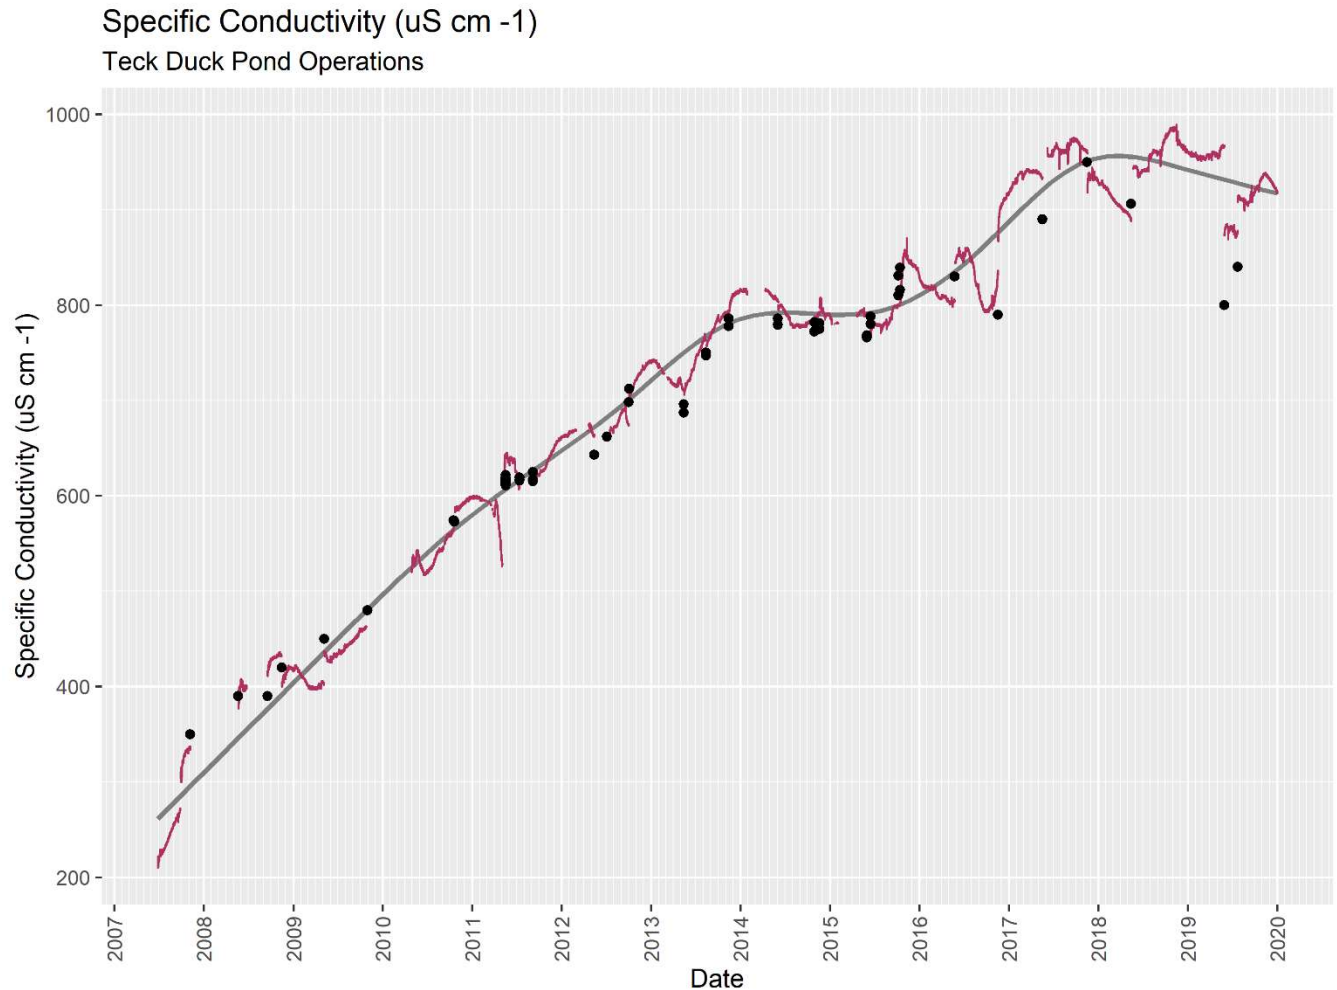
In 2019, specific conductivity values continued to rise above historical values, as seen in Table 9, though the later portion of the year showed a decline in levels compared to the previous three years (Figure 15).

A plateau phase from 2014 to late 2015 was observed prior to a rising trend from 2016 onwards. At this time, water level in the tailings management area was lowered to perform long-term stabilization work. A lower water level and deposition of materials may have resulted in the sudden increase in conductivity. However, levels have not declined significantly in 2019.

Figure 15: Specific Conductivity at Well after Tailings Dam, Teck DPO

In Figure 16, data from 2017-2019 show a distinct and separate data plateau from that seen from 2014 to 2016. Median values are significantly higher in 2017-2019. This may have resulted from work within the tailings management area as discussed in the previous Figure 15.
