# Real-Time Water Quality Deployment Report

## Teck Duck Pond Operations

2019

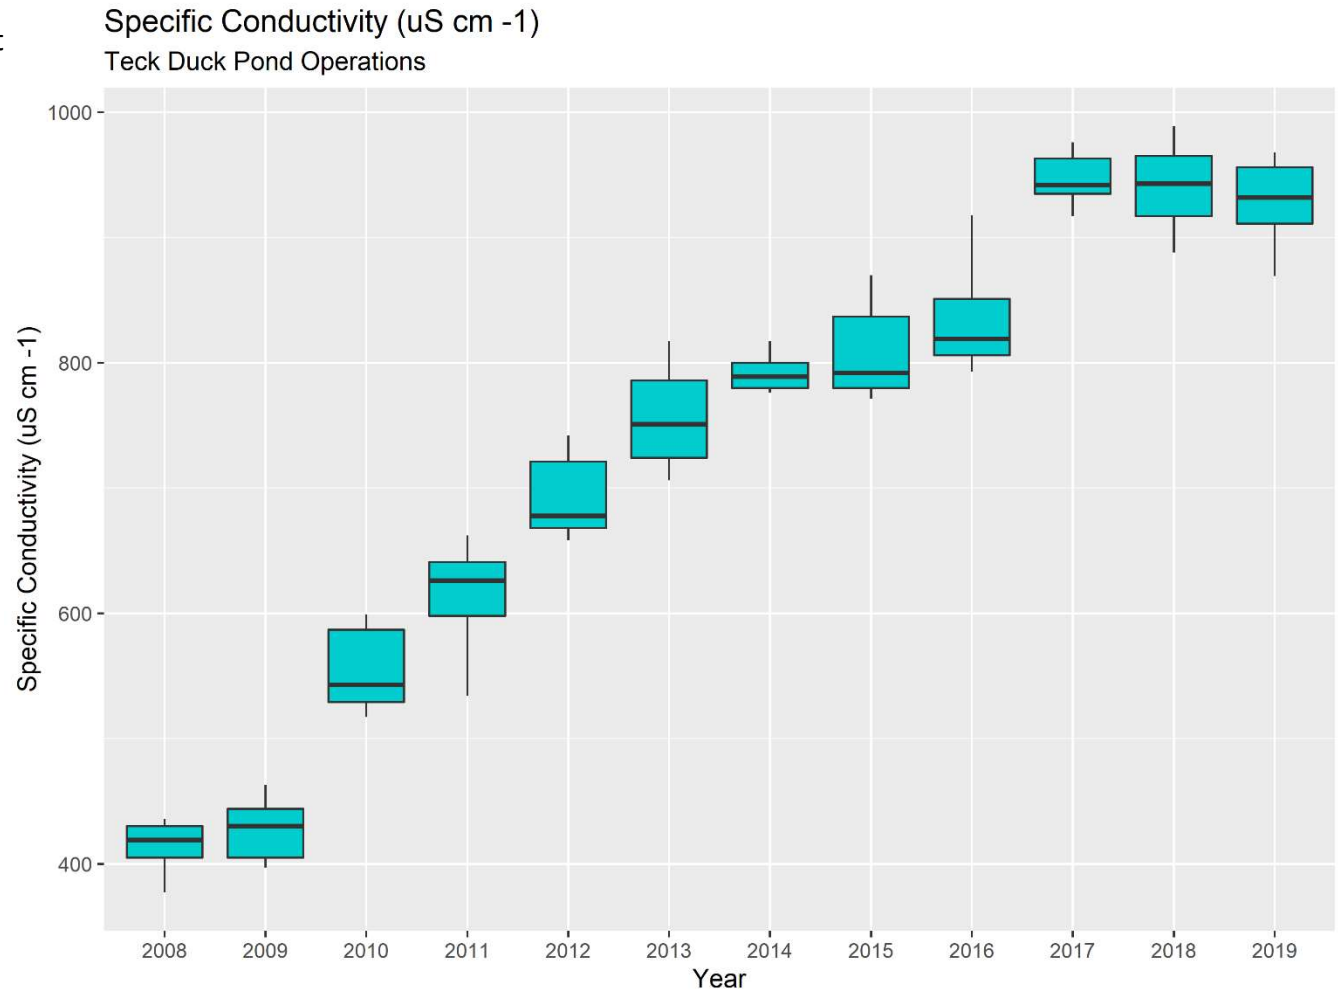
In Figure 16, data from 2017-2019 show a distinct and separate data plateau from that seen from 2014 to 2016. Median values are significantly higher in 2017-2019. This may have resulted from work within the tailings management area as discussed in the previous Figure 15.

Figure 16: Boxplots of specific conductivity at Well after Tailings Dam, Teck DPO , from 2008 to 2019

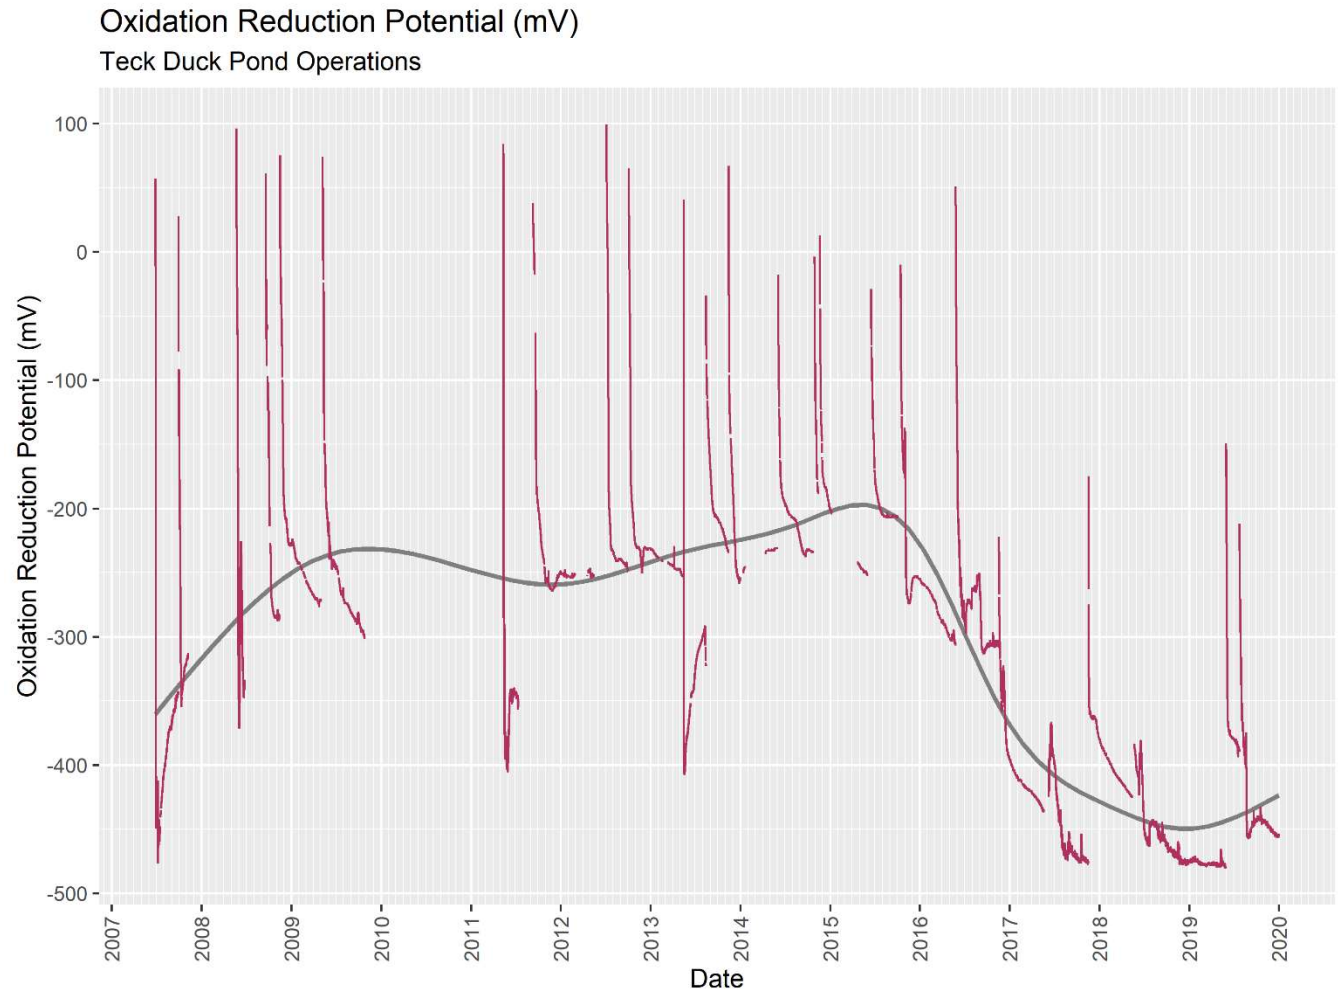
Much like pH, ORP tends to take a number of days to settle following routine maintenance as depicted in Figure 17. From 2007 to 2016, post-maintenance ORP values were found to be oxidative (> 0 mV) for a brief period before quickly falling to reductive levels (< 0 mV).

There is an indication that ORP values are becoming more reductive over time. From 2015 to 2019, stable ORP values began to fall lower and even post-maintenance ORP values were no longer oxidative.

Figure 17: ORP at Well after Tailings Dam, Teck DPO

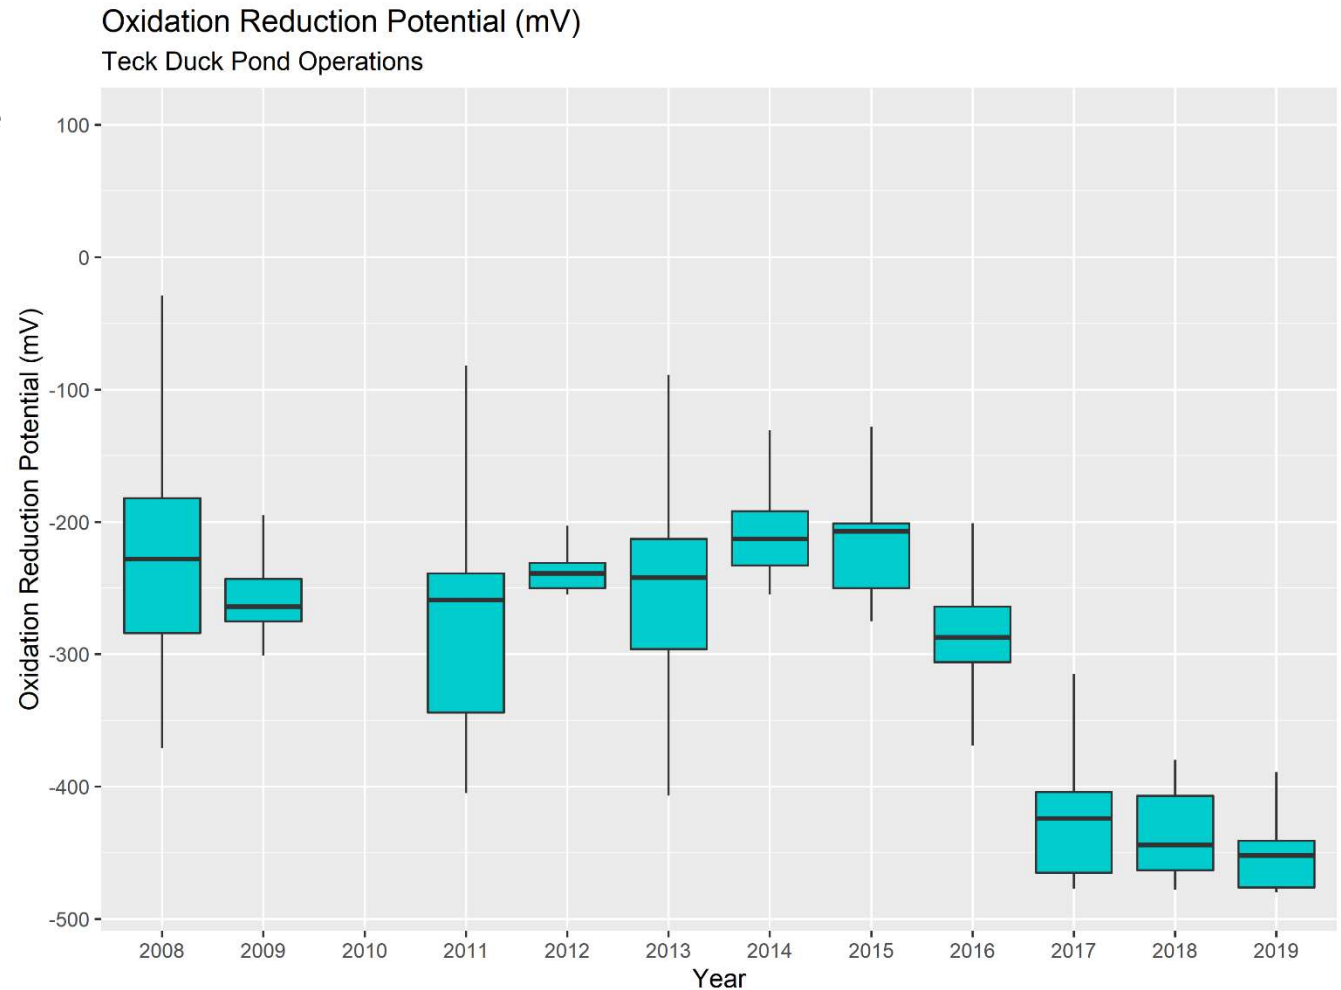
Figure 18 readily shows a continuous decline in ORP from 2016 and into 2019. This decline follows a period of plateau in specific conductivity and could be indicative of a particular chemical change in the aquifer.

Notably, the change from 2016 to 2017 was significant, and ORP continues to decrease annually from 2017-2019.

Figure 18: Boxplots of ORP at Well after Tailings Dam, Teck DPO, from 2008 to 2019

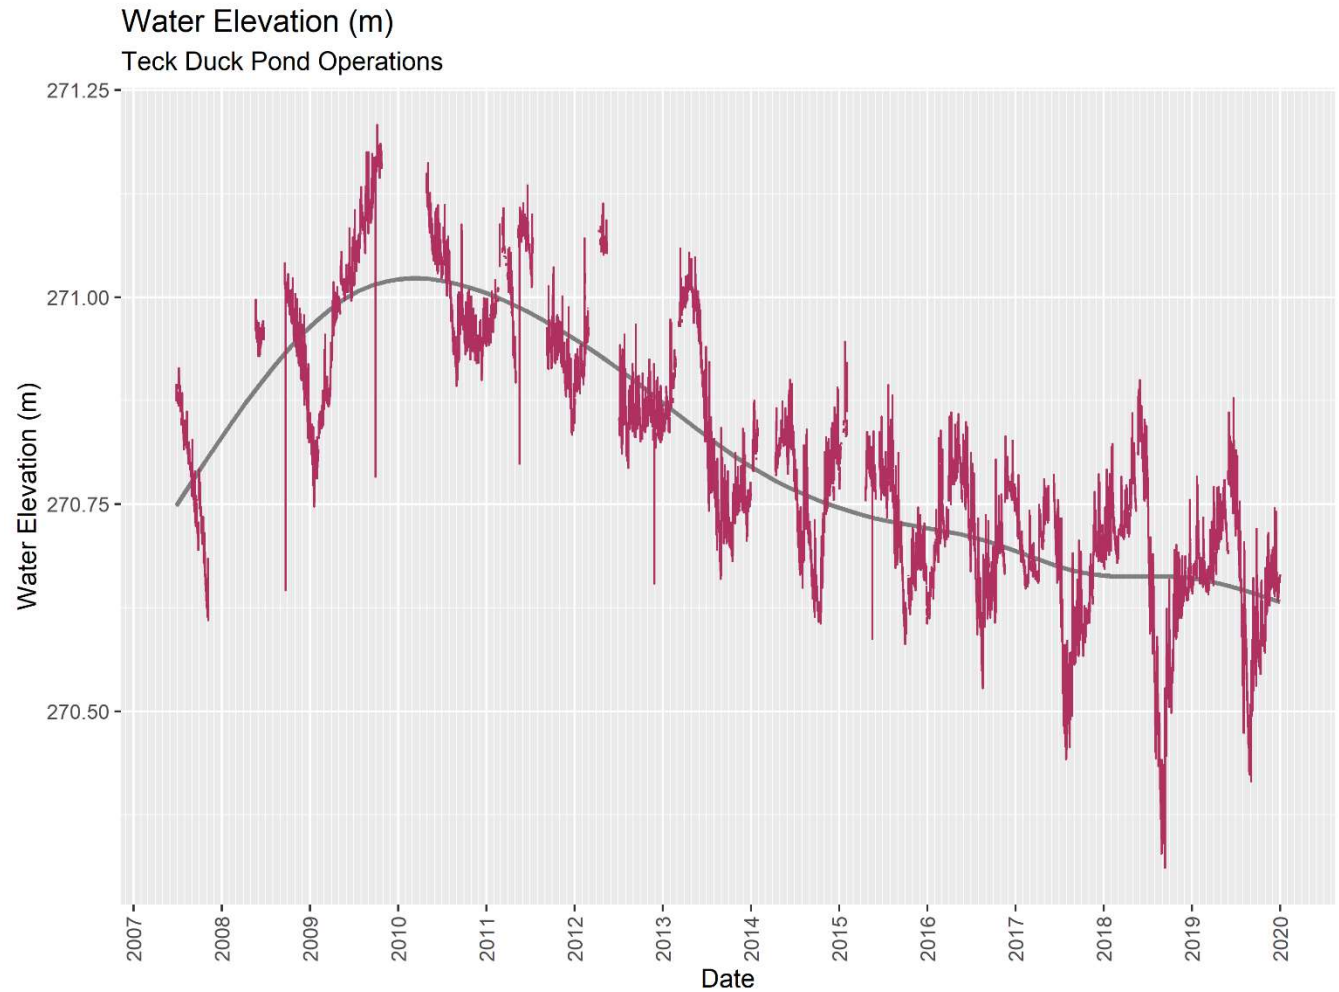
Water elevation indicates the surface of the aquifer above sea level. Water level peaked in 2009 and declined until 2017 when a small uptick was observed in the latter part of 2017 into mid-2018 (Figure 19) before continuing to decline once again.

In 2019, water level showed very little variance (0.463m).

**Figure 19: Water elevation at Well after Tailings Pond, Teck DPO**

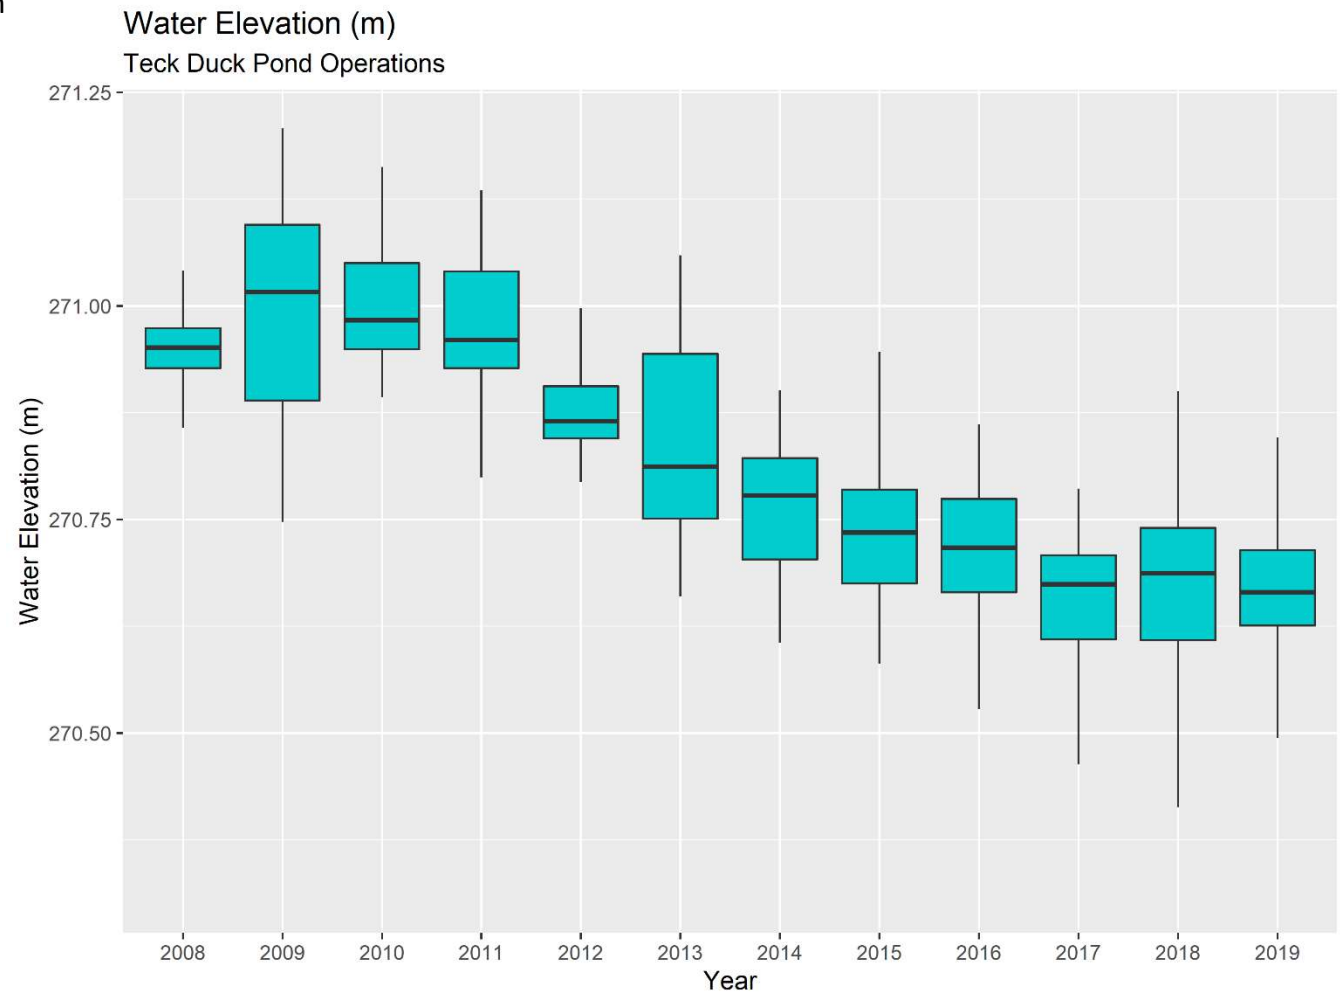
Figure 20 illustrates the long-term decline in water level from 2009 to 2017, the uptick observed in 2018, and the continued decline in 2019.

Figure 20: Boxplots of water elevation at Well after Tailings Pond, Teck DPO, from 2008 to 2019

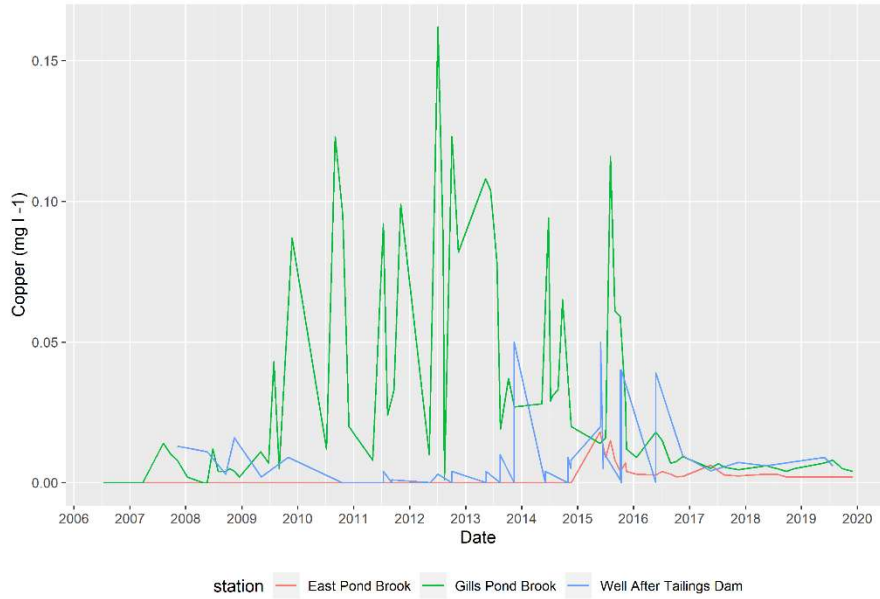
Grab samples of Copper (mg l<sup>-1</sup>)  
Teck Duck Pond Operations - Well after Tailings Dam A

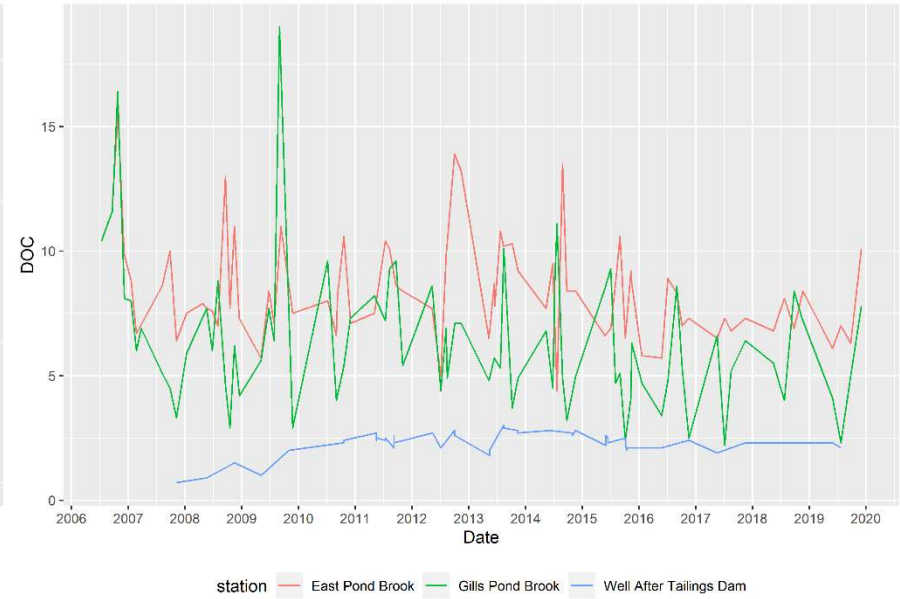
Grab samples of DOC  
Teck Duck Pond Operations - Well after Tailings Dam A

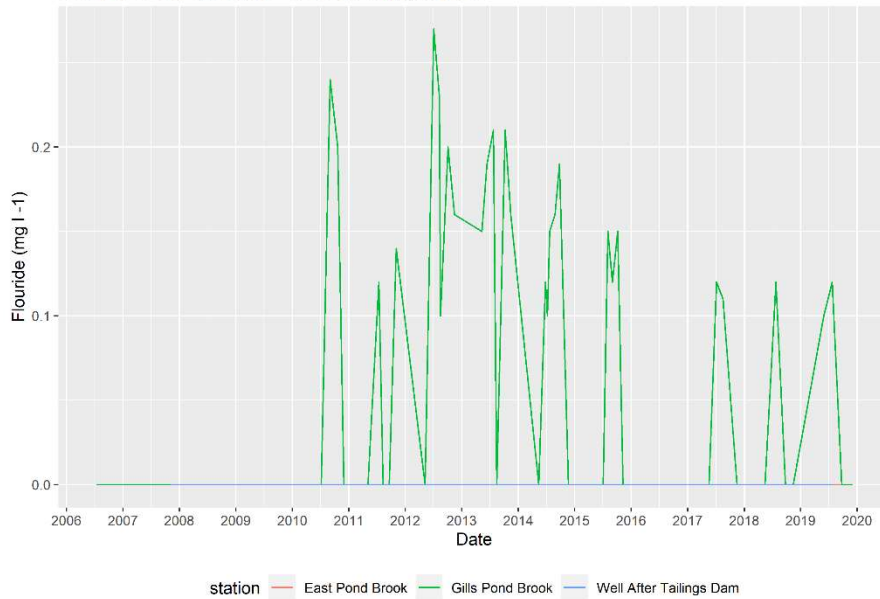
Grab samples of Flouride (mg l<sup>-1</sup>)  
Teck Duck Pond Operations - Well after Tailings Dam A

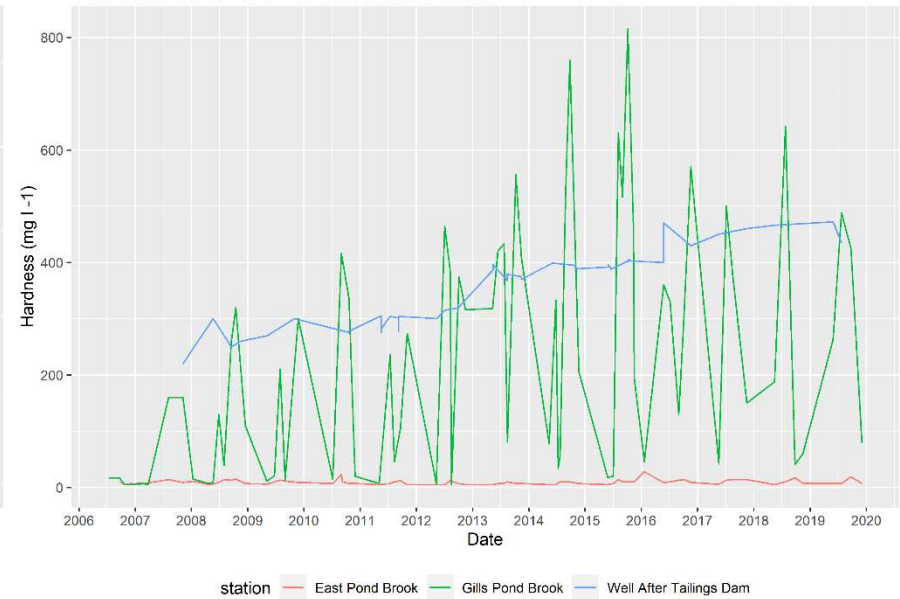
Grab samples of Hardness (mg l<sup>-1</sup>)  
Teck Duck Pond Operations - Well after Tailings Dam A

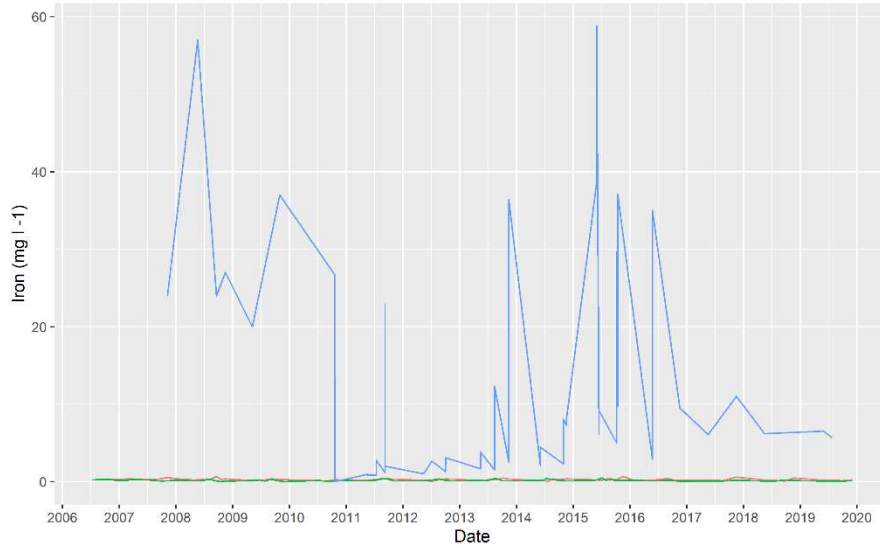
Grab samples of Iron (mg l<sup>-1</sup>)  
Teck Duck Pond Operations - Well after Tailings Dam A

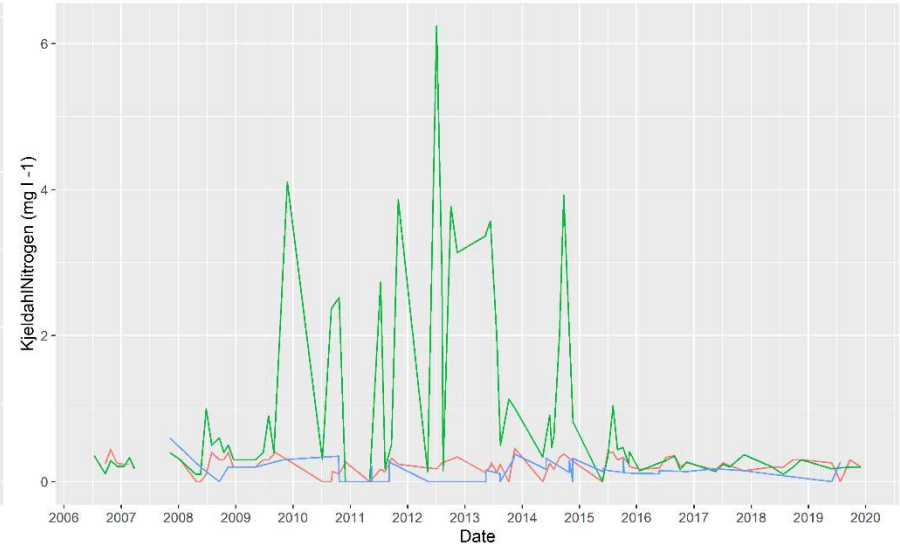
Grab samples of KjeldahlNitrogen (mg l<sup>-1</sup>)  
Teck Duck Pond Operations - Well after Tailings Dam A

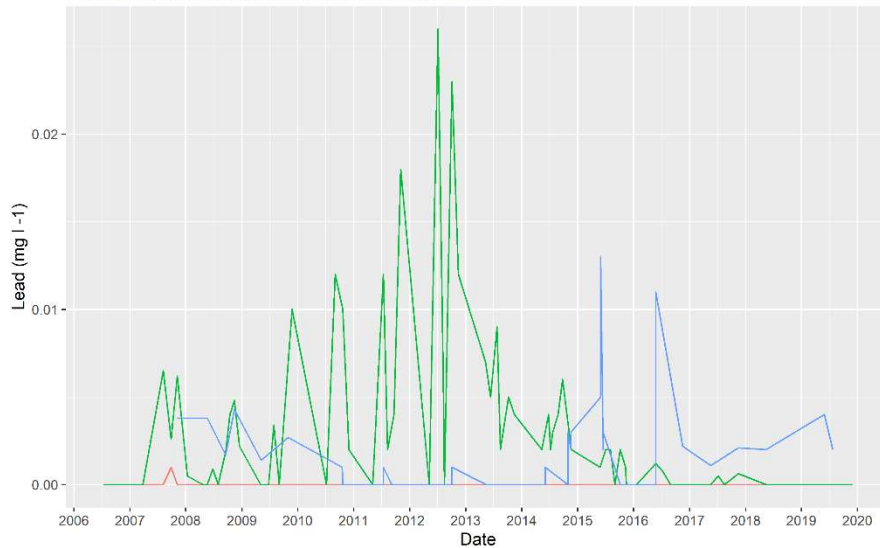
Grab samples of Lead (mg l<sup>-1</sup>)  
Teck Duck Pond Operations - Well after Tailings Dam A

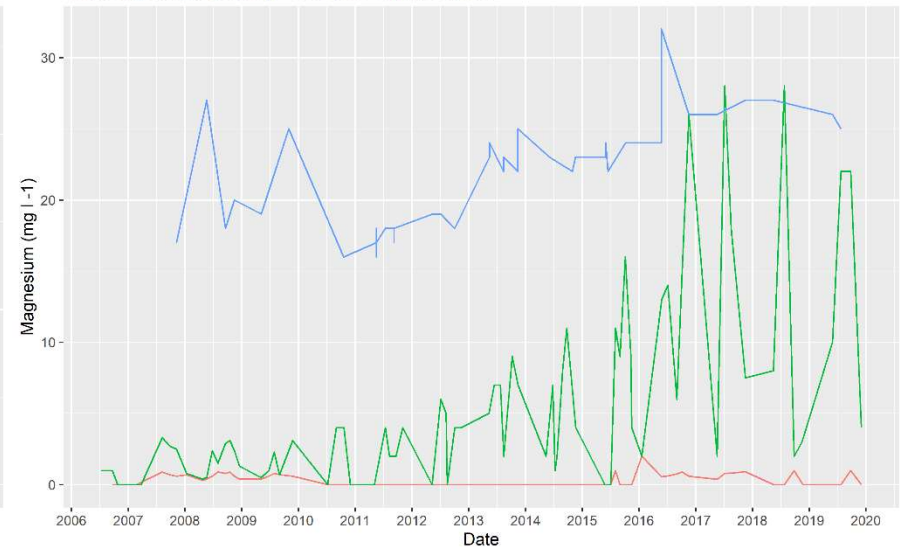
Grab samples of Magnesium (mg l<sup>-1</sup>)  
Teck Duck Pond Operations - Well after Tailings Dam A

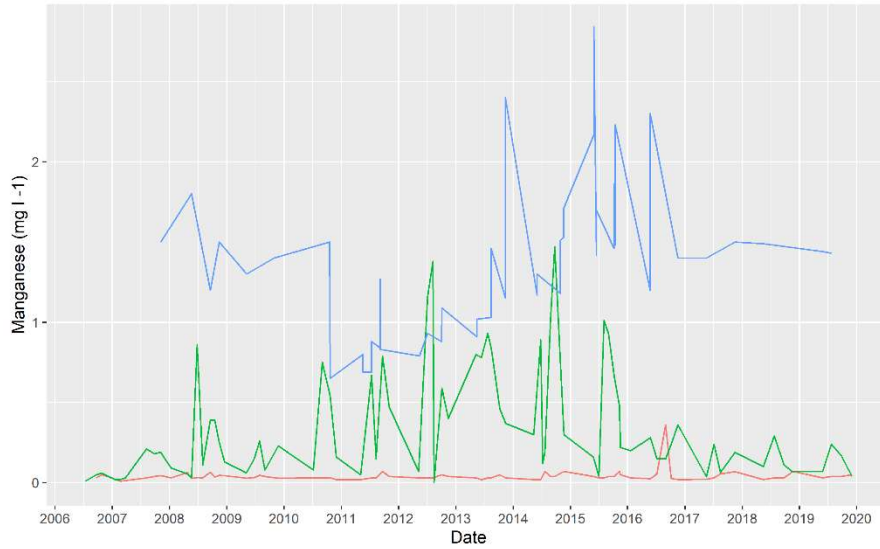
Grab samples of Manganese (mg l<sup>-1</sup>)

Teck Duck Pond Operations - Well after Tailings Dam A

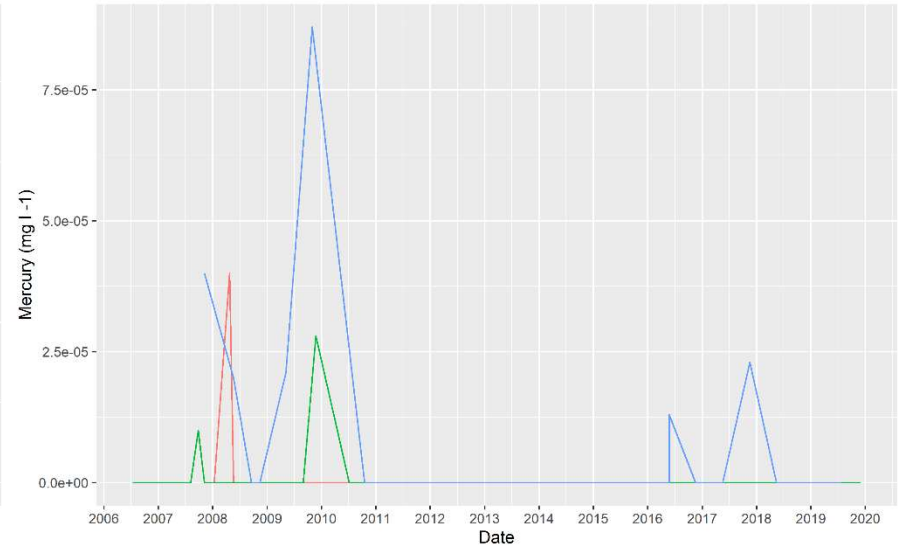
Grab samples of Mercury (mg l<sup>-1</sup>)

Teck Duck Pond Operations - Well after Tailings Dam A

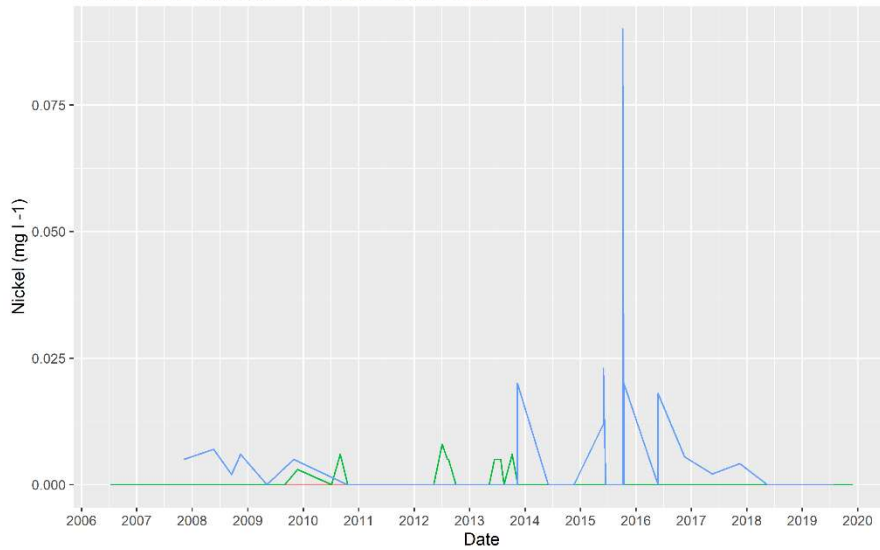
Grab samples of Nickel (mg l<sup>-1</sup>)

Teck Duck Pond Operations - Well after Tailings Dam A

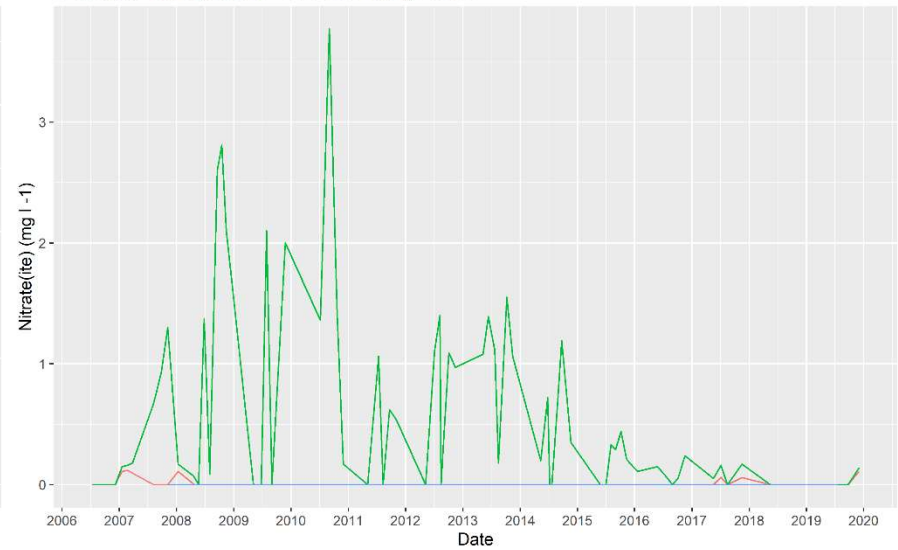
Grab samples of Nitrate(ite) (mg l<sup>-1</sup>)

Teck Duck Pond Operations - Well after Tailings Dam A

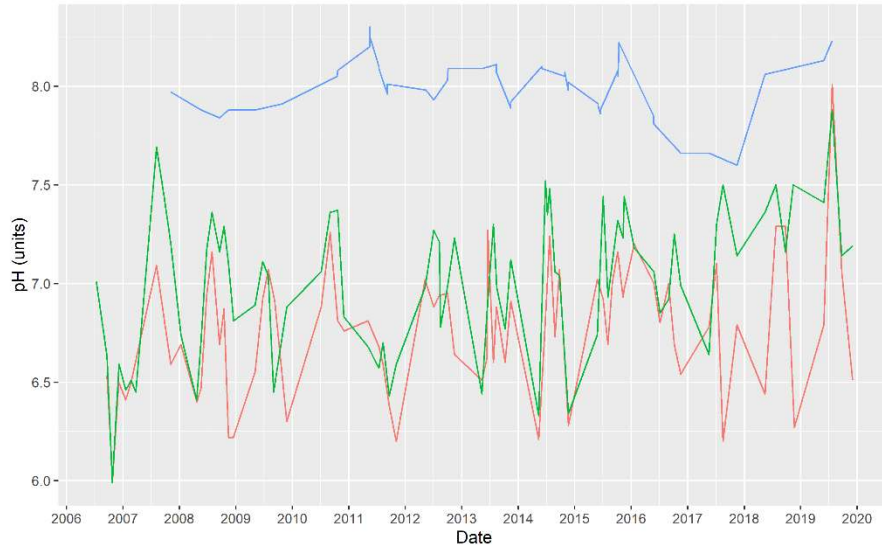
Grab samples of pH (units)  
Teck Duck Pond Operations - Well after Tailings Dam A

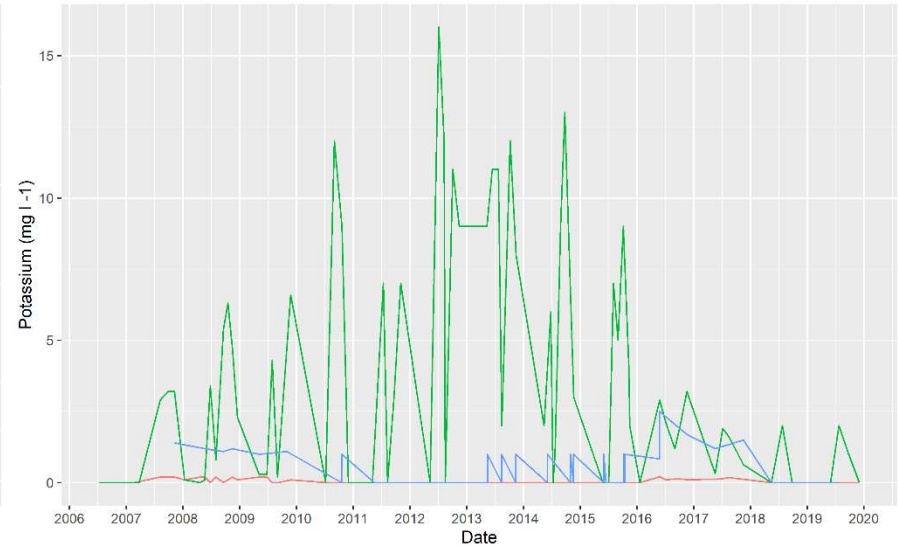
Grab samples of Potassium (mg l<sup>-1</sup>)  
Teck Duck Pond Operations - Well after Tailings Dam A

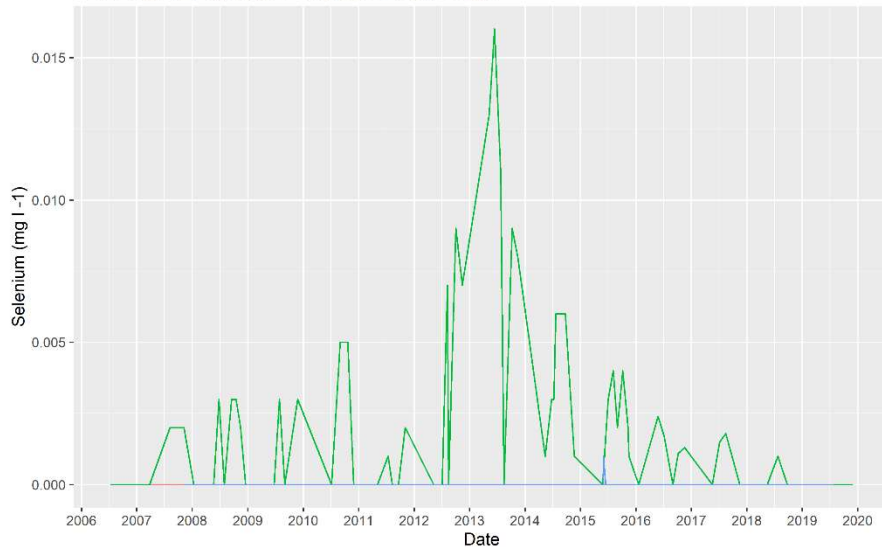
Grab samples of Selenium (mg l<sup>-1</sup>)  
Teck Duck Pond Operations - Well after Tailings Dam A

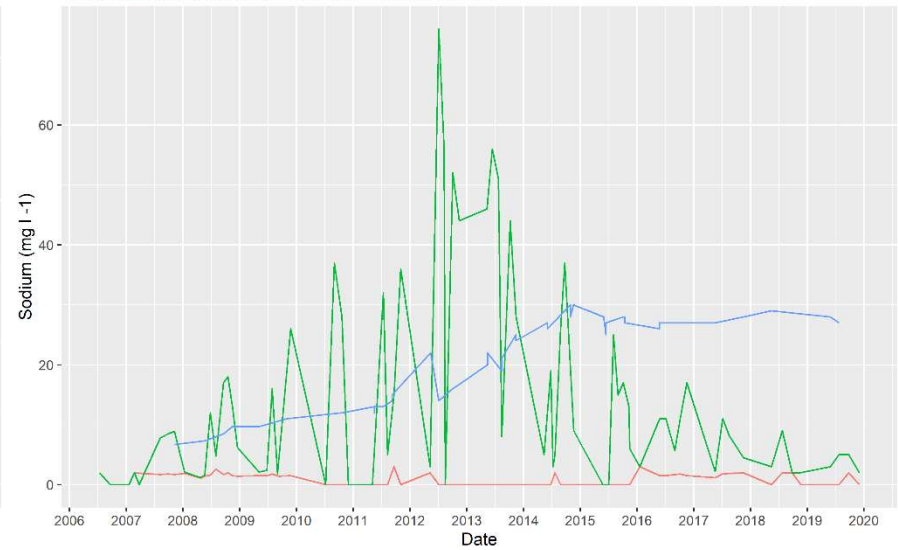
Grab samples of Sodium (mg l<sup>-1</sup>)  
Teck Duck Pond Operations - Well after Tailings Dam A

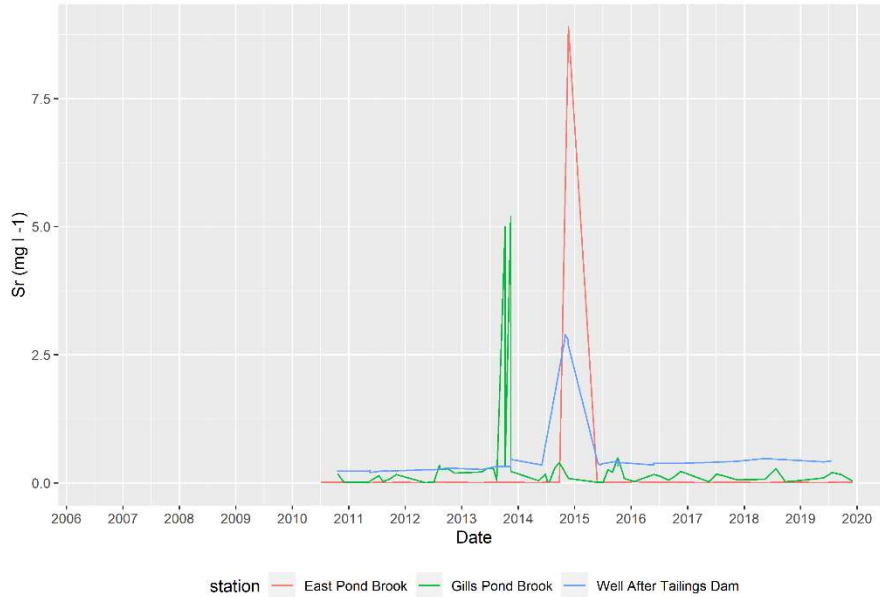
Grab samples of Sr (mg l<sup>-1</sup>)  
Teck Duck Pond Operations - Well after Tailings Dam A

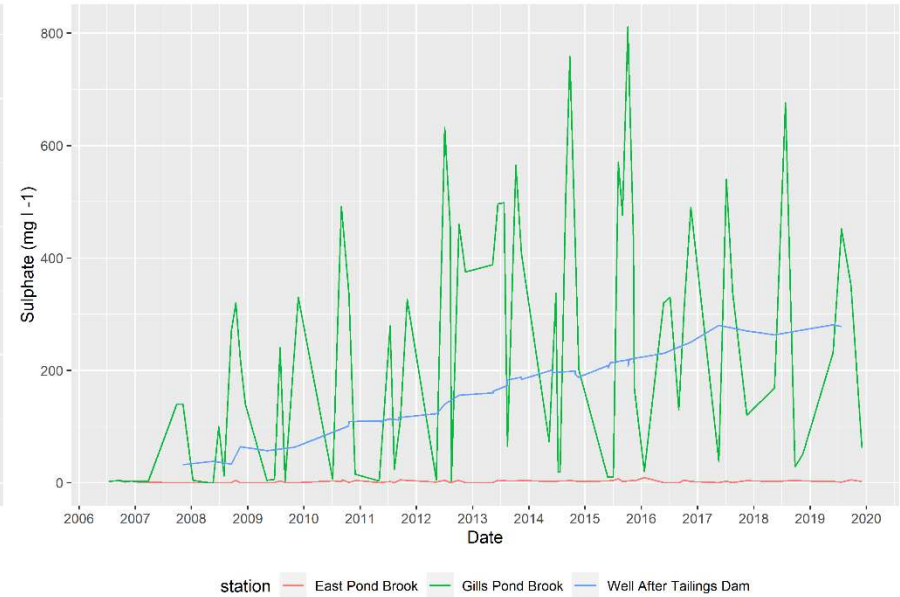
Grab samples of Sulphate (mg l<sup>-1</sup>)  
Teck Duck Pond Operations - Well after Tailings Dam A

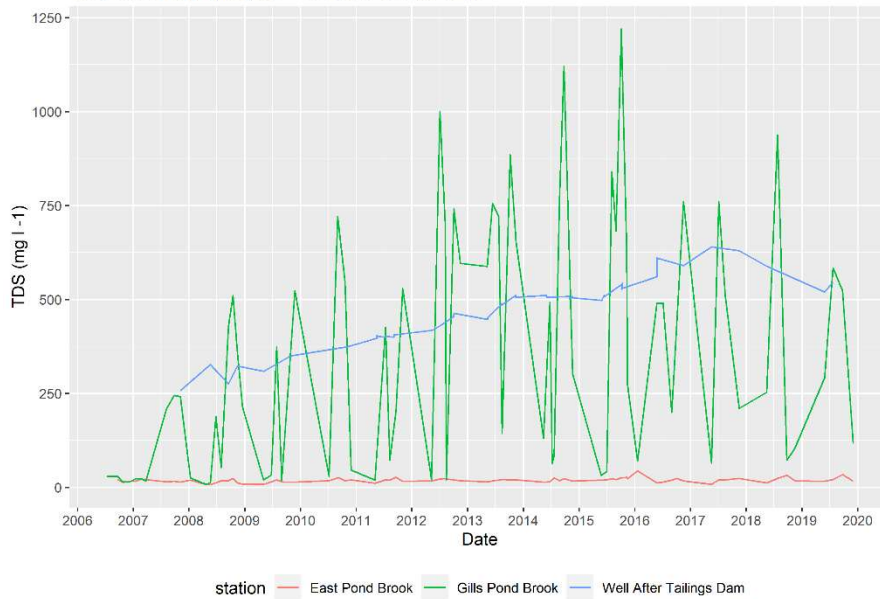
Grab samples of TDS (mg l<sup>-1</sup>)  
Teck Duck Pond Operations - Well after Tailings Dam A

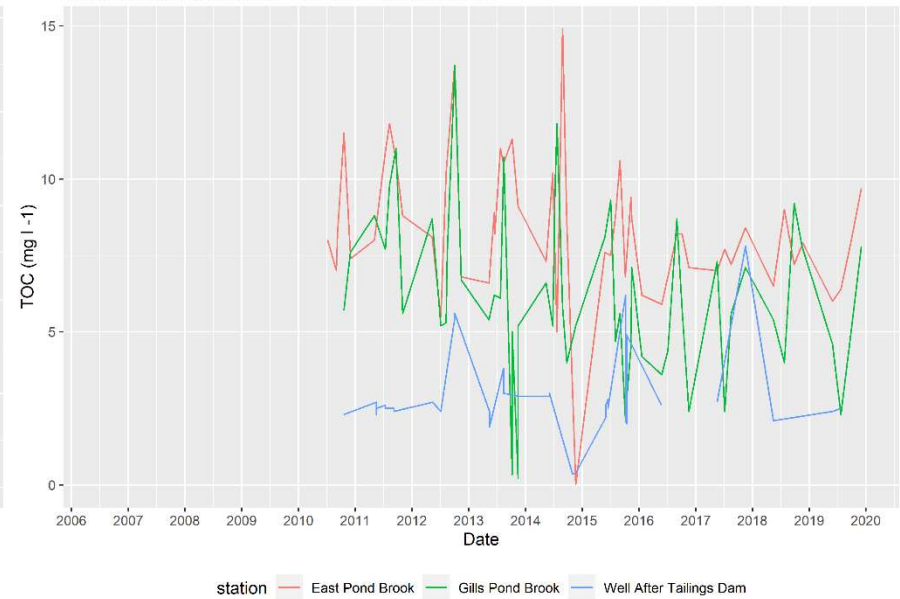
Grab samples of TOC (mg l<sup>-1</sup>)  
Teck Duck Pond Operations - Well after Tailings Dam A

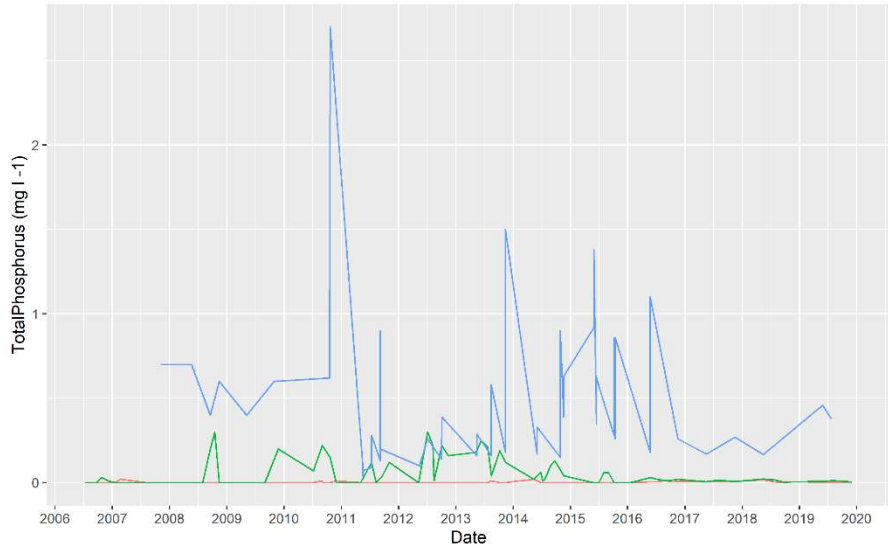
Grab samples of TotalPhosphorus (mg l<sup>-1</sup>)  
Teck Duck Pond Operations - Well after Tailings Dam A

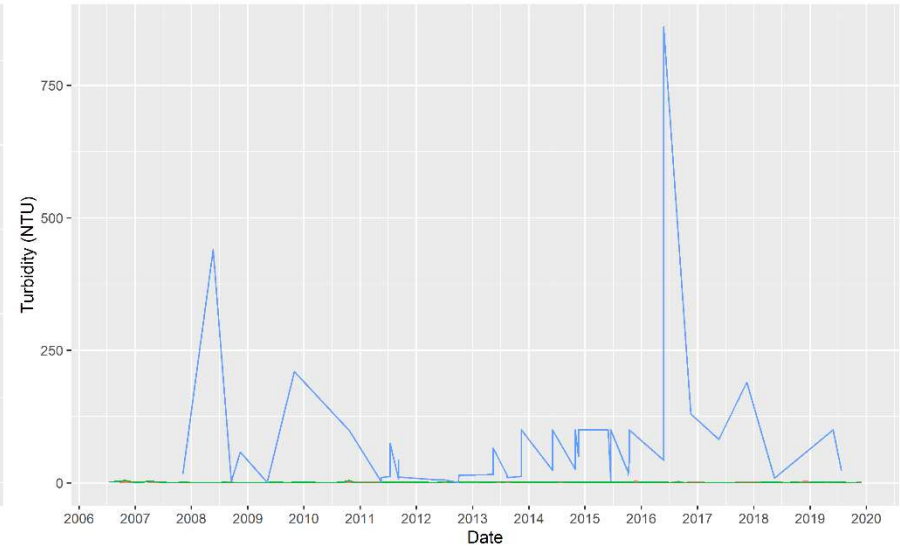
Grab samples of Turbidity (NTU)  
Teck Duck Pond Operations - Well after Tailings Dam A

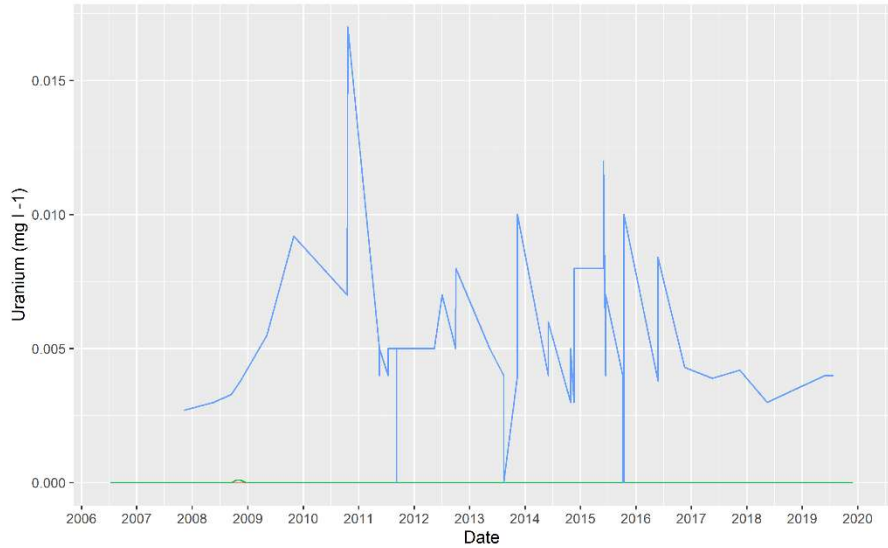
Grab samples of Uranium (mg l<sup>-1</sup>)  
Teck Duck Pond Operations - Well after Tailings Dam A

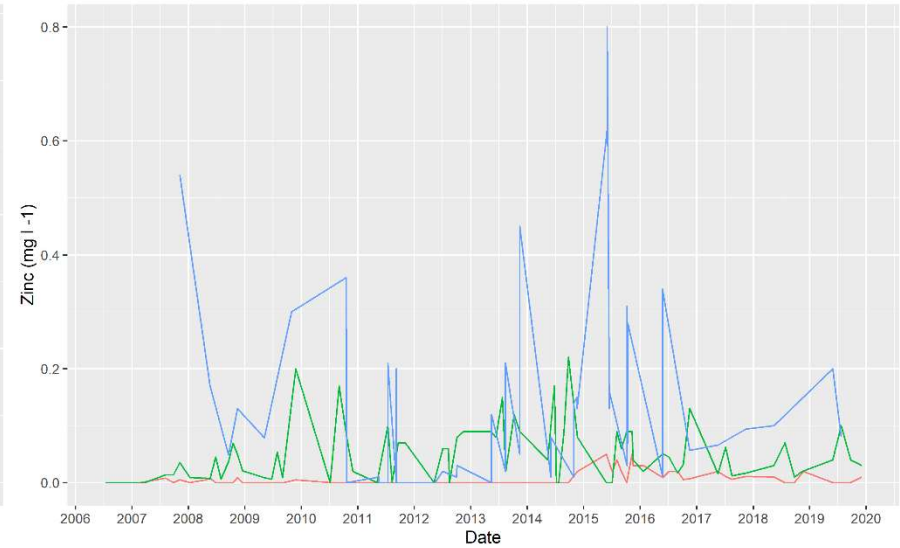
Grab samples of Zinc (mg l<sup>-1</sup>)  
Teck Duck Pond Operations - Well after Tailings Dam A
