Real-Time Water Quality Deployment Report

Teck Duck Pond Operations

2021

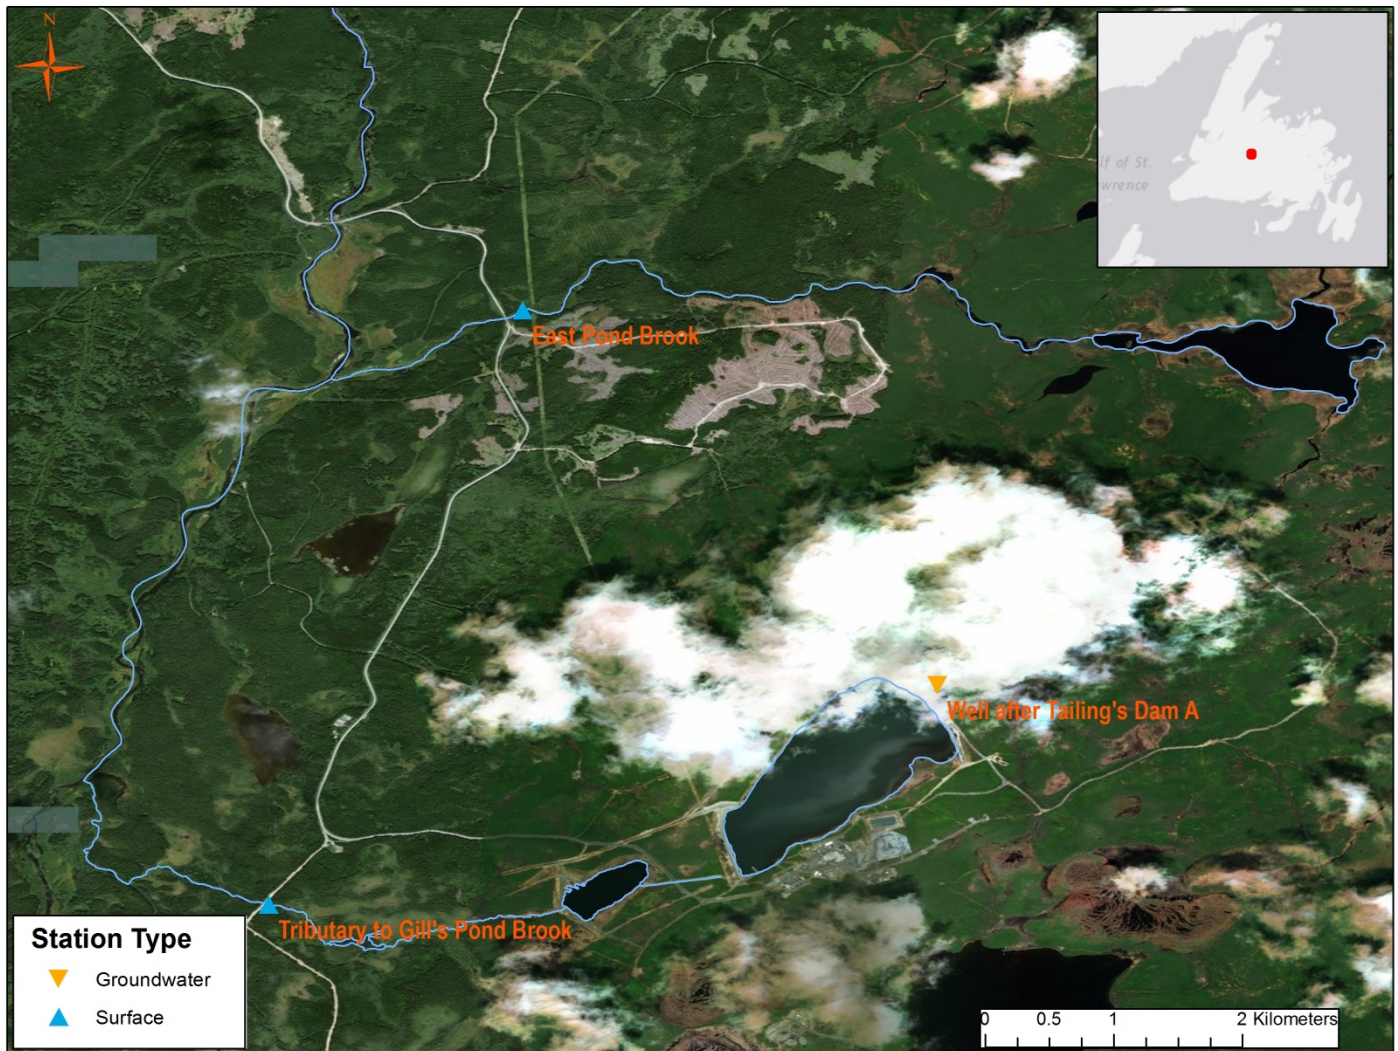
Photo 1: Aerial photo of Teck DPO project site and water quality stations

These stations, identified in Photo 1, were situated to observe water quality at key locations over the course of the Teck DPO project. EPB station was placed to intercept potential seepage from underneath flow control

structures that maintain the tailings management area. TGPB is placed to observe water quality following the ultimate discharge of treated effluent from the polishing pond into the environment. Well after Tailings Dam A is also located in the East Pond Brook watershed, but is immediately adjacent to the flow control structure that ensures the tailings management area drains towards the polishing pond and the eventual discharge point above TGPB station.

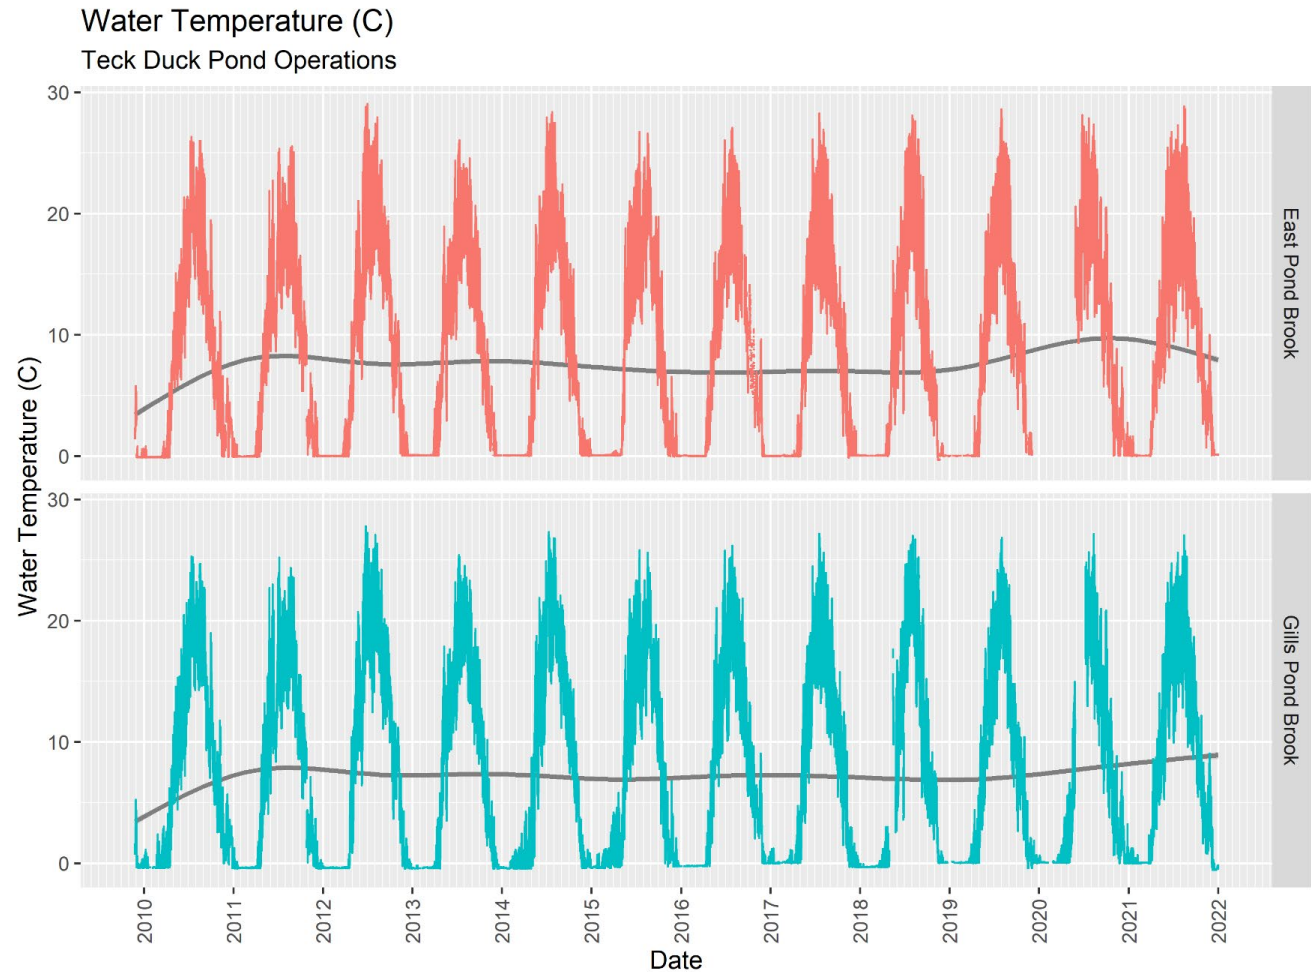
Figure 1: Water Temperature at Teck DPO

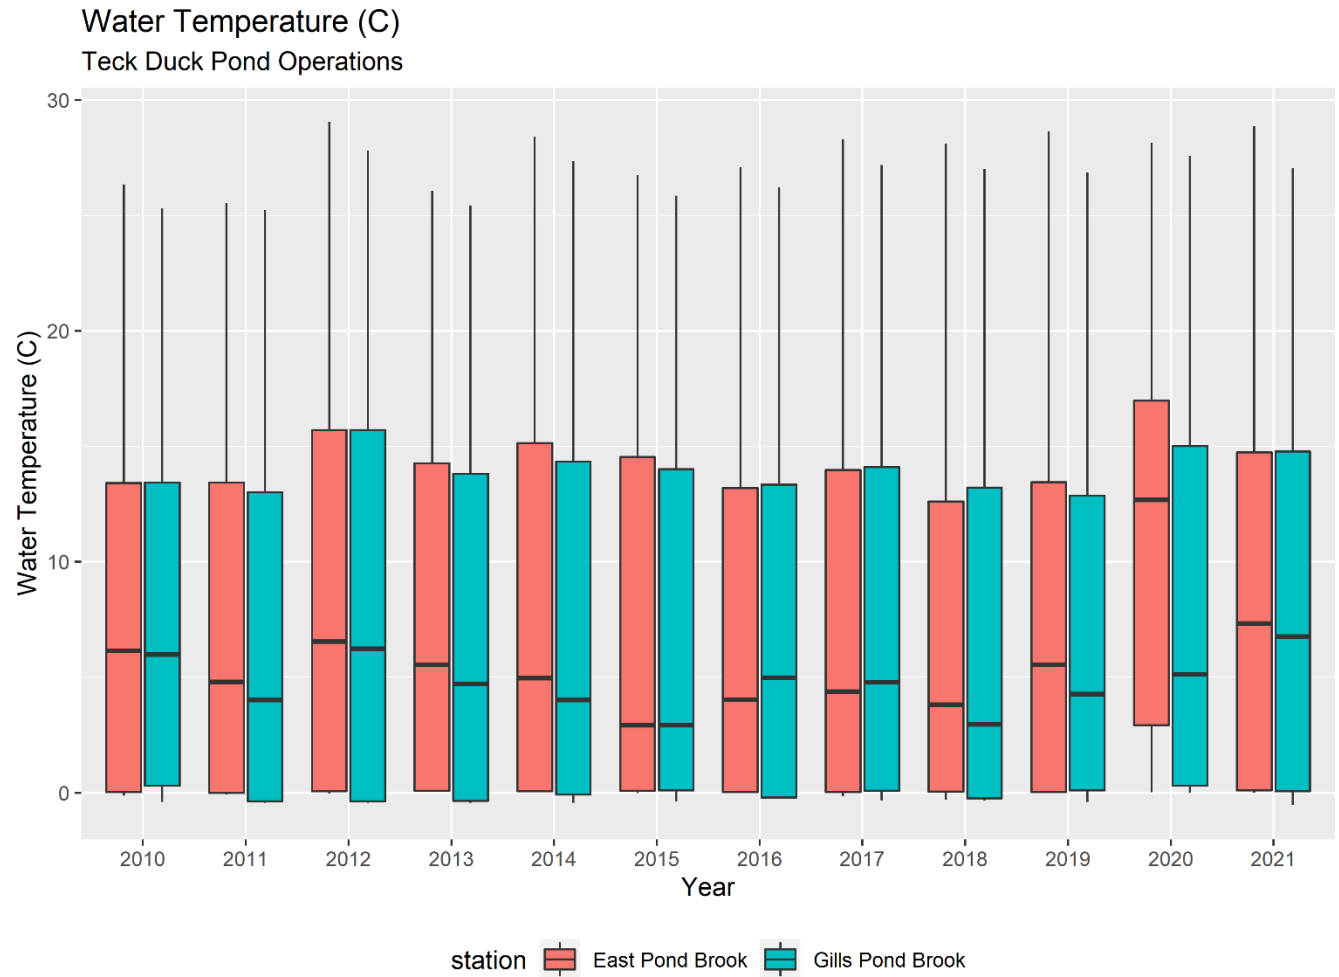
Figure 2 shows the range in water temperatures at EPB and TGPB stations since 2010. In that time span, at TGPB, 2021 was on par with 2020 but warmer than previous years. EPB was cooler than 2020 due to skewed 2020 data (missing winter values), but warmer than the previous few years.

Data from EPB and TGPB from 2021 were very similar to each other.

Figure 2: Boxplots of water temperature at Teck DPO

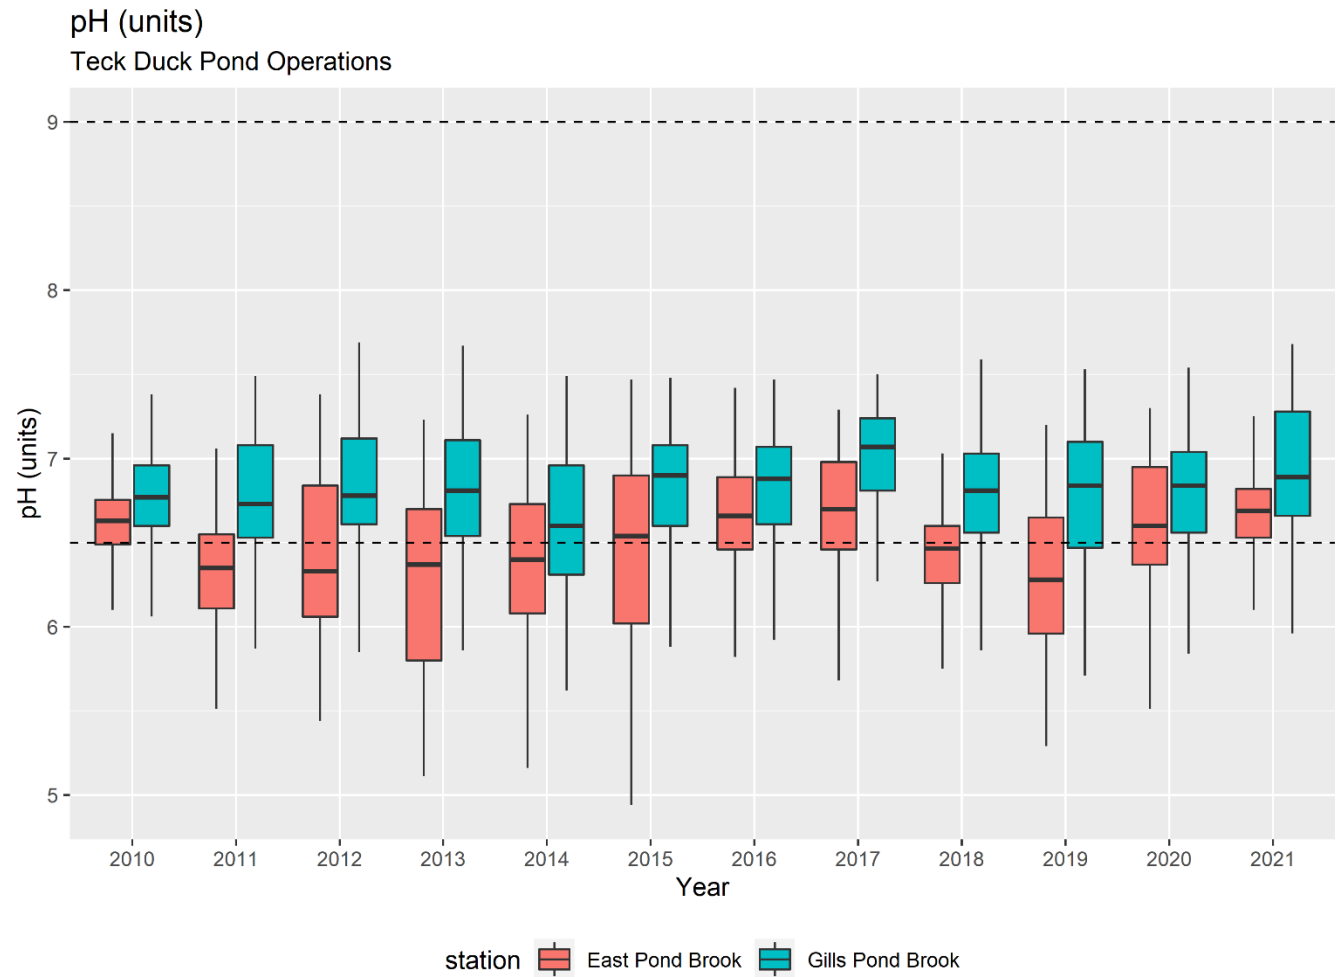
pH values at EPB 2021 were somewhat higher than those observed 2018-2020. 2021 TGPB data was on par with 2018-2020 data, as seen in Figure 4. Median annual pH values at EPB reached a historical low in 2019, but have continually risen since then, while TGPB has been relatively stable during the same timeframe.

Figure 4: Boxplots of pH at Teck DPO

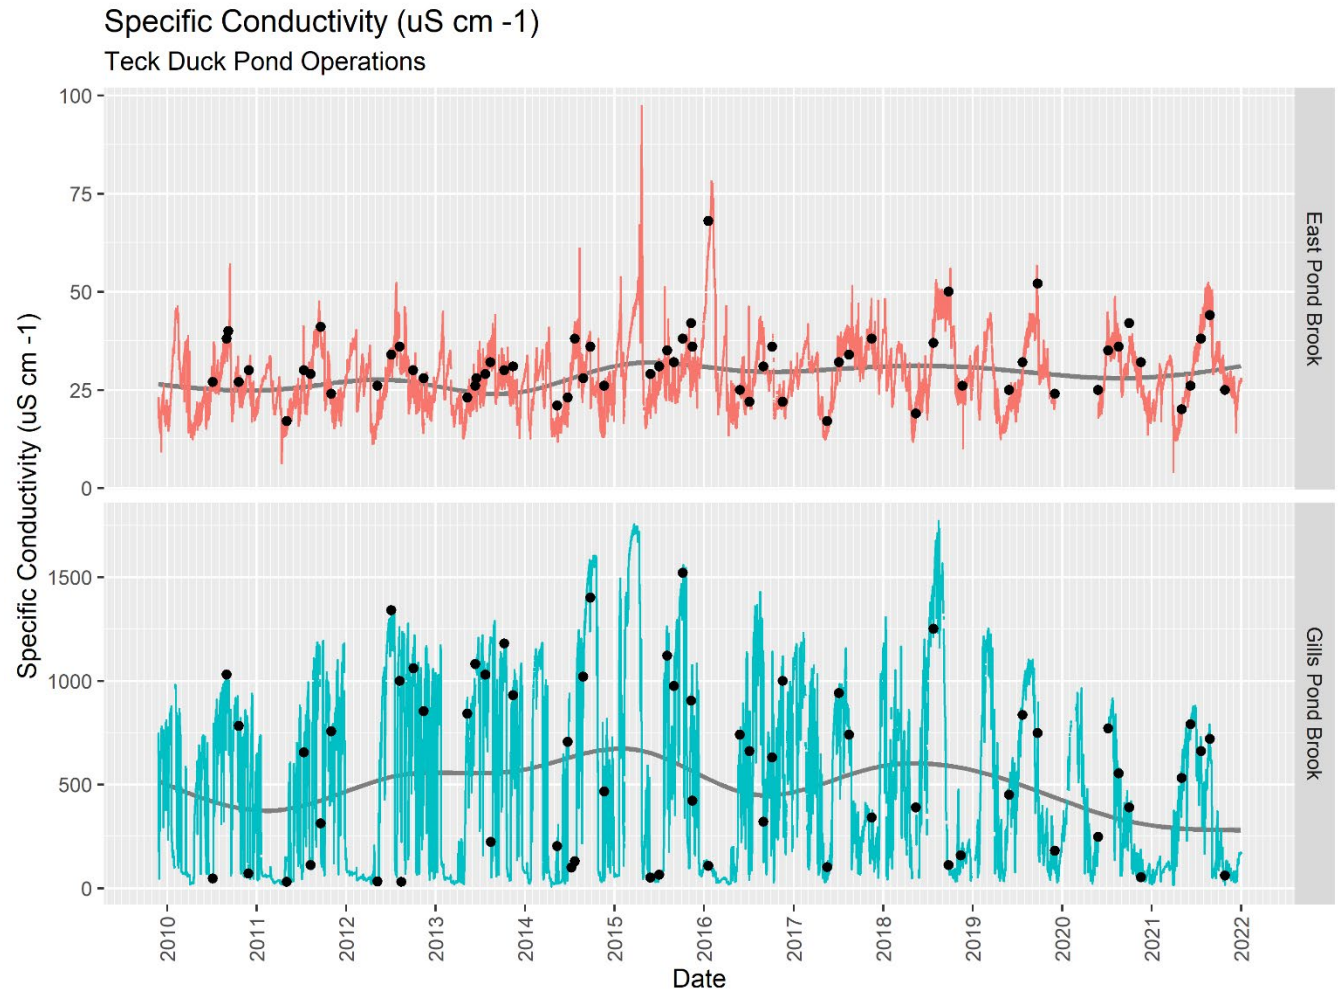
A slow and long term rising trend in conductivity previously observed in East Pond Brook data is evident in 2021 data, although it was not in the 2020 data, as shown by the trend line in Figure 5. The driving force behind this increase may be related to a number of factors such as atmospheric deposition of dust from industrial activity in the area, soil disturbance from nearby logging activities, or movement of dissolved solid-laden groundwater from the tailings management area higher in the watershed.

Figure 5: Specific Conductivity at Teck DPO

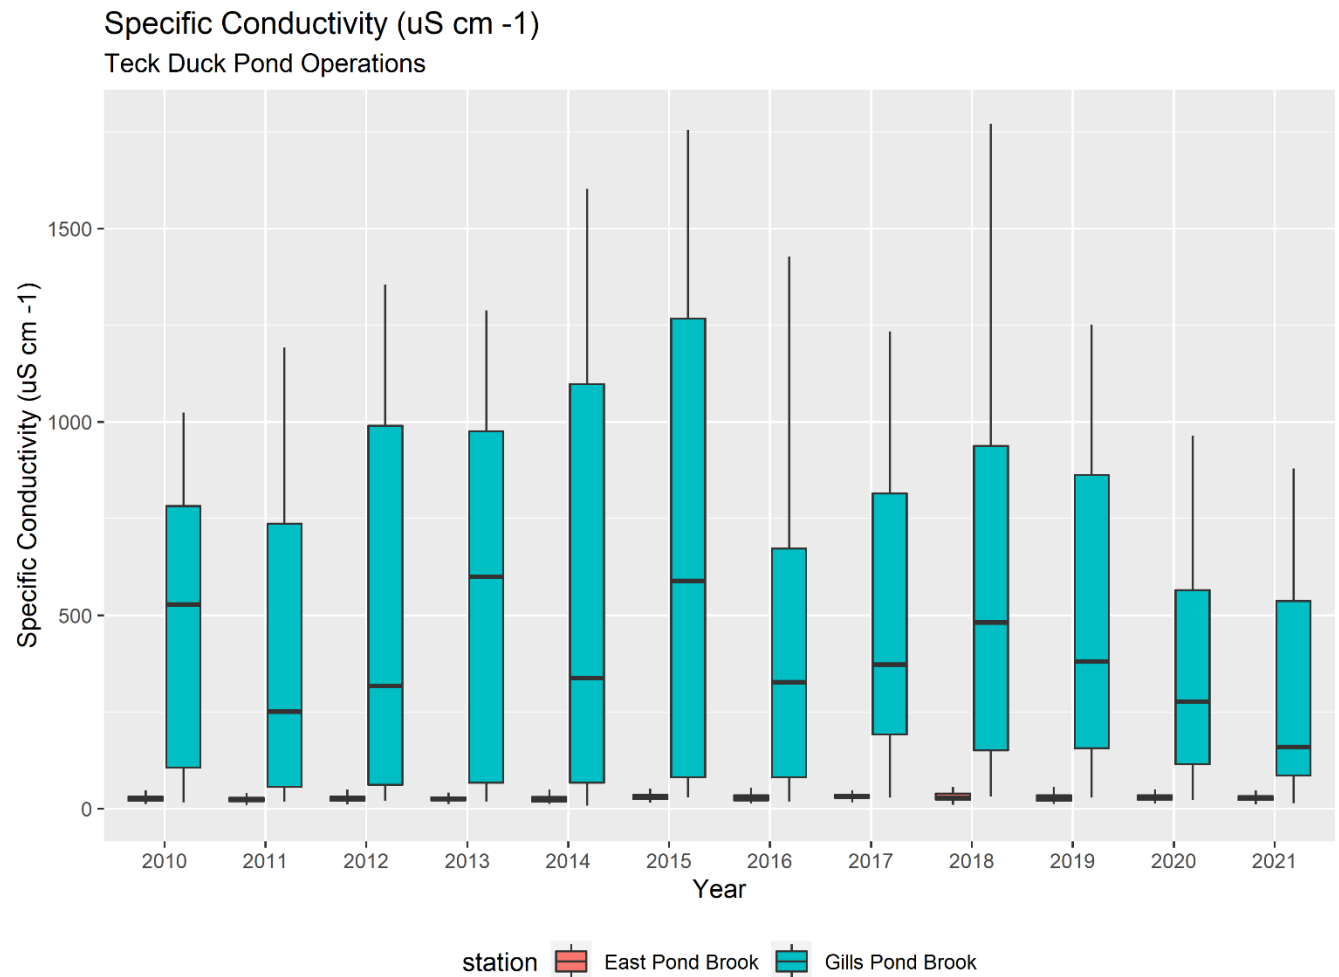
The influence of polishing pond effluent on water quality in Gill's Pond Brook over time is evident in Figure 6. Without polishing pond effluent, specific conductivity levels at EPB and TGPB stations would report values similar to one another. Specific conductivity at TGPB station, however, is substantially higher than EPB station which barely registers on the plot to the right.

Figure 6 also clearly shows how the gap between TGPB and EPB conductivity levels has decreased steadily as the mine proceeds through its operational and now decommissioning phases.

Figure 6: Boxplots of specific conductivity at Teck DPO

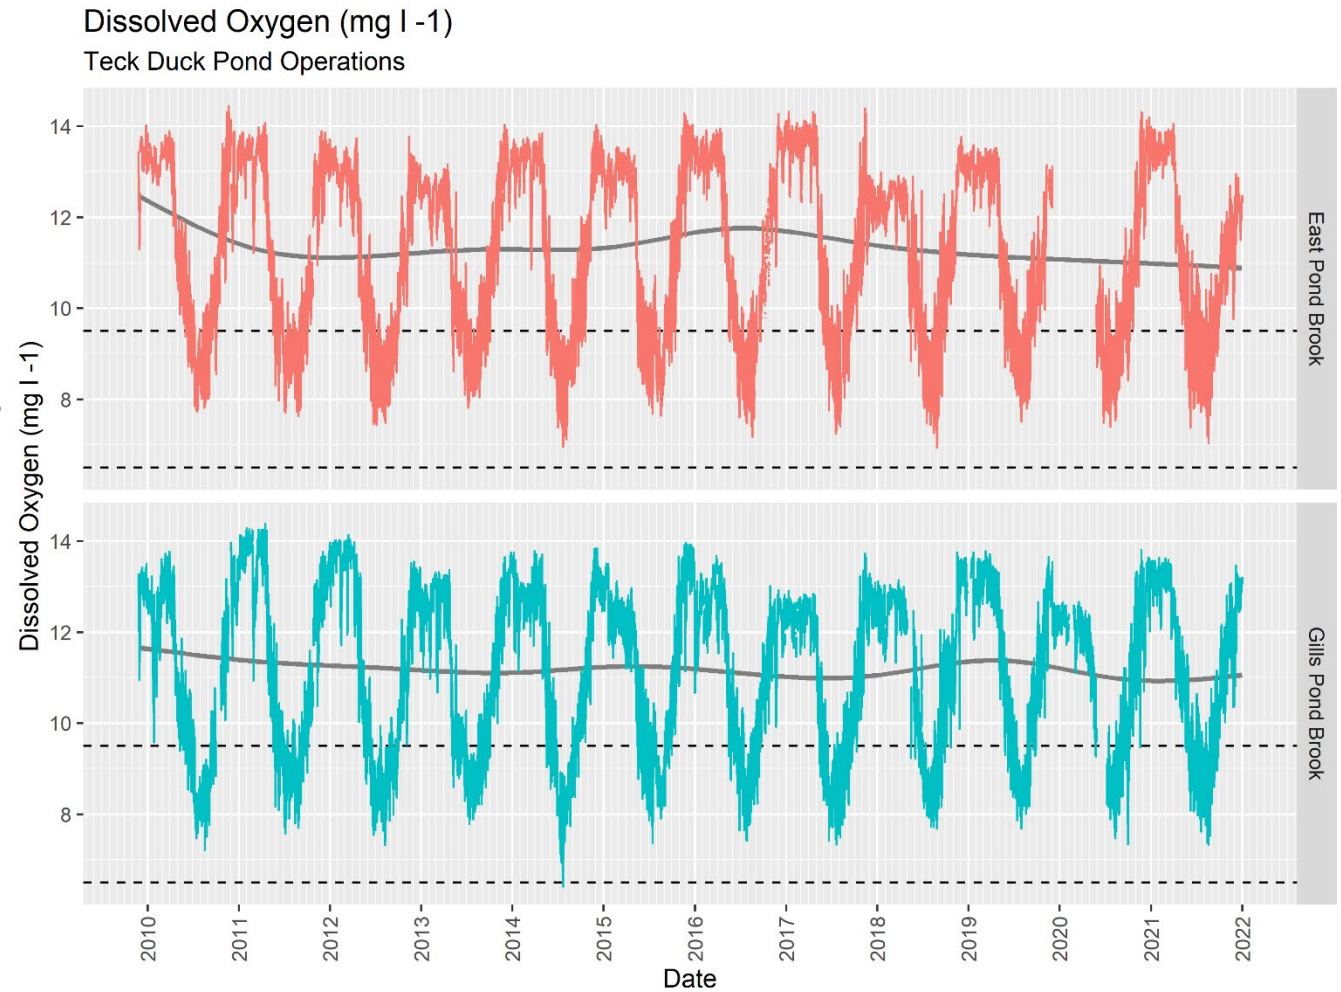
In 2021, all dissolved oxygen values were found to be above the CCME Aquatic Life Guideline for other life stages (6.5mg/L), but below the guideline for early stages (9.5 mg/L) during the warmer seasons when water can hold less oxygen (Figure 7). Guidelines are indicated on Figure 7 by dashed lines.

Figure 7: Dissolved oxygen at Teck DPO

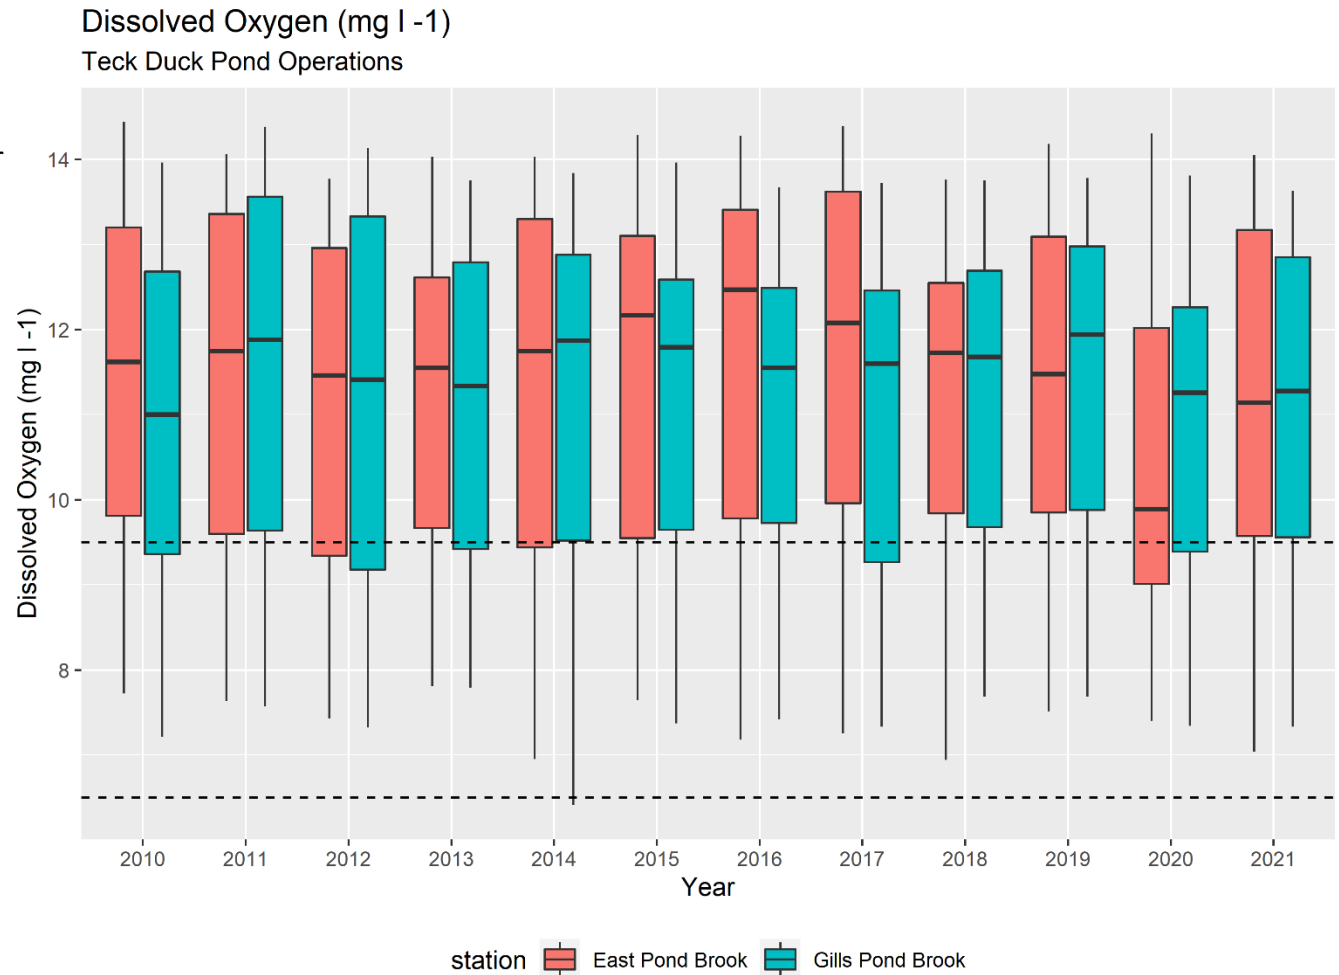
As seen in Figure 8, dissolved oxygen concentrations have not changed in any considerable up- or downward trend since monitoring began. East Pond Brook's 2020 data is an exception, with significantly lower than normal oxygen levels. This is due to skewed 2020 data, with more data during the warmer summer months and no data from the cooler January to May months to affect the median.

Each box, which represents the central 75% of values, is generally greater than the least-conservative CCME guideline of 9.5 mg/l for the protection of aquatic biota in early life stages (black, dashed lines).

Figure 8: Boxplots of dissolved oxygen at Teck DPO

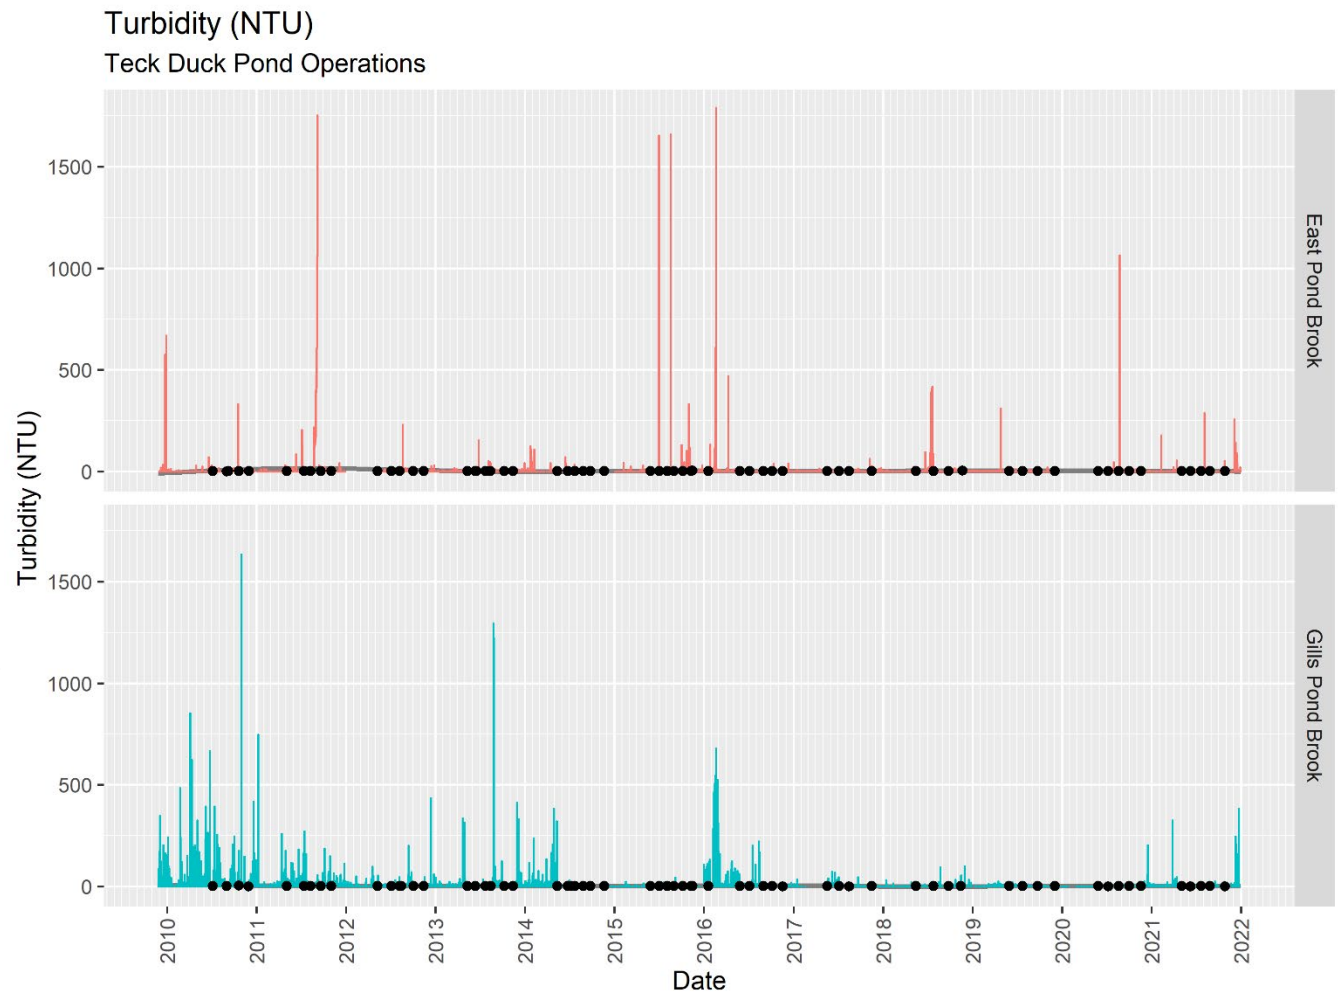
Despite median values of 0 NTU historically, Figure 9 shows that there are some notable periods of higher turbidity. At TGPB station, these periods are especially obvious from 2010 to mid-2014 and again in 2016. Following this period, turbidity events became fewer in number and lower in magnitude. In 2021, both stations reported a small level of background turbidity, with sporadic increases. Both stations reported maximum levels much lower than the historical averages. Only a small number of turbidity events were encountered at either station and were short in duration.

Figure 9: Turbidity at Teck DPO

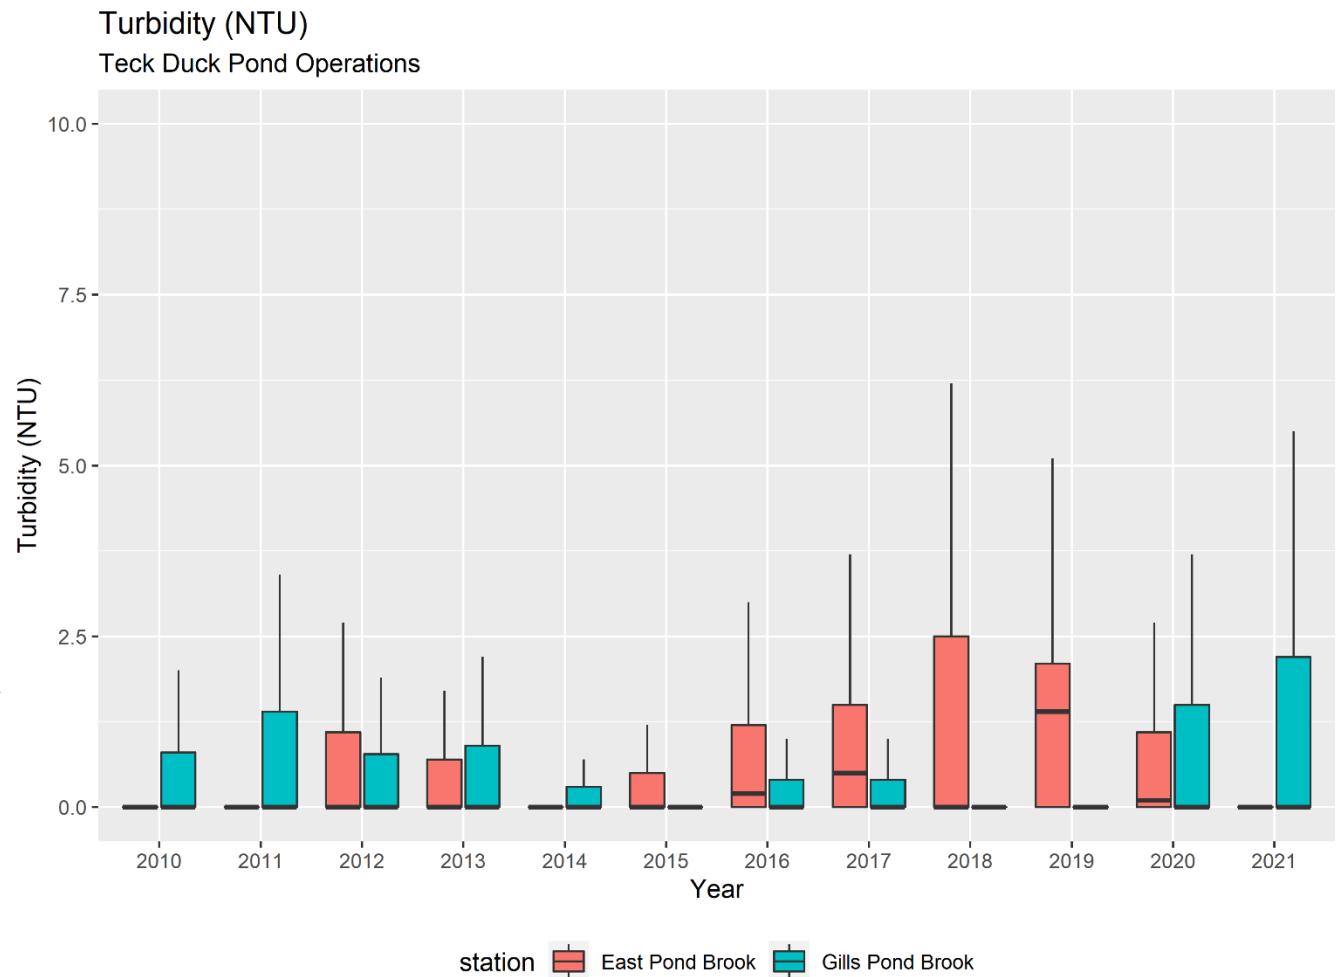
The long-term characteristics of turbidity at the Teck DPO sites are seen in Figure 10. Within each boxplot, a central, horizontal black bar indicates median turbidity. Median values are generally located at 0 NTU, except for East Pond Brook in 2016, 2017, 2019 and 2020. Those four years seemed to indicate a rising trend in turbidity at that time, which has since decreased. The 2021 median value is lower than 2020. The upper range of turbidity values at East Pond Brook showed steady increases from 2015 to 2018. The 2019-2021 values show a decline, indicating a decreasing trend since 2018.

The mechanisms responsible for this increase and more recent decrease are not known but are likely related to closure work at Teck DPO or logging work occurring in the area.

Figure 10: Boxplots of turbidity at Teck DPO

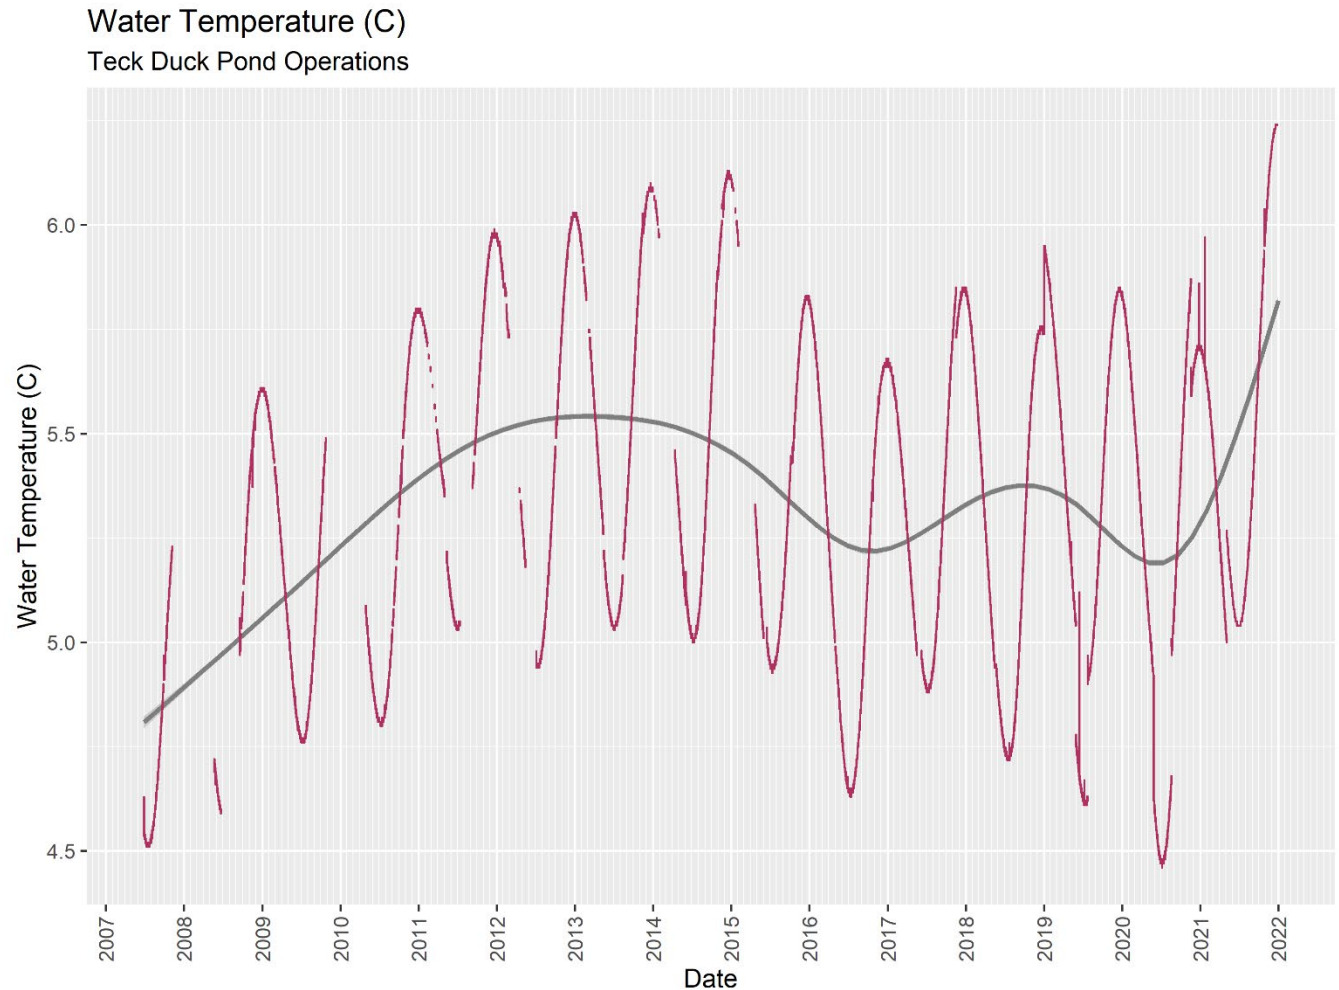
Figure 11 shows that annual low temperatures tend to occur in mid-July and annual high temperatures tend to occur in mid to late December. The 2021 data followed this trend while also recording the highest temperature on record.

Figure 11: Water temperature at Well after Tailings Dam, Teck DPO

Interestingly, Figure 14 appears to mirror an opposite and inverse relationship with water temperature (Figure 11). In years where water temperature is cooler, pH levels tend to be more alkaline and when water is warmer, conditions appear to be more acidic. It is unclear if this is coincidental or if there is an actual relationship between the two parameters at this location.

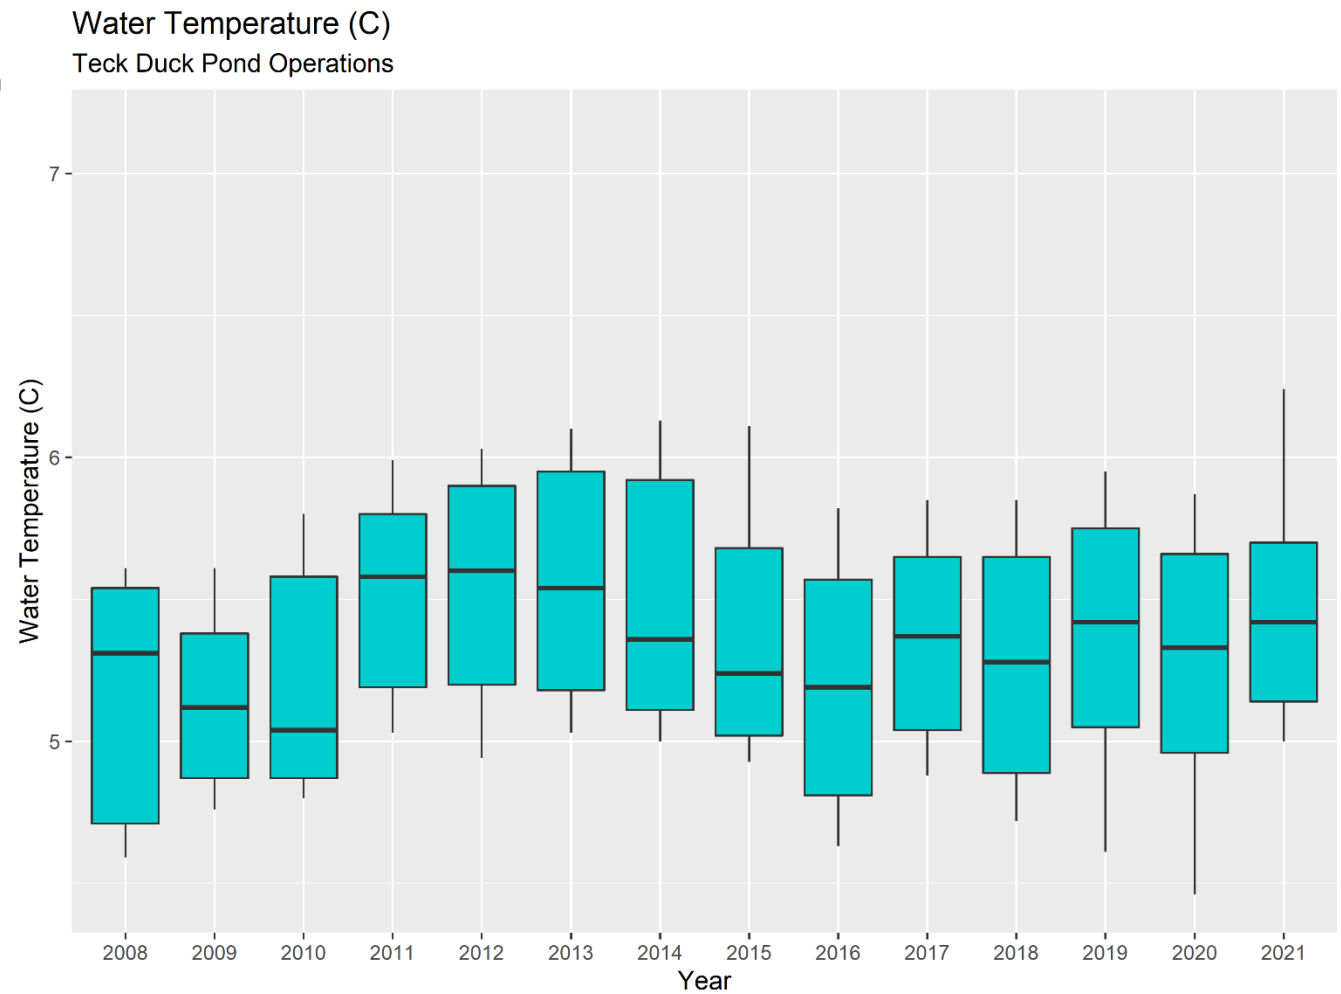
Figure 12 shows the consistency of water temperatures from 2008 to 2021 where there is considerable overlap in ranges from one year to the next. No notable trend is obvious at this time.

Figure 12: Boxplots of water temperature at Well after Tailings Dam, Teck DPO

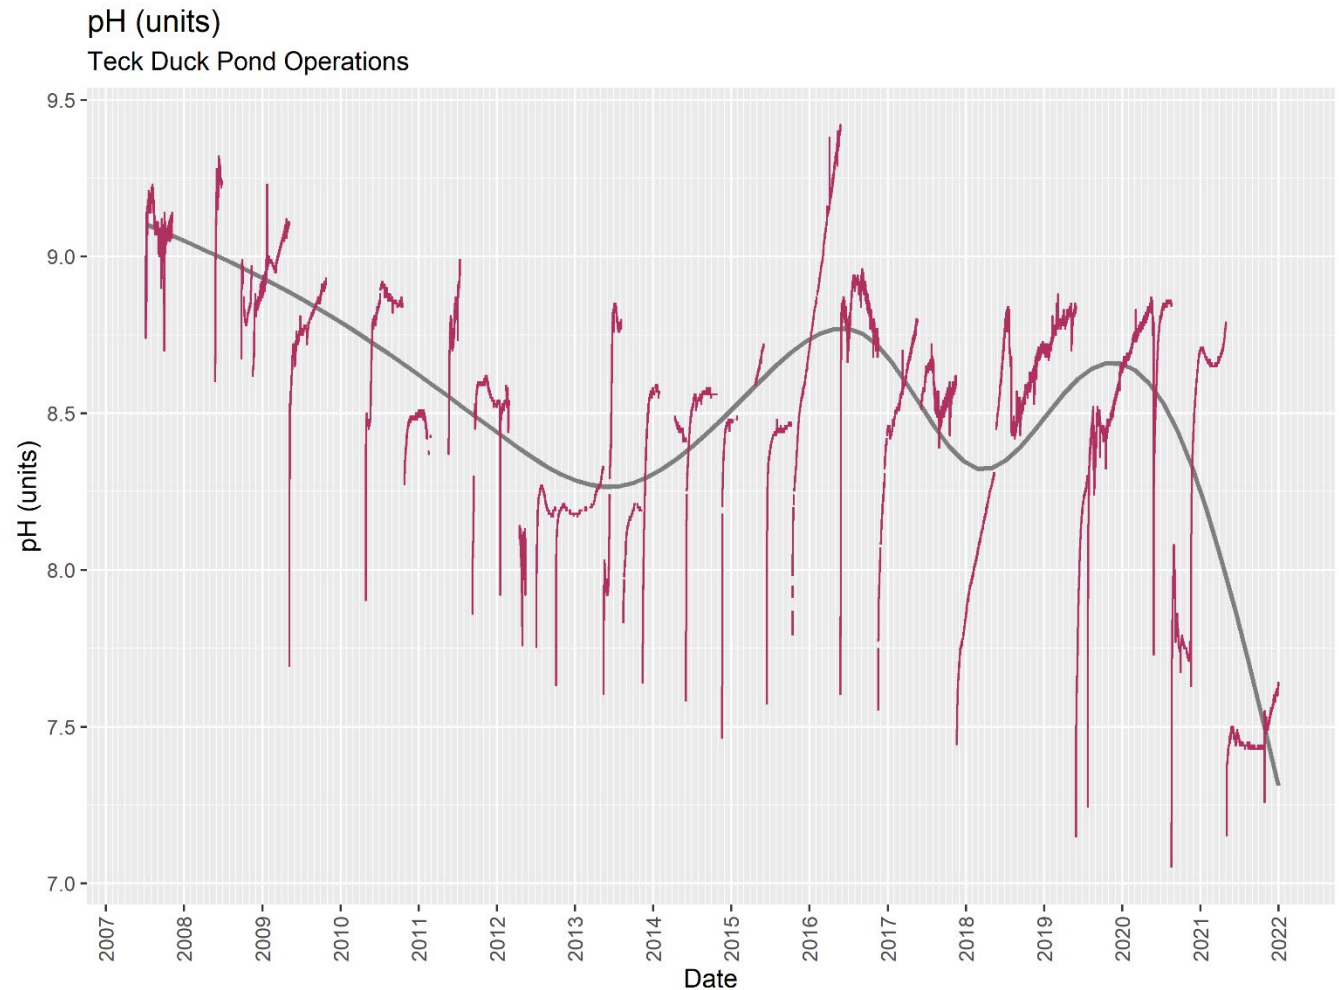
Readily apparent in Figure 13 is the long period of time it takes for pH to stabilize in the well following routine maintenance. This effect can be attributed to factors such as sensor stabilisation or chemical change resulting from aquifer water being pulled into the borehole. The rising trend can take upwards of a month to stabilize.

Figure 13: pH at Well after Tailings Dam, Teck DPO

The variance observed in Figure 13 makes it challenging to pick out trends or overall changes in pH. Figure 14 offers a clearer view of pH over time.

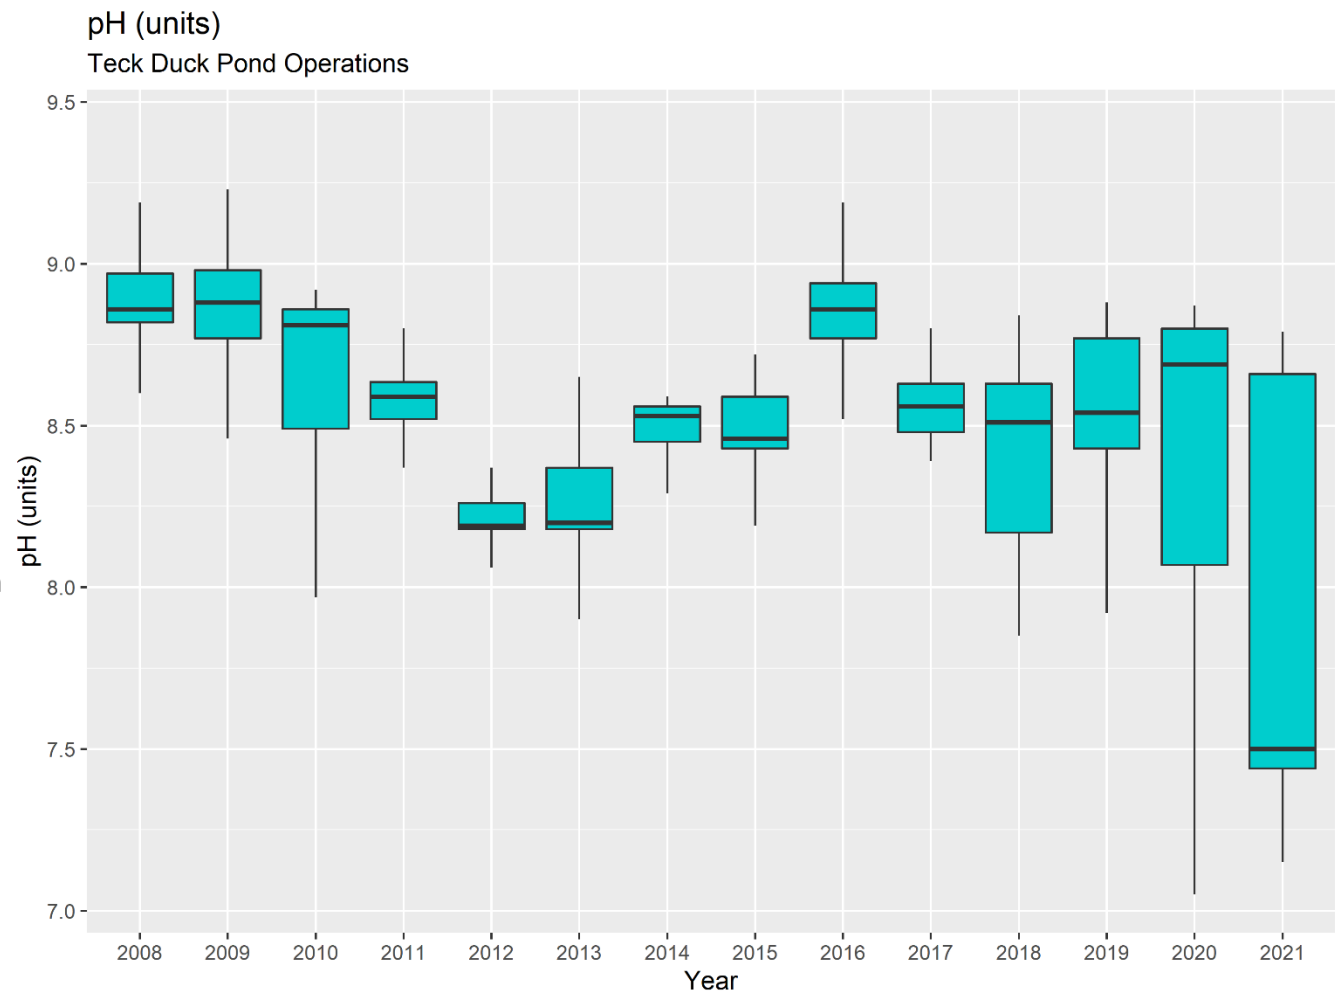
pH levels within the well tend to be alkaline in nature. Median levels from 2017 to 2020 were relatively stable with varying ranges, but the 2021 data is much lower and data falls within a very large range. The larger than normal range may be the result of the newly installed equipment being more capable of responding to changes in the aquifer, or the result of chemical changes in the aquifer.

Figure 14: Boxplots of pH at Well after Tailings Dam, Teck DPO

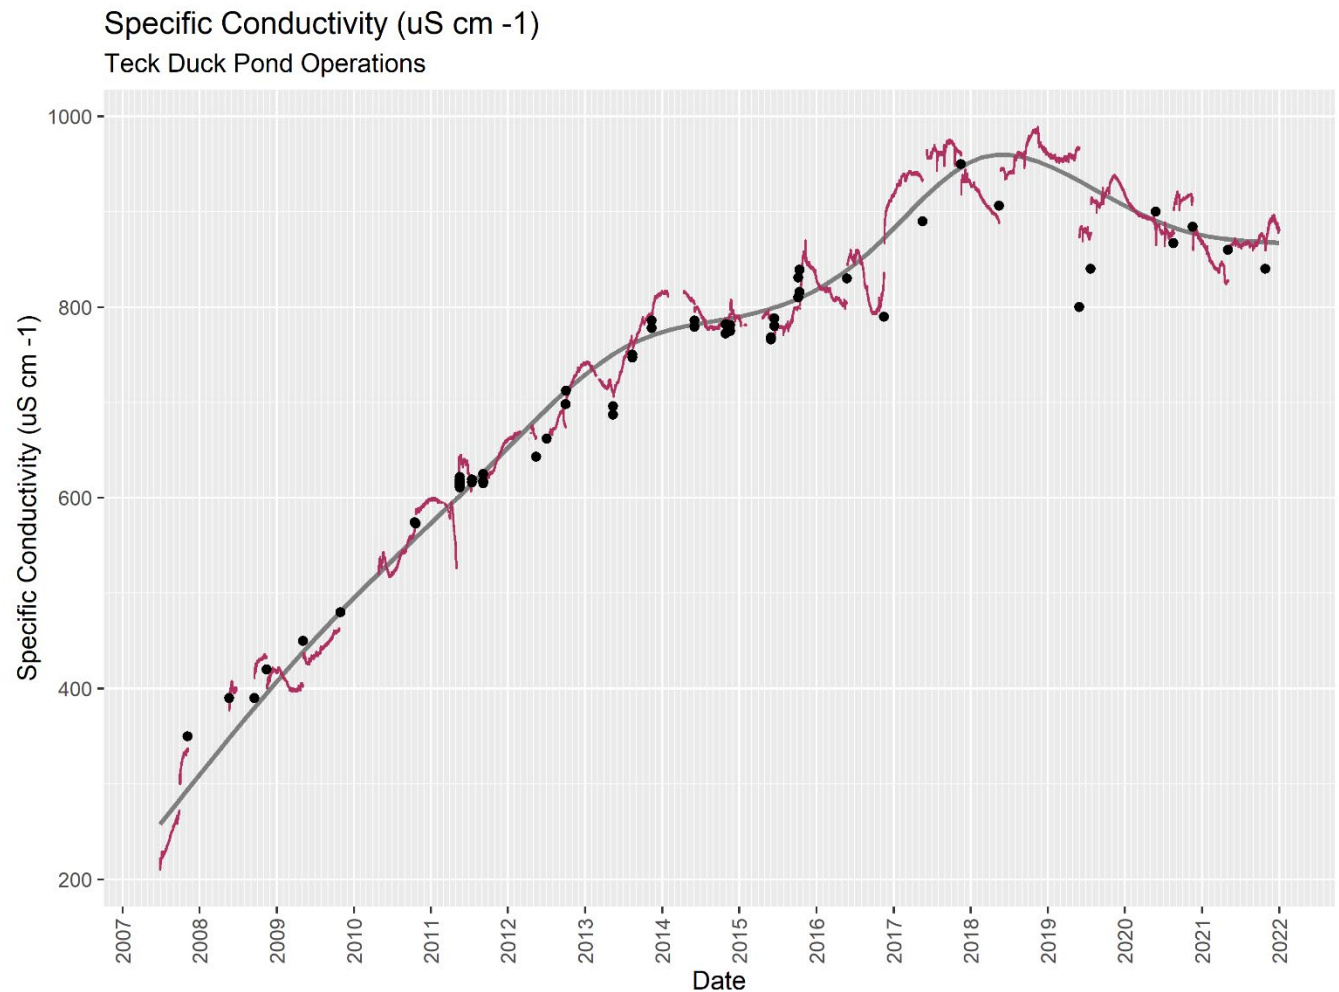
In 2021, specific conductivity values continued to show a downward trend (2018-2021) after peaking mid-2018 (Figure 15). The median value from 2021 was higher than historically, but values remained relatively stable throughout the year, varying minimally as per Table 9.

A plateau phase from 2014 to late 2015 was observed prior to a rising trend from 2016 to 2018. At this time, water level in the tailings management area was lowered to perform long-term stabilization work. A lower water level and deposition of materials may have resulted in the sudden increase in conductivity. Levels have declined steadily since 2018.

Figure 15: Specific Conductivity at Well after Tailings Dam, Teck DPO

In Figure 16, data from 2017-2019 show a distinct and separate data plateau from that seen from 2014 to 2016. Median values were significantly higher in 2017-2019 than in previous years. This may have resulted from work within the tailings management area as discussed in the previous Figure 15. Data from 2019-2021 show a continuing downward trend.
