Real-Time Water Quality Deployment Report

Teck Duck Pond Operations

2021

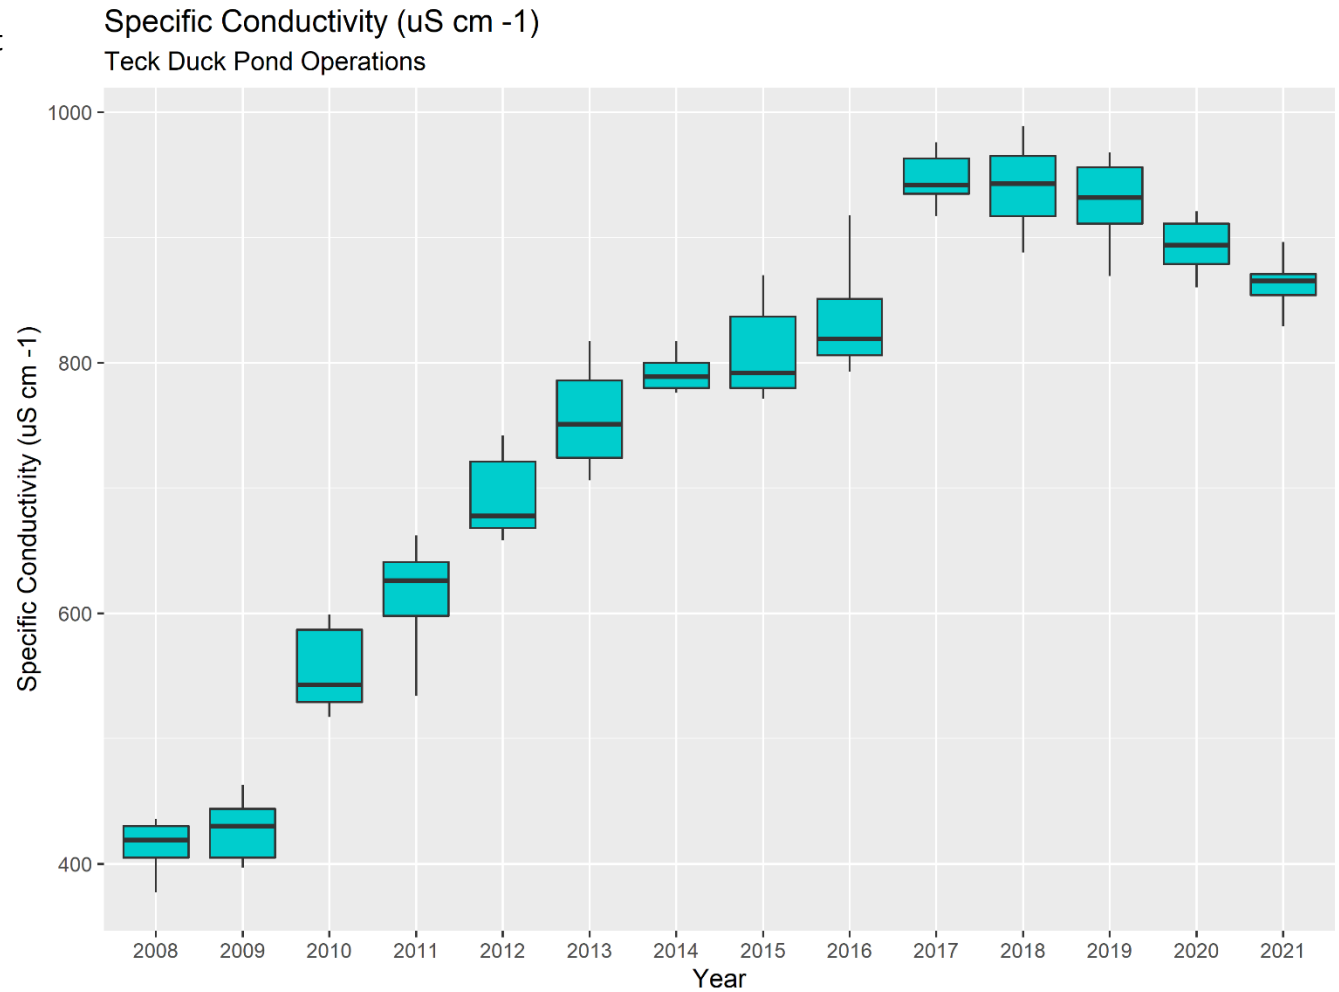
In Figure 16, data from 2017-2019 show a distinct and separate data plateau from that seen from 2014 to 2016. Median values were significantly higher in 2017-2019 than in previous years. This may have resulted from work within the tailings management area as discussed in the previous Figure 15. Data from 2019-2021 show a continuing downward trend.

Figure 16: Boxplots of specific conductivity at Well after Tailings Dam, Teck DPO

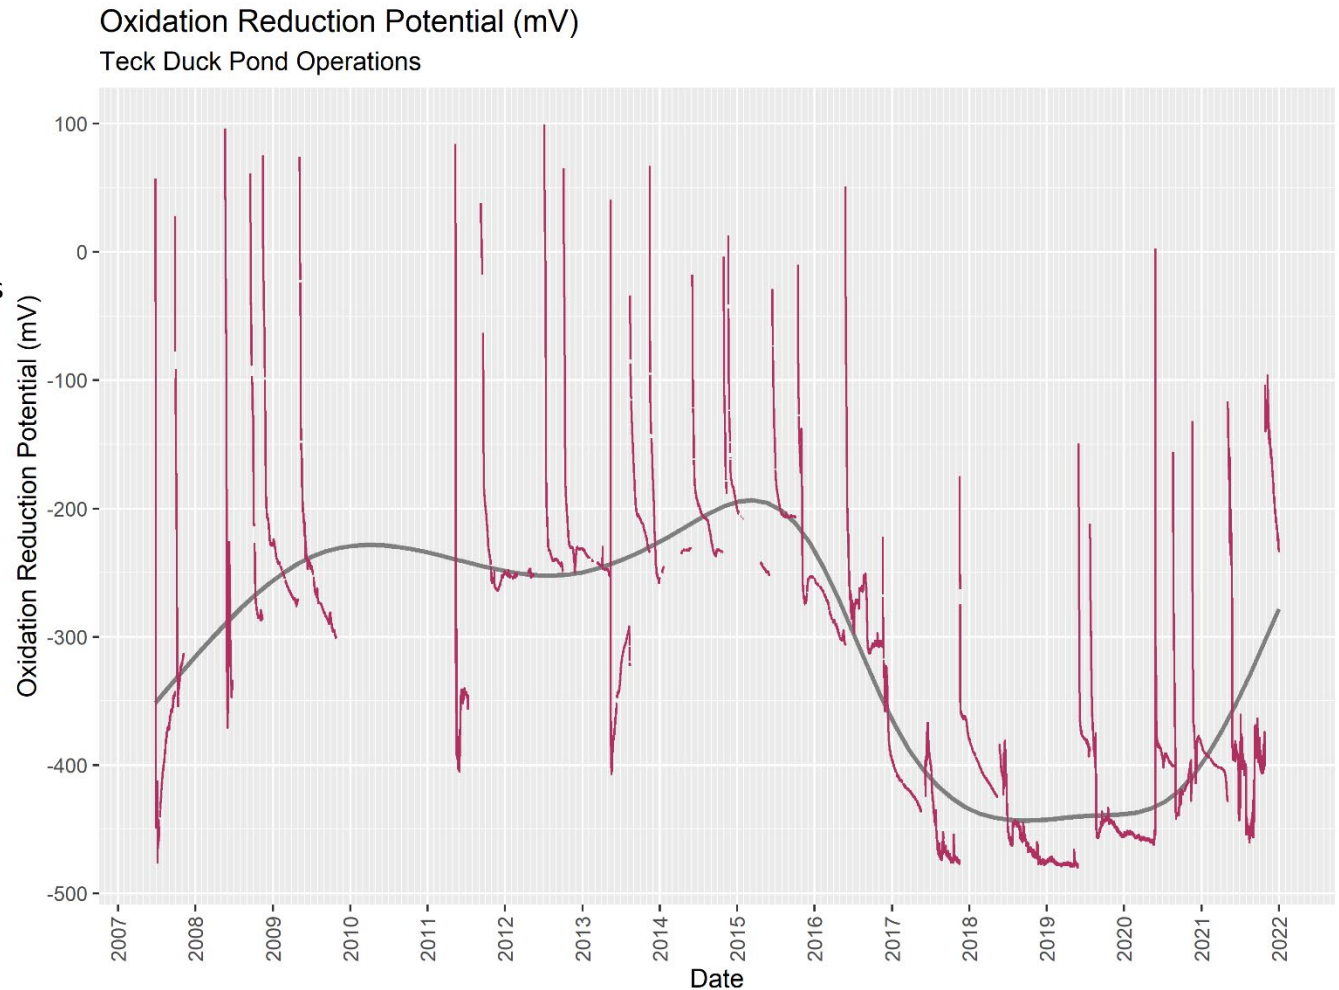
Much like pH, ORP tends to take a number of days to settle following routine maintenance as depicted in Figure 17. From 2007 to 2016, post-maintenance ORP values were found to be oxidative (> 0 mV) for a brief period before quickly falling to reductive levels (< 0 mV).

From 2016-2018, ORP values became increasingly reductive over time, before plateauing in 2018-2019. ORP values now show an upward trend for 2020-2021, although post-maintenance ORP values rarely reach oxidative levels. This may be evidence of a changing trend within the system.

Figure 17: ORP at Well after Tailings Dam, Teck DPO

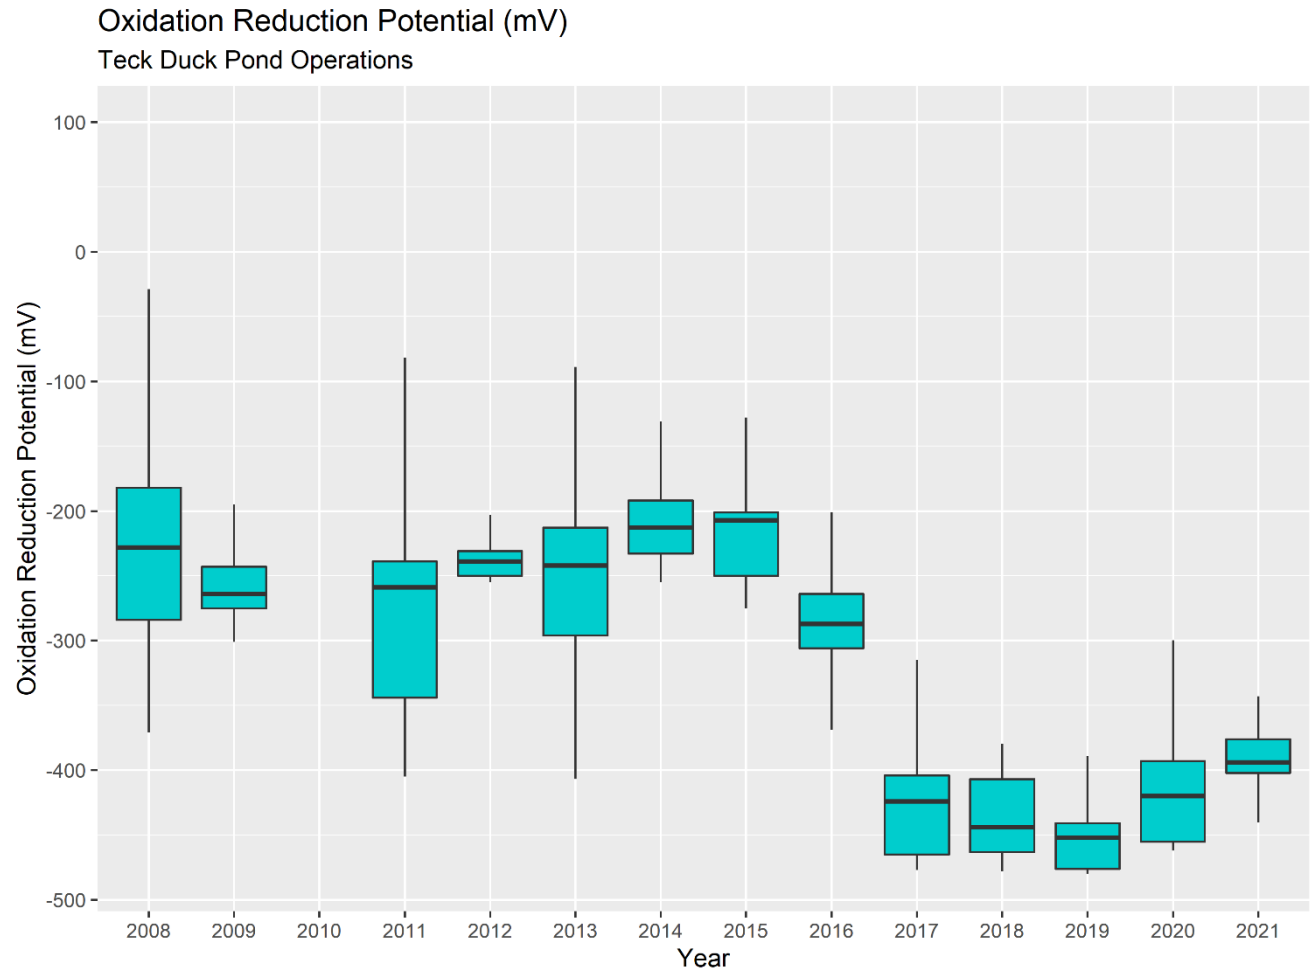
Figure 18 readily shows a continuous decline in ORP from 2016 to 2019, but an increase in 2020 and 2021. These changes could be indicative of a chemical change in the aquifer.

Notably, the change from 2016 to 2017 was significant, with a continuing downward trend 2017-2019 followed by increases in 2020-2021.

Figure 18: Boxplots of ORP at Well after Tailings Dam, Teck DPO

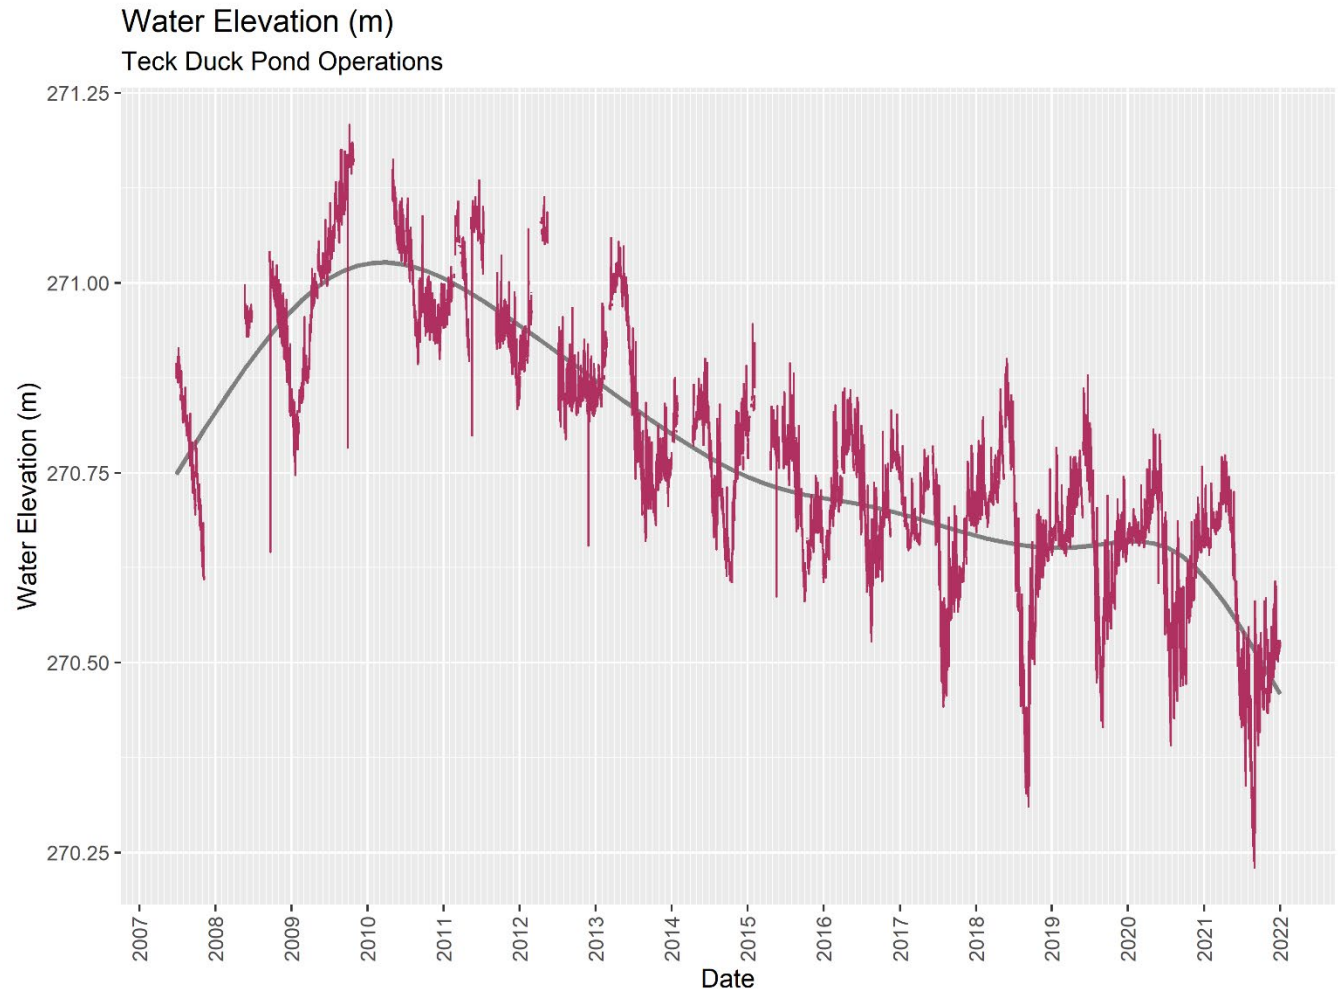
Water elevation indicates the surface of the aquifer above sea level. Water level peaked in 2009 and declined until 2017 when a small uptick was observed in the latter part of 2017 into mid-2018 (Figure 19) before continuing to decline once again into 2021.

There was a pronounced drop in elevation early 2021 before it slowly rebounded again.

Figure 19: Water elevation at Well after Tailings Pond, Teck DPO

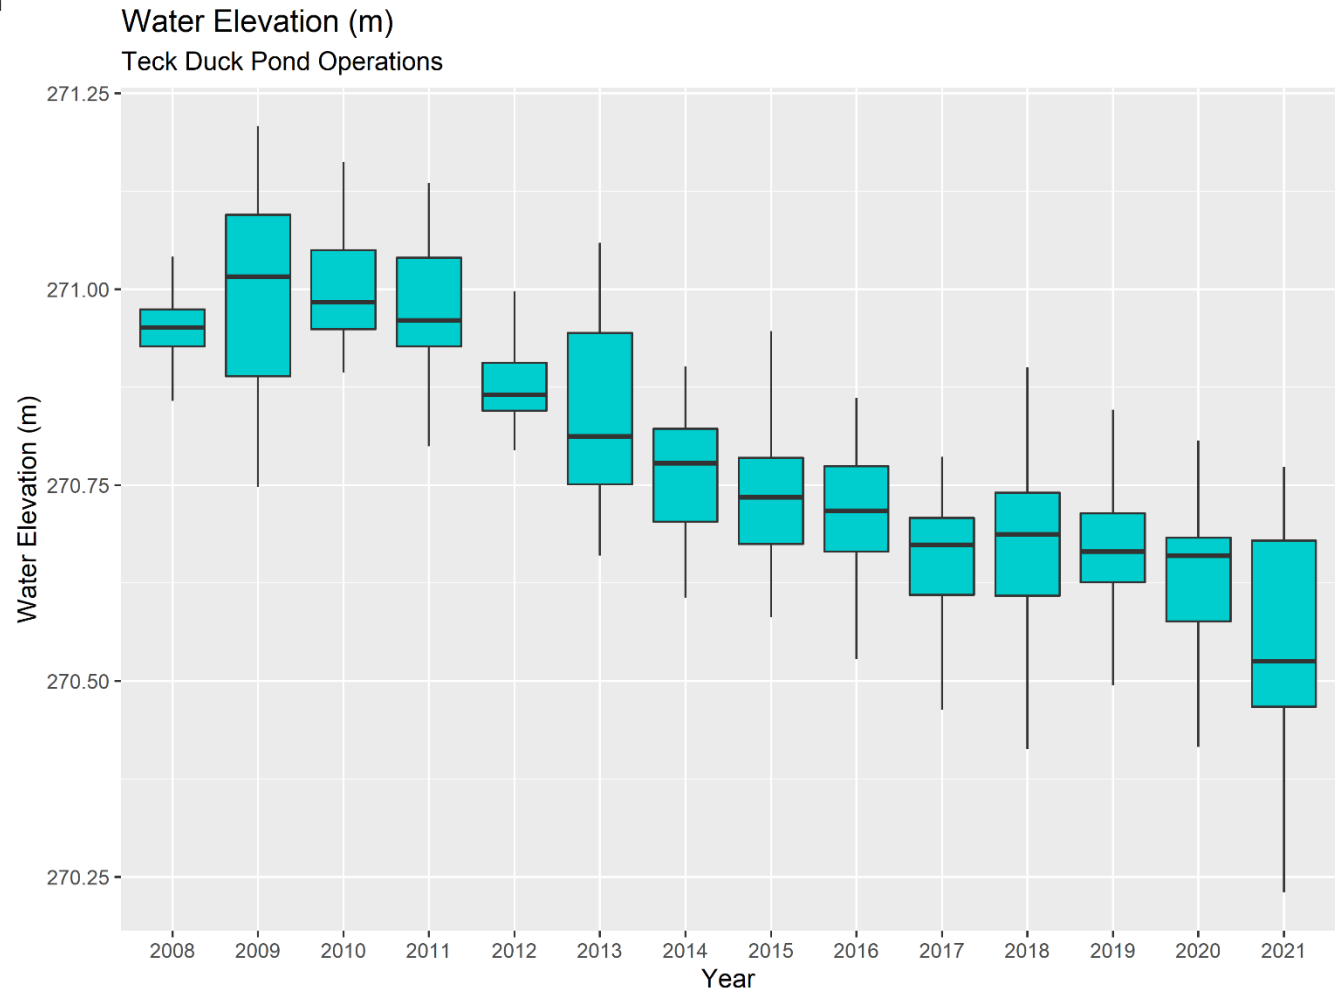
Figure 20 illustrates the long-term decline in water level from 2009 to 2017, the uptick observed in 2018, and the continued decline into 2021.

Figure 20: Boxplots of water elevation at Well after Tailings Pond, Teck DPO

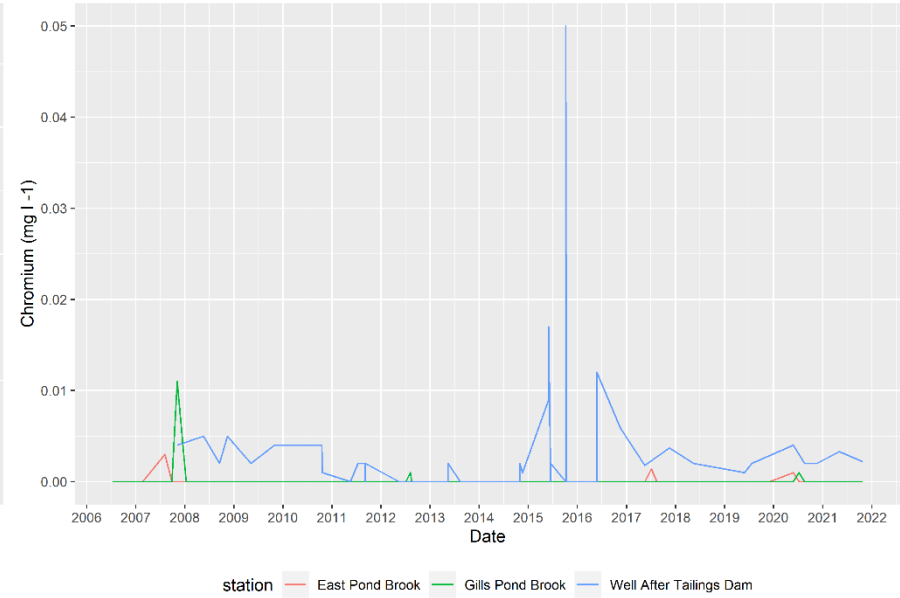
Grab samples of Chromium (mg l⁻¹)
Teck Duck Pond Operations - Well after Tailings Dam A

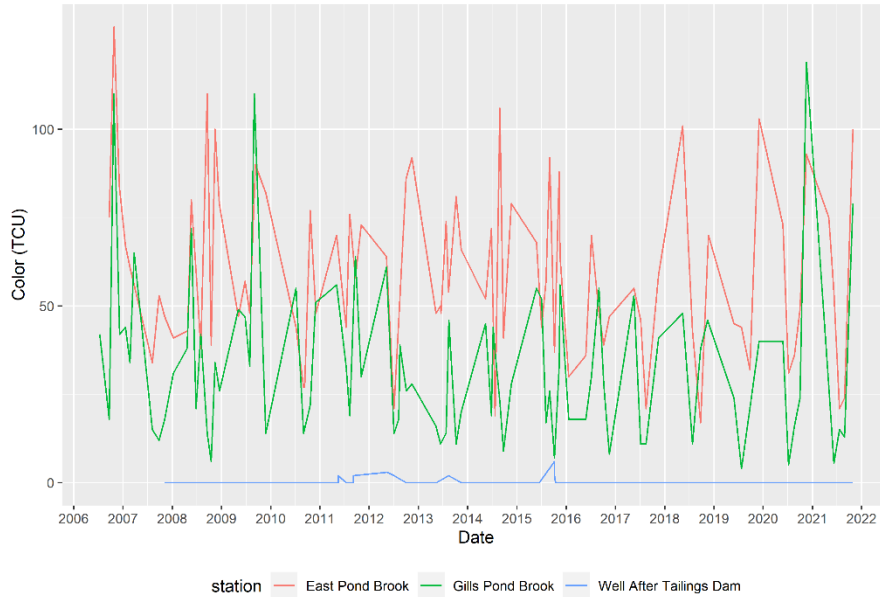
Grab samples of Color (TCU)
Teck Duck Pond Operations - Well after Tailings Dam A

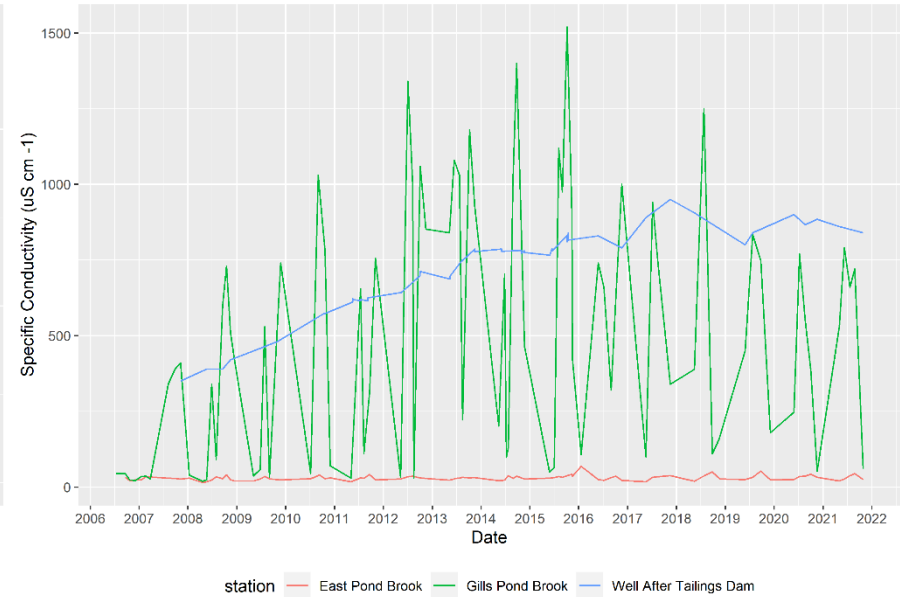
Grab samples of Specific Conductivity (uS cm⁻¹)
Teck Duck Pond Operations - Well after Tailings Dam A

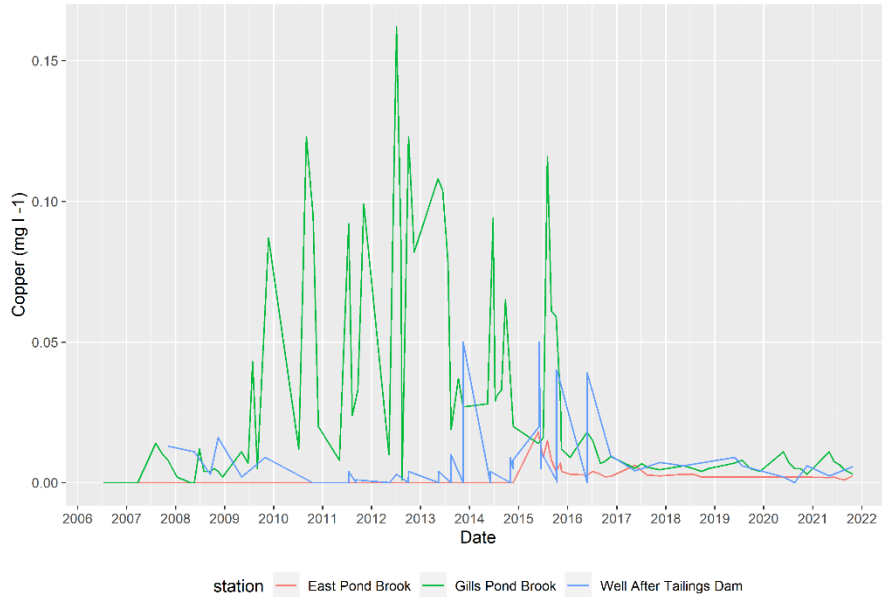
Grab samples of Copper (mg l⁻¹)

Teck Duck Pond Operations - Well after Tailings Dam A

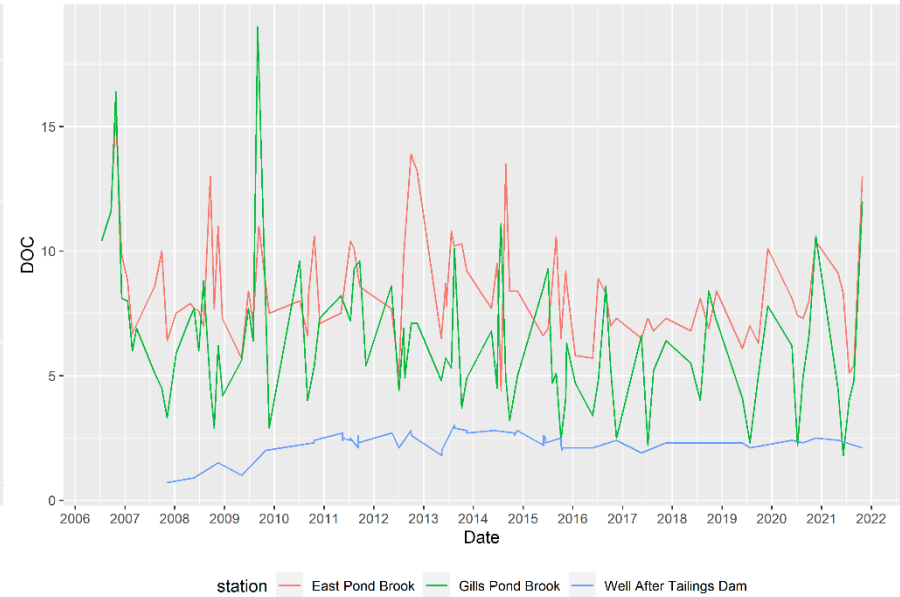
Grab samples of DOC

Teck Duck Pond Operations - Well after Tailings Dam A

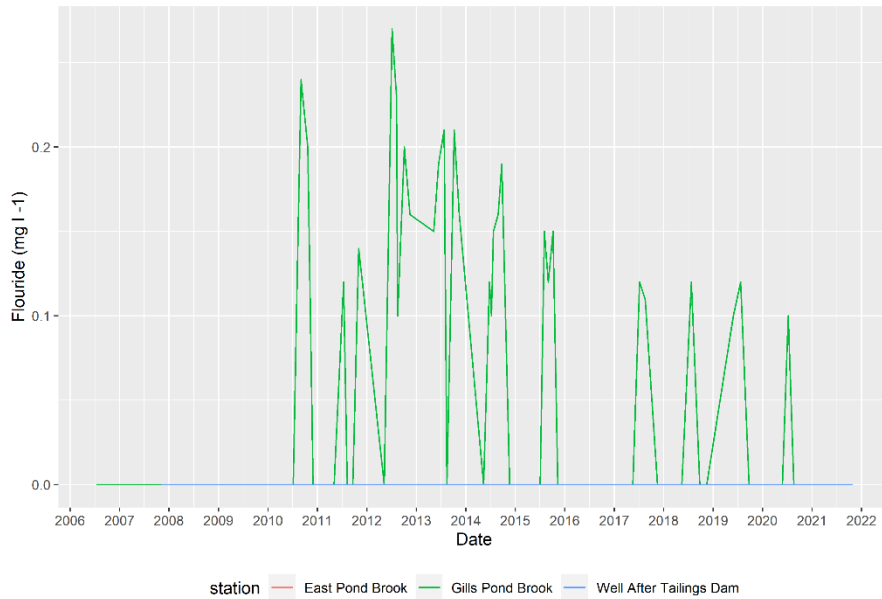
Grab samples of Fluoride (mg l⁻¹)

Teck Duck Pond Operations - Well after Tailings Dam A

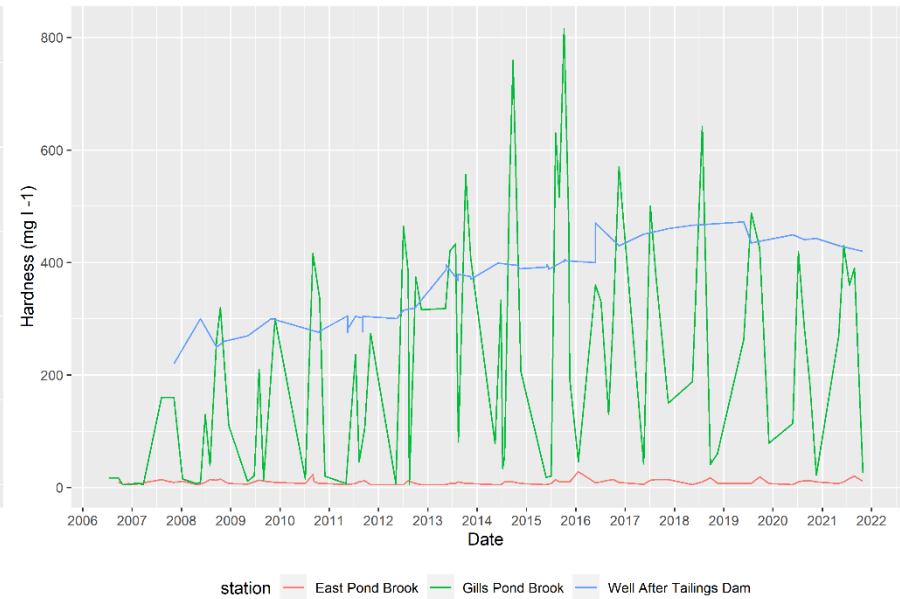
Grab samples of Hardness (mg l⁻¹)

Teck Duck Pond Operations - Well after Tailings Dam A

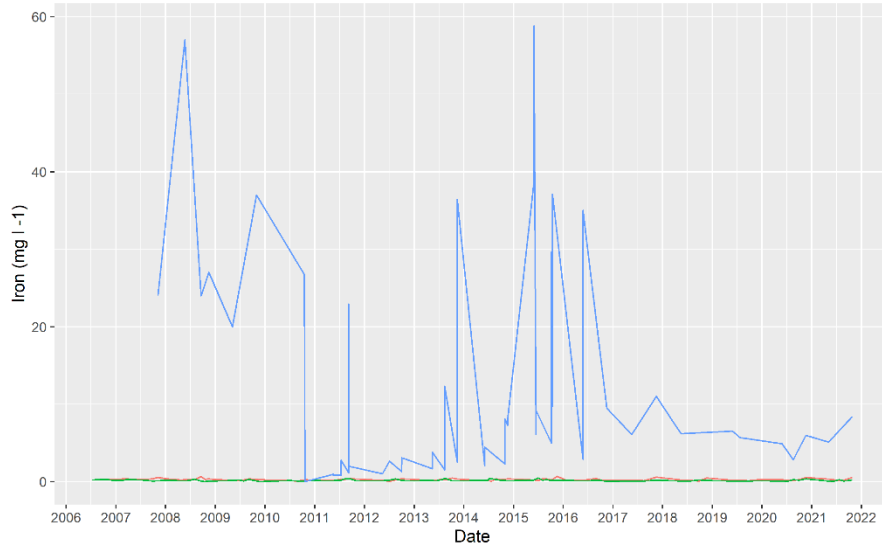
Grab samples of Iron (mg l⁻¹)
Teck Duck Pond Operations - Well after Tailings Dam A

station — East Pond Brook — Gills Pond Brook — Well After Tailings Dam

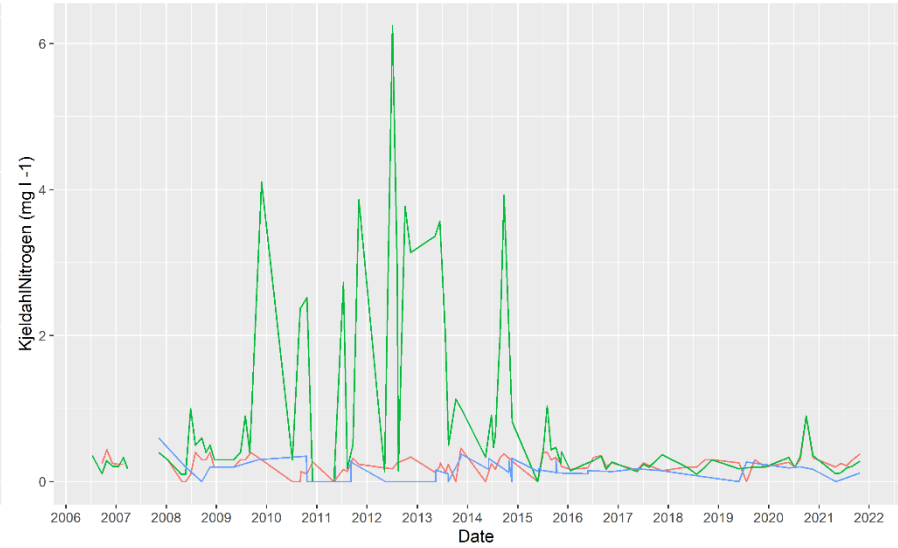
Grab samples of KjeldahlNitrogen (mg l⁻¹)
Teck Duck Pond Operations - Well after Tailings Dam A

station — East Pond Brook — Gills Pond Brook — Well After Tailings Dam

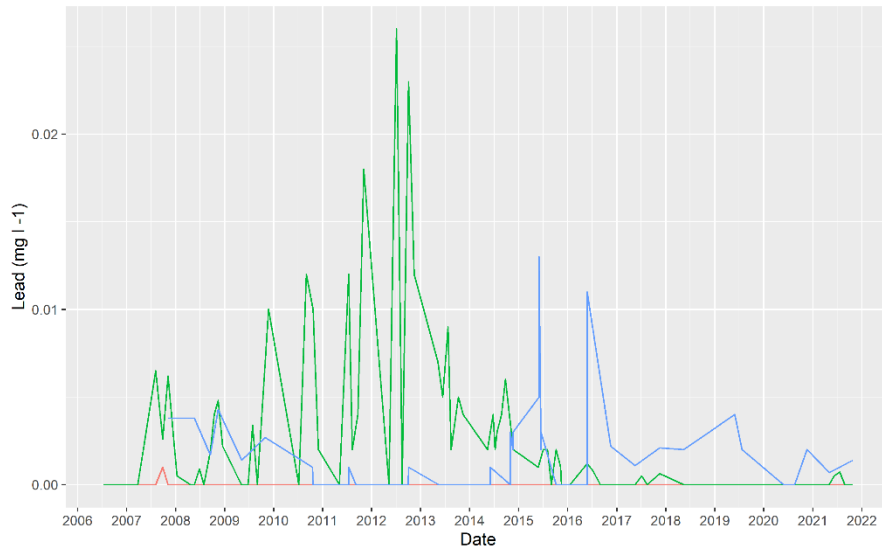
Grab samples of Lead (mg l⁻¹)
Teck Duck Pond Operations - Well after Tailings Dam A

station — East Pond Brook — Gills Pond Brook — Well After Tailings Dam

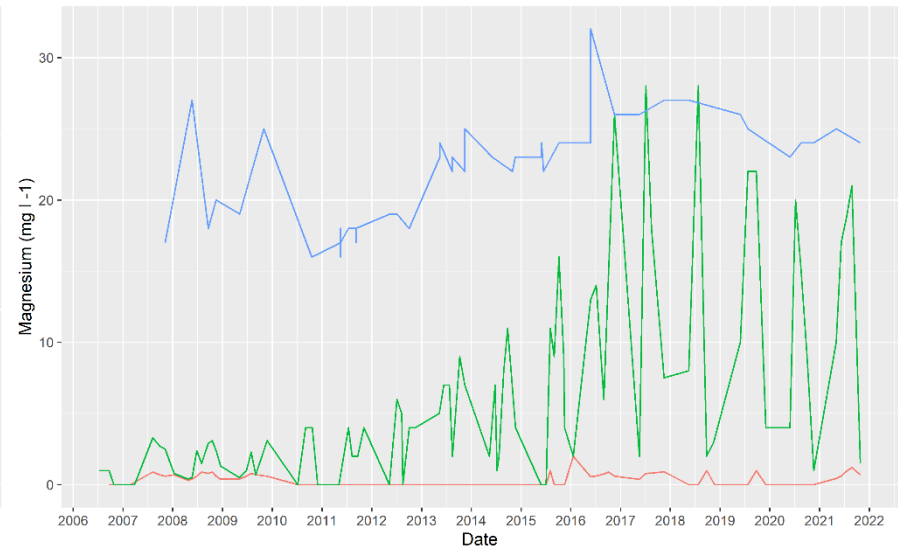
Grab samples of Magnesium (mg l⁻¹)
Teck Duck Pond Operations - Well after Tailings Dam A

station — East Pond Brook — Gills Pond Brook — Well After Tailings Dam

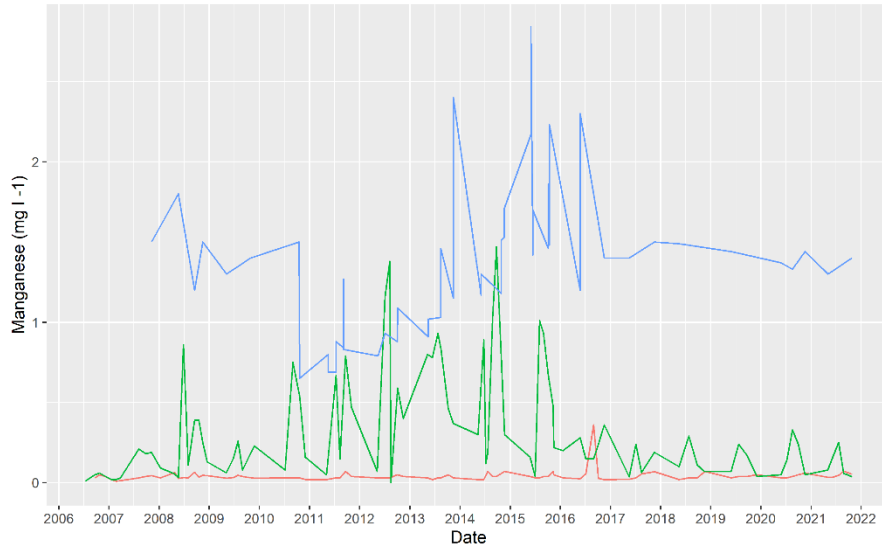
Grab samples of Manganese (mg l⁻¹)

Teck Duck Pond Operations - Well after Tailings Dam A

station — East Pond Brook — Gills Pond Brook — Well After Tailings Dam

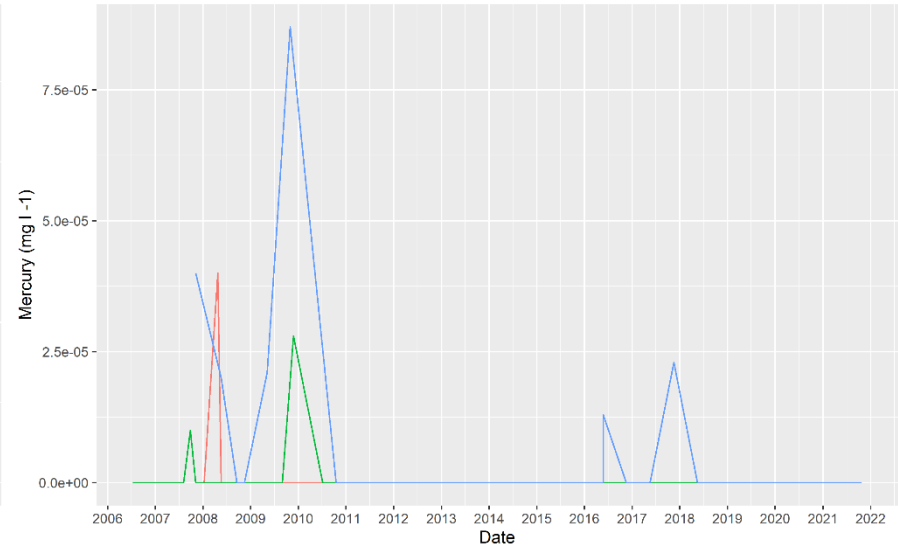
Grab samples of Mercury (mg l⁻¹)

Teck Duck Pond Operations - Well after Tailings Dam A

station — East Pond Brook — Gills Pond Brook — Well After Tailings Dam

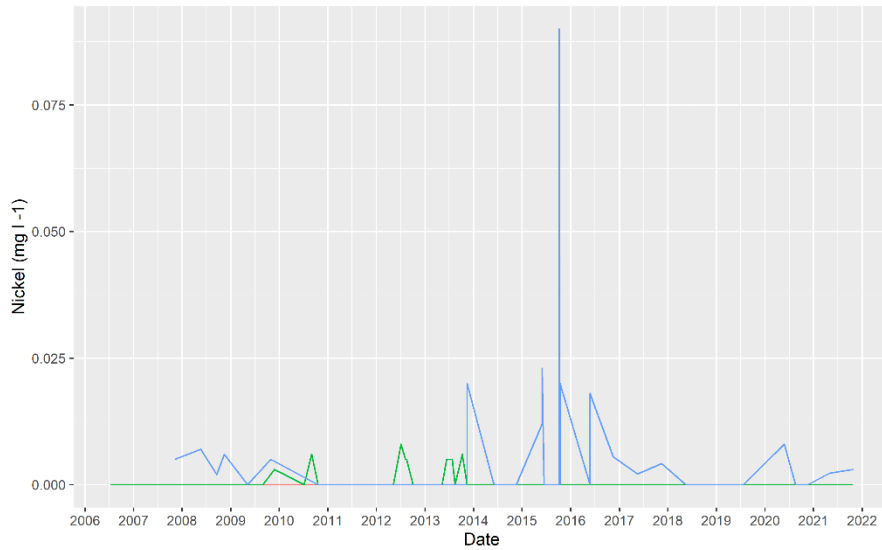
Grab samples of Nickel (mg l⁻¹)

Teck Duck Pond Operations - Well after Tailings Dam A

station — East Pond Brook — Gills Pond Brook — Well After Tailings Dam

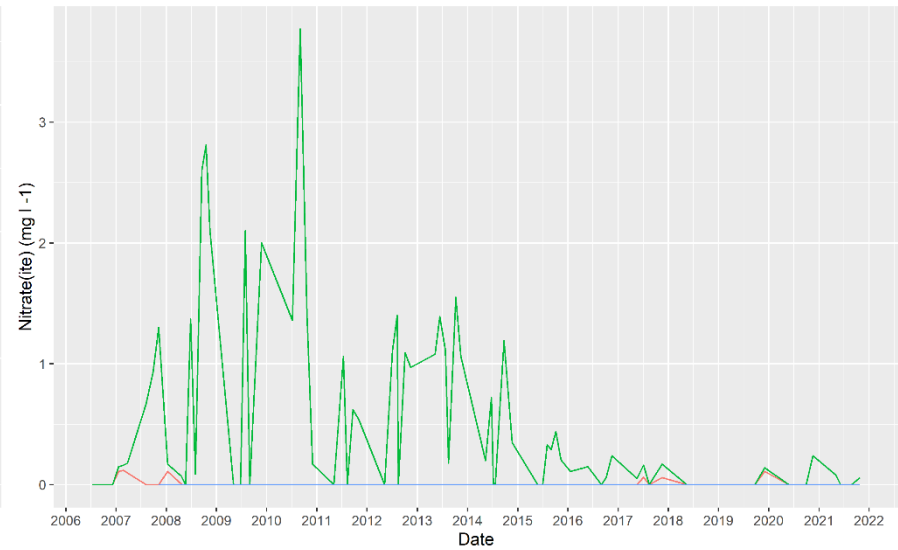
Grab samples of Nitrate(ite) (mg l⁻¹)

Teck Duck Pond Operations - Well after Tailings Dam A

station — East Pond Brook — Gills Pond Brook — Well After Tailings Dam

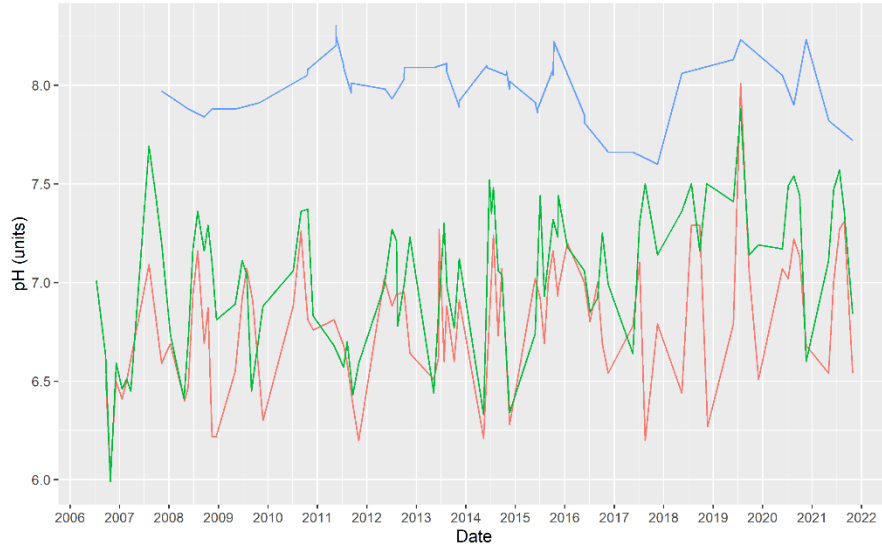
Grab samples of pH (units)
Teck Duck Pond Operations - Well after Tailings Dam A

station — East Pond Brook — Gills Pond Brook — Well After Tailings Dam

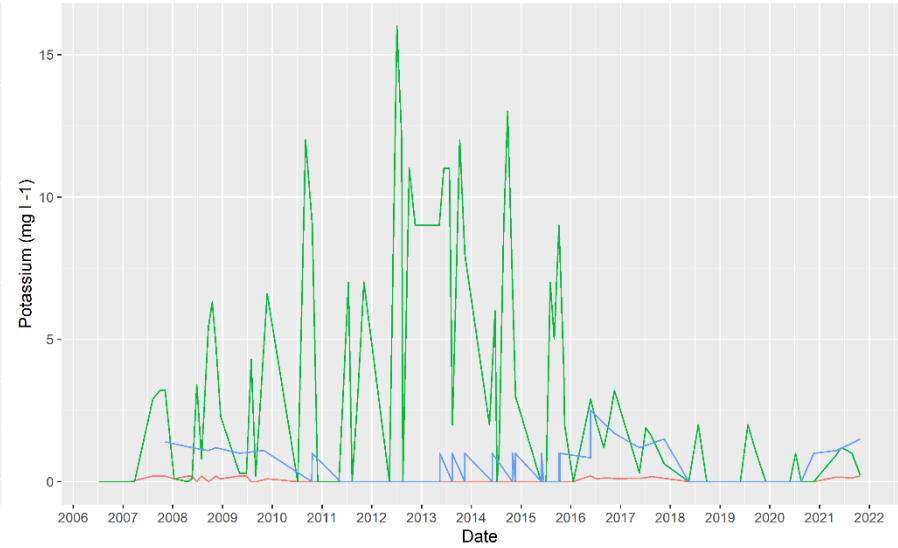
Grab samples of Potassium (mg l⁻¹)
Teck Duck Pond Operations - Well after Tailings Dam A

station — East Pond Brook — Gills Pond Brook — Well After Tailings Dam

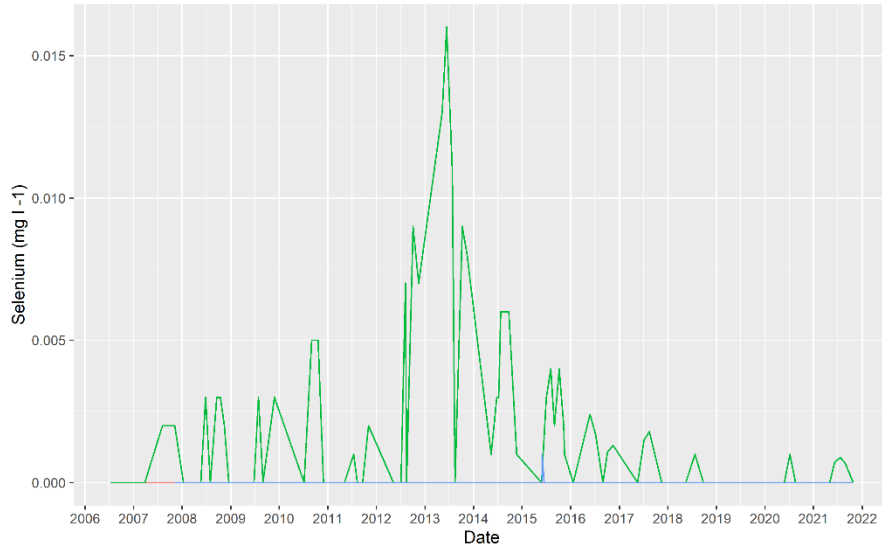
Grab samples of Selenium (mg l⁻¹)
Teck Duck Pond Operations - Well after Tailings Dam A

station — East Pond Brook — Gills Pond Brook — Well After Tailings Dam

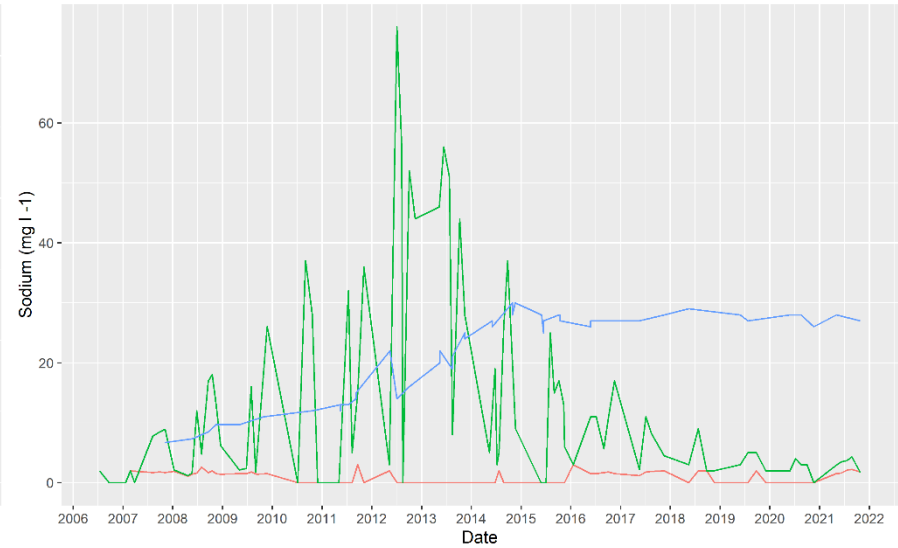
Grab samples of Sodium (mg l⁻¹)
Teck Duck Pond Operations - Well after Tailings Dam A

station — East Pond Brook — Gills Pond Brook — Well After Tailings Dam

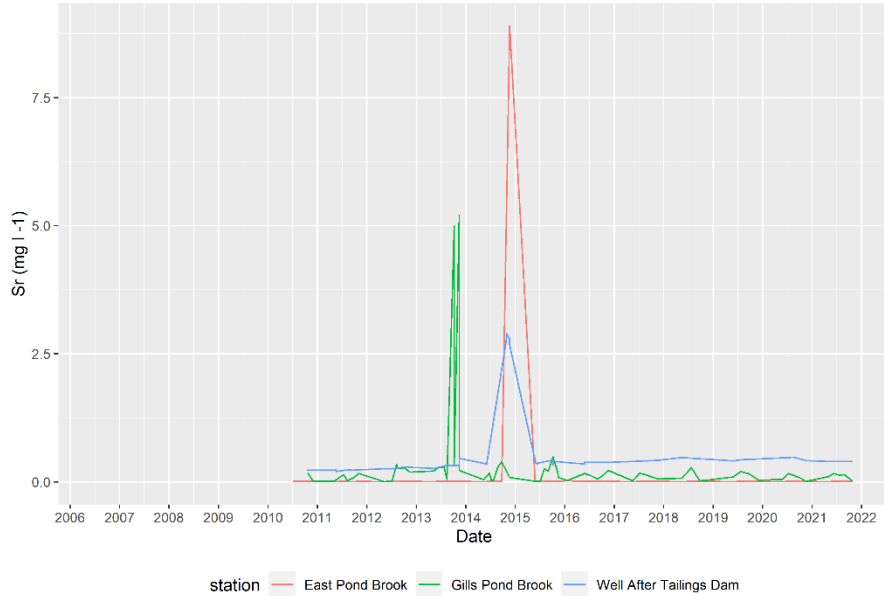
Grab samples of Sr (mg l⁻¹)
Teck Duck Pond Operations - Well after Tailings Dam A

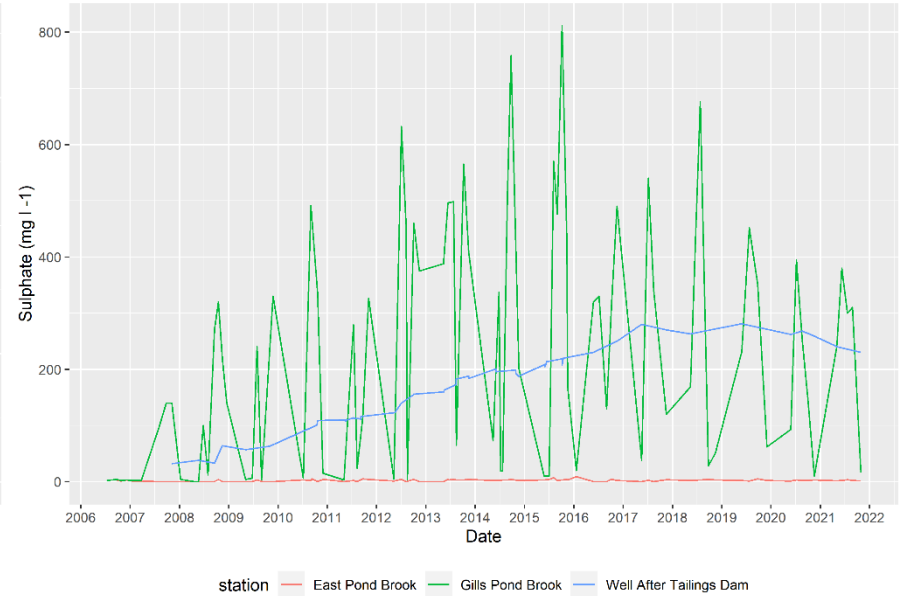
Grab samples of Sulphate (mg l⁻¹)
Teck Duck Pond Operations - Well after Tailings Dam A

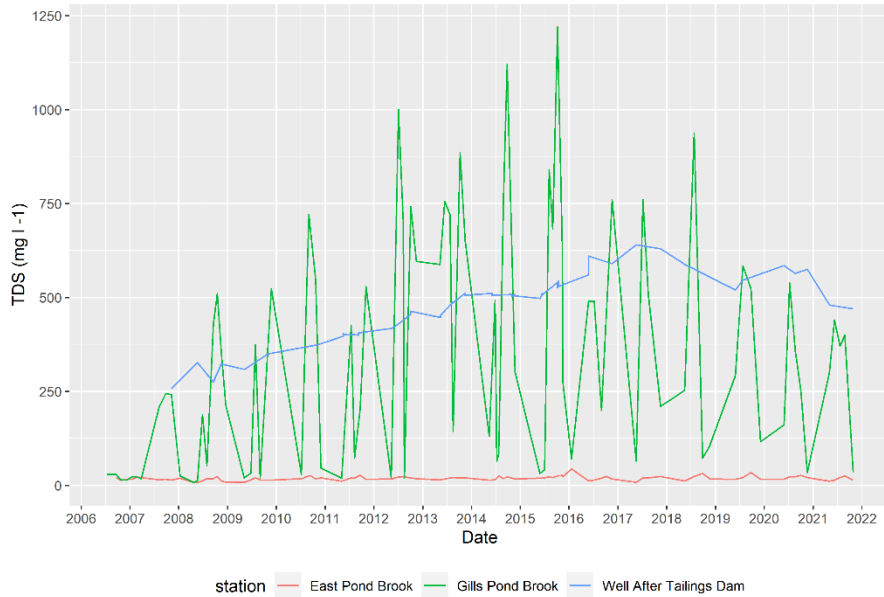
Grab samples of TDS (mg l⁻¹)
Teck Duck Pond Operations - Well after Tailings Dam A

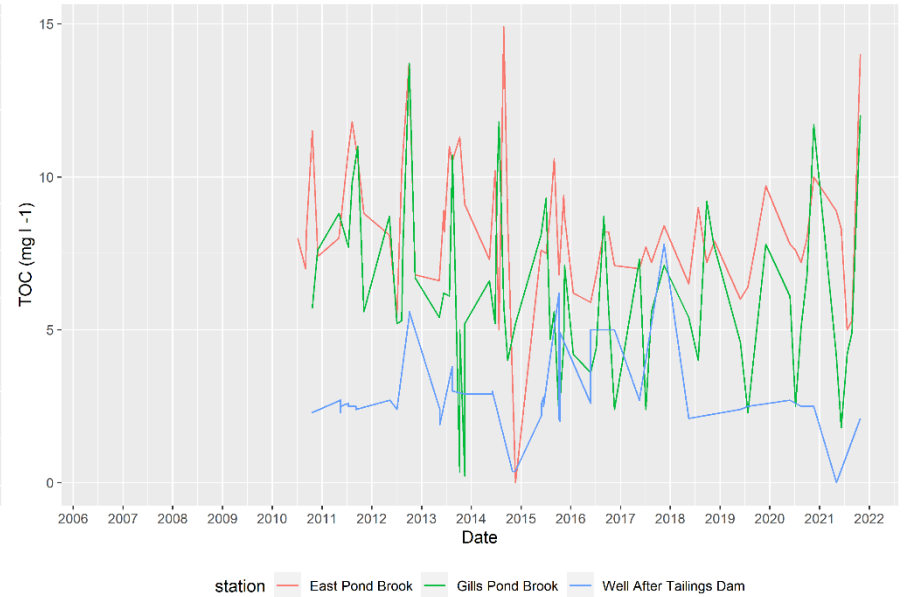
Grab samples of TOC (mg l⁻¹)
Teck Duck Pond Operations - Well after Tailings Dam A

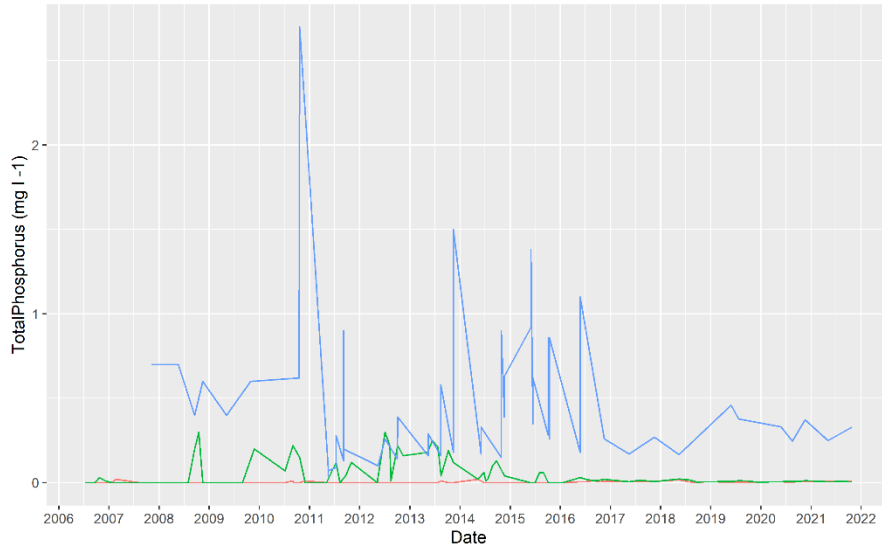
Grab samples of TotalPhosphorus (mg l⁻¹)

Teck Duck Pond Operations - Well after Tailings Dam A

station — East Pond Brook — Gills Pond Brook — Well After Tailings Dam

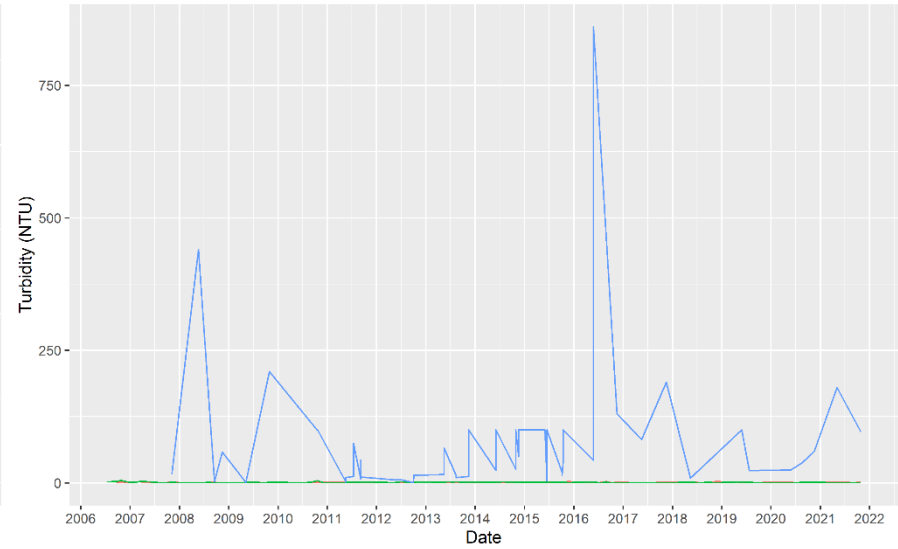
Grab samples of Turbidity (NTU)

Teck Duck Pond Operations - Well after Tailings Dam A

station — East Pond Brook — Gills Pond Brook — Well After Tailings Dam

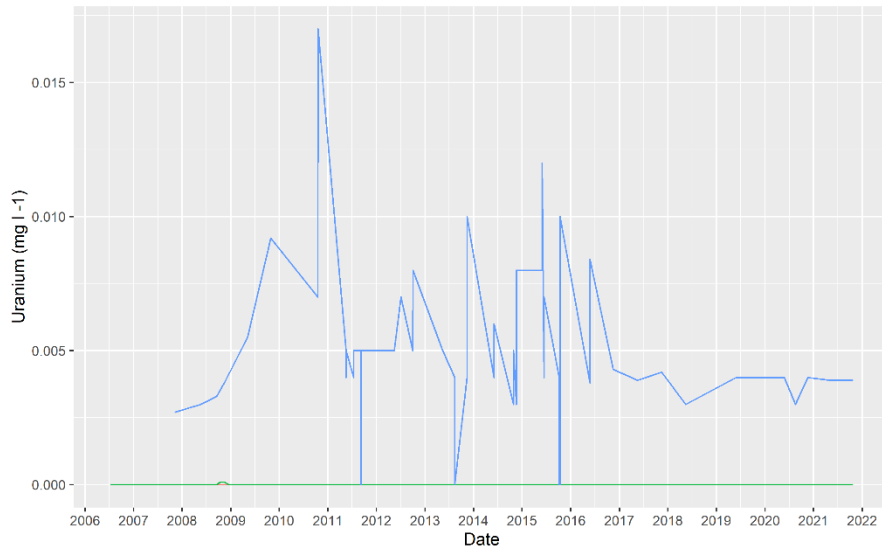
Grab samples of Uranium (mg l⁻¹)

Teck Duck Pond Operations - Well after Tailings Dam A

station — East Pond Brook — Gills Pond Brook — Well After Tailings Dam

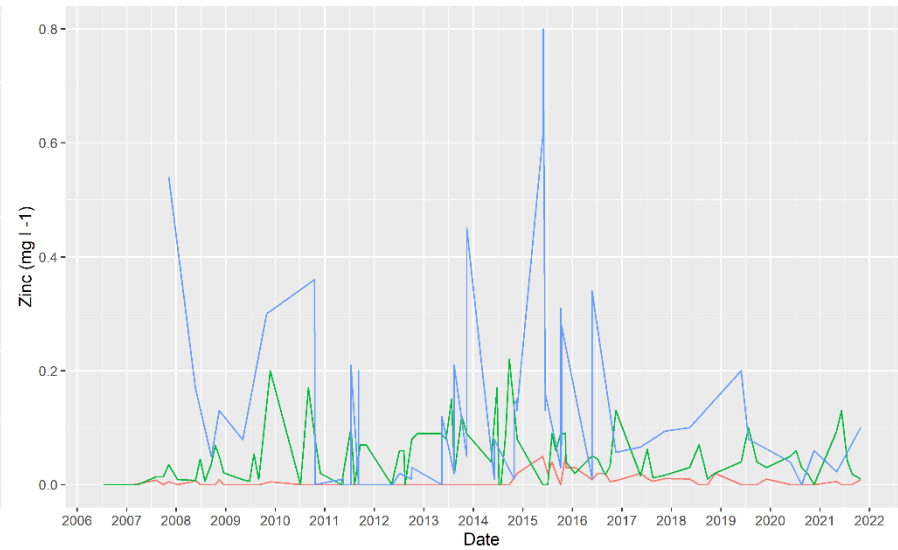
Grab samples of Zinc (mg l⁻¹)

Teck Duck Pond Operations - Well after Tailings Dam A

station — East Pond Brook — Gills Pond Brook — Well After Tailings Dam
